RESIDENTIAL BUILDING SURVEY

Croydon, Surrey CR0

Mr Q

INDEPENDENT CHARTERED SURVEYORS

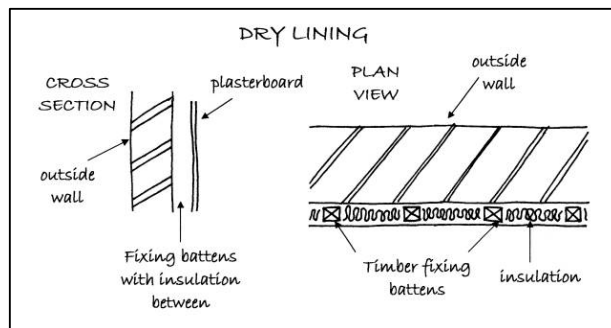
Cladding

1.1 The property is a 1970's cross wall construction, which is a construction which is no longer commonly used. Cross wall construction means the weight of the roof is supported on the main brick walls and the in fill walls (the cladding panelled walls and the render walls) are a lightweight construction. Typically in a 1970's construction they were not insulated or not insulated very well at the time of construction (although they could have been insulated after by the Local Authority).

1.2 They are likely to have used concrete lintels which can cause condensation in this age, type and style of property.

ANTICIPATED COST: In the region of £250 to £500 for investigation work, as it will need a tower scaffolding for all the cladding boards to be removed safely. Please note our comments later on about the damage and deterioration to some of the cladding boards.

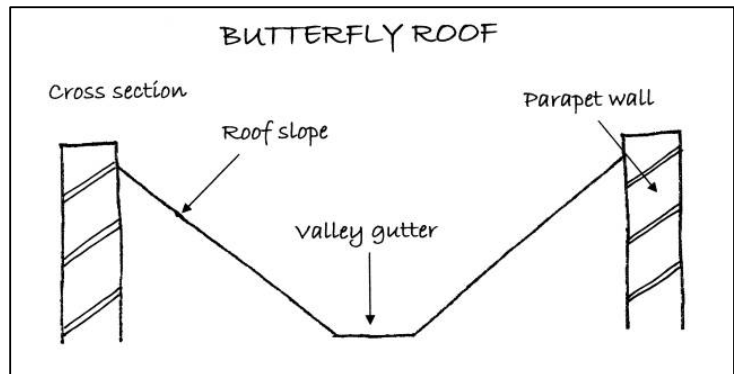
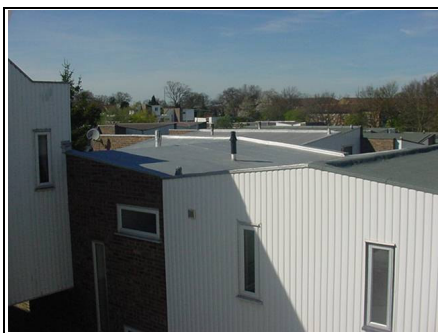
Overview of roof

Unfortunately we could not see the roof properly. We have viewed it from next door's property and can see this is a modern butterfly roof. Typically this type of roof would have been built in the 1880's/1890's and was revived in the 1970s. Both eras of roofs are well known for their problems.

We would refer you to our comments in the Executive Summary. From the photos the roof looks in reasonable condition, although we cannot see the valley gutters which are typically the problem areas, as well as the parapet walls and around the flues and drainage points.

Unfortunately we were only able to see the roof via access from next door's property, looking down from their third floor bedroom, which is not ideal. We have made our best conclusions based upon what we could see, however a closer inspection is recommended and may reveal other defects.

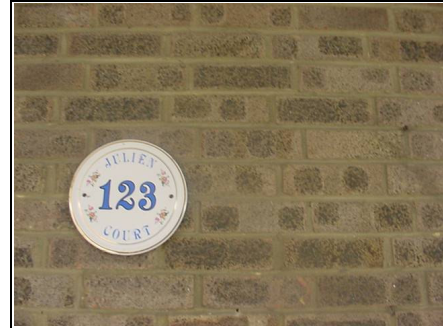
Stretcher Bond brickwork

The mastic is starting to fail and this will lead to dampness. We think some dampness is already getting into the brickwork, as can be seen in the adjoining photo. It may also be due to the window detailing.

We noted that some of the mastic seals externally to the brickwork/cladding/render were starting to deteriorate and these should be replaced as they will allow damp in.

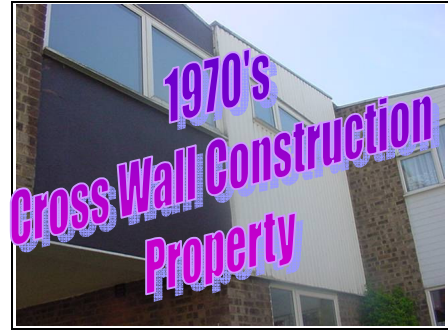
Render

Hairline cracks to the render

In this instance we can see some render cracks that have been repaired. We also noted on other buildings that the render has been completely clad over. Doing this gives the opportunity to add insulation as well as additional weather protection.

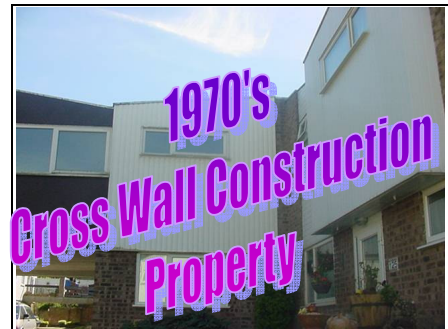
Cladding

The property has a plastic cladding. There is no way of knowing what is beneath the cladding, however with this age of property they tend to be poorly insulated and it is likely it goes on to a timber frame which in turn then has the plasterboard that is inside of the room.

There certainly looks to be a problem with the cladding in some areas where it is deteriorating at the base. To us this indicates it is getting in at roof level, possibly via the parapet wall (if you recall we mentioned in the roof section that the parapet walls can be a problem), then transferring down behind the cladding and coming out at the base. We have come across this problem several times previously.

ACTION REQUIRED: You need to check the parapet walls on the roof to ensure they are watertight and we recommend you strip back a section of the cladding to check the condition underneath. It could be that it sits on timber battens and these are rotting due to the water that is being transferred down from the roof.

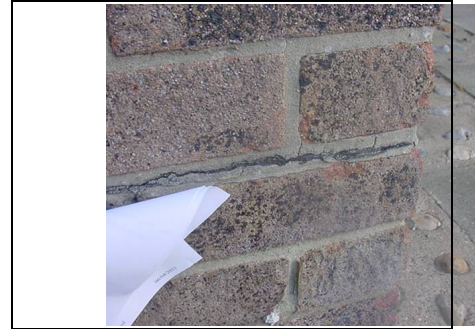
All modern properties should incorporate a damp proof course (DPC) and good building practice dictates that a differential of 150mm (6 inches) should be maintained between the damp proof course and ground levels. In this case, we could see a DPC visible which looks to be the older bitumen style DPC. Your attention is drawn to the section of the report specifically dealing with dampness.

Damp proof course

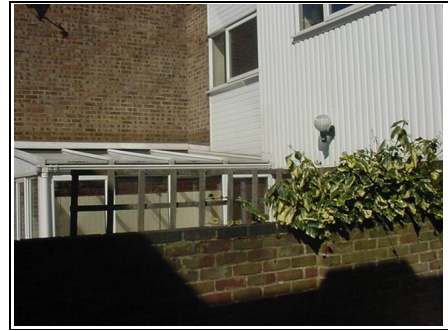
Conservatory

The property has had a conservatory extension added. We assume that some form of guarantee was obtained with this. We would also advise that typically in our experience these roofs always leak and are prone to condensation.

ACTION REQUIRED: Your solicitor to ask the existing owners about a guarantee.

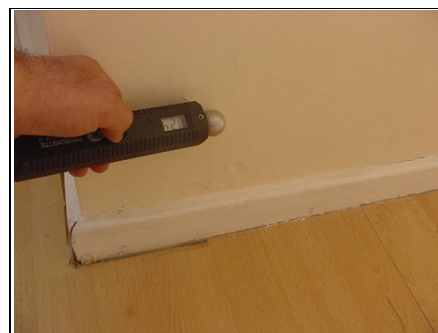
We would normally carry out tests with an electronic damp meter. However, as your property is dry-lined we were limited in what readings we could get. We carried out a visual inspection and did not find any signs of significant dampness coming through but has the property been 'painted to sell'?

Checking for rising damp

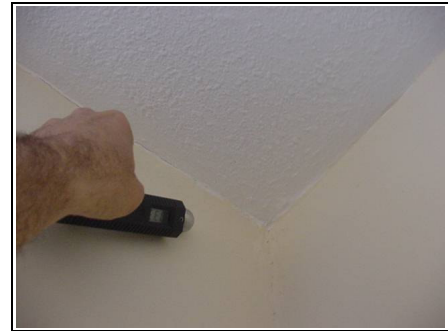
Again, we would normally carry out tests with an electronic damp meter. However, as your property is dry-lined we were limited in what readings we could get. We carried out a visual inspection and did not find any signs of significant dampness coming through but, as mentioned previously, has the property been 'painted to sell'?

Checking for lateral dampness
but property dry lined

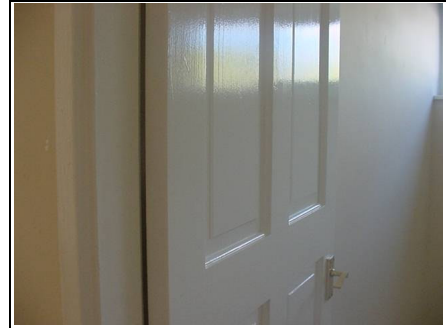
The property has pine glazed doors and panel pressed doors and, all things considered, they are in average condition and fit reasonably.

We note that the glazed doors do not have the British Standards kite mark, meaning that this is not safety glass, which it is now required to be. We would emphasise the importance of safety glass in doors, particularly if you have small children living in the property, as they can literally run into these types of doors.

Painted panel door

ACTION REQUIRED: Replace with safety glass or replace doors.

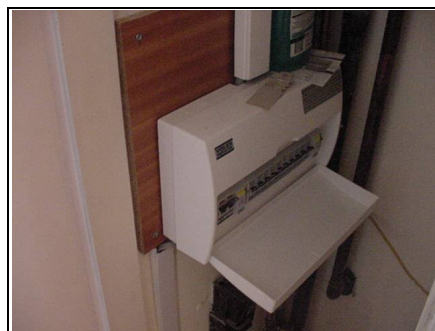
The electric fuses and consumer units were located next to the kitchen. We would date the fuseboard as being from the 1990s and not the best now available.

Fuseboard

ACTION REQUIRED: If there is no record of an electrical test having been undertaken within the last five years, it is recommended that the installation be tested by a competent electrician (NICEIC registered) and all recommendations implemented. Thereafter, the installation should be re-tested every five years.

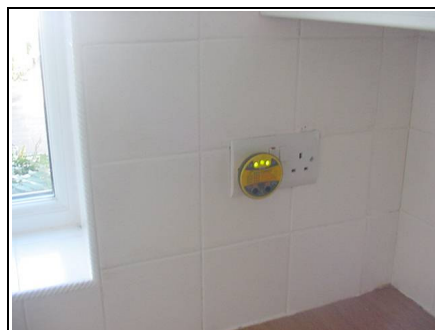
We carried out an earth test in the kitchen area to the socket point that is normally used for the kettle and this proved satisfactory.

Neither of these indicators can give certainty as to the condition of the rest of the wiring.

Earth test

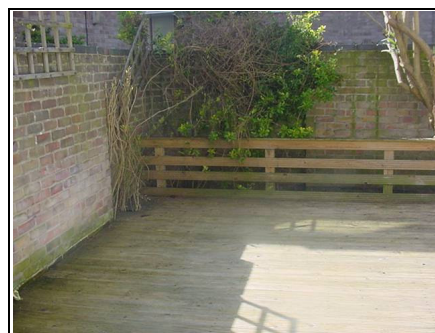
There is decking in this area. Please be aware that rodents living underneath decking is quite a common problem. The decking comes right up to the walls of the property and the garden which can cause dampness. We also do not think it is ideal to hide the drains.

Garden
