# RESIDENTIAL BUILDING SURVEY

**Dagenham,  
Essex,  
RM10 xxx**

INDEPENDENT CHARTERED SURVEYORS

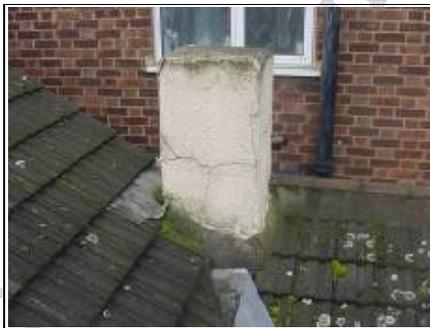
The rear chimney has a part lead flashing but needs to be all lead.

**ACTION REQUIRED:** Remove cement flashings and add lead flashings. Also employ a roofer for half a day to reposition the displaced tiles. We would also recommend that you have a supply of tiles for when the roof next causes a problem. Ask the roofer to leave you some extra tiles.

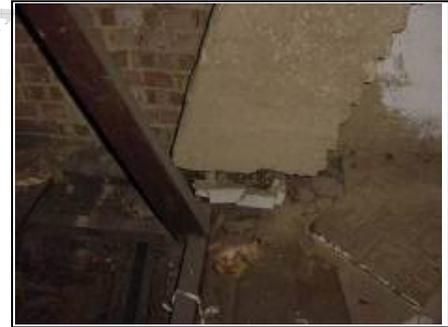
The chimney to the front left of the property ( all directions given as you face the front of the property) has been removed internally without support. This chimney would have terminated to the front of the property in what is now the through lounge before the wall was removed. Building Regulations require appropriate support such as a lintel to be added. We also see gallows brackets on older properties.

Removed chimney

**ACTION REQUIRED:** Your Legal Advisor needs to specifically check with the Local Authority for removed chimneys and associated chimney breasts and Building Regulations

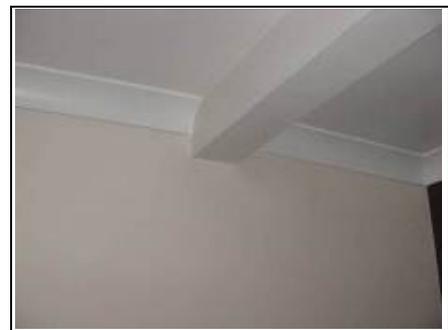
Wall removed

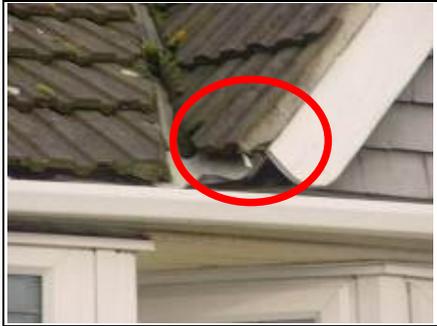
There are valley gutters to the front pitched roof where the concrete is coming away.

Valley gutter with concrete coming away

**ACTION REQUIRED:** This needs re-bedding and/or replacing with lead.

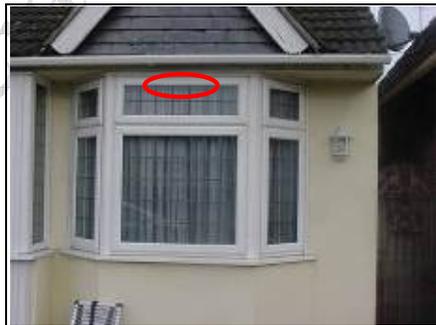
6.1 The lack of air ventilation externally as there are no trickle vents to the windows.

Front bay.  
No trickle vent in window

**ACTION REQUIRED:** Large humidity controlled extract fans to be added to the kitchen, bathroom and possibly the conservatory. If this is not carried out you may find black mould is occurring. We are still in the early days of discovering the health problems associated with this black mould.

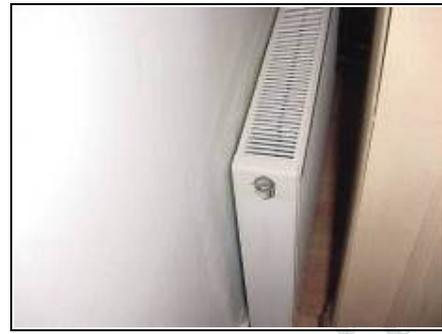
6.2. The lack of good air circulation internally due to the radiators being placed on internal walls rather than under windows.

Radiator on internal wall

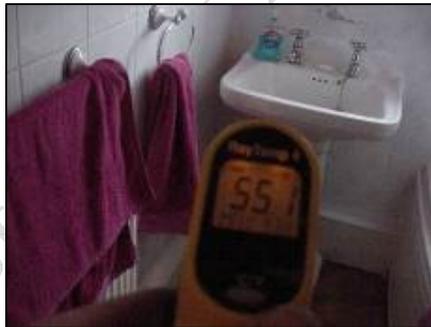
This is the highest difference in temperature we have ever had between the top and bottom of a wall.

Surface temperature reading at the bottom of the wall is 55

**ACTION REQUIRED:** We recommend you start off with the other alterations that we have mentioned earlier such as adding large humidity controlled extract fans and trickle vents to windows. We would also recommend taking care over what is

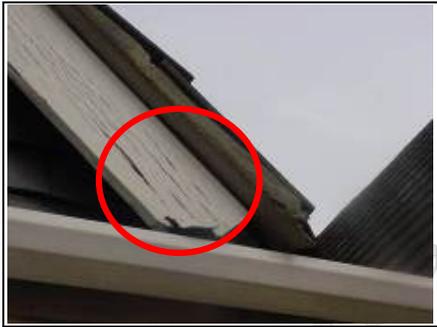
Fascias need painting

**ACTION REQUIRED:** Re-decorate.

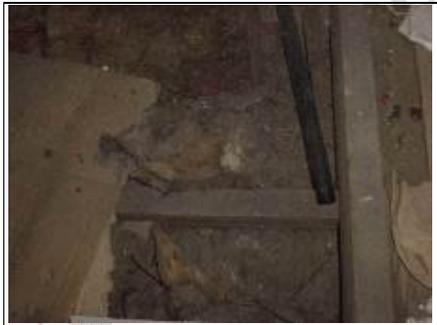
With us moving more and more towards energy efficiency measures in buildings we would note that the roof was not insulated and that the conservatory area was not double glazed. It would be relatively hard to double glaze within the wood units but it is possible although the sealed units may suffer from movement and could break the seals. Secondary glazing may be an option.

No insulation

**ACTION REQUIRED:** Insulate the roof but ensure it is appropriately ventilated and also consider double glazing to the conservatory.

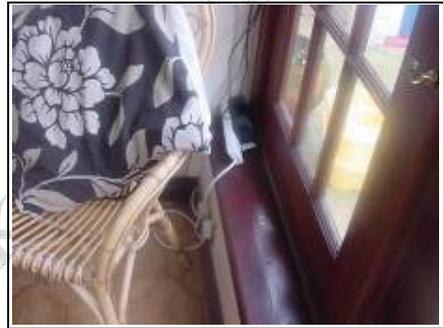
Extension lead within the conservatory

**ACTION REQUIRED:** Replace the fuse board and you may wish to add additional socket points.

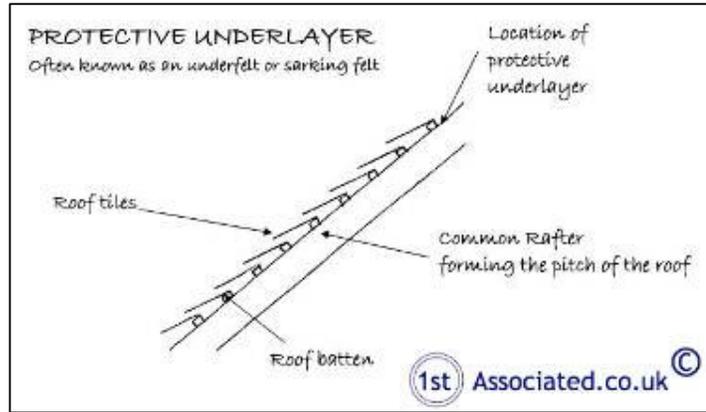
Protective Underlayer

When we inspected the loft space we found a Hessian based Bitumen membrane behind the building paper. This type of protective membrane has been used since the 1960s. We cannot confirm its condition as it was hidden by the building paper but the area that we opened, up as seen in the photo, was in average condition.

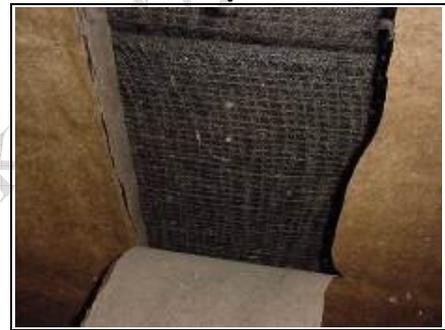
Hessian based underlayer behind the building paper

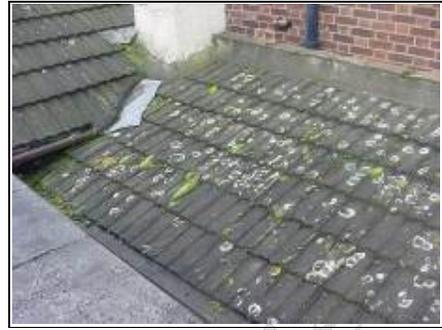
Rear single pitched roof

This is clad in concrete tiles and has a fair amount of moss on it. Again this needs cleaning particularly as it goes into the awkward and poorly detailed valley gutter to the rear. Remember you will rarely see these valley gutters so if there is a problem the first time you will notice is because of dampness inside the property.

**ACTION REQUIRED:** Please see our comments within the Executive Summary.

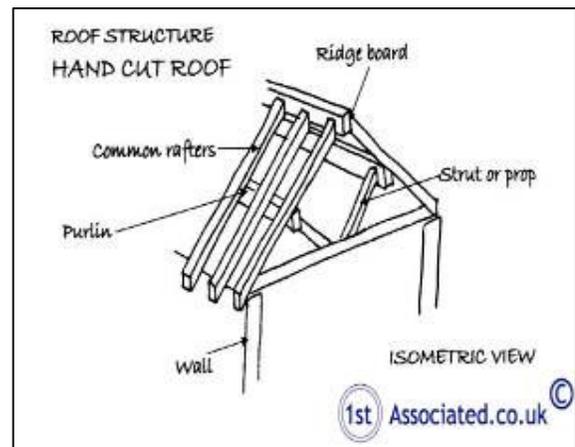
Cut timber roof

This type of roof structure has what is known as a cut timber roof. This is a roof that is purpose made and hand built on site. Without the original design details we cannot categorically confirm that there are no defects; however it is in line with what we typically see.

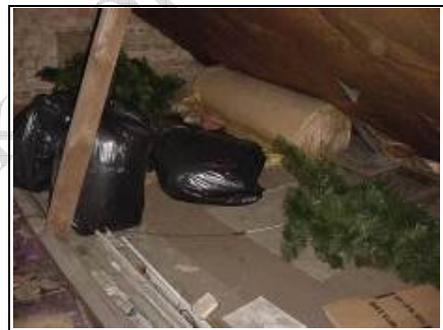
Our examination was limited by the general configuration of the roof and the stored items. Our view was also limited by the building paper so we could not see the common rafters and these are the rafters that form the pitch of the roof. What we could see was generally found to be in average condition for its age, type and style. It is, however, feasible that there are problems in the roof that are hidden.

Stored items limit our view to the ceiling joists and the building paper limited our view to the common rafters..

**ACTION REQUIRED:** The only way to be 100 per cent certain is to have the roof cleared and checked.

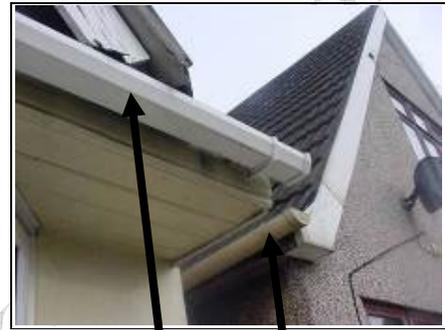
Profile plastic gutter

There may be some minor leaks but most people would be happy to live with these providing repairs are carried out within the next six to twelve months. Specifically we would advise you that the front left hand gutter would benefit from a slate being put between the guttering and the building to protect it from dampness.

**ACTION REQUIRED:** We would recommend you stand outside the property next time it rains heavily and see how well the drains cope with the rainwater particularly looking at the guttering and the joints.

We would also recommend that the gutters and downpipes are cleaned out, the joints are checked and the alignment checked to ensure that the gutters fall towards the downpipes.

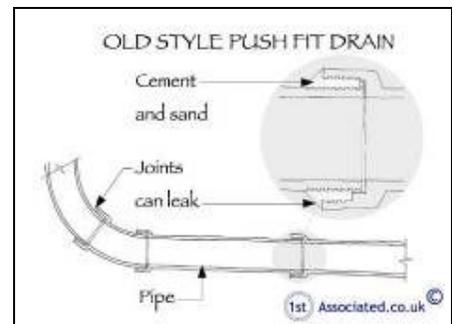
We noted cracking on the right hand neighbours building. This may indicate some leaks to the drainage. Older drains tend to be a push-fit type system that do leak.

Push fit drain

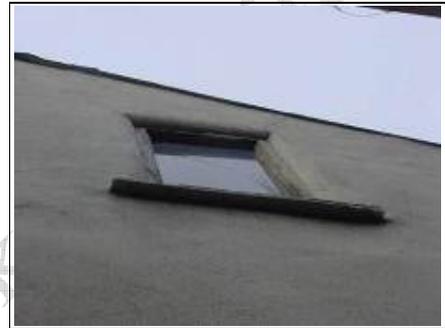
With regard to the window drip detail there are not any windows that should have a drip detail apart from the side windows, which we can see, do not.

Side window

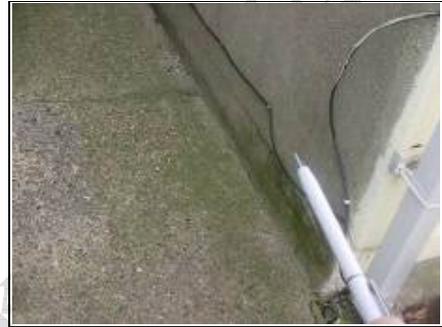
All modern properties should incorporate a damp proof course (DPC) and good building practice dictates that a differential of 150mm (6 inches) should be maintained between the damp proof course and ground levels. In this case we cannot see a DPC because of the render although to the left hand side there does appear to have been some slippage on a damp proof course. In this era of property the damp proof course it likely to be slate.

Slippage on DPC

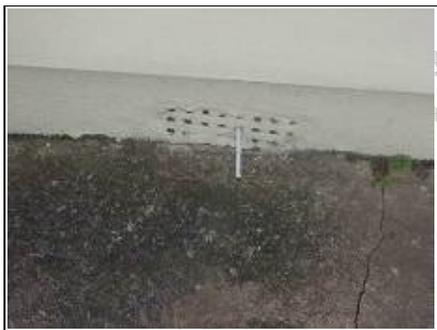
There are air bricks to the front bay at low level and we could also see some to the side of the property. We would however prefer to see some airbricks to the rear of the property to allow a through flow of air. Air bricks are essential to have a through flow of air as this helps to reduce the chances of wet rot, dry rot and woodworm.

Air brick to the front bay at low level

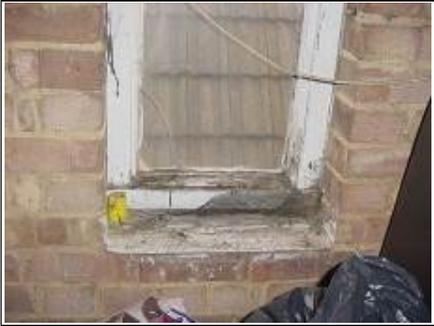
Timber windows in roof space need re-decoration

**ACTION REQUIRED:** We would suggest that it may be worth adding trickle vents to the double glazed windows. The timber windows on the right hand side that give light into the roof space are in need of repair

and redecoration. Please see our comments within the executive Summary.

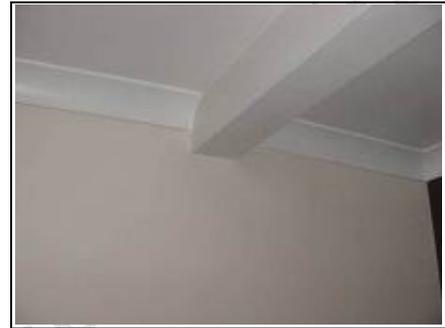
A wall has been removed that is not to Building Regulations (if Building regulations existed when it was done) as it has not got a pier. Typically this would be 450mm.

Removed wall

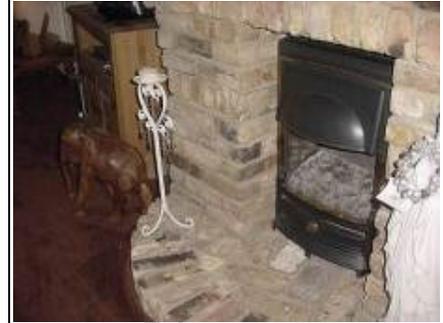
Fireplace in lounge  
The owner did not say if this is used

At the time of the survey the chimney was not in use. When we spoke to the occupier, as we understood it, she said that she did not use the chimney, Note if you do wish to use the chimney you need to have it swept and the lining checked in this age of property. If you do not propose to use the chimney it should be capped and ventilated to prevent dampness.

**ACTION REQUIRED:** Please see our comments within the Executive Summary with regard to the chimney having been removed.

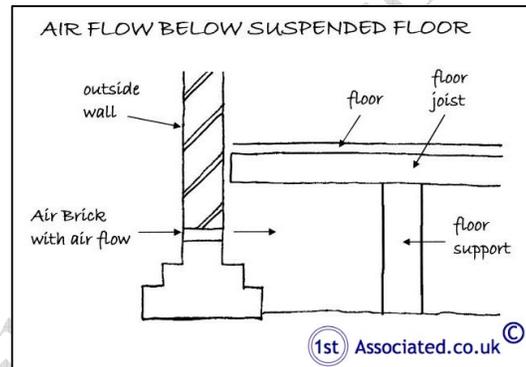
The floors to the front of the property are suspended timber floors which require air movement underneath to minimise wet rot, dry rot and woodworm. However this is blocked by the solid floor.

Suspended timber floor

**ACTION REQUIRED:** We recommend that air bricks are added in the Utility Room or the cupboards in the kitchen.

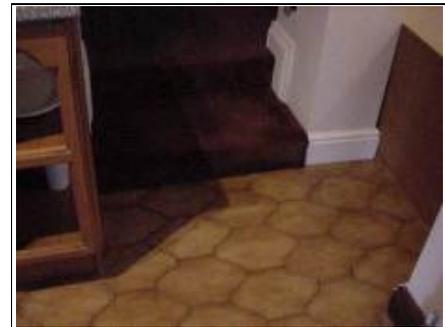
The floors to the rear felt solid under foot so we have assumed that they are constructed in concrete which will block the suspended timber floor. Sometimes vents are added but we cannot see them in this instance.

Step down from the timber floor to the concrete floor

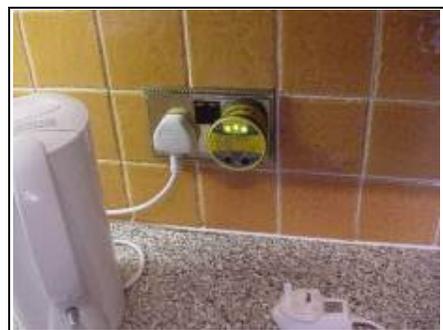
Earth Test

We carried out an earth test in the kitchen area to the socket point that is normally used for the kettle, this proved satisfactory.

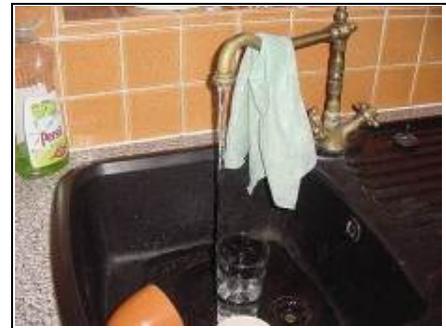
When the taps were run to carry out the drainage test we checked the pressure literally by putting a finger over the tap and this seemed average. The Water Board have to guarantee a certain pressure of water to ensure that things like boilers, particularly the instantaneous ones have a constant supply of pressured water (they would blow up if they didn't!).

Running the tap to carry out drainage test and to check the pressure

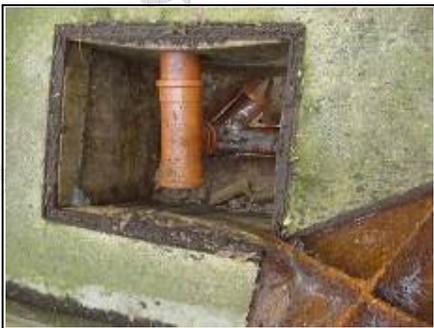
Manhole- rear right

We have identified one inspection chambers / manholes to the rear right hand side (this is where we found most cracks in the render).

We duly lifted the cover and found it to be free flowing at the time of our inspection.

From what we could see it is brick built. It appears to have had a new plastic pipe added to it which we assume is from the kitchen.

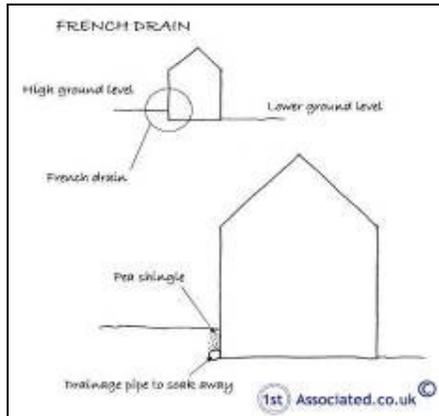
French Drain

French drains would typically have been used where water was getting into a property.

**ACTION REQUIRED:** Please see our article in the appendices.

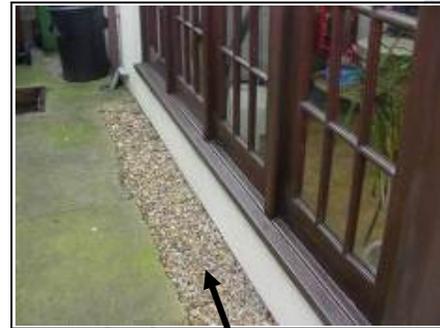
Is this a real French Drain?
