# RESIDENTIAL BUILDING SURVEY

East Dulwich,  
London  
SE22

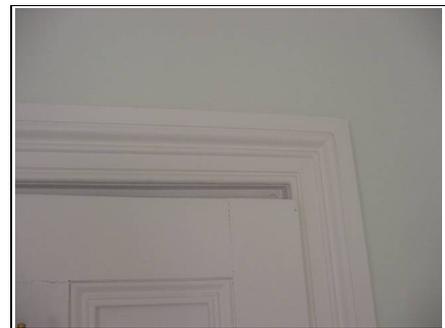
Movement can be seen in the property via movement in the doors

Movement can be seen around the doors

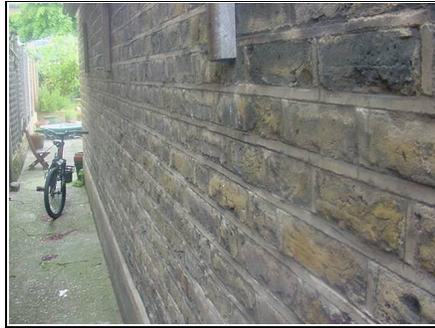
The walls have been repointed in a cement mortar, they would have originally had a lime mortar, which traps in dampness (although to some extent this age of property should have slightly damp walls).

Cement mortar repointing

**ACTION REQUIRED:** We would recommend gradual repointing of the property, with a regular visit from an old bricklayer who knows how to work in lime mortar, who uses a stiff brush against the mortar to remove it.

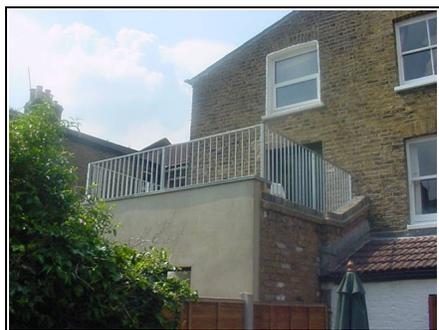
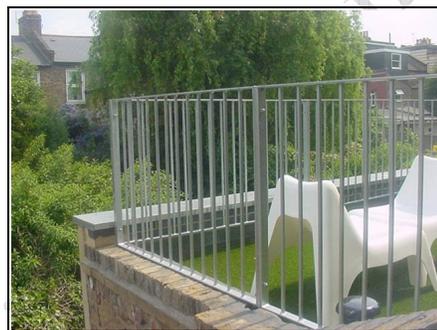
To the rear of the property is a balcony that looks relatively new that overlooks the garden. This may or may not be a concern to you (we personally would not like it). This should have been screened.

Next door's balcony

Close up of next door's balcony

**ACTION REQUIRED:** Your legal adviser to check and confirm there has been planning permission for this.

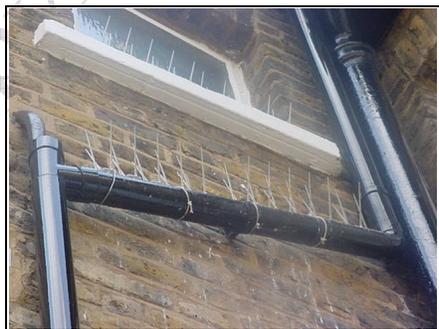
We noticed there were bird defence spikes around the property, which may mean there has been a problem with birds near the property. This has blocked some of the windows from opening properly.

Pigeon defence spikes

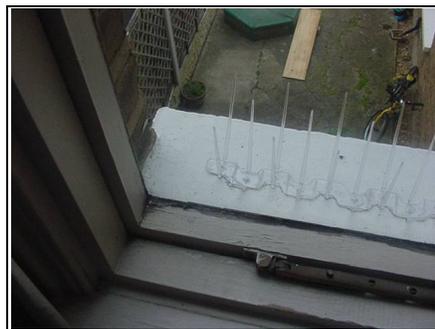
These also block the window from opening

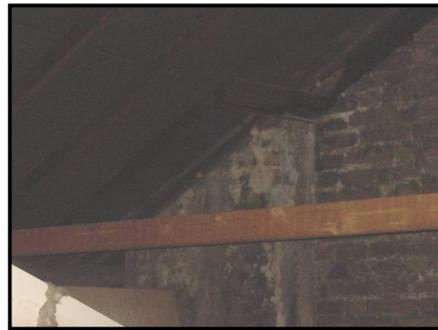
Dampness visible inside

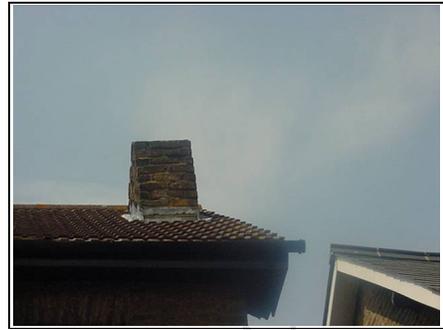
Front left hand chimney  
(photo taken from rear of property)

This is a brick built chimney that has been reduced in height, with a lead flashing and no chimney pots.

Unfortunately we were unable to see the top of the chimney known as the flaunching, we therefore cannot comment upon them.

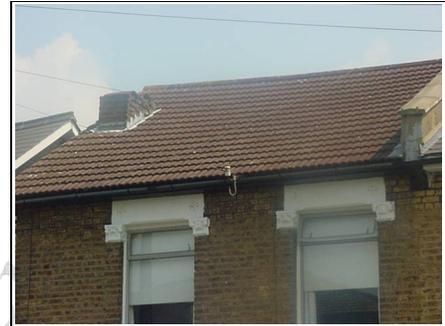
The main roof is pitched and clad with concrete tiles and, from ground level, this looks in average condition considering the roof's age type and style. We believe this roof replaced the original roof and is much heavier.

Concrete roof tiles

**ACTION REQUIRED:** Please see our comments in the Executive Summary. Carry out periodic inspections and maintenance of the roof, as required.

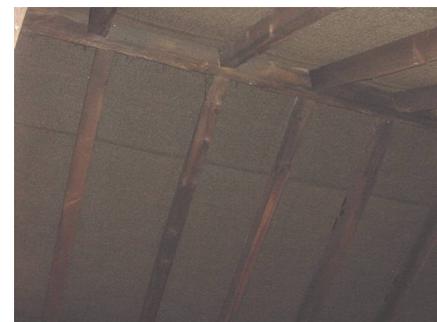
When we inspected the loft space we found a Hessian base Bitumen membrane. This type of membrane has been used since the 1960s. We generally found it to be in average condition, with damage in some areas which is what we typically find.

This photo shows the common rafters (the ones that form the pitch of the roof) and the dark area between is the protective underlayer. 33

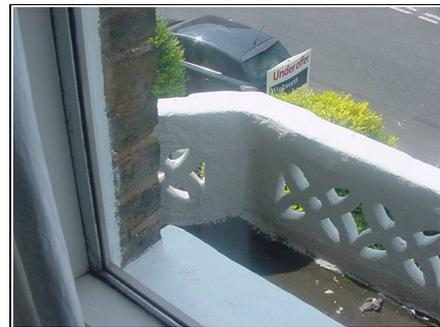
Bay roof

The bay roof is covered with felt.

**ACTION REQUIRED:** Please see our comments in the Executive Summary about the outlet and the general trouble the property will have with these bay windows.

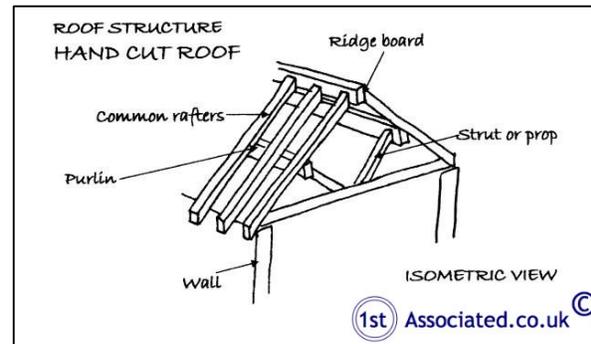
The roof has been amended and we can see new timbers within it. The amendments should have had Building Regulations Approval for a new roof, unless this roof is very old prior to Building Regulations requirements. Please see our comments in the Executive Summary.

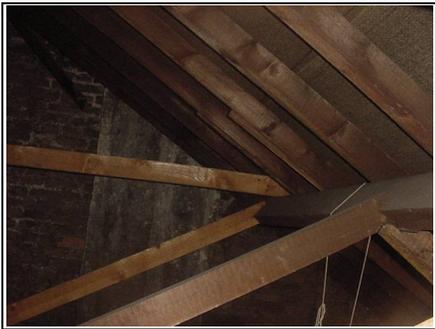
Our examination was limited by our concerns of accessing the roof so we have viewed everything from a ladder via the access hatch. We can see that extra timbers have been added to give additional support. As mentioned, you need to establish that these are correctly added via Building Regulations.

New back to back timbers have been added

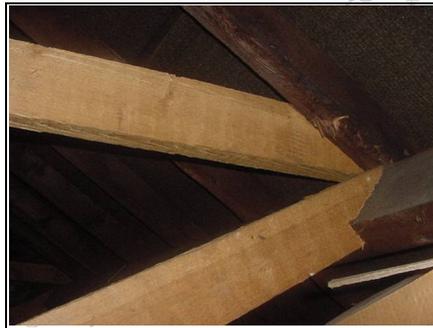
Close up of new timbers

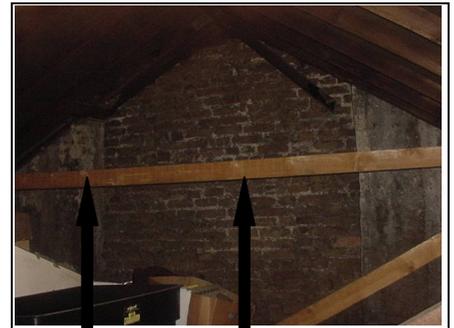
Timber coming away from chimney

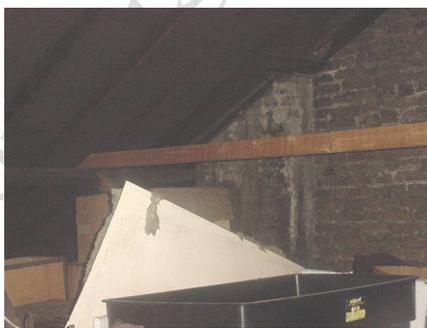
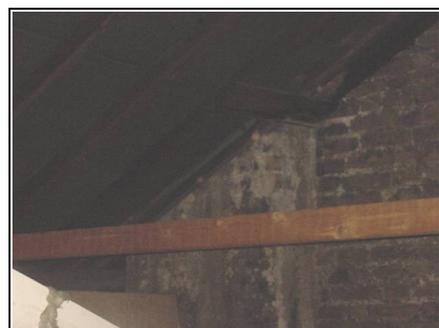
The colour of the chimney shows that dampness is getting in

**ACTION REQUIRED:** The only way to be 100 per cent certain is to have the roof cleared and checked.

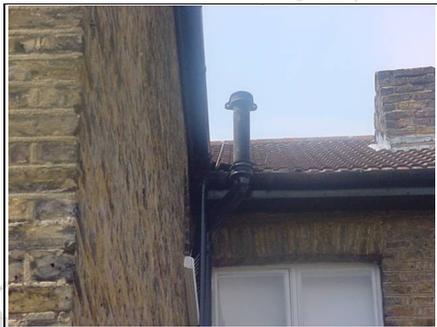
The main soil and vent pipe is cast iron, with other pipes being in plastic. There are no obvious visual signs of defects.

Soil and vent pipe

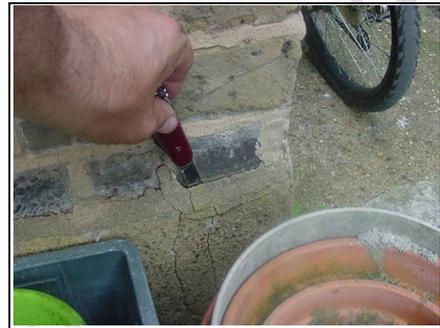
Close up of cement mortar

**ACTION REQUIRED:**  
Please see our comments  
in the Executive  
Summary.

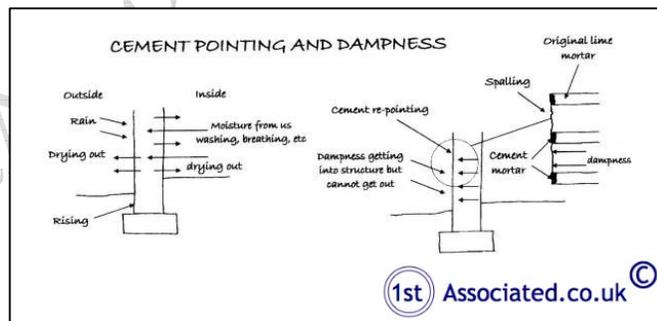
There looks to have been repointing carried out around the rear window. The owner advised they had not carried out any work to this area, although it looks like there has been.

**ACTION REQUIRED:** Your legal adviser to specifically ask the question what work has been carried out with regard to the walls.

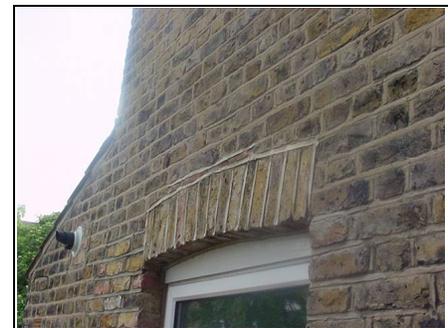
Looks to have been repointing over the rear window

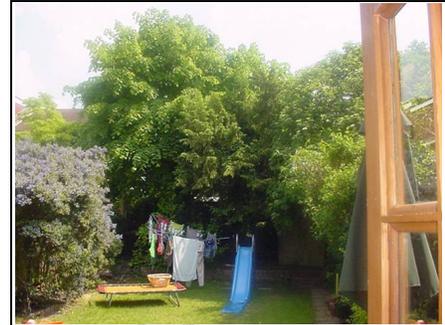
There are trees in the rear garden which may be within what insurance companies would term as influencing distance of the property.

Trees in rear garden

**ACTION REQUIRED:** We recommend you speak to an insurance company before you purchase this property (although we are advising against purchasing it) to confirm insurance requirements.

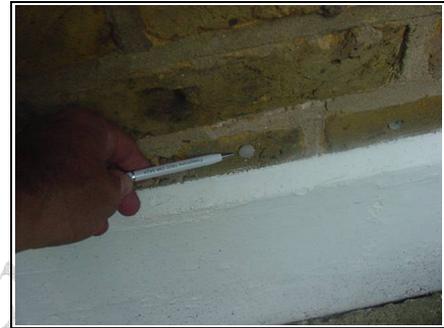
Pen pointing to injected DPC

There is a rendered plinth around the property which normally has a slate DPC in it. In addition to this we can see that an injection course has been added just above it and further to this we can find some dampness in the property so we do not believe that the DPC is working. This is because the ground outside is at too high a level to the inside ground.

We therefore recommend a French gully. However, we would also comment that the kitchen is not a habitable room so you may be able to live quite happily without it, but many mortgage companies do require this type of work.

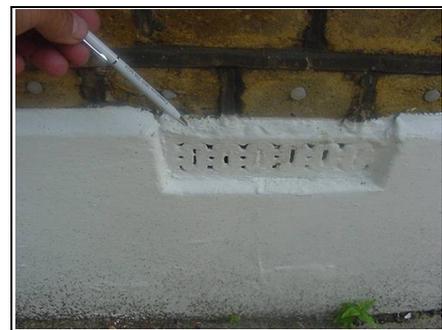
Air brick to front bay needs unblocking

**ACTION REQUIRED:** We would suggest that you clear all the air bricks to allow a through flow of air

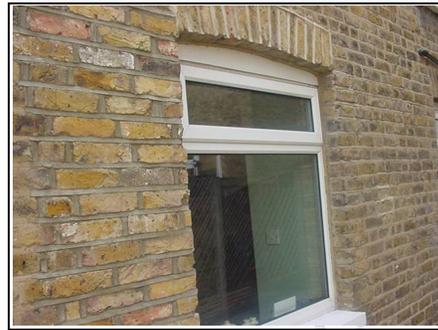
To the rear we noted windows from what we would term the cheaper end of the market from the fact there were no trickle vents. It is, in our opinion, a shame to have lost the original windows being replaced by the aluminium and plastic windows.

No trickle vent to window

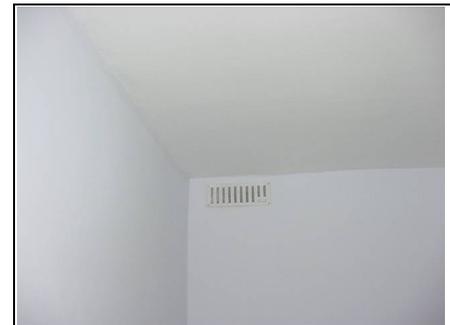
Air vent in rear bedroom will help reduce condensation

**ACTION REQUIRED:** We would recommend humidity controlled extract fans be added to kitchens and bathrooms.

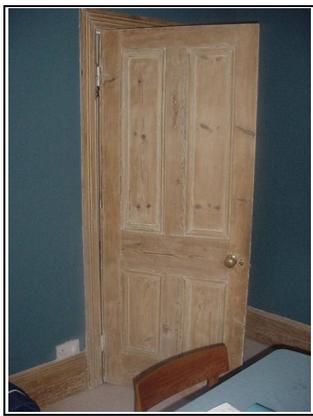
Panel door stripped of paint

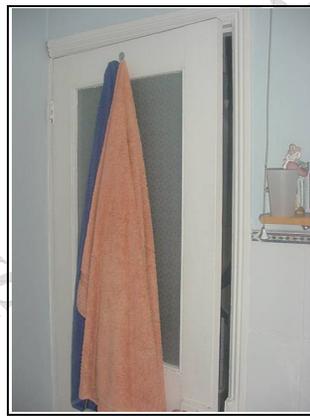
Bathroom door with opaque glass panel

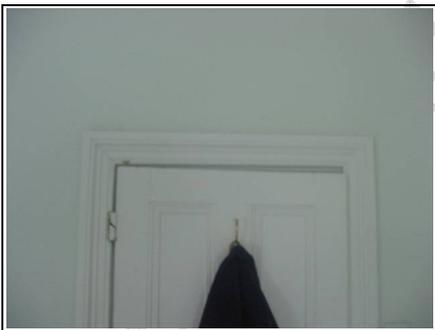
The property has painted panel doors, which is how they originally would have been, and some stripped panel doors, which is how many people like their doors to be today. There is also a glazed door to the bathroom with an opaque glass. There has been some movement in the building which can be seen in the doors.

Twist in door to master bedroom, emphasised by the door not shutting

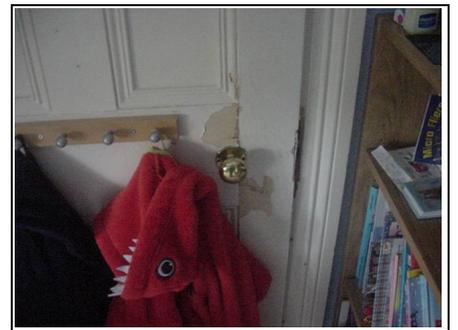
Door to middle bedroom needs some work

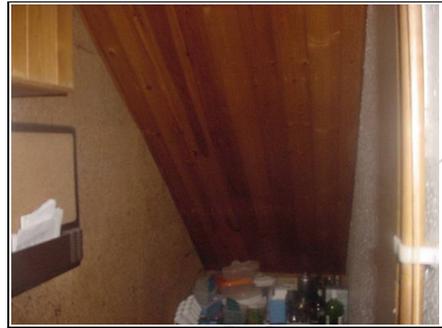
We were unable to examine the underside of the stair timbers due to it being lined, which precluded our inspection, so we cannot comment further upon the stair structure. We can, however, say that the lining gives a resistance to the spread of fire if such circumstances were to occur.

Stairs lined

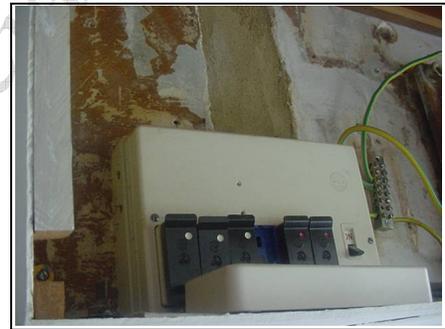
The fuse board is from the 1960's/1970s and looked dated and much better are now available.

Dated fuseboard

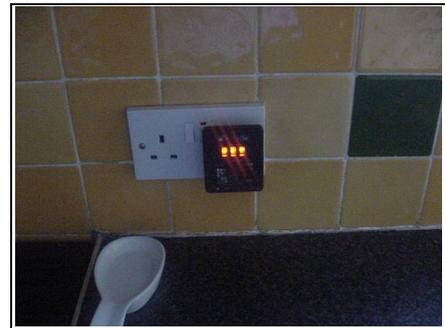
We carried out an earth test in the kitchen area to the socket point that is normally used for the kettle, this proved satisfactory.

Earth Test

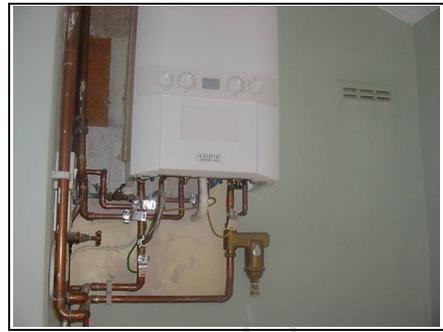
The wall mounted boiler was located in the kitchen, it is manufactured by Logic, a make we rarely come across and cannot comment upon how well it performs.

Our limited inspection of the hot water and central heating system revealed no evidence to suggest any serious defects but we would nevertheless recommend that the system be tested and overhauled before exchange of contracts and that a regular maintenance contract be placed with an approved heating engineer.

Logic boiler

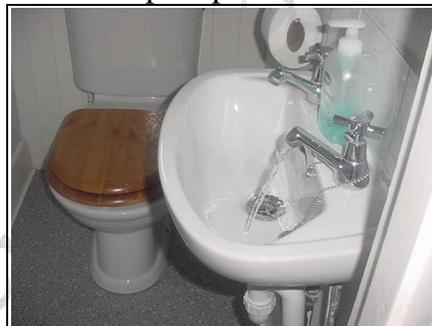
The cold taps have been run for approximately quarter of an hour in the bathroom and kitchen. No build up or back up was noted.

Running water for 15 minutes

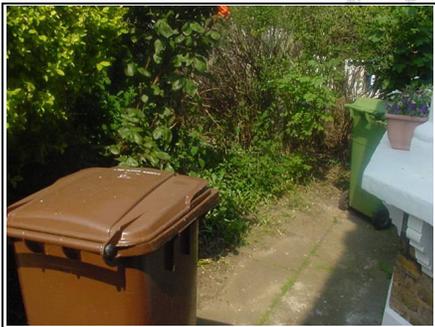
Front Garden

The property has a small front garden. The front path is deteriorating and needs putting back together again.

**ACTION REQUIRED:** Make repairs to front path. The bushes to the front of the property would also benefit from being cut back.

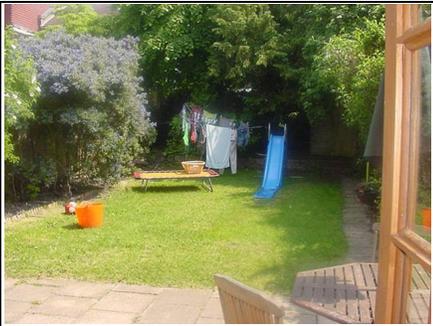
Rear Garden

The rear garden is grassed with a patio area and trees to the rear.

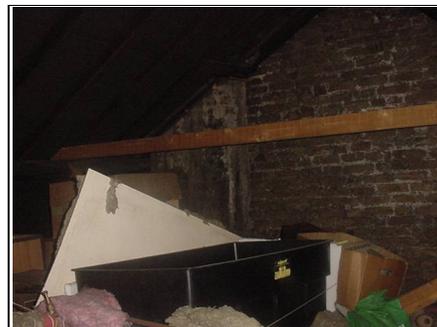
as we were not happy to go into the roof and it being full of stored items which limited our view further

Mass of stored items in roof
