RESIDENTIAL BUILDING SURVEY

Dulwich,
SE24 xxx

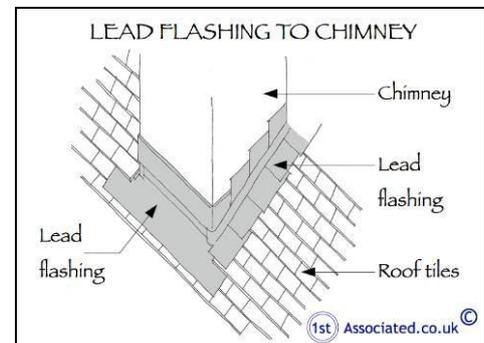
Lead flashing

Some of the chimneys appear to be letting dampness in. To the rear of the rear chimney, where we could see the flashing properly, we noted a cement flashing rather than a lead flashing has been used. The cement flashings generally tend to become brittle and crack over time and allow water in.

Flashings prevent dampness from entering the property, usually at junctions where materials change. Such a junction is the one between the chimney and the roof.

ACTION REQUIRED: We would recommend that all flashings are checked and replaced with lead flashings as shown in the adjoining sketch.

ANTICIPATED COST: The work will only cost a few hundred pounds but the difficulty is gaining access to these areas and is likely to need scaffolding. We would estimate the cost of this to be in the region of £1,500 to £2,500; please obtain quotations.

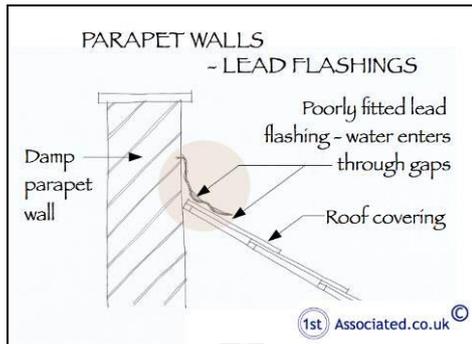
Parapet wall

We can see also different cements indicating that repair work has been carried out. Internally we can see dampness is getting in.

ACTION REQUIRED: Your Legal advisor needs to specifically request what work has been carried out to the parapet walls and if there are any guarantees that comes with it. If not we suspect that you will end up renewing this poor quality flashing.

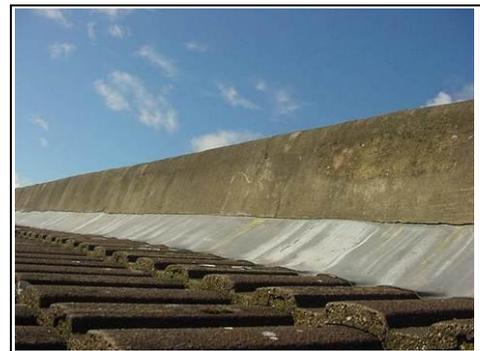
Parapet wall and cover lead flashing.

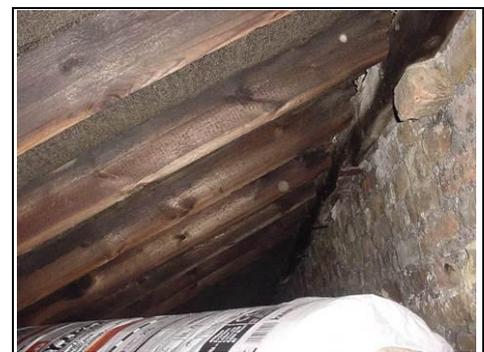
The darker timber indicates that dampness is getting into the roof space

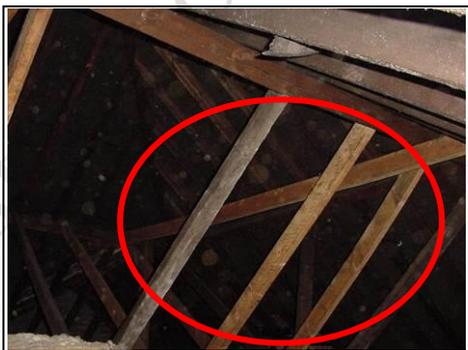
The property would originally have had a slate roof which has been replaced with a heavier concrete tile. We can see from within the roof space that original timbers have been added to help support the roof. We would comment that the original hipped cut timber roof has timbers smaller than we would normally expect.

The diagonal and horizontal timbers are extra timbers added to support the roof

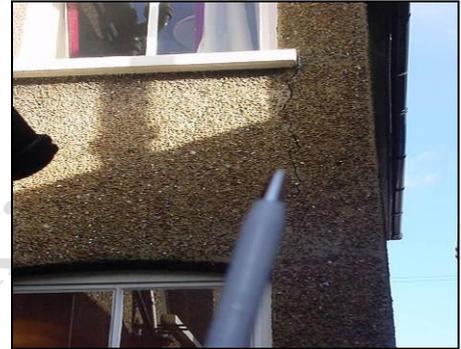
We noted cracking to the render in the rear wall. We could not see any cracks internally but we did, however, note cracks on next doors property. This leads us to believe that the cracks are possibly related to leaking drains.

The render has been carried out in a cement mortar which is slightly too hard and where there has been movement around the windows this has caused cracking in the render.

Cracking to your rear wall

ACTION REQUIRED: Have a closed circuit TV camera report of the drains carried out to check if they are leaking and repair as necessary.

The only way to be one hundred per cent certain with regard to the cracking is to have it monitored for a year as recommended by the Building Research Establishment (BRE) and most insurance companies.

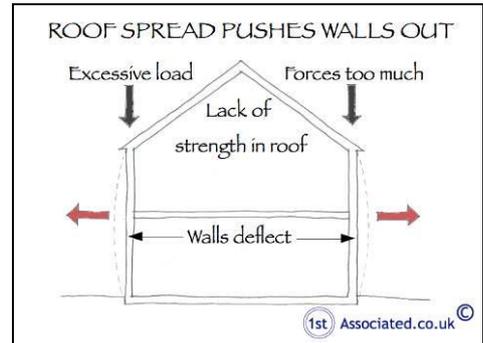
Roof spread

Movement within the hipped roof is causing roof spread.

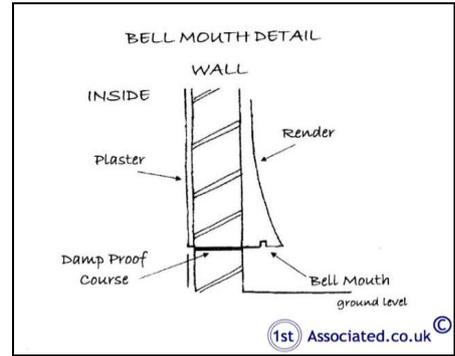
Bell mouth detail

We found dampness to the rear of the property. We can see that damp proof courses have been inserted in the past which are generally considered not to work in this type of older style property.

ACTION REQUIRED: We would recommend that a bell mouth detail is added to the base of the render (see

ANTICIPATED COST: To add the bell mouth to the render will be approximately £2,000 to £3,000; please obtain quotations.

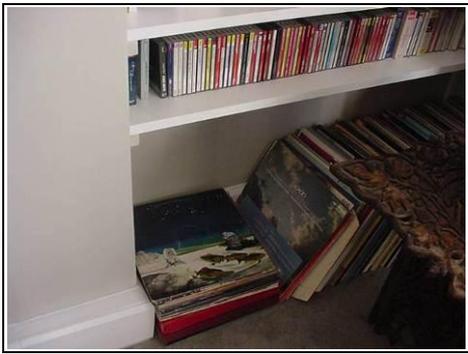
Where we took readings in the lounge

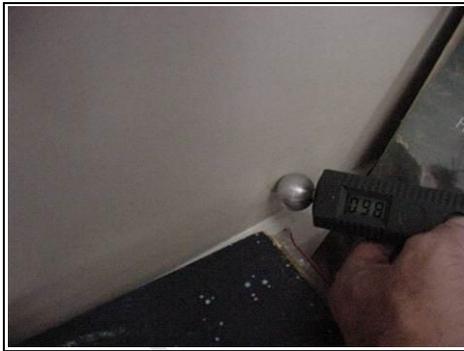
Taking damp readings in the late 90's. We would typically expect readings of 30-60

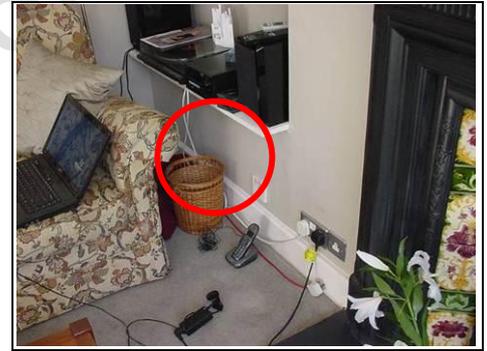
This area has a false wall out and we cannot take readings here and we would make a similar comment with regard to the kitchen

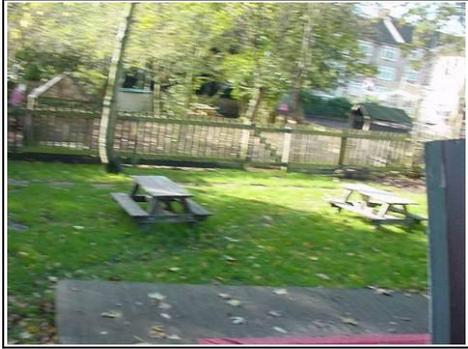
At the back of your property

To the rear of your property is what we originally thought to be a pub or a club of some sort but from looking at the location plan it appears to be Herne Hill School. From what we could see there is a childrens climbing frame, seating and what looks like a sand pit or pond in the grounds?

ACTION REQUIRED: This needs further investigation by you.

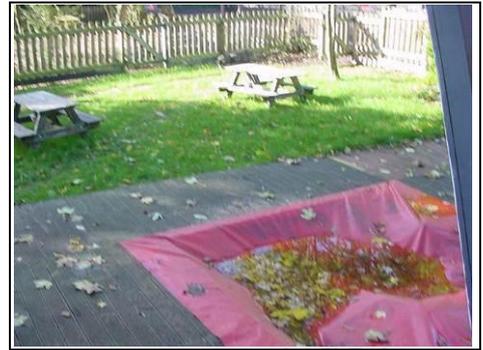
Sand pit or pond?

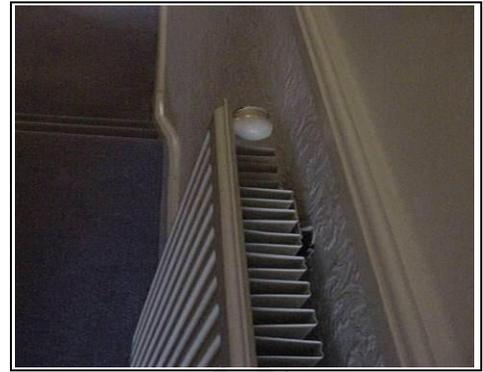
We would also draw your attention to the radiators which are a combination of single and double panel radiators. Single panel radiators may not warm the house as much as you would like or will struggle to reach the temperature you would like.

Single panel radiator with convector

ACTION REQUIRED: Replace the single panel radiators with double panel radiators. We would recommend the internal radiators are moved under windows where possible if you are upgrading.

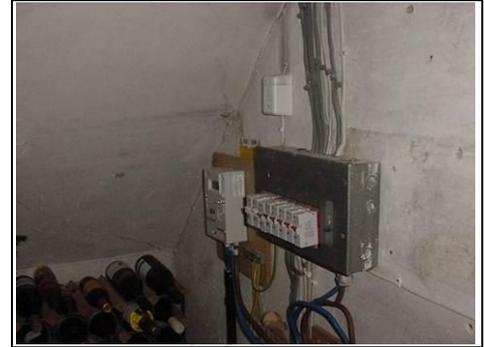
Fuse board

The fuse board looked dated circa 1970's /1980's and better are now available.

ACTION REQUIRED: Check all wiring is tested to Institute of Electrical Engineers (IEE) standards and carried out by an NICEIC registered and approved electrical contractor or equivalent unless the existing owner can provide up to date certificates.

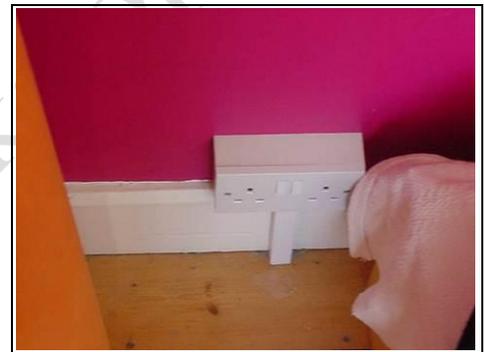
There are some surface mounted electric socket points. This tends to mean DIY electrical alterations.

Surface mounted electric socket

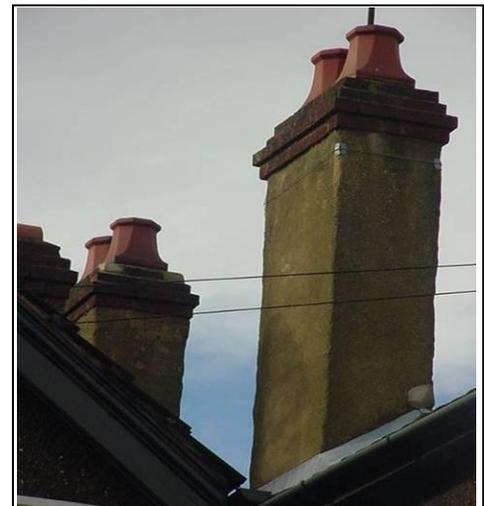
Chimney - front left

This chimney is finished in render with a lead flashing to the render with a brick top and two chimney pots. From what we could see from ground level it looked in average condition considering its age, type and style although in an exposed location such as this we would expect some dampness to be getting in.

Unfortunately we were unable to see the top of the chimney known as the flaunching, we therefore cannot comment upon them.

ACTION REQUIRED: Periodically inspect the chimney.

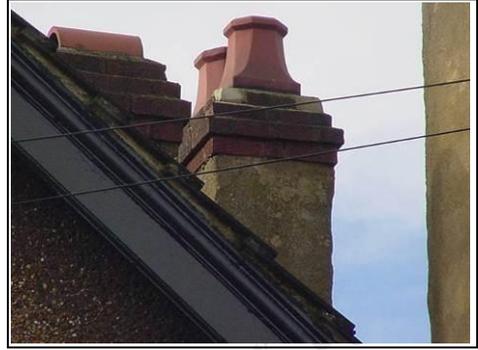
Chimney – middle left

This chimney is finished in render with two chimney pots. We would make similar comments as to the first chimney although in this case our view was much more limited.

ACTION REQUIRED: We would take the opportunity to check both of these chimneys as soon as possible.

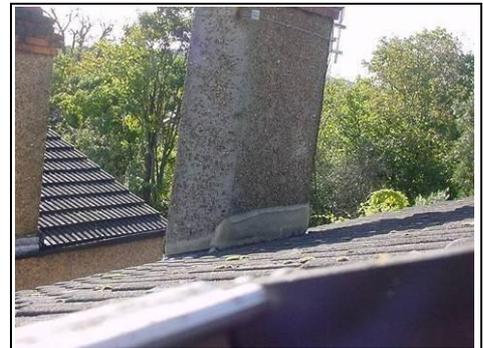
Poor detail to back of rear chimney

ACTION REQUIRED: Please see our comments within the Executive Summary. We see no reason why cement flashing would not have been used on the other chimneys as well so we recommend these are investigated and work carried out as necessary

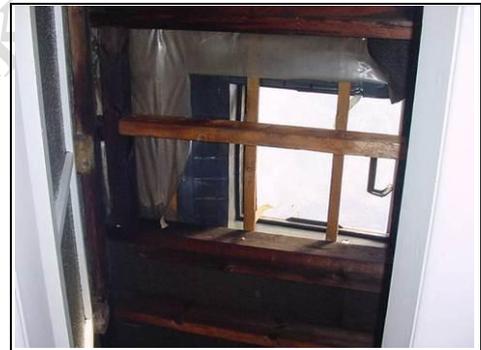
There is a rear roof window that we could not see from ground level but which we noted from within the roof space. This roof window is from the cheaper end of the market and is a plastic window and surround. From our experience these do leak and should be replaced. However no leaks were noted during the course of our survey.

Looking up at roof window

ACTION REQUIRED: We would recommend replacing before the winter of 2013.

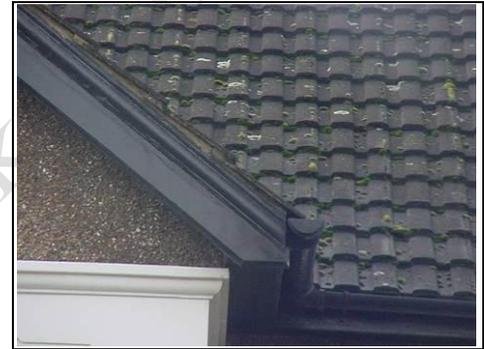
This age of property would originally have had a slate roof. The problem with adding a concrete roof to a roof that was originally slate is the extra weight. Building Regulations now require this to have additional support in the roof. We can see some additional supports in this roof but whether they would meet Building Regulation approval is another matter.

Concrete tiles
(replacing the original slate)

ACTION REQUIRED: Please see our comments within the Executive Summary. Your Legal advisor to check and confirm if the roof structure amendments have been Building Regulation approved.

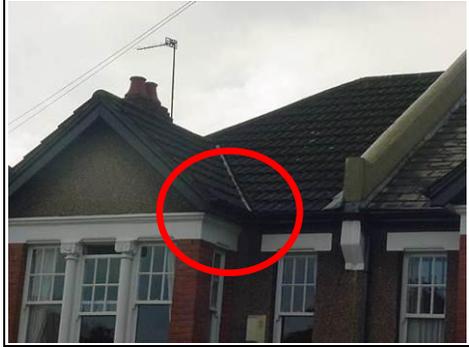
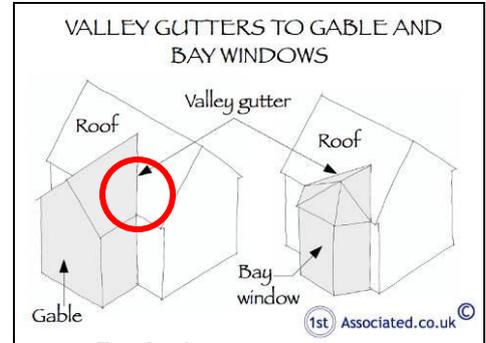
Valley gutter

A weak area of this roof is the valley gutters to the front which look to be in average condition in this case.

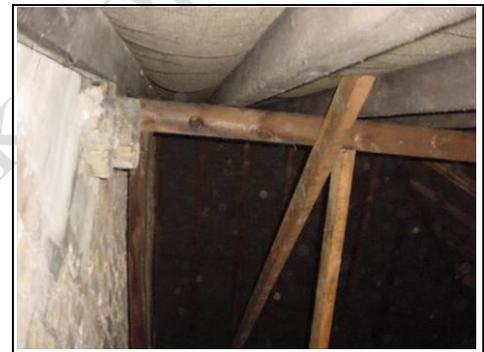
From what we could see within the roof we believe to be a Hessian base Bitumen membrane. This type of membrane has been used since the 1960s. We generally found it to be in average condition, with damage in some areas which is what we typically find.

ACTION REQUIRED: We would recommend adding a loft hatch to allow access to the front of the roof.

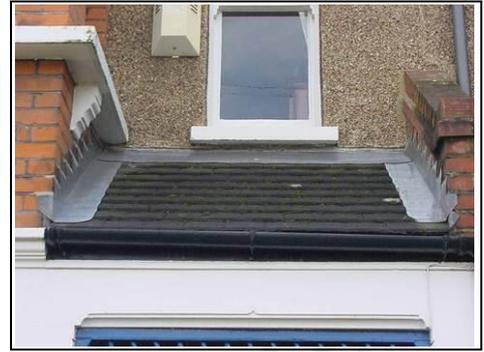
Front porch roof

This again would originally have been slate and has been replaced with a concrete tile. We would add that the flashing does not look like the typical flashing for this type of roof as the lap is too great and does not look to go underneath the tiles at all.

ACTION REQUIRED: In due course you may have to the flashings re-done.

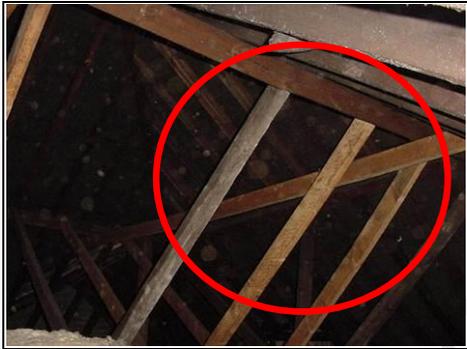
Front roof – supports added

ACTION REQUIRED: It is essential that your Legal Advisor checks and confirms if Building Regulation applications have been made in regard to this roof.

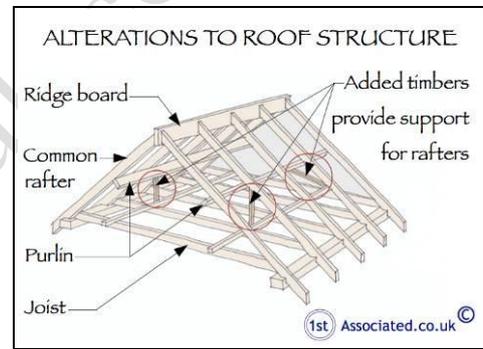
Alterations to roof

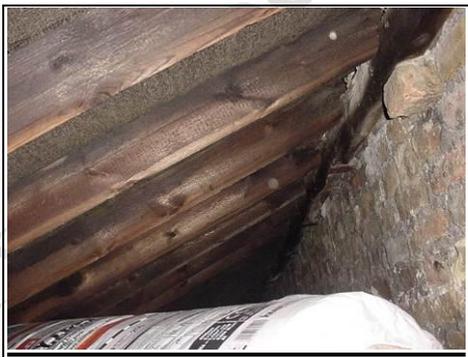
Dampness coming in rear roof

ACTION REQUIRED: Your Legal Advisor needs to carry out checks with regard to this roof. The only way to be 100 per cent certain is to have an access hatch formed and have the roof cleared and we can re-check it.

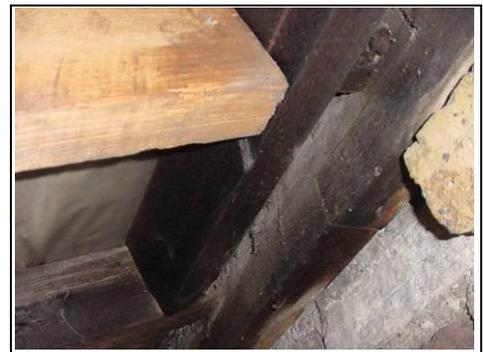
New timbers have been added in rear roof

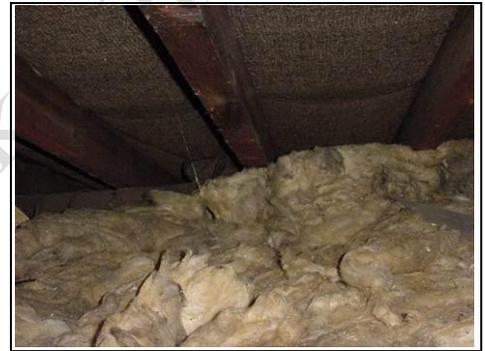
Insulation in rear roof

Our examination was limited by the general configuration of the roof, the insulation and not being able to access the front section of the roof. What we could see was generally found to be in below average condition for its age, type and style and needs investigating. It is, however, feasible that there are problems in the roof that are hidden.

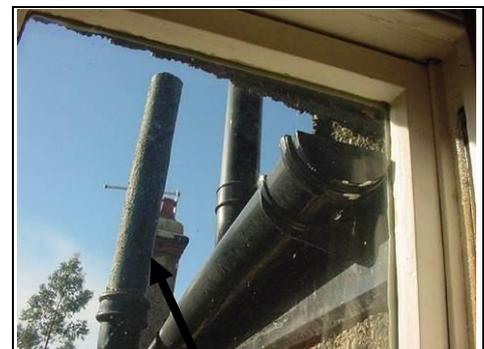
Cast iron soil and vent pipe

The property has cast iron soil and vent pipes. Cast iron of this age can crack and rust and needs regular maintenance.

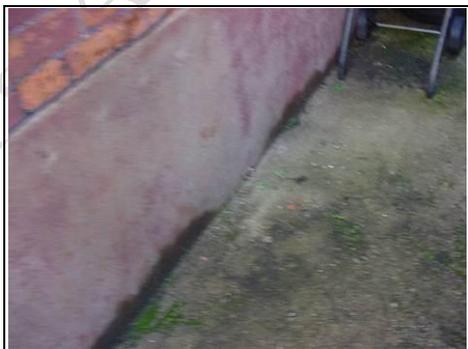
To the base of the render there was no bell mouth detail.

Bell mouth needs to be added

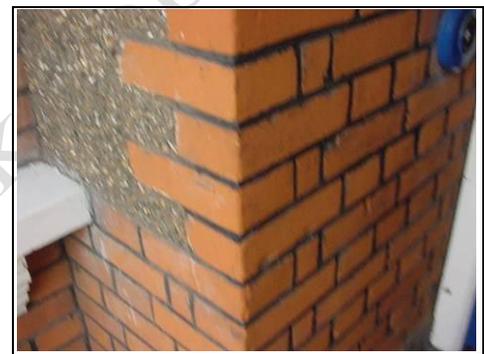
Soot darkened mortar

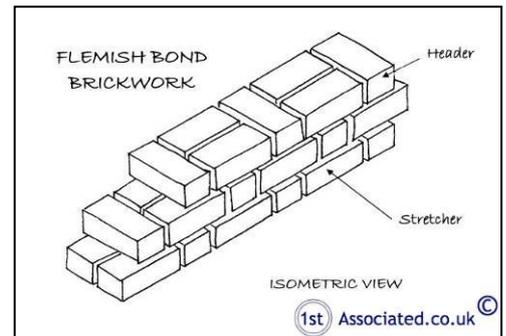
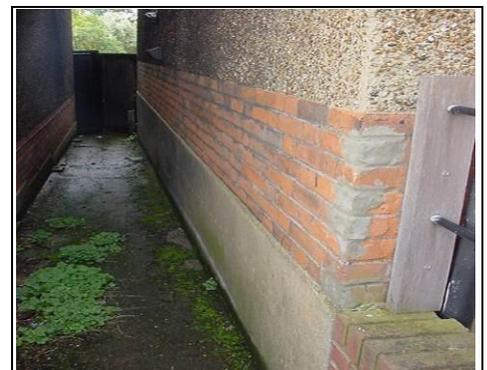
Repairs to brickwork

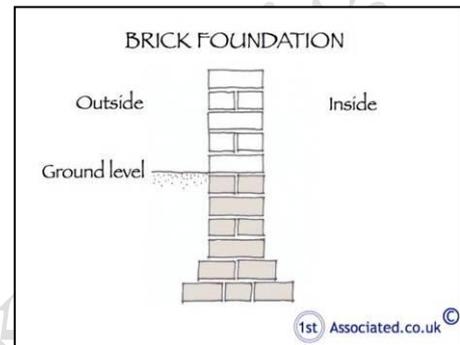
Brick foundation

Given the age of the property you may find different depths of foundations. We would expect to find a stepped brick foundation possibly with a bedding of lime mortar.

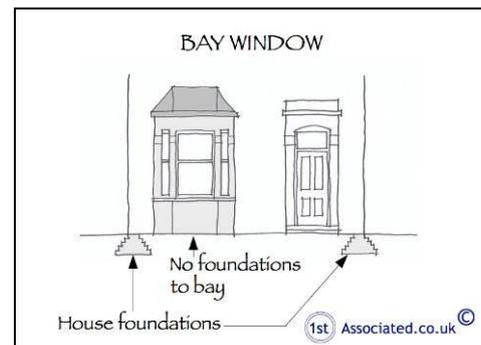
Bay window

Bay windows in this era of property typically do not have foundations underneath them and have been subject to movement. We are aware that some insurance companies underpin bay windows with a modern foundation. We think this is excessive and unnecessary.

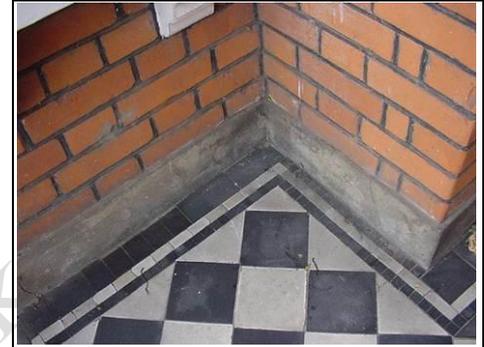
Plinth for the DPC - front

All modern properties should incorporate a damp proof course (DPC) and good building practice dictates that a differential of 150mm (6 inches) should be maintained between the damp proof course and ground levels. In this case, we can see a DPC has been inserted. It is likely in this age of property that it was originally a slate damp proof course. Many people and research tell us that this type of inserted damp proof course doesn't work in this era of property.

ACTION REQUIRED: Please see our comments within the Executive Summary regarding dampness

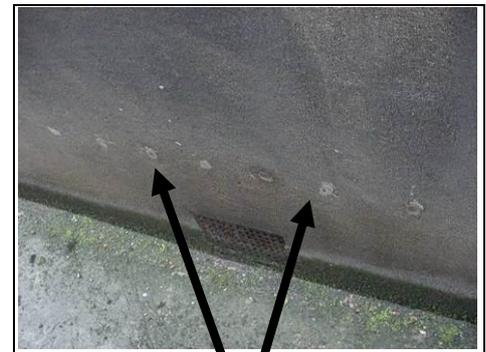
Circular holes drilled to inset DPC

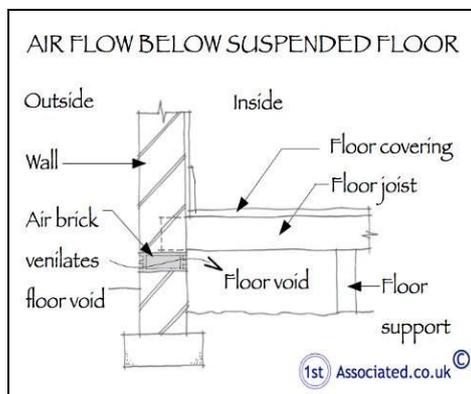
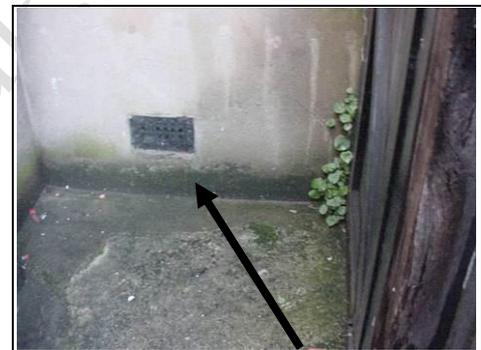
Air brick

The property has a suspended timber floor. Air bricks are essential to have a through flow of air as this helps to reduce the chances of wet rot, dry rot and woodworm.

ACTION REQUIRED: Please see our comments within the Executive Summary.

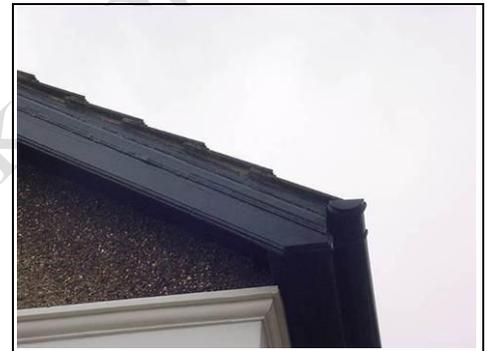
Fascia board

The fascias and soffits are timber. They are painted and we would comment they are in slightly below average condition for their age, type and style.

ACTION REQUIRED: We would recommend re-decoration in the summer of 2014. Make sure gutters and downpipes are watertight before carrying out any work on fascias and soffits.

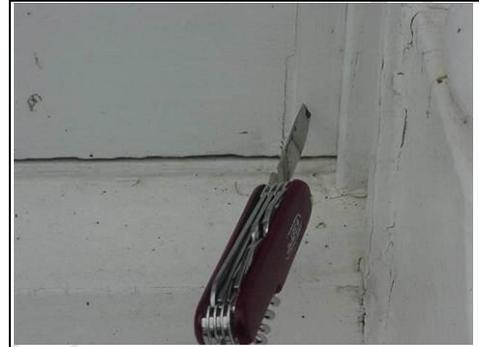
Knife test

The knife test to the front windows showed them to be in average condition although we did note some rain was getting in and rot was visible in one of the bay windows.

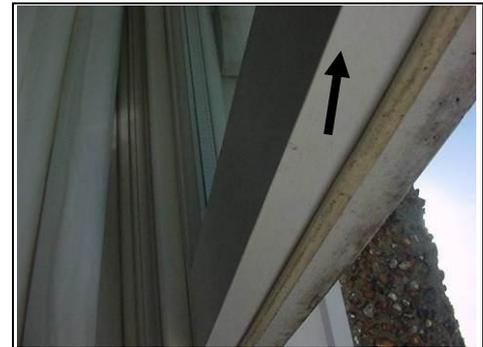
We noted some sashes have been replaced but not the frames that they fit into.

Weather strip
Sash replaced but not frame

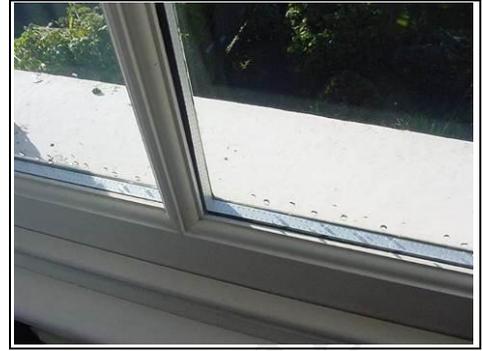
Double glazing

We would draw your attention to the fact that sealed double glazed units can fail, particularly as a result of poor workmanship during installation. Failure of the seal leads to condensation between the two panes of glass and simply replacing the affected units may not provide a satisfactory long-term solution.

Enquiries should be made as to the existence of any transferable guarantees. Generally it is considered that double glazed units have a life of about ten years.

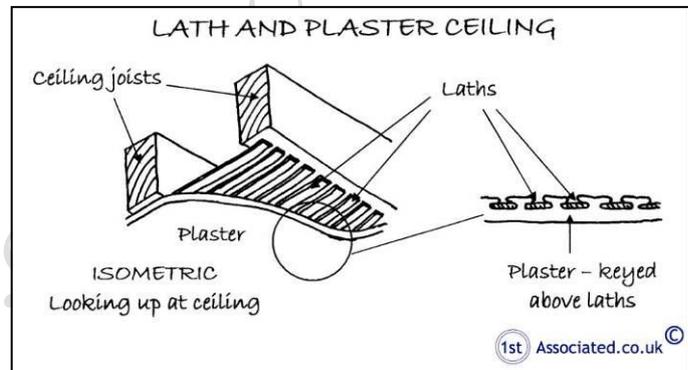
**Cracking in the ceiling**

We did note some hairline cracking in the ceiling which is often the case with old lath and plaster where it is starting to lose its key, please see the above sketch.

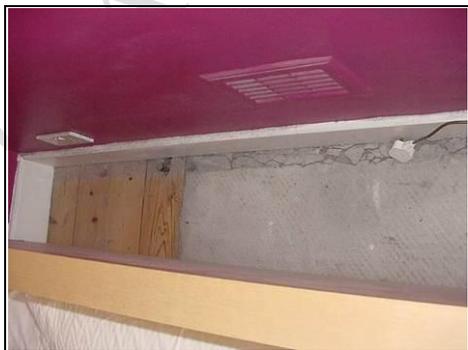
Vented chimney in rear bedroom
Concrete where the hearth once was

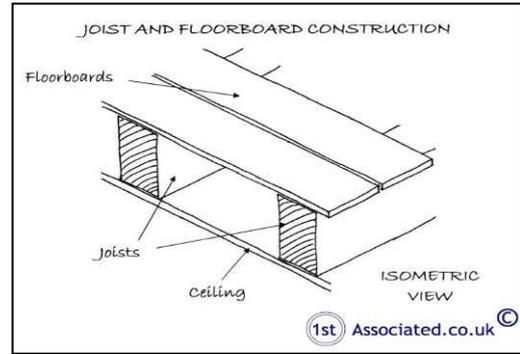
Deflection to the front bedroom

There was more deflection in the front bedroom than we were expecting. Please see our comments within the Executive Summary.

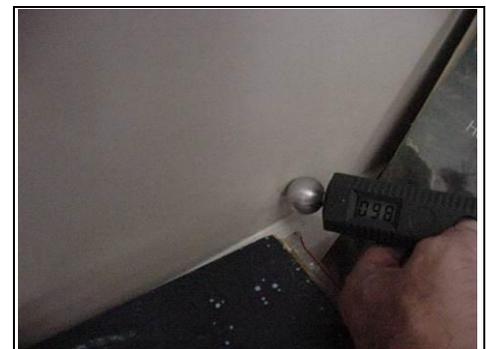
A random visual inspection and tests with a moisture meter have been taken to the perimeter walls. In this particular case we have found rising damp.

High damp readings in
the lounge

ACTION REQUIRED: Please see the Executive Summary regarding dampness.

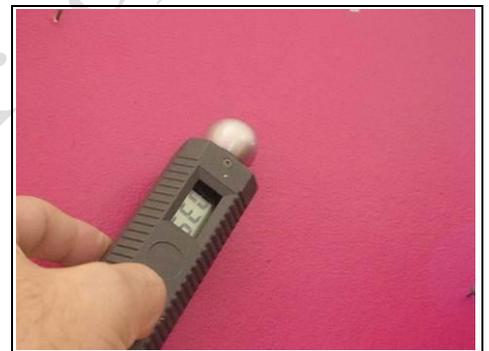
Testing for lateral dampness

We used a damp meter on the external walls. This is in line with what we typically find between 30 and 60.

ACTION REQUIRED: Please see our comments in the Executive Summary.

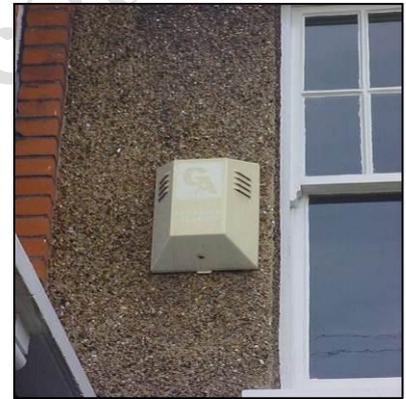
Alarm box
front right hand side

A security system has been installed. A good alarm system should not only help reduce break-ins but also your insurance. We are not experts in this field and therefore cannot comment further.

ACTION REQUIRED: Further information should be obtained from the vendor.

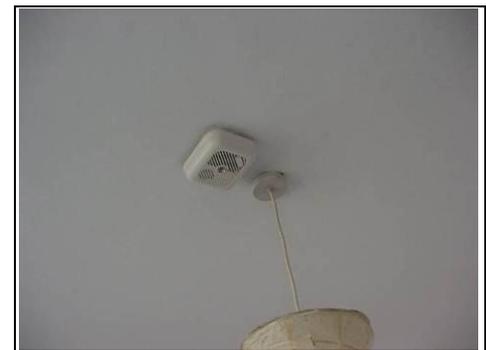
Some battery operated smoke detectors were noted. The current Building Regulations require that they be wired into the main power supply. Obviously in a property of this age this is difficult, as it would mean having surface mounted wires or cutting wiring into the plaster.

Battery operated smoke detector

ACTION REQUIRED: We would always recommend a hard wired fire alarm system and are also aware that some now work from a wireless signal

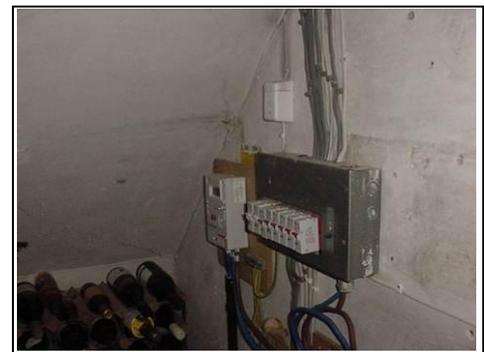
Fuse Board

The electric fuses and consumer units were located in the cupboard under the stairs. The fuse board looked dated circa 1970's/1980s and better are now available.

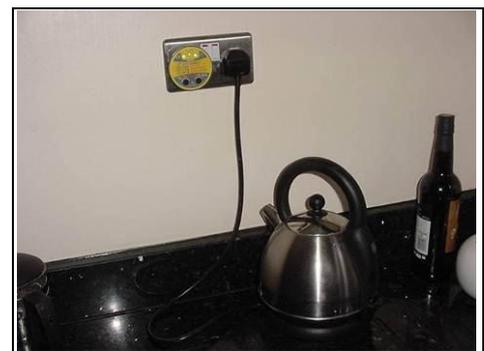
Earth Test

We carried out an earth test in the kitchen area to the socket point that is normally used for the kettle, this proved satisfactory.

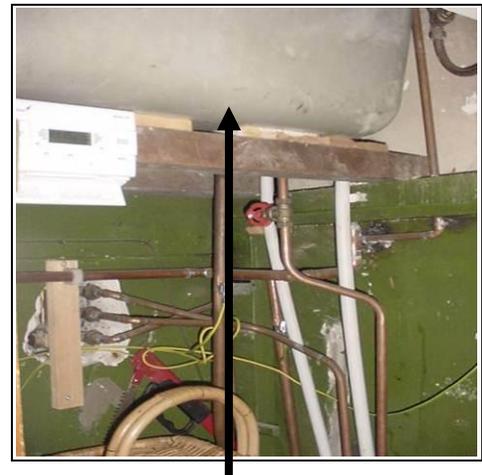
Water tank

There is a water tank in the airing cupboard on the landing. This looks to be a glass reinforced plastic (GRP) water tank. These have been fairly commonly used since the 1970's replacing the older cast iron tanks.

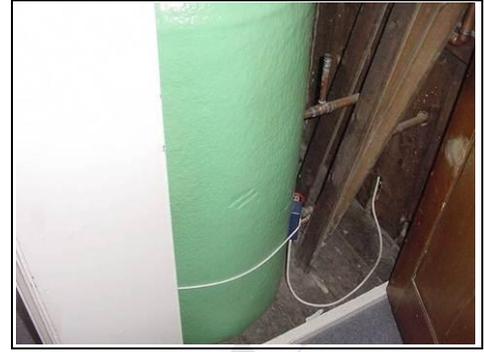
Hot water cylinder

There is a hot water cylinder located in the airing cupboard on the landing. It is factory insulated, which indicates that it is relatively new (in this case we mean in the last 30 years). This cylinder will therefore have a good thermal efficiency, although not as good as the more modern hot water cylinders.

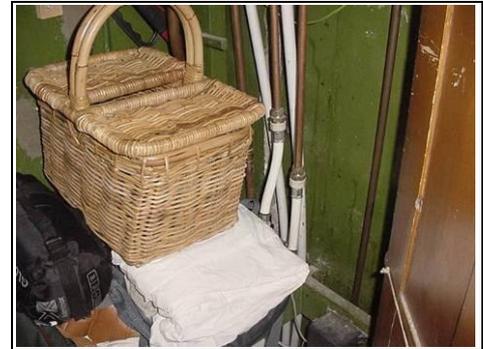
We have had problems recently with plastic pipes fitting to copper pipes, as in this case, where the joints have failed. We have had experience of this both in a brand new house and in an older installation.

Plastic piping in airing cupboard

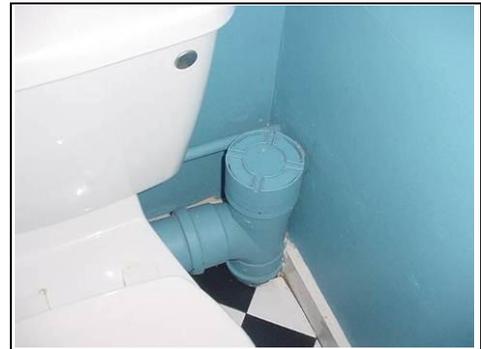
This is a vent pipe which vents into the area surrounding it rather than a traditional soil and vent pipes which vents at roof level

Air inlet valve
Trade name Durgo valve

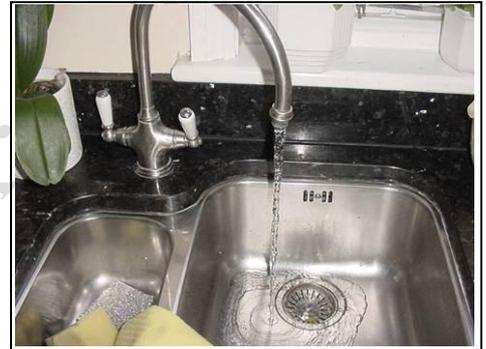
The cold taps have been run for approximately quarter of an hour in the kitchen. No build up or back up was noted.

Taps ran in the kitchen

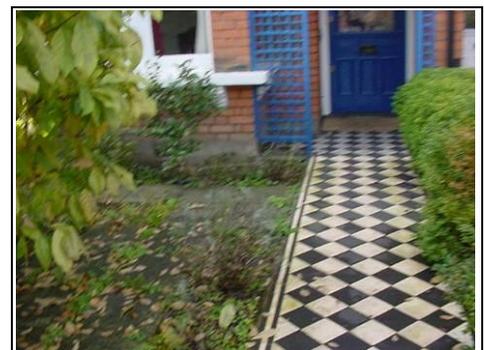
Front Garden

There is a front garden with an original tiled pathway.

We were advised that the left hand boundary is your responsibility.

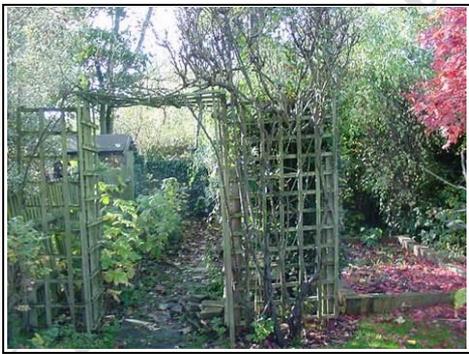
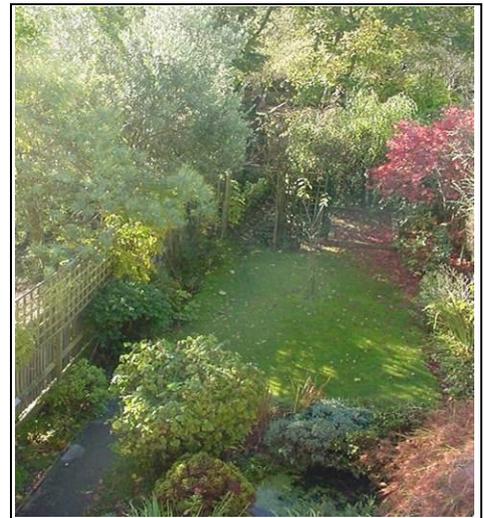
Rear Garden

There is a good sized garden to the rear with established shrubs and plants.
