# RESIDENTIAL BUILDING SURVEY

**XXXXXXXXXX,  
Dulwich,  
London,  
SE22 xxx.**

**INDEPENDENT CHARTERED SURVEYORS**

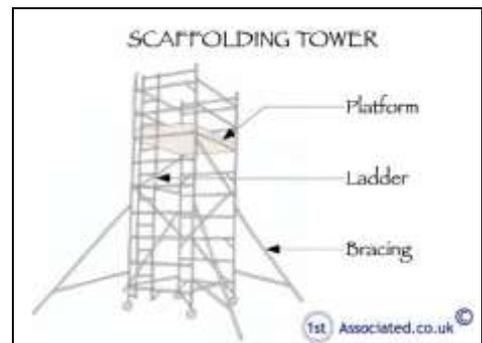
Tower scaffold

Left parapet wall needs re-pointing

**ACTION REQUIRED:** We recommend re-pointing the parapet wall within the two years and that you also check the flashings and the chimneys.

**ANTICIPATED COST:** You'll need high level access probably in the form of a tower scaffold. The costs involved are likely be in the region of £1,000 to £2,000 mainly due to the cost of the scaffold; please obtain quotations.

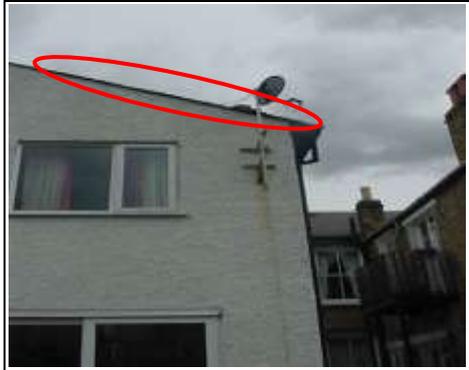
Rear roof

We cannot see the rear roof, however it appears to be a slate roof from what we could see from within the roof space.

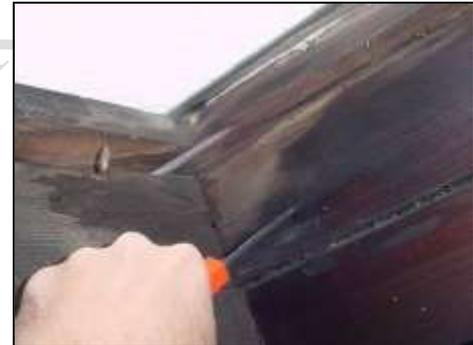
There is a roof window to the roof but unfortunately we were unable to open this window to view the roof. The window has a metal mechanism that opens it but this has rusted. We can see some dampness coming in via the window and is probably the reason the mechanism has rusted over.

Roof window is allowing dampness in

**ACTION REQUIRED:** We would recommend that the window mechanism is eased and adjusted to get this in working order. It would be a shame to have to replace it as it has an almost antique value! This would then allow a proper view of the rear roof, parapet walls and rear chimney.

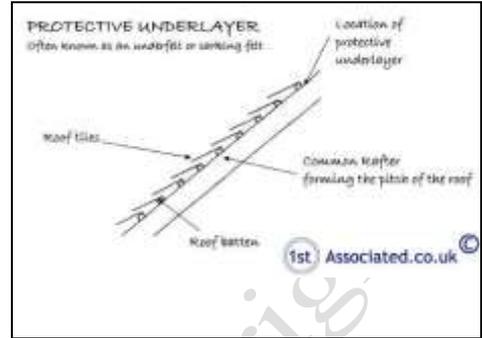
Protective underlayer

The roof has one of the earliest types of protective underlayers known as building paper. This is deteriorating more than we would usually expect to see. Without the secondary protective underlayer the roof is more prone to leaking.

**ACTION REQUIRED:** To replace all of the underlayer is almost as expensive as re-roofing the property as it would require scaffolding which is a major cost. It would also require removing all of the roof tiles and battens then adding the protective under layer and then re-battening and re-tiling. We would therefore recommend patch repairs are carried out. We would also recommend adding ventilation to the roof.

**ANTICIPATED COST:** To patch repair the roof in the region of £2,000 to £4,000. To add ventilation will be in the region of £250 to £1,000 dependent upon whether this can be carried out from within the roof or the outside of the roof; please obtain quotations.

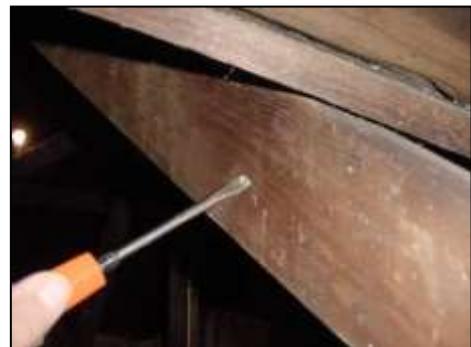
Checking to see if the timber is soft that would indicate woodworm, wet rot or dry rot

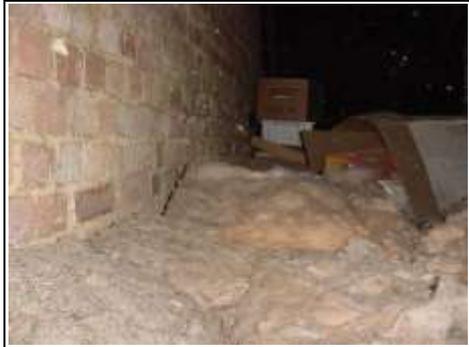
There is a mass of insulation within the roof and also bundles of excess insulation. This combined with the lack of ventilation in the roof may have caused condensation in the roof space which could explain why the building paper has deteriorated.

Mass of insulation

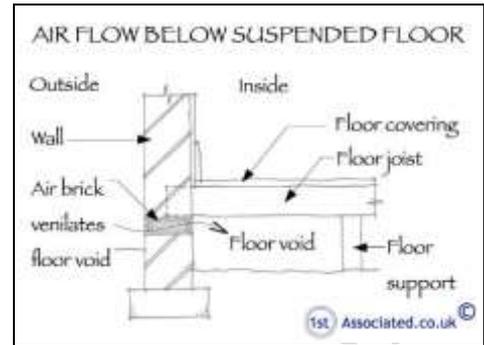
Suspended timber floor

The property has a suspended timber floor which needs airflow underneath it via airbricks to prevent deterioration. We can see that the airbricks to the rear of the property are too low.

This means that the floor may have problems with wet rot or in a worst case scenario dry rot and wood worm. We simply cannot see this to advise as the top of the floor has then been covered with a laminate flooring, this stops the floor from breathing and seals in any dampness problems.

**ACTION REQUIRED:** A worst case scenario will mean replacing floorboards due to wet rot, dry rot or woodworm. You need to open up all the airbricks and ensure they are protected from acting as gutters allowing water into the property. We would suggest lifting a section of floor beneath the staircase to check the condition.

Otherwise you should try to compensate for the risk by requesting a reduction in the price of the property. We would expect costs in a worst case scenario to be in the region of £5,000 or possibly more. However more typically the timber will have survived and costs will only be for the opening up of the floor, a few hundred pounds, to check the condition; please obtain quotations.

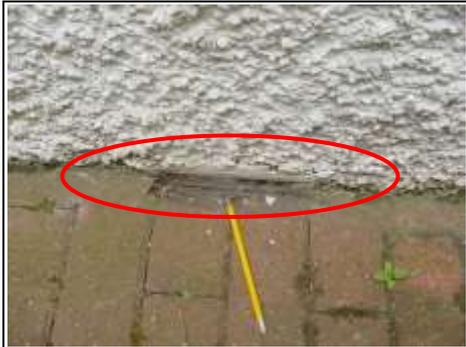
Air brick is too low (rear left)

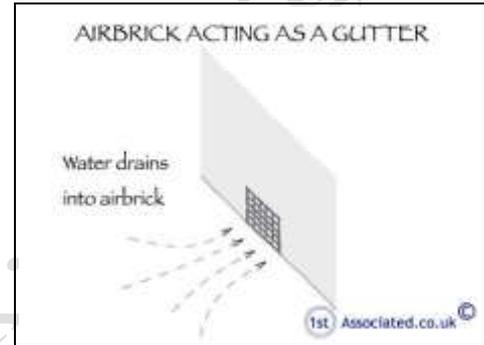
Air brick acting as a gutter

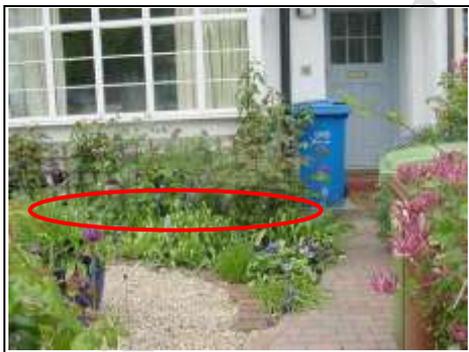
We simply cannot see the air bricks to the front of the property at all.

High ground level, the airbricks have been covered over

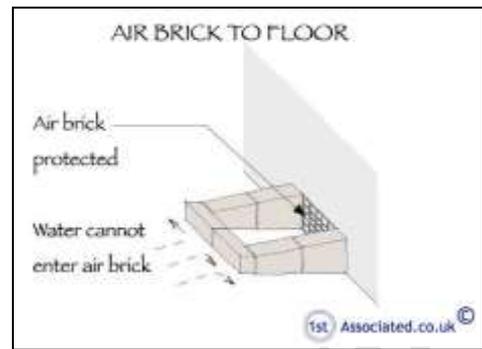
Protected air brick stops water entering the air brick.

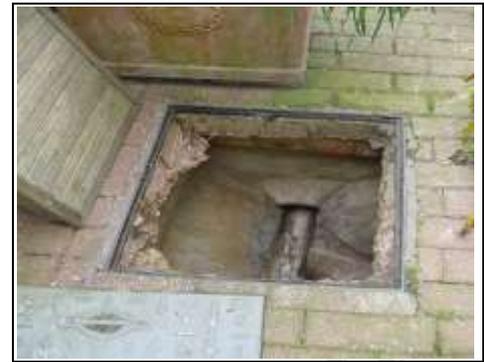
When we opened the manhole to the rear of the property we found that it was concrete built indicating that it is newer than the building as a whole. This could also be due to the kitchen extension/alterations but in general we do find there is some leakage to the old push fit drains.

Drain is concrete, which can indicate work has taken place to the drains

**ACTION REQUIRED:** Your Legal Advisor to specifically ask in writing if repair work has been carried out to the drainage system. We would also enquire with the insurers to see if there have been any problems in relation to the drains and associated insurance claims that may affect your premium or your ability to obtain insurance.

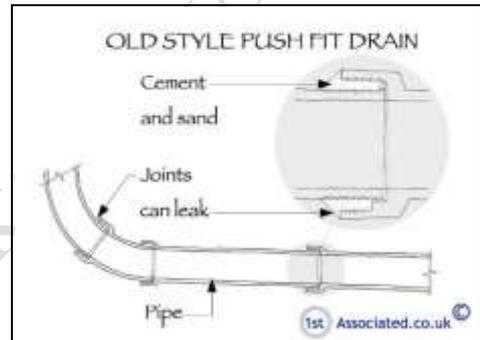
Push-fit drain

In older properties, such as this, drainage was often push fitted together rather than bonded together which means that they may leak over the years.

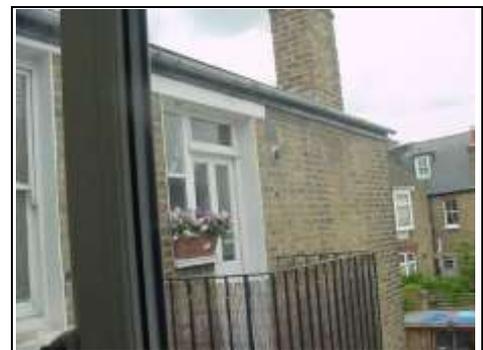
The neighbouring property has a balcony that practically overlooks the rear bedroom, rear bathroom and the rear garden.

Neighbours balcony

**ACTION REQUIRED:** You need to consider this as a characteristic of the building and ensure you are happy with it before you proceed to purchase.

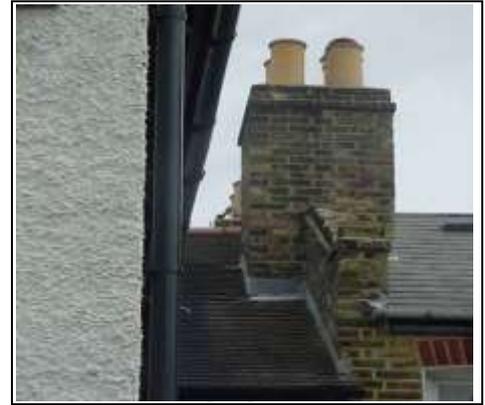
Rear left chimney

This chimney is brick built with a lead flashing and four pots (two of which we believe are yours). From what we could see from ground level it looked in average condition considering its age, type and style but in this case our view was very limited to the left side of the chimney (all directions given as you face the front of the property).

**ACTION REQUIRED:** Again we would comment that the parapet wall has deteriorated and weathered and we would recommend that this chimney is checked as well when work is carried out to the parapet wall. You may be able to get a better view once the roof window is opened up. Please see our comment on this within the Executive Summary.

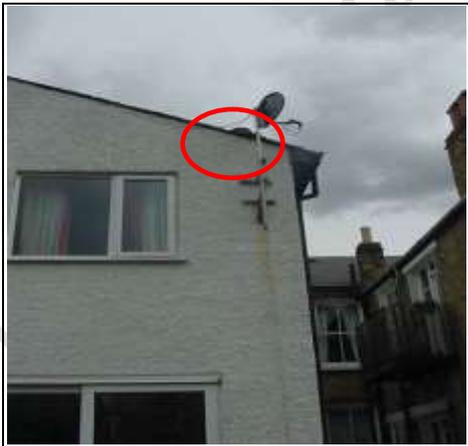
Rear chimney

Unfortunately we were able to view very little of this chimney. We were expecting to be able to see it via the roof window but as mentioned we could not open this.

**ACTION REQUIRED:** Once the roof window is opened we would recommend that the chimney is checked.

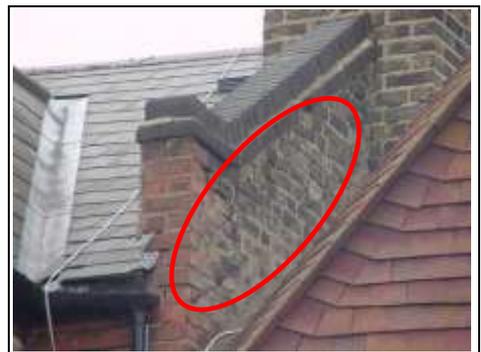
The left parapet wall is built of brick and needs re-pointing.

Left parapet wall needs re-pointing

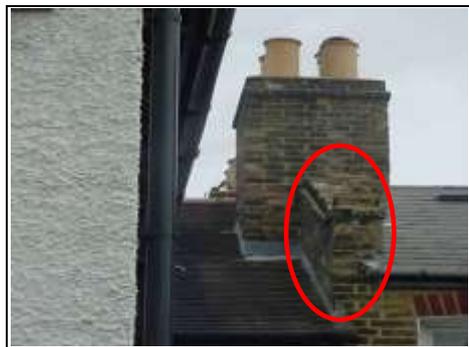
Rear left parapet wall is difficult to see

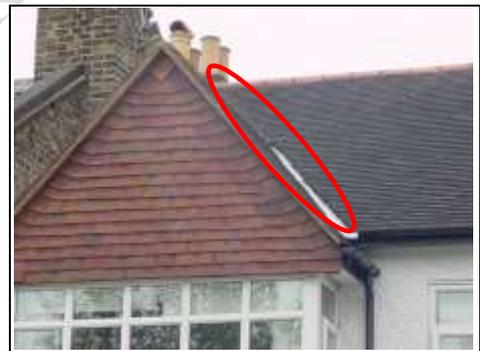
Main roof with valley gutter where it meets the bay window

With this age of roof there will usually be a few missing or displaced tiles and which there is in this case, this is nothing unusual. Our concern with the missing tiles is that the secondary protective underlayer also known as sarking felt is deteriorating.

**ACTION REQUIRED:** Carry out periodic inspections and maintenance of the roof, as required. The protective underlayer is deteriorating which means you do not have secondary protection. Please see the following section.

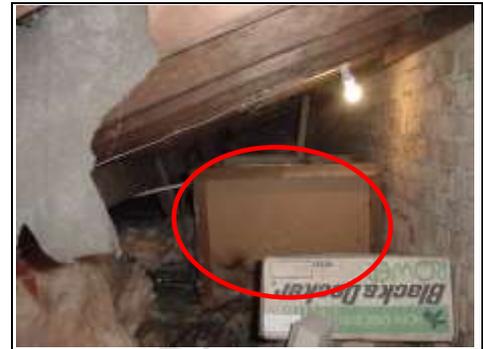
Water tank

We noted a water tank in the roof space. This looks to be a glass reinforced plastic tank and does not appear to have a lid.

We would always recommend that water tanks be drained down and cleared of any debris etc. (we have seen dead birds and other unmentionable things in these tanks). As you are often cleaning your teeth with this water it is best that it is as clean as possible!

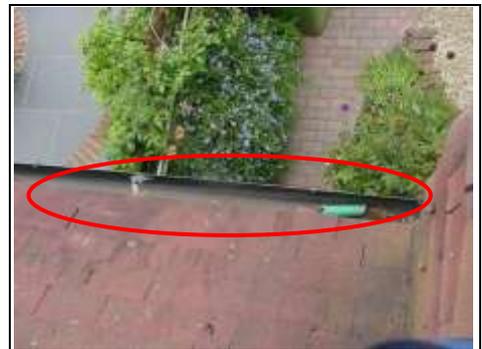
Clear the gutter. We are always mystified by what ends up in the gutters

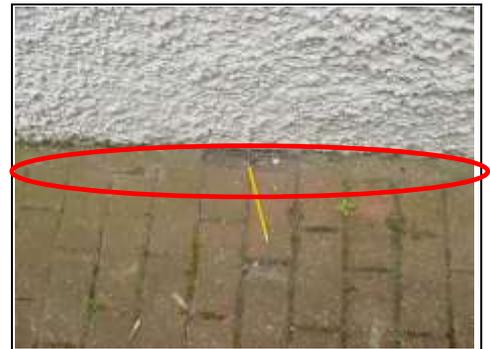
To the base of the render there is no bell mouth detail.

No bell mouth to render

**ACTION REQUIRED:** We would recommend that a bell mouth is added to the base of the property to reduce dampness.

**ACTION REQUIRED:** Please see our comments within the Executive Summary.

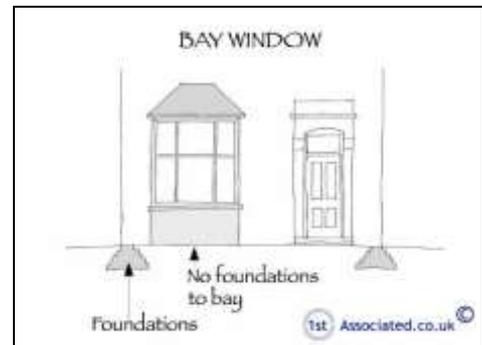
Bay window

Bay windows in this era of property typically do not have foundations underneath them and have been subject to movement. We are aware that some insurance companies underpin bay windows with a modern foundation. We think this is excessive and unnecessary.

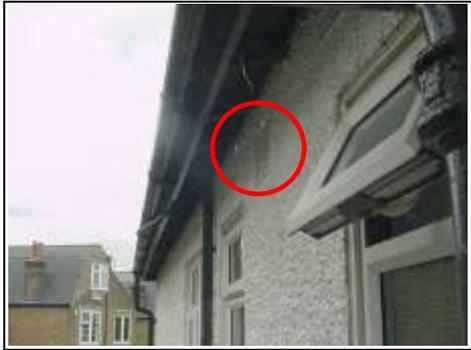
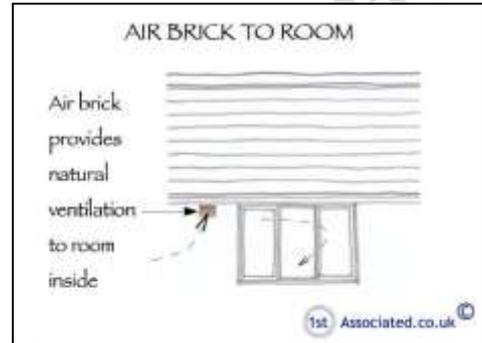
Air brick

There are vents at high level. High level air bricks are to help air circulation within the property. We noticed airbricks in the bathroom which we were pleased to see giving natural ventilation. However we do prefer mechanical ventilation in the form of large humidity controlled extract fans.

**ACTION REQUIRED:** Add humidity controlled extract fans to bathroom, en suite, kitchen and any rooms used for laundry/drying of clothes.

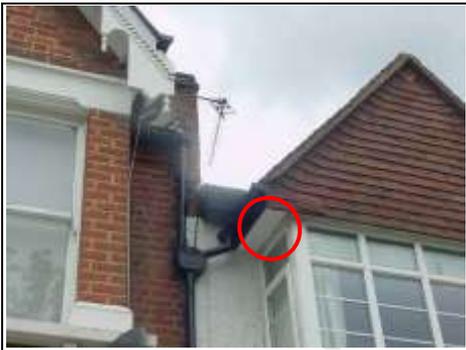
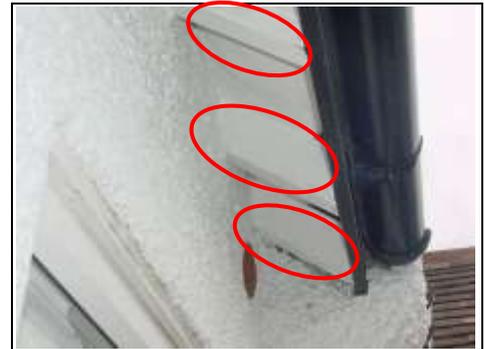
Fascias and soffits

The fascias and soffits are timber with exposed rafter feet in some areas which are sometimes difficult to paint and often get neglected. We would comment they are in average condition for their age, type and style.

**ACTION REQUIRED:** Make sure gutters and downpipes are watertight before carrying out any work on fascias and soffits.

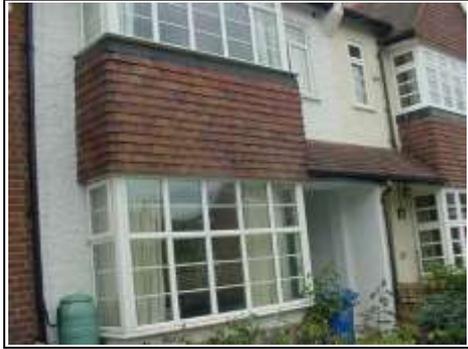
Two storey bay window

Generally they look to be of an average quality for their age, type and style. In this case there is a two storey bay window that is unlikely to have foundations underneath it and so there can be some movement particularly when the original windows have been replaced with double glazing.

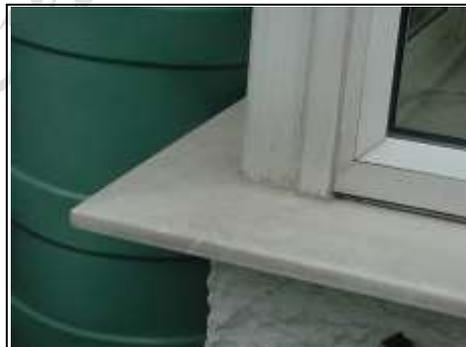
Ingrained dirt

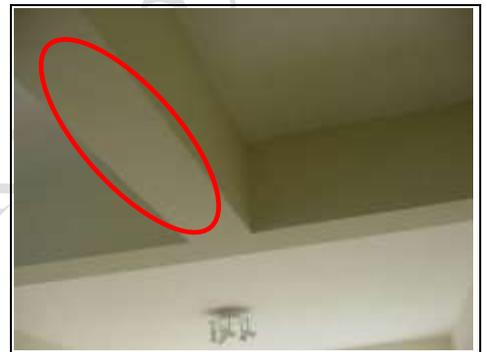
These are, we believe a mixture of solid (including steels that have been added in the kitchen extension) and studwork construction, for example, to the en suite shower room. It is of course impossible to determine the construction without opening up the walls and we have therefore taken an educated guess.

Steels have been put in

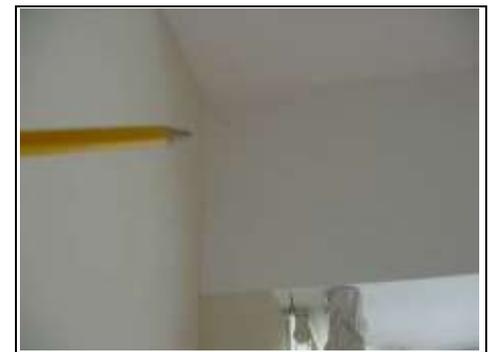
Slight mark under where the valley gutter is near the bay window and may be the first sign of dampness getting in

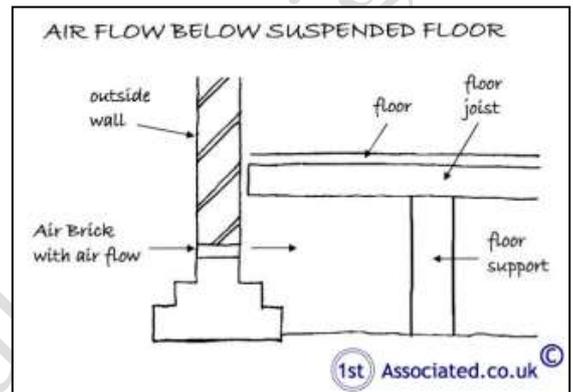
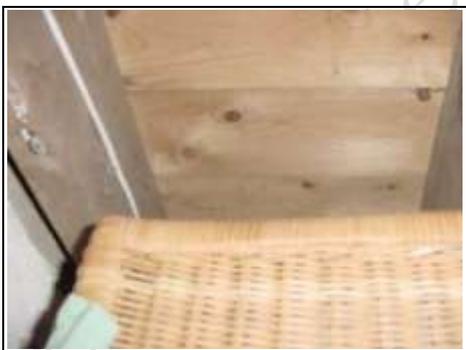
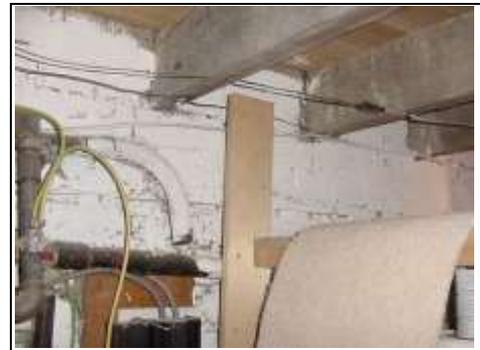
Suspended timber floor

We can see the suspended timber floor, in this instance, by going into the cellar. The timbers we could see look relatively new and many are not original. We could only see a small area to the right hand side of the property and as mentioned the lack of airbricks and the blocking of air bricks means that there is no air flow through this part of the floor which could have caused wet rot, dry rot or woodworm.

Timbers look fairly new, by this we mean twenty to thirty years

Timbers embedded in the walls

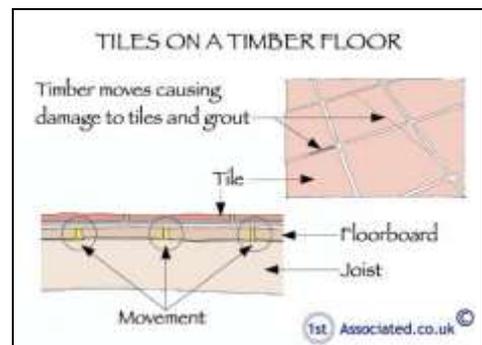
We noted that tiles have been laid in the en suite bathroom. We tend to find that over time, where tiles are put over a wooden floor, the grout becomes loose and comes out. Although in our opinion the tiled floors look good you will have to re-grout from time to time.

Tiles on a timber floor

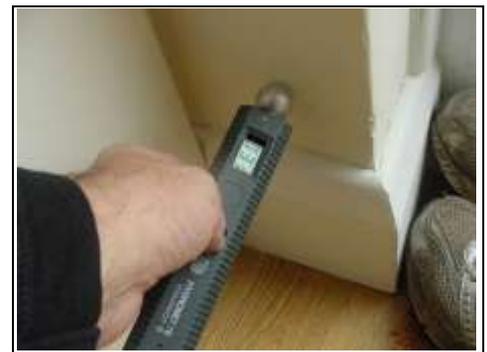
Testing for rising damp

A random visual inspection and tests with a moisture meter have been taken to the perimeter walls. In this particular case we have found no rising damp which we were surprised about given the high ground levels and the blocking of the air bricks.

**ACTION REQUIRED:** Please see the Executive Summary.

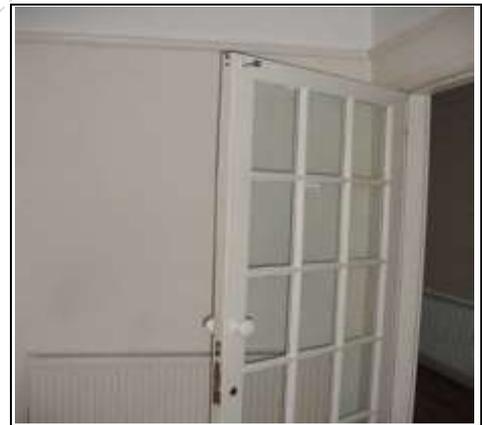
We have recently seen one of these doors caught by the wind resulting in the glass smashing. We did not notice any British Standard safety kite marks on the glass.

Glass door without kite marks to glass

**ACTION REQUIRED:** Your Legal Advisor to enquire if this is safety glass or not.

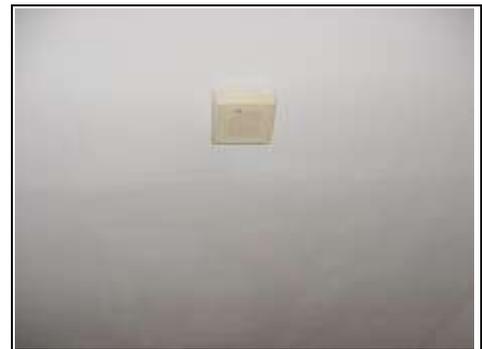
Smoke alarm

Some smoke detectors were noted. The current Building Regulations require that they be wired into the main power supply. Obviously in a property of this age this is difficult, as it would mean having surface mounted wires or cutting wiring into the plaster.

**ACTION REQUIRED:** We would recommend, for your own safety, that smoke detectors be installed. We would always recommend a hard wired fire alarm system and are also aware that some now work from a wireless signal which may be worth investigating. Whilst fire is relatively rare it is in a worst case scenario obviously devastating.

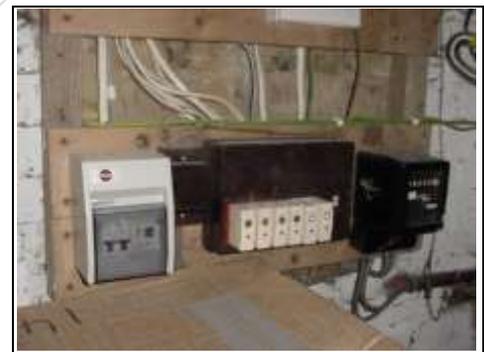
Fuse Board

The electric fuses and consumer units were located in the cellar. The fuse board looked dated, circa 1960's/1970's, and better are now available. Please see our comments within the Executive Summary.

**ACTION REQUIRED:** As the property is changing occupancy an Institute of Electrical Engineers (IEE) test and report should be carried

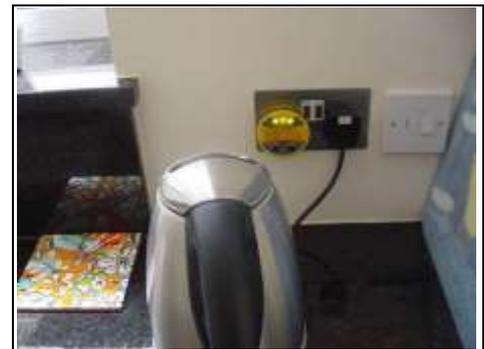
Earth Test

We carried out an earth test in the kitchen area to the socket point that is normally used for the kettle, this proved satisfactory.

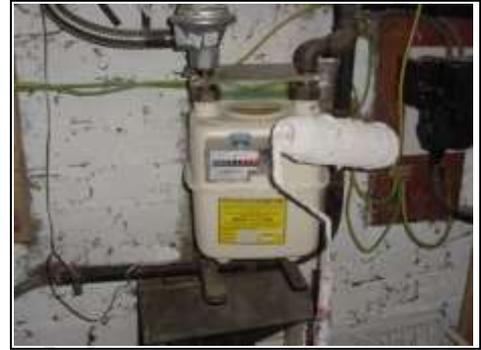
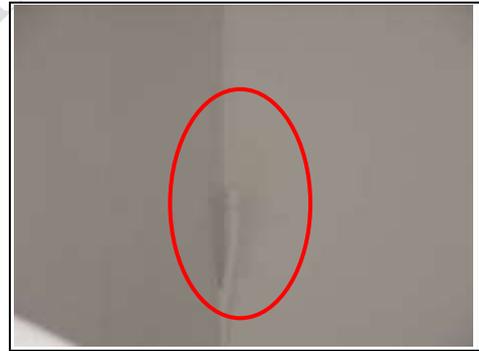
We can see a pipe to the landing area but we cannot be certain if this is a gas pipe or not. It would be more usual to have a pipe leading to the water tank in this location and this looks to have been cut off.

Gas pipe in landing area on rear wall

**ACTION REQUIRED:** As a matter of course it is recommended that the entire gas installation is inspected, including the cut off pipe, and made good, as necessary, by a Gas Safe registered contractor. Thereafter the installation should be serviced annually.

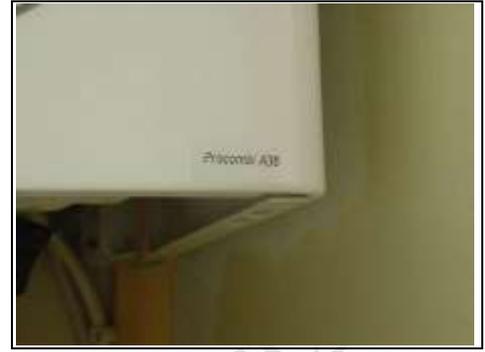
Our limited inspection of the hot water and central heating system revealed no evidence to suggest any serious defects but we would nevertheless recommend that the system be tested and overhauled before exchange of contracts and that a regular maintenance contract be placed with an approved heating engineer.

Procombi A36 boiler

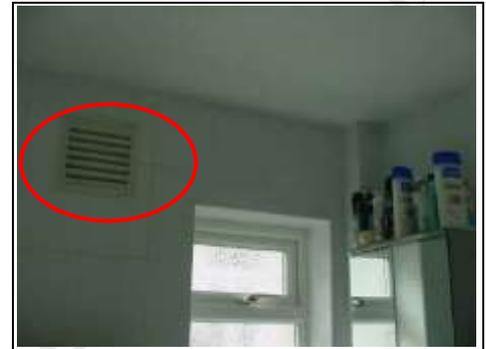
Air vent at high level

**ACTION REQUIRED:** You may wish to add large humidity controlled extract fans in the bathrooms.

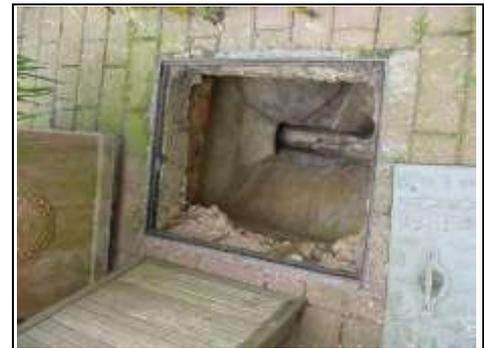
Manhole one- rear left

We duly lifted the cover and found it to be free flowing at the time of our inspection.

From what we could see it is concrete built. This is unusual as we would expect to see brick built manholes in this age of property. However this could have been added in for the kitchen extension.

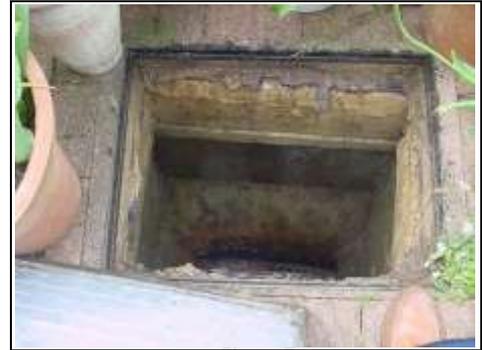
Manhole two- rear

We duly lifted the cover and found it to be free flowing at the time of our inspection.

Again from what we could see this is also concrete built.

**ACTION REQUIRED:** Please see our comments within the Executive Summary regarding the drains.
