# RESIDENTIAL BUILDING SURVEY

**Esher,  
KT10**

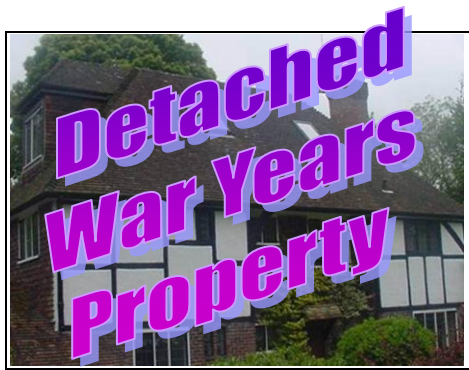
Main roof

We believe that the roof (assuming it will be maintained) has many years of life left in it. However, if you are carrying out work to the top floor we would recommend a new roof or, to be more exact, re-roof re-using the tiles and adding a modern breathable protective underlayer.

We would add from what we have seen this was originally an above average roof construction for its age, type and style and it has been reasonably well maintained over the years.

**ACTION REQUIRED:** It is a very close call on whether to replace the roof or not. If you were not carrying out extensive work such as extensions and other roof work then we would recommend that you keep the existing roof. However with the combination of extensions and alterations to the building we feel it will be worthwhile re-roofing and adding the benefit of a modern breathable protective underlayer.

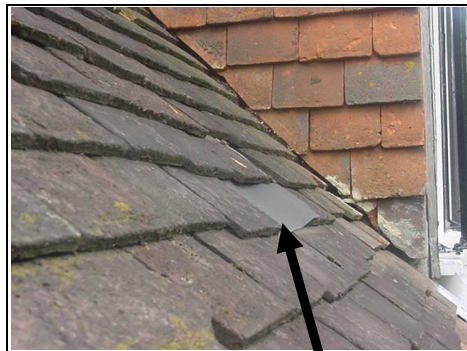
The reason for this is, the type of roof that you have is susceptible to wind driven rain and snow in the extremes of weather and repairing any slipped and damaged tiles is likely to become more onerous. This is particularly as you have quite a high roof and there are a limited number of roofers that can do the work easily i.e. having the right size ladders or tower scaffolding.

Missing tile

**ANTICIPATED COST:** In the region of £50,000 - £75,000 (fifty thousand pounds to seventy five thousand pounds). The reason for the variation in the cost is because the roof is likely to require scaffolding and probably a scaffold tin roof over the top to protect the interior from water damage; please obtain quotations.

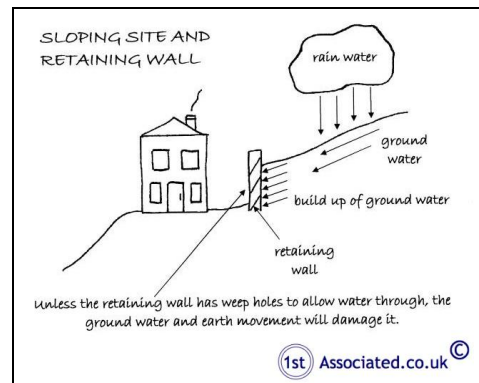
### 3.1 Weep Holes

The property sits on a sloping site. The rainwater on this property travels from the left to the right so you need to ensure that there is a good route for the rainwater to travel otherwise it will travel underneath the house which is not an ideal situation.

There is a retaining wall to the left hand side of the property and there are several things that should be carried out to improve the drainage and thereby improve the effects that it has.

**ACTION REQUIRED:** Add weep holes to the retaining wall on the left hand side of the property.

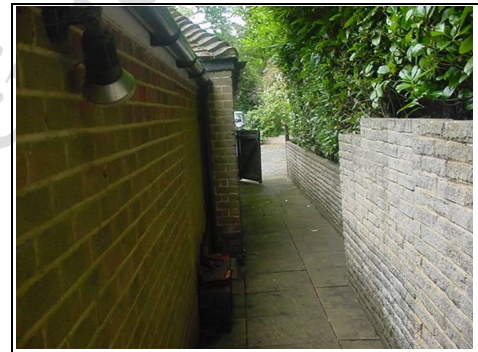
The wall needs weep holes adding to it

**ANTICIPATED COST:** A few hundred pounds.

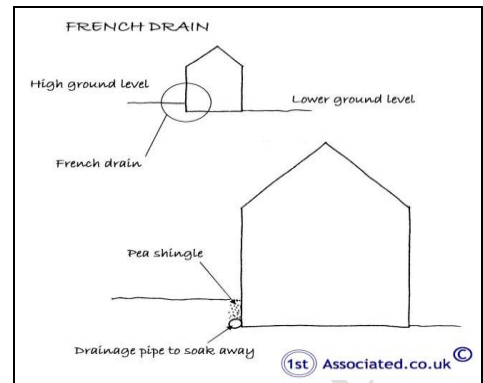
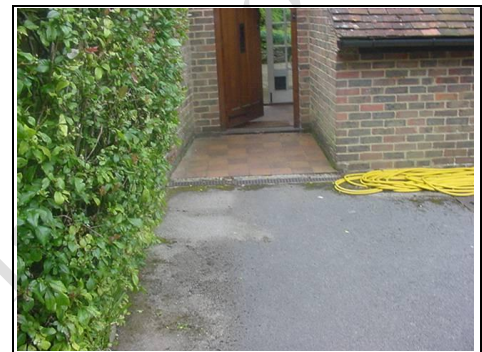
This is where the water runs to and sits.

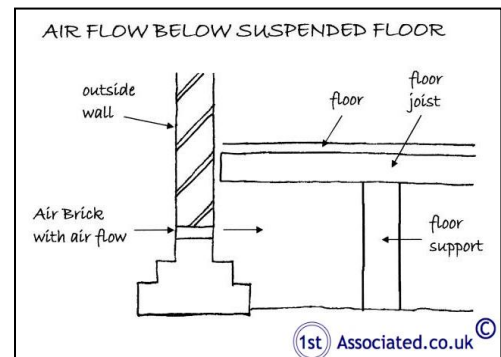
Air brick needs clearing

**ACTION REQUIRED:** We recommend that they are protected as shown in the sketch below and that sections of the floor, as mentioned earlier, are opened up to check the condition of the timbers beneath.

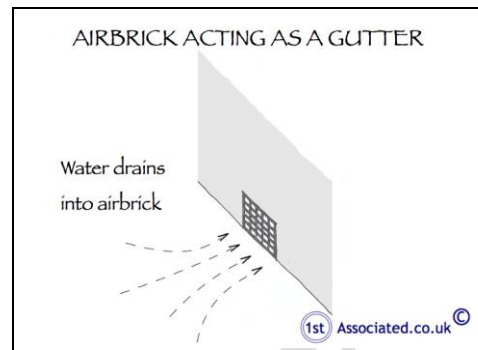
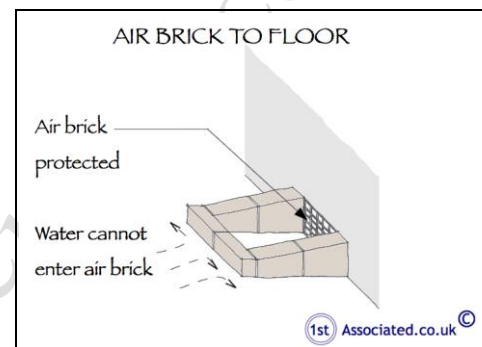
With reference to the previous section, number three the sloping site.

To the front of the property to the left hand door we can see moss on the brick work where rainwater has run against it over the years and sat against it. This in turn could have led to deterioration within the floor around this area. Whilst we believe the floor around this area is concrete there may be other similar problems elsewhere.

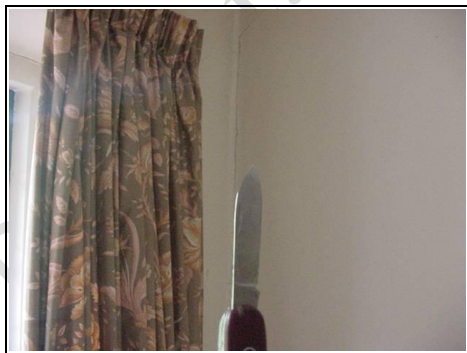
At first floor level we can see cracking to the left hand central wall. We can also see this to the stairway area. This is likely to relate to the alterations that have been carried out in the kitchen area where we believe the wall has been removed.

Cracking in the corner, front left hand bedroom

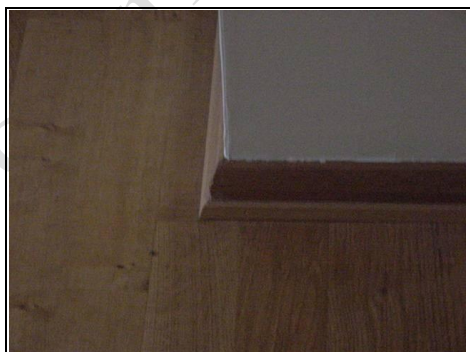
As discussed some of the laminate flooring is of a DIY standard. We showed you the quadrant bead which generally means that the work is not to a top end standard.

DIY laminate flooring

**ACTION REQUIRED:** You may wish to take the floor up and re-secure it or replace it.

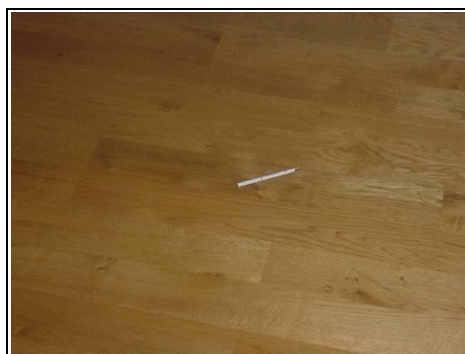
Spongy area of the floor marked by the pen

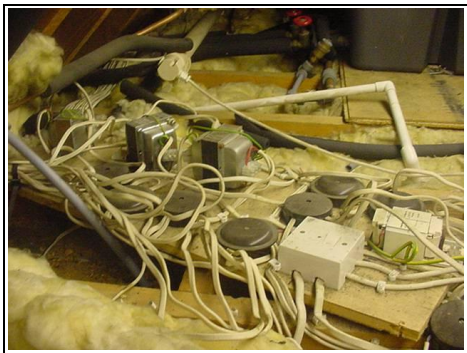
The electrics are circa 1960 and dated and need replacing. Better are now available and they need tidying up.

Dated electrics

**ACTION REQUIRED:** Have an Institute of Electrical Engineers standards (IEE) test and report carried out by an NICEIC registered and approved electrical contractor or equivalent. Upgrade the fuse board and any other upgrades that the IEE test certificate requires.

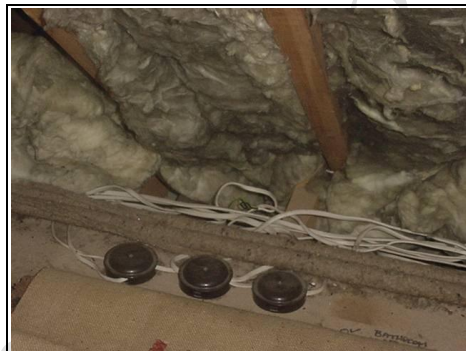
Old electric points

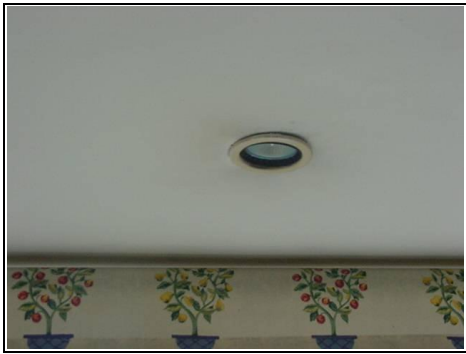
The property has older style electric ceiling lights. In some instances these can cause problems as the heat given off has in some cases lead to outbreaks of fire; these tend to be in the older type of ceiling lights and we recommend that where ceiling lights are used that the rear of the light is not covered.

Old style ceiling light in kitchen

**ACTION REQUIRED:** We would recommend the replacement of these lights.

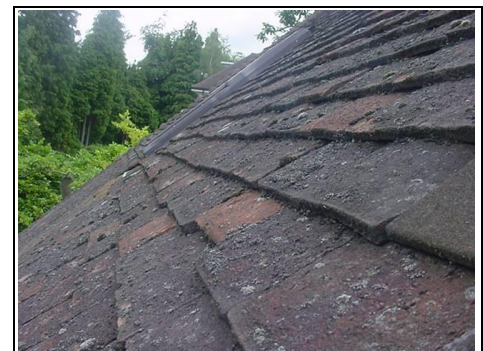
The main roof is pitched and clad with nibbed concrete tiles and, from ground level, this looks in slightly below average condition considering the roofs age type and style. With this age of roof there will usually be a few missing or displaced tiles, this is nothing unusual.

Roof tiles

**ACTION REQUIRED:** Please see our comments within the Executive Summary. Until such time as you replace the roof you will have to carry out good regular maintenance of the roof, as required.

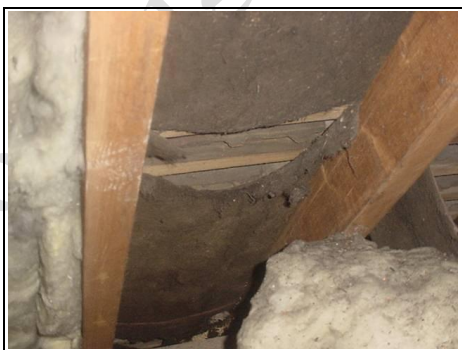
The tiles are nibbed with a builders felt underneath. This is deteriorating in some areas. It is generally in average condition but not as good as a modern protective underlayer.

Deteriorating builders felt

**ACTION REQUIRED:** Ideally we would remove the insulation between the common rafters but if you intending a major re-roof then it is not worth it. Please see our comments within the Executive Summary.

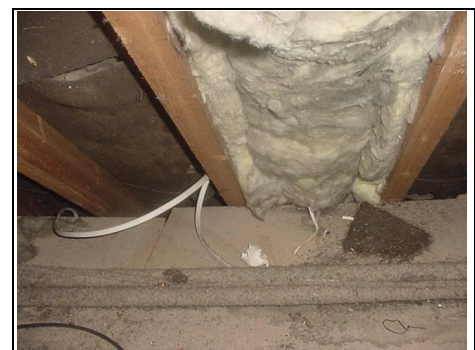
Insulation added in between the common rafters

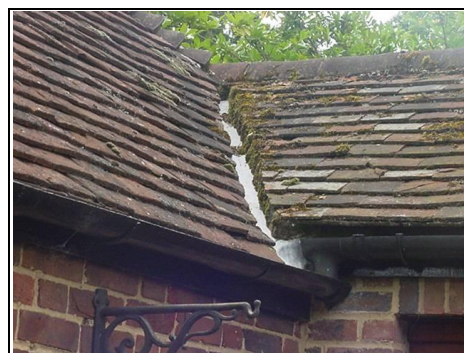
From our discussions you will be demolishing the garage to the left hand side of the property. We have inspected the garage and would comment that the flat roof is in reasonable condition whilst the pitched roof is in poor condition. The demolition of this building, as discussed, would mean that you could re-use these tiles on the main roof.

Pitched roof where it meets the walkthrough roof

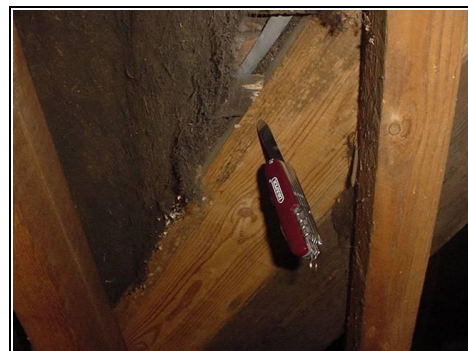
Testing the timber to the front of the property

Our examination was limited by the general configuration of the roof, the insulation and stored items. What we could see was generally found to be in slightly below average condition for its age, type and style due to the dampness getting in. It is, however, feasible that there are problems in the roof that are hidden.

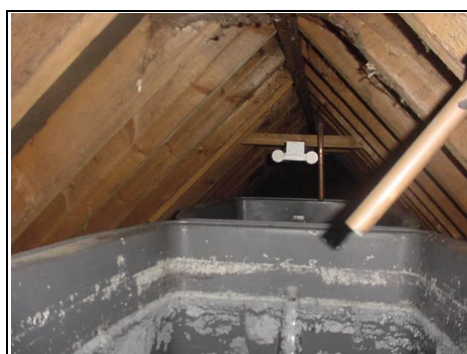
The water tank in the roof does not have lid. We would recommend that the water tank is cleaned out, lidded and refilled. As discussed a modern system would not normally have a water tank. Water tank installations are from the days when we had twenty four hours of reserve water within each property.

Inside the tank - you clean your teeth with this water!

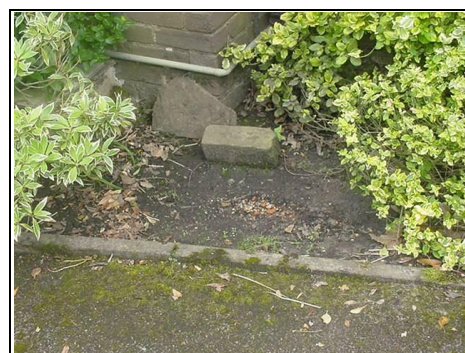
There are some areas where the gutters leak particularly badly which Xxxx (the handyman) explained during our question and answer session.

Water from leaking gutter is washing away the soil

**ACTION REQUIRED:** The cast iron needs to be maintained and needs to be decorated using a 'rust stop' paint in the deteriorating areas.

We would also recommend that the gutters and downpipes are cleaned out, the joints are checked and the alignment checked to ensure that the gutters fall towards the downpipes.

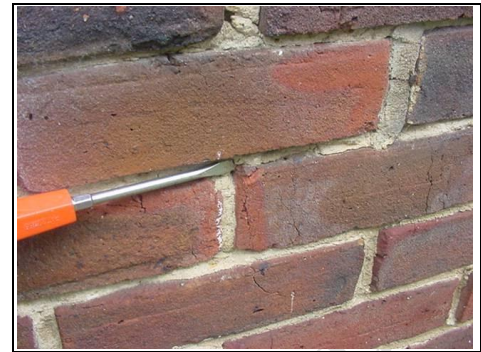
The pointing is weathered and would benefit from re-pointing. This should be re-pointed in a lime mortar to allow the building to breathe.

Re-pointing is necessary

Unfortunately the cement re-pointing, whilst well meaning, is not appropriate for this type of construction. A cement mortar has been used rather than a lime based mortar. We recommend you use lime mortar in any future repairs regardless of what the builders say! Using lime mortar will limit further damage to the brickwork, which is almost impossible to repair successfully. However, we would add that many, if not most, of the properties that are re-pointed are re-pointed wrongly; it is only in recent years that we have discovered the problems that can occur from it.

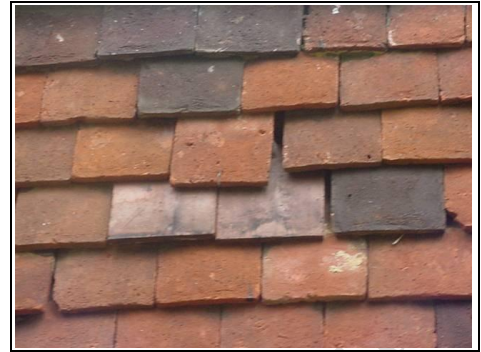
There is vertical tiling to the property that needs some repair work. By this we mean one day or possibly a few days work is needed to re-secure any slipped or broken tiles. Most importantly you need to ensure you have a matching correctly sized tile. We suggest you keep a supply of these at the property for future use.

Slipped tiles and mismatched tiles

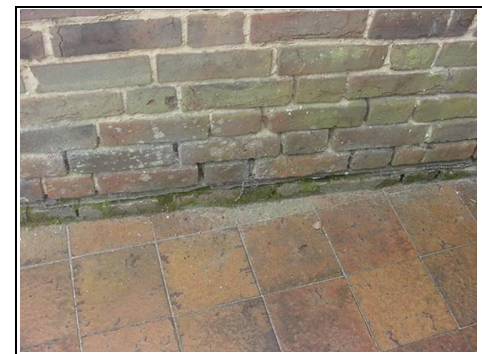
All modern properties should incorporate a damp proof course (DPC) and good building practice dictates that a differential of 150mm (6 inches) should be maintained between the damp proof course and ground levels. In this case, we could see a thickening of the DPC in some areas. We could also see it was too low in some areas and there was moss at the base of the brickwork. We believe this is due to the property sitting on a sloping site and a combination of high ground levels.

DPC is too low in some areas

**ACTION REQUIRED:** Please see our comments within the Executive Summary. Ideally you should lower the level of the flower beds around the property.

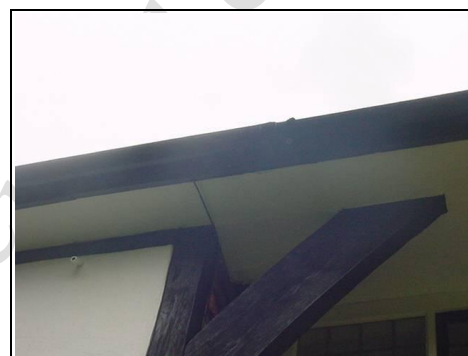
The fascias boards are partly hidden by the guttering but where they can be seen look to be in average condition for their age, type and style. The soffits are in average condition also. Our concern is that they may be asbestos from the dull appearance of them.

Fascias and soffits

**ACTION REQUIRED:** Please see our comments within the Executive Summary with regard to the asbestos flue and have an asbestos test carried out when the asbestos flue is removed.

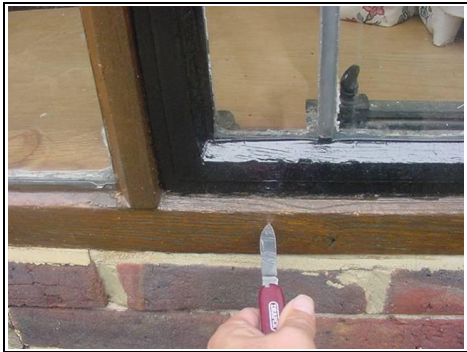
We have only opened a few of the windows and these worked reasonably well considering they are metal windows which do buckle and rust over time. On the windows we opened there were no signs of rusting and on the frames that we knife tested there were no signs of wet rot.

Knife testing window to the rear right of the property

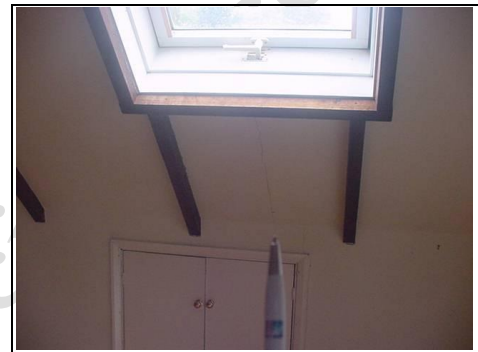
A straight crack such as this indicates plasterboard or board of some type. We assume the roof conversion was done after the original build.

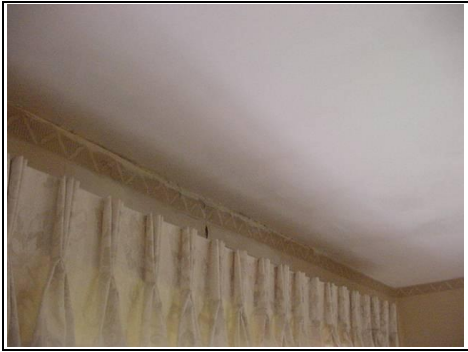
Old leak visible on ceiling. This has now been resolved

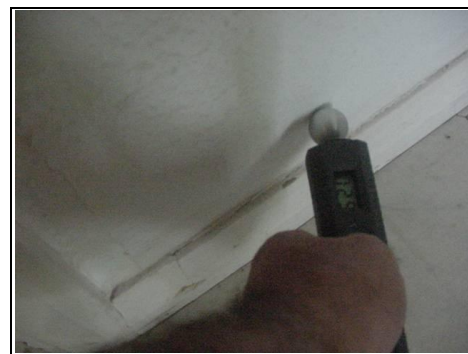
A random visual inspection and tests with a moisture meter have been taken to the perimeter walls. In this particular case we have found minor rising damp probably due to a combination of the property being empty and the sloping site with high ground levels we mentioned at some areas.

Checking for dampness

**ACTION REQUIRED:** Please see the Executive Summary.

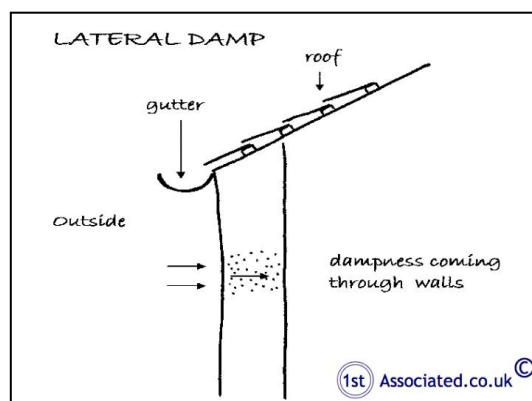
We used a damp meter on the external walls. We have found minor readings because the property has been empty.

**ACTION REQUIRED:** Please see our comments in the Executive Summary.

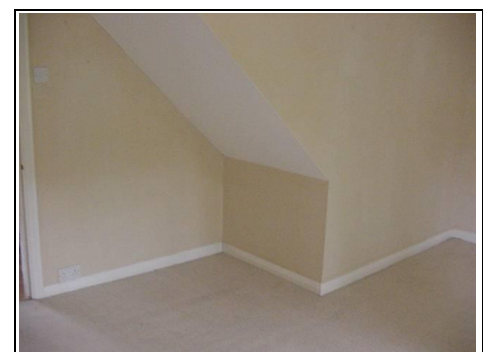
We were unable to examine the underside of the stair timbers due to them being lined, which precluded our inspection, so we cannot comment further upon the stair structure. We can, however, say that the lining gives a resistance to the spread of fire if such circumstances were to occur.

Lined underside of the stairs-  
middle rear bedroom – first floor

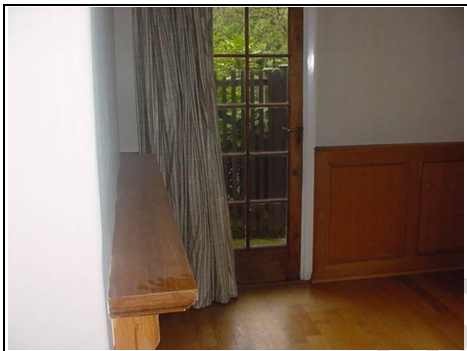
Glazed doors may be a security risk

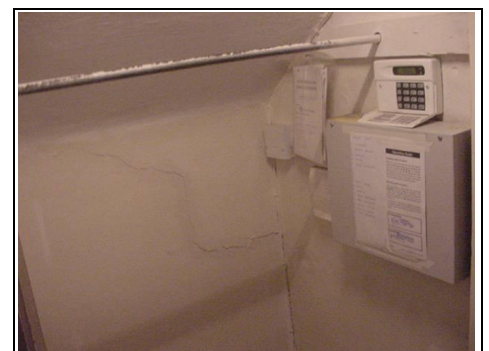
A security system has been installed. Xxxx (gardener /handyman ) not aware if this was working or not. A good alarm system should not only help reduce break-ins but also your insurance. We are not experts in this field and therefore cannot comment further.

Alarm panel

**ACTION REQUIRED:** Further information should be obtained from the vendor or the installer at a later date.

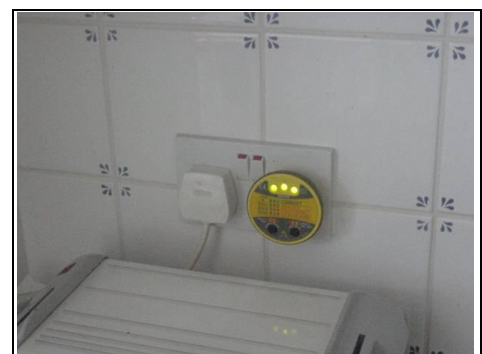
Earth Test

We carried out an earth test in the kitchen area to the socket point that is normally used for the kettle, this proved satisfactory.

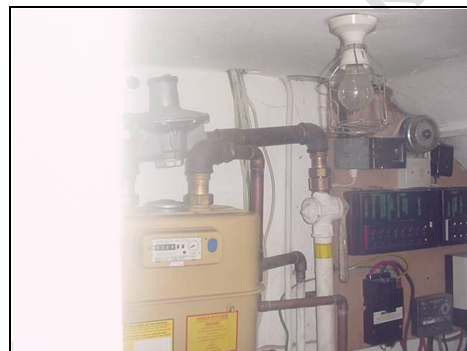
We are advised that the property has mains gas. The consumer unit is located in the service cupboard near the left entrance to the property.

**ACTION REQUIRED:** As a matter of course it is recommended that the entire gas installation is inspected and made good, as necessary, by a Gas Safe registered contractor. Thereafter the installation should be serviced annually.

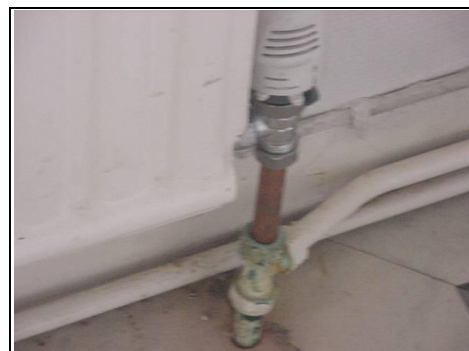
There was rusting to the joint and we assumed there had been problems with it in the past. However, Xxxx (gardener/ handyman) advised us there had not been any problems during his time working at the property.

Copper pipe visible and rusting to the joint

Our limited inspection of the hot water and central heating system revealed no evidence to suggest any serious defects but we would nevertheless recommend that the system be tested and overhauled before exchange of contracts and that a regular maintenance contract is placed with an approved heating engineer.

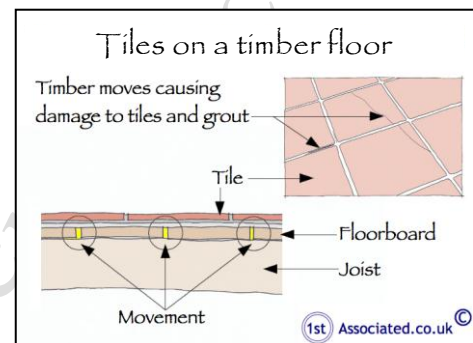
With a wooden floor you will always get some deflection, however minor. This deflection in the floor will ultimately mean that the tiles will need re-grouting.

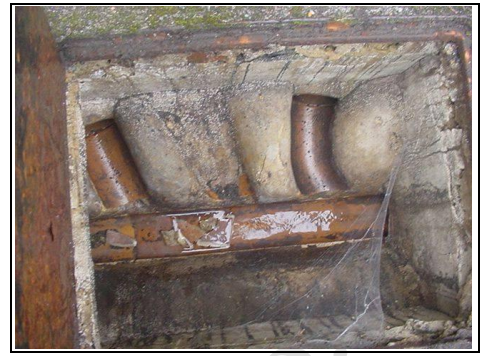
Manhole two

We duly lifted the cover and found it to be free flowing at the time of our inspection. However it does have some debris from the drainpipe in it.

**ACTION REQUIRED:** Please see our comments within the Executive Summary.

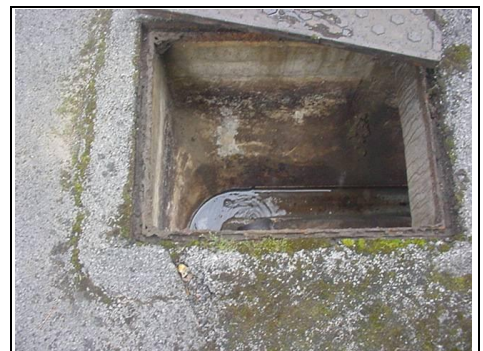
Manhole Four

We duly lifted the cover and found it to be free flowing at the time of our inspection.

This is a precast concrete ring. This means the manhole is newer.

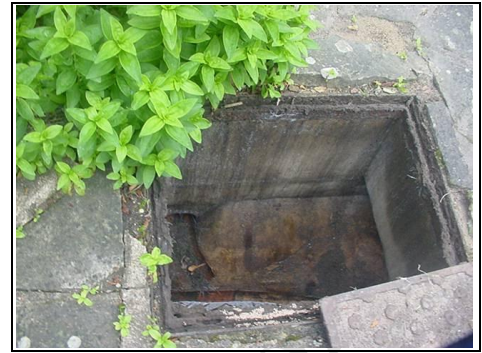
Manhole Five

We duly lifted the cover and found it to be free flowing at the time of our inspection.

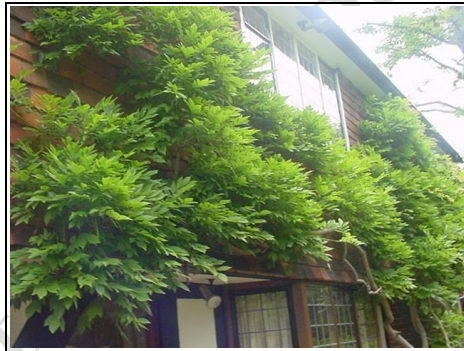
Wisteria needs cutting back
