RESIDENTIAL BUILDING SURVEY

Flitwick, Bedfordshire. MK45

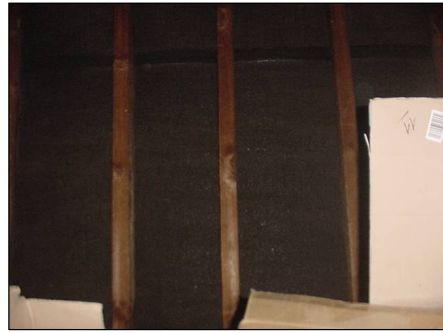
When we inspected the loft space we found a Hessian base Bitumen membrane. This type of membrane has been used since the 1960s. We generally found it to be in average condition, it is damaged in a few more places than we normally find.

This photo shows the common rafters (the ones that form the pitch of the roof) and the dark area between is the underlayer.

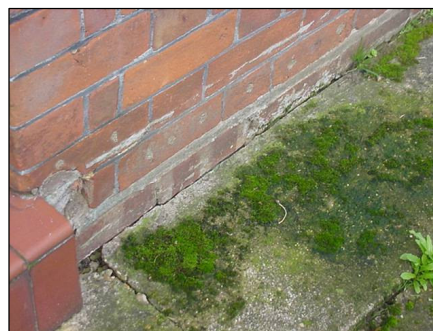
All modern properties should incorporate a damp proof course (DPC) and good building practice dictates that a differential of 150mm (6 inches) should be maintained between the damp proof course and ground levels. In this case, the damp proof course is too low to the ground level due to the concrete being put too high which means when the rain hits it, it can bounce over the height of the damp proof course, we also note that a damp proof course has been inserted (the circular holes).

Inserted damp proof course

ACTION REQUIRED: We recommend you reduce the ground level and put in a French drain.

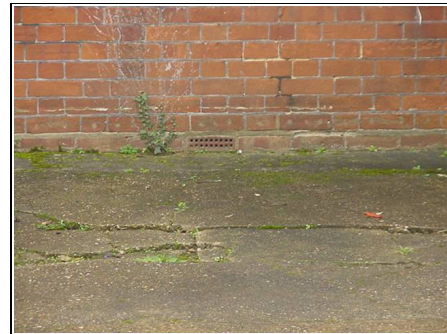
The front of the property has a suspended timber floor the rear has a solid floor and this means that there is not an air flow underneath the timbers which means they are susceptible to rot. In addition to this you have an airbrick acting as a gutter which will allow water into the property.

Airbrick acting as gutter

ACTION REQUIRED: You need to amend the airbricks to the front and also we recommend a French drain is added. You also need to add a vent to the rear of the suspended timber floor. You also need to open up the floor to check the condition of the timbers beneath. Typically there is normally enough room to go underneath the floor and carry out repairs.

ACTION REQUIRED: We recommended within the Executive Summary a French drain is added generally to the front, this should stop the airbricks acting as gutters and in addition to this you need to add a vent within the property to allow the through flow of ventilation.

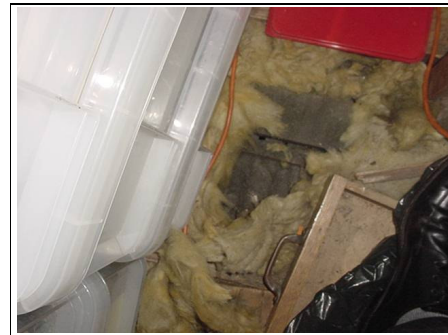
From our visual inspection of the ceilings and our general knowledge of this age and type of construction we believe that the ceilings are originally lath and plaster, but in some areas have had plasterboard tacked over them or replaced. This type of work is normally carried out where the ceilings are in poor condition, as removing lath and plaster is very messy, time consuming and expensive as it is labour intensive (the above was confirmed during our question and answer session with the owner).

Lath and plaster visible

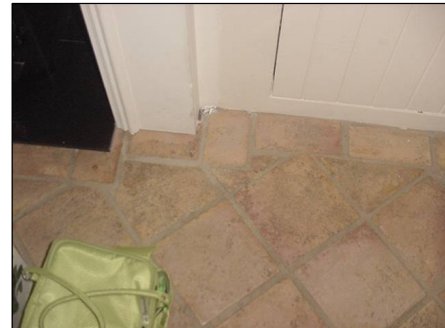
Quarry tiled floor to rear of property

ACTION REQUIRED: You need to ensure there is a through flow of air ventilation to the timber floor and check its condition by opening it up. In an ideal world the concrete floor to the rear should be removed, but this is expensive and disruptive work, we would only reckon it if a major refurbishment of the property was taking place

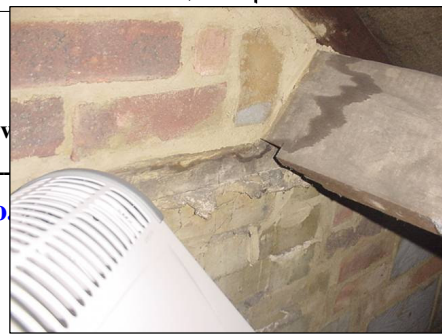
significant penetrating/lateral dampness was seen. However in this age of property you should expect some dampness particularly during the wetter months. We would draw your attention to our comments we have made with regard to the dampness in the roof space, particularly to the purlin ends.

Lateral dampness

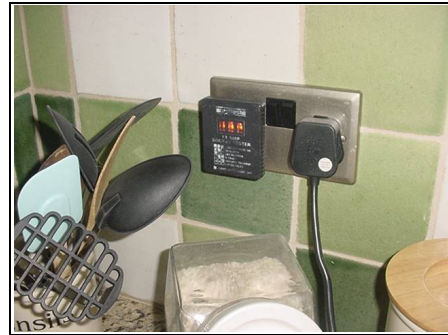
We carried out an earth test in the kitchen area to the socket point that is normally used for the kettle, this proved satisfactory.

Earth Test

ACTION REQUIRED: As the property is changing occupancy an IEE report should be carried out by a NICEIC registered and approved electrical contractor.

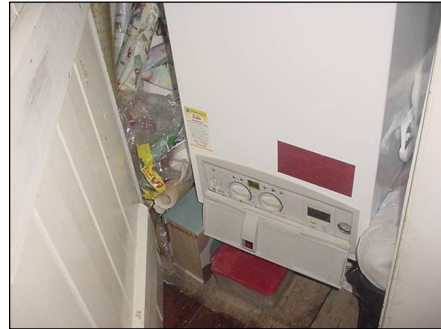
The wall mounted boiler was located in a cupboard on the landing, it is manufactured by Bosch. Our limited inspection of the hot water and central heating system revealed no evidence to suggest any serious defects, however we would recommend that the system be tested and overhauled before exchange of contracts and that a regular maintenance contract be placed with an approved heating engineer.

Wall mounted boiler in cupboard

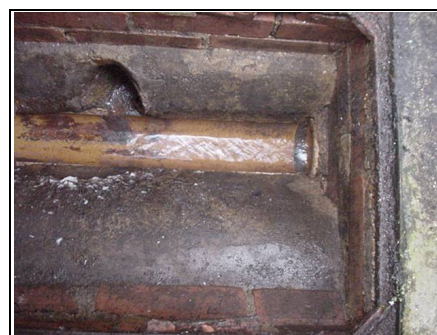
Manhole one

We duly lifted the cover and found it to be free flowing at the time of our inspection.

From what we could see it is brick built.

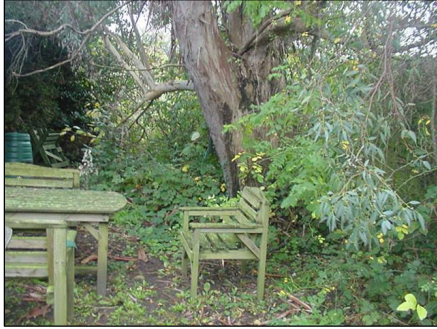
There is a patio area with uneven paving slabs and a further garden then an overgrown section of garden.

Rear garden
