RESIDENTIAL BUILDING SURVEY

Flitwick, Bedfordshire MK45

FOR
Mr T

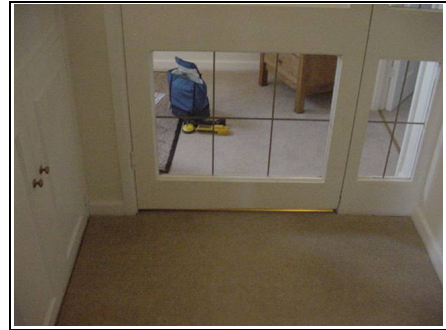
The glazed glass within the entrance door is not, as far as we can see, safety glass as there is no British Standard kite mark on the glass.

ACTION REQUIRED: We recommend replacement, unless evidence can be proved that it is safety glass.

ANTICIPATED COST: Costs in the region of £75 to £150, depending upon whether you need to have safety glass at the top and the bottom of the door. Please obtain quotations.

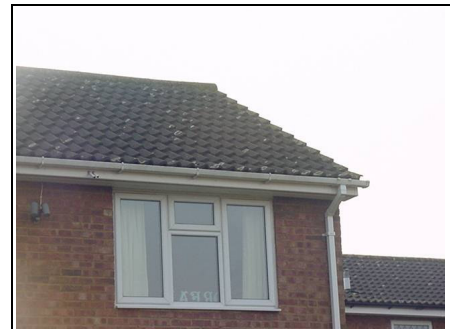
The roof and the concrete perimeter are pitched and clad in a large interlocking concrete tile. From what we could see the concrete tiles are lying level and true and look in reasonable condition considering their age. Sometimes we find deterioration to the ridges and the perimeter, so you should periodically check these areas.

Concrete roof tiles

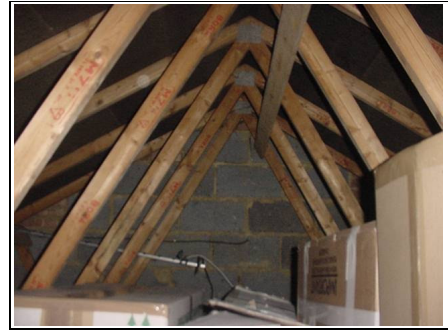
We found the roof timbers generally in average condition considering their age. We have inspected the roof structure for:

Pre-fabricated truss rafter

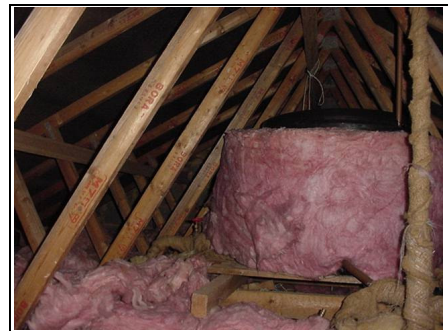
The water tank is formed in plastic and we therefore assume they are relatively new (in surveying terms, in this instance, that is the last 30 years). It is insulation which unfortunately hides part of it. We recommend draining down the tank and cleaning it particularly important if you clean your teeth with the water!

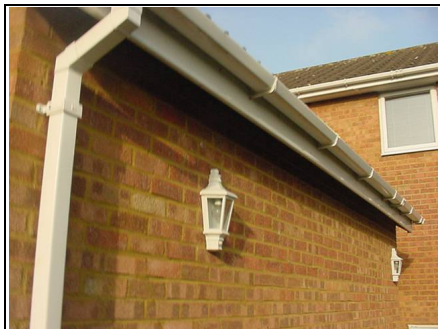
From ground level the gutters and downpipes looked to be, what is known as, profile plastic, which means the gutters and downpipes are shaped. There may be some minor leaks, but we feel that most people could live with these.

We noted that the downpipes discharge directly into the ground. We much prefer gutters, as this does allow any debris that gets past down a downpipe to be cleared.

Gutters and downpipes

ACTION REQUIRED: We would always recommend that the gutters and downpipes are cleaned out, the joints are checked and the alignment checked to ensure that the gutters fall towards the downpipes.

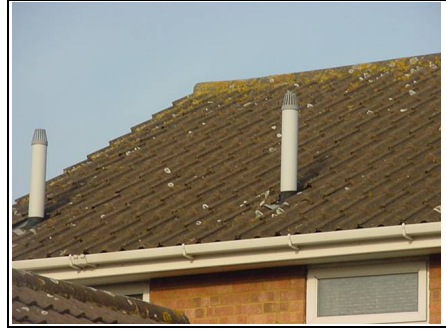
The property has plastic flues visible at roof level. Where they come through the roof there is a rubber flashing which can perish over the years. From ground level this looked in reasonable condition.

Plastic flue

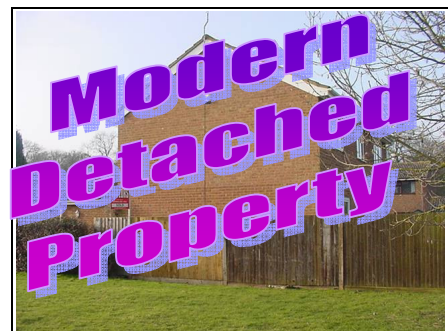
We could also see banding to the brickwork, which is a phenomena where different colour bricks are used.

Banding of brickwork

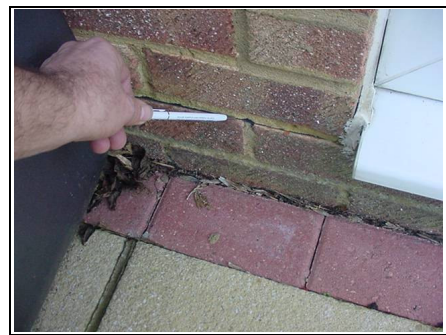
In this case, we can see a plastic DPC in some areas as the property is relatively new (last 30 years in this case) and this is what we would expect to find, often known by its trade name of hyload.

Damp proof course

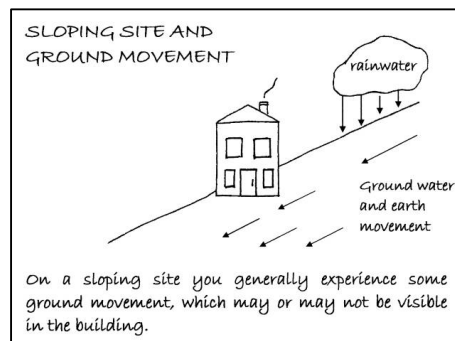
As the drive slopes towards the road we would advise in a worse case scenario you can flood the garage. Please see our comments in the Executive Summary.

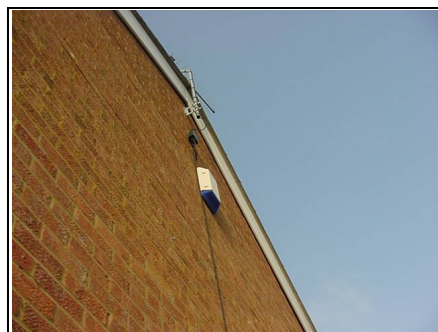
A security system was noted. We did not test and can't confirm if it's working or not.

Alarm system

It is a personal decision as to whether you feel one is necessary. We are not experts in this field and therefore cannot comment further. We suggest you contact a member of NACOSS (National Approval Council for Security Services), obtainable through directory enquiries, or your local Police Force for advice on a security system.

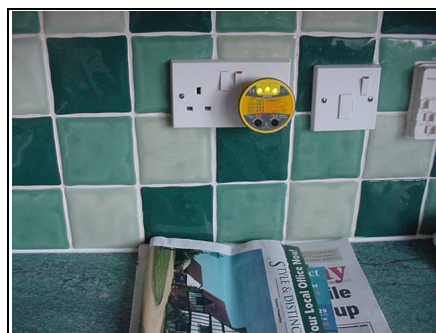
We carried out an earth test in the kitchen area to the socket point that is normally used for the kettle and this proved satisfactory.

Earth test

ACTION REQUIRED: If there is no record of an electrical test having been undertaken within the last five years, it is recommended that the installation be tested by a competent electrician (NICEIC registered) and all recommendations implemented. Thereafter, the installation should be re-tested every five years.

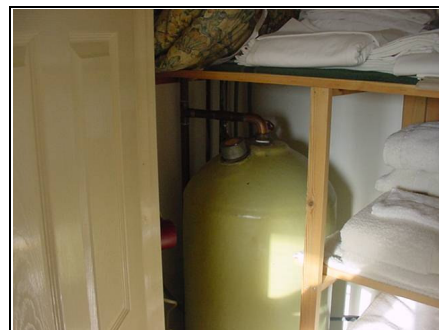
The hot water cylinder is relatively new (in this case we mean in the past 30 years) as it is factory lagged and located in the airing cupboard.

Hot water cylinder

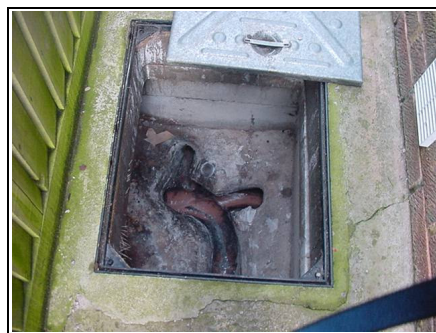
Manhole one

We duly lifted the man hole/ inspection chamber cover and found the drain to be free flowing; we noted it was finished in concrete.

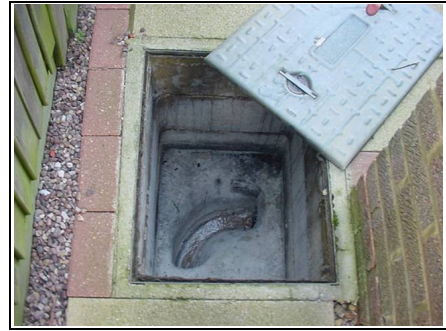
Manhole two

This manhole was lifted and found to be free flow and built, as previously described.
