RESIDENTIAL BUILDING SURVEY

London Borough of Lewisham

This is a two storey end terrace house with a basement to the front of the property and a two storey height bay window. Alterations and repairs have been carried out to the property over the years.

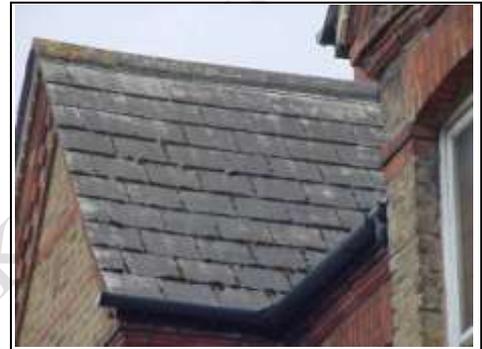
The roof covering, we are advised, was carried out fairly recently. It is a manmade slate (please see our comments on manmade slates below). We do tend to find that they become lighter/grey/white over the years and they do gather more moss than traditional slates in our experience.

Moss around man made slate and slates becoming lighter

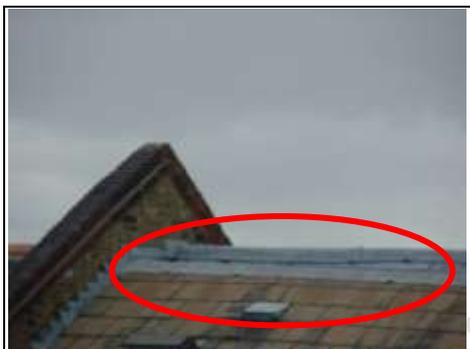
There is an unusual lead upstand/lead flat roof to this property. We are unable to see it properly however we believe it is a flat section on the main roof from what we can see within the roof. It may have been added to straighten the building up following the lie of the land or possibly added due to movement in the structure. Either way it is allowing rainwater into the roof structure.

Unusual lead upstand

ACTION REQUIRED: The main roof needs to be accessed and this entire lead detail needs to be checked along with the decking beneath it. With regard to access it is likely to need expensive scaffolding or access may be possible via a cherry picker.

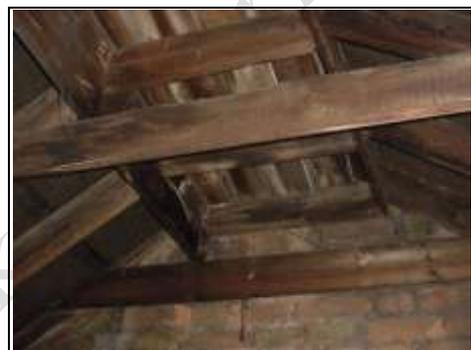
Rainwater causing dampness via the lead upstand

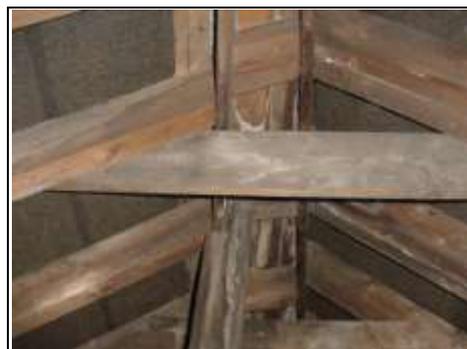
Condition of timber under the lead from what we could see in the roof looks to be poor

ANTICIPATED COST: It really depends upon what you find at high level. We would estimate in the region of £2,500 - £5,000 depending upon how easy or difficult access is and how badly damaged the decking is. In the above photo you can see the dampness visible within the roof in the darker timbers.

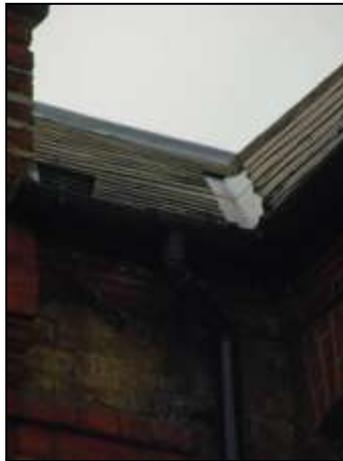
Although the valley gutters appear to be in quite good condition externally we can see internally that they are allowing dampness into the property.

Valley gutter

ACTION REQUIRED: We would recommend that the lead to the valley gutter is checked, made watertight and possibly the replacement of the boarding beneath and possibly the cement fillet.

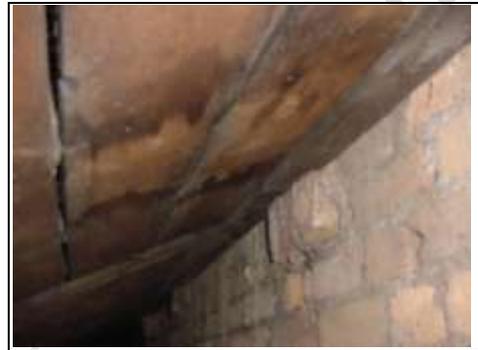
From our vantage point in the adjoining block of flats we were able to see that the lead flashing had slipped and we were also able to see the water damage beneath when we went into the rear part of the roof.

Dampness coming into rear single pitched roof

ACTION REQUIRED: Leadwork needs replacing.

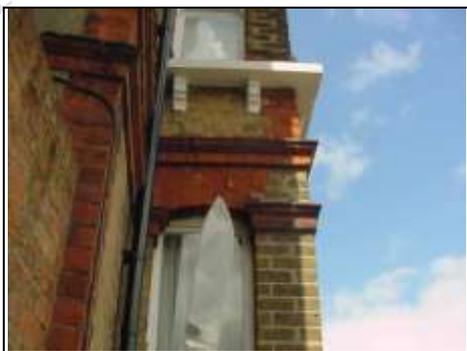
From what we can see there still appears to be some movement in the property. The area we believe is a clay area and as such in our experience you will always find some movement to a greater or lesser extent. See our article at the end of the report on the Settlement, Subsidence and Heave.

Movement over arch to front bay

ACTION REQUIRED: You need to accept that the movement and the repairs and peoples opinion of this type of property are part of the character of this property. There is little that you can do to change many of them. It may result in a lower than average price being obtained for this type of property and/or selling taking a long time.

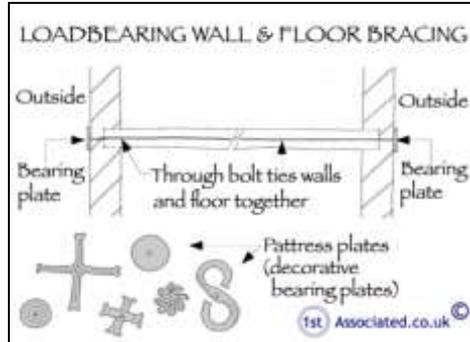
We noted a tie bar in the structure. These tended to be used post war when cracking was generally not considered as big a problem.

Tie bars

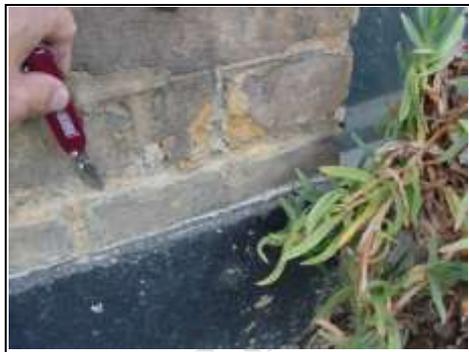
We would draw your attention to the cement mortar re-pointing that has been carried out on the exterior of the property that we feel is not appropriate to this building. Originally it will have been built with a lime-based mortar and this is what should be used for any re-pointing in the future.

Cement pointing

The use of cement mortar causes deterioration to brickwork and does lead to the face of the bricks deteriorating, which in turn leads to dampness. This is a very important point.

ACTION REQUIRED: Find an old bricklayer that is used to using lime mortar and for them to gradually remove the cement mortar over several years with a soft brush and repoint in lime mortar to allow the building to breathe.

ANTICIPATED COST: A few hundred pounds per year; please obtain quotations. The good thing about cement mortar is that it does tend to fall away. Eighty percent of houses that we look at tend to have been wrongly repointed in a cement mortar.

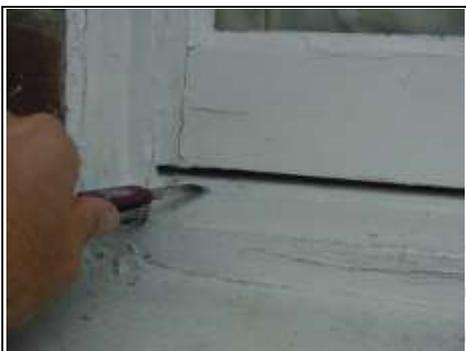
The sliding sash windows fit poorly in some cases and would generally benefit from redecoration.

Sliding sash windows don't fit

ACTION REQUIRED: Ease and adjust the windows to make them fit as well as possible and possibly add draught seals and redecorate in the summer of XXX. We would also advise that you may wish to add secondary glazing.

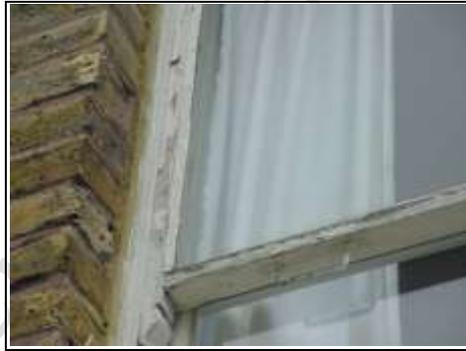
Sliding sash windows need redecoration

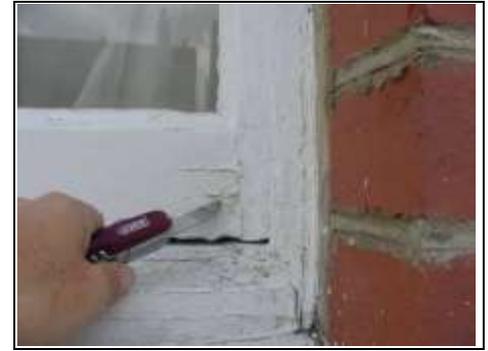
Windows in need of redecoration

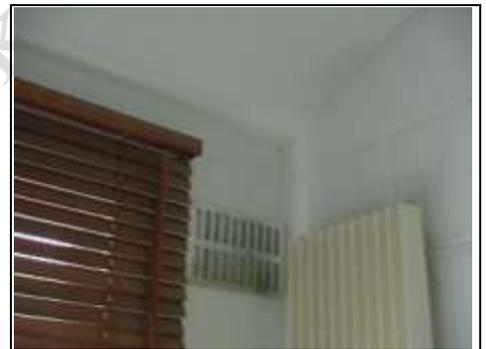
Vent rather than extract fan in bathroom

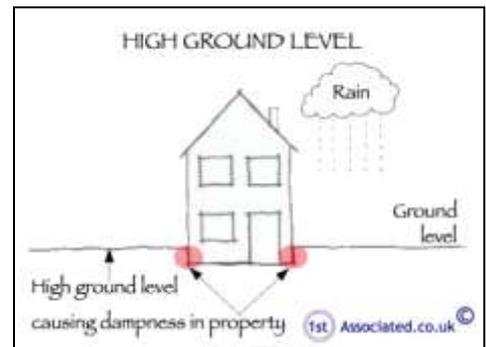
We believe the problem relates to the property having a high ground level in some areas and air vents that are acting as gutters. We can also see other areas where there are no vents or the vents have been covered over which means there will be dampness in the suspended timber floor.

High ground level

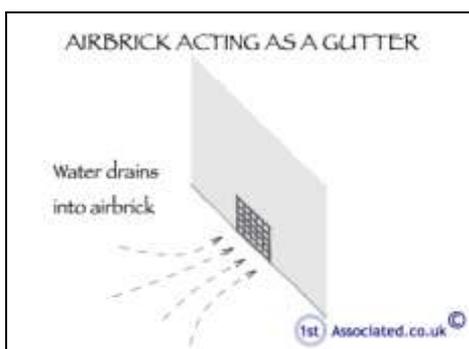
Airbrick acting as gutter

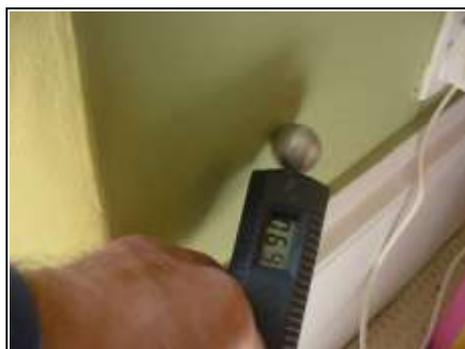
High damp readings

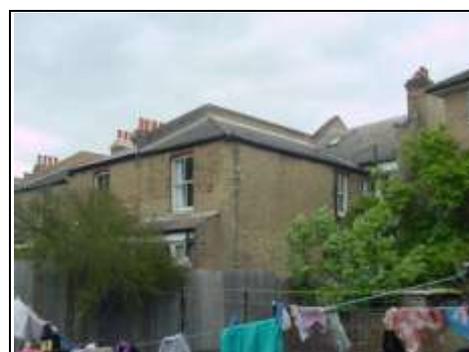
We have viewed the property from the flats built to the left hand side of the property and noticed that your house and garden to some extent is overlooked.

View from left hand side flats of your property

ACTION REQUIRED: You need to ensure you are happy with this, we suggest that you have a walk around the nearby block of flats and have a view for yourself.

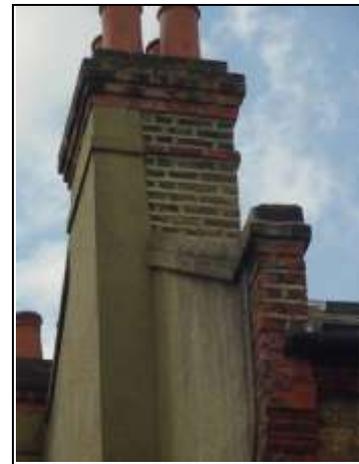
Chimney one

Unusually the chimney sits outside the parapet wall and we believe the brickwork to the chimney also gives support to the house as a whole although we haven't been able to inspect this area closely. This chimney is brick finished with render to the gable end and numerous chimney pots, we are not absolutely sure with regards to the flashing although we can say that it is allowing water inside. From our limited view at ground level and our view inside we suspect there is a problem with the flashing or the flaunching or the pointing.

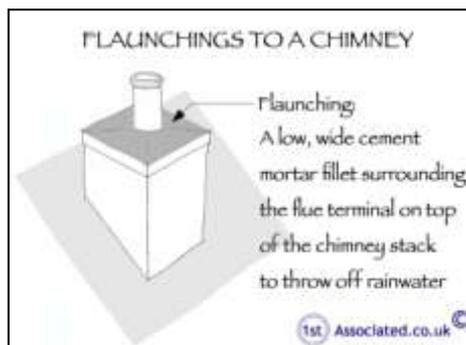
Flaunchings

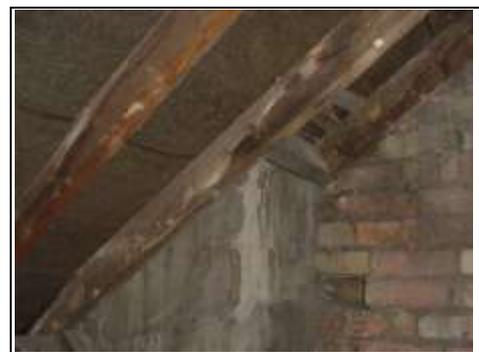
Dampness coming in around chimney

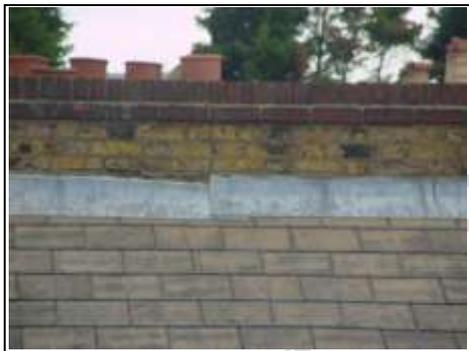
In this case there are parapet walls to the front and also to the rear right hand side. They are brick built. We could see from our vantage point from the flats to the rear of the property that the flashing has come away and also we obtained damp meter readings within the roof space.

Lead flashing coming away on parapet wall

ANTICIPATED COST: We would estimate the scaffolding would be more expensive than the actual work. In the region of £2,000 - £5,000 to repair the flashing; quotations required.

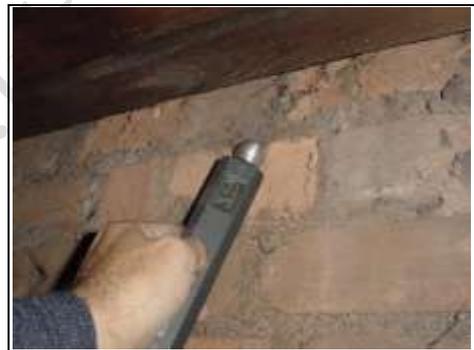
Dampness to parapet wall

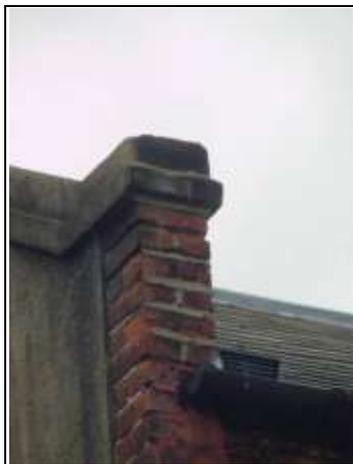
Parapet wall to left side in need of some repointing

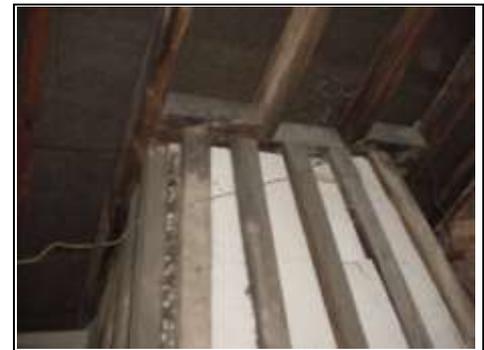
The property has a purpose made roof window, which looked in average condition. The important factor with roof windows is the flashing around them; in this instance we simply couldn't see it as we didn't have a vantage point where we could see the roof window properly.

Roof window that goes into landing area

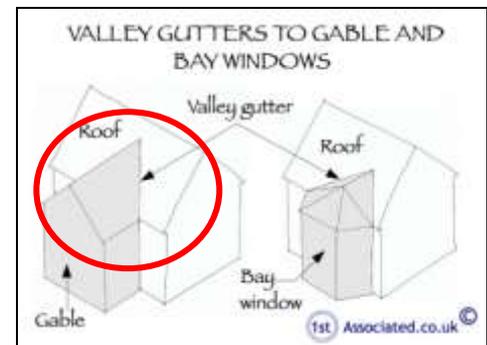
Valley gutter

This property has valley gutters. Valley gutters are formed where two roofs meet and these are generally problematic.

ACTION REQUIRED: Please see our comments in the Executive Summary.

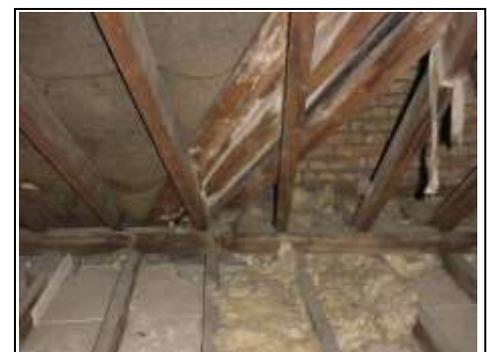
Valley gutters to front of property seen within roof space

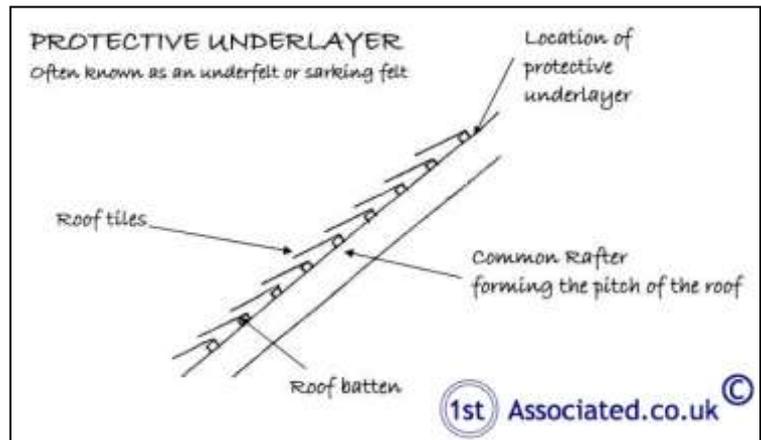
Protective underlayer

When we inspected the loft space we found a Hessian base Bitumen membrane. This type of membrane has been used since the 1960s. We generally found it to be in average condition, with damage in some areas which is what we typically find.

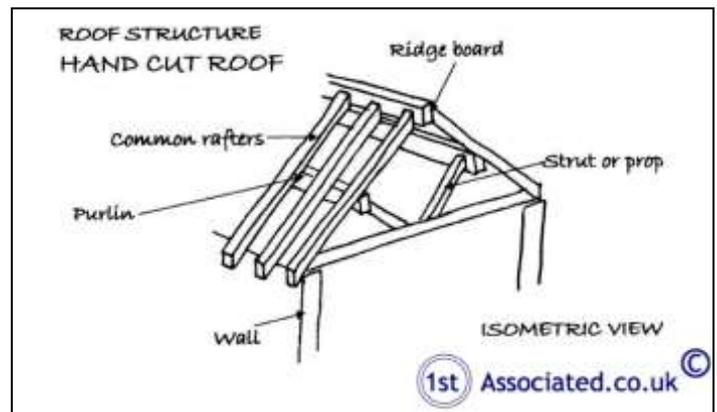
Cut timber roof

This type of roof structure has what is known as a cut timber roof. This is a roof that is purpose made and hand built on site. Without the original design details we cannot categorically confirm that there are no defects however we would comment that the roof structure is lightweight

and the timbers are thinner than we would expect.

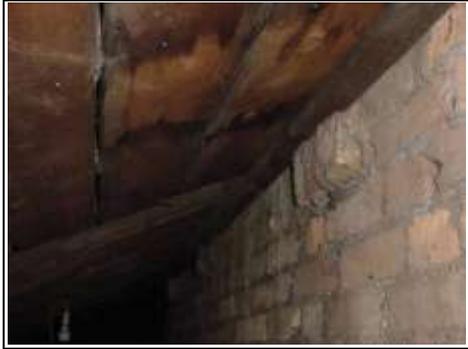
Dampness from parapet wall

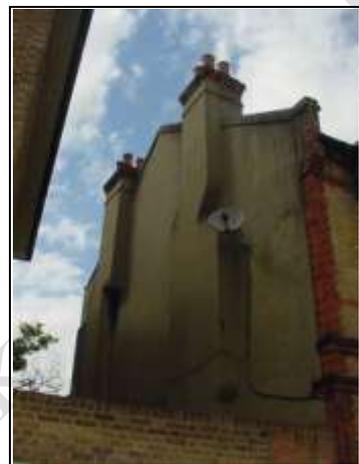
We were not able to view this area properly due to the way the building is constructed. From what we can see of the render there were dark areas which may be due to lack of airflow around the building particularly as there is a large block of flats to the left hand side.

Render to gable end on left side

We would remind you that any hairline cracks that appear in the render need to be sealed as soon as possible to stop dampness and water getting in and causing blisters and hollow areas. The brickwork areas should also be repaired to stop further deterioration.

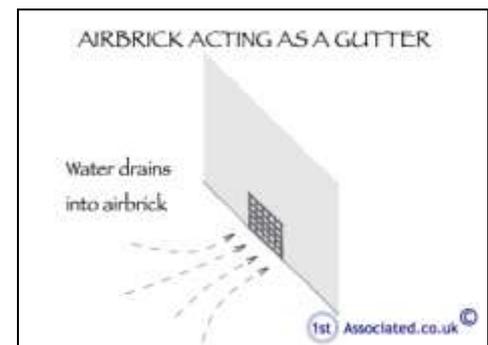
Airbricks acting as gutters

ACTION REQUIRED: Please see our comments in the Executive Summary. Make sure there is a clear flow of air through the building and ensure that none of the air bricks are acting as gutters (please see our earlier comments).

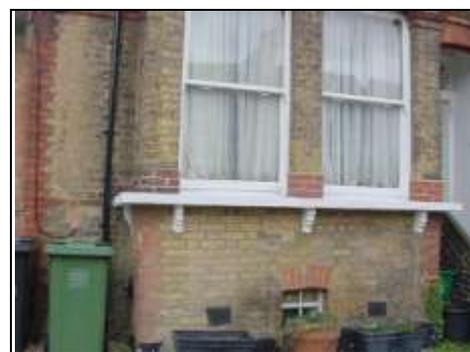
Sliding sash windows

The property has single glazed timber sliding sash windows. We would specifically comment that the windows do not fit properly and are in need of redecoration.

ACTION REQUIRED: Please see our comments in the Executive Summary.

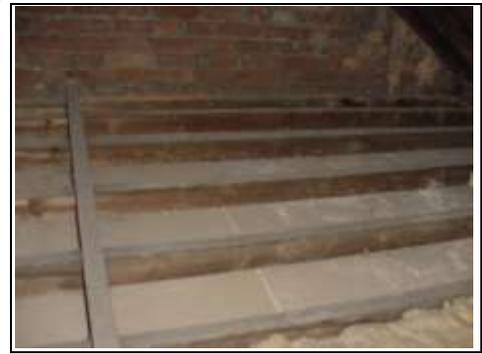
From our visual inspection within the roof and our general knowledge of this age and type of construction we believe that the ceilings are a mixture of the original lath and plaster with replacement plasterboard. We particularly noted to the front right hand side which is over the master bedroom new plasterboard in this area which in turn means the cornice has been recreated (the owner during our question and answer session confirmed this).

Replacement ceiling over master bedroom

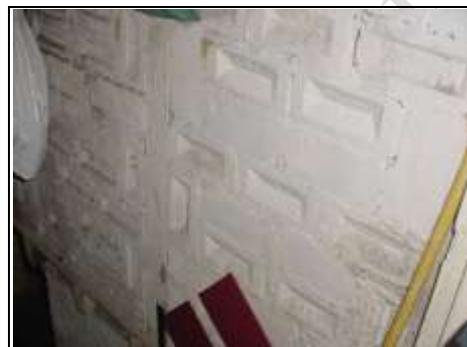
Based upon our knowledge of this age, type and style of construction we believe the majority of the walls are solid brickwork walls with more modern partition walls for example around the utility room. The only place we could see the partition wall (without taking a wall down) is to the side of the cellar area where we could see a brick on edge had been used.

Brick on edge within cellar.

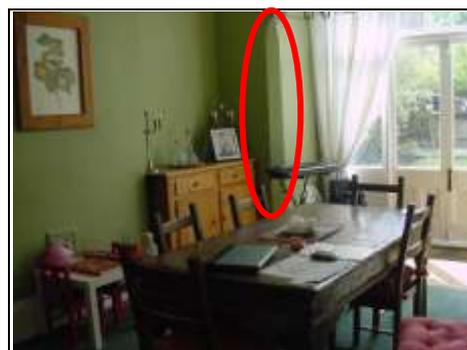
Originally these would have been constructed with solid wall, Flemish bond brickwork with a wet plaster applied. Some of the walls seemed too smooth to be an original lime plaster; we assume these have been upgraded by the existing owner who as you may know is a plasterer. We spoke to his wife during the question and answer session who advised that all she could remember for definite that had been carried out was to the rear lounge/dining room where he had evened out the splays to the side of the French door area.

Splays to French door area

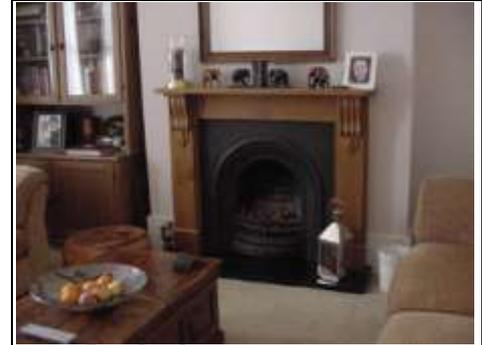
At the time of the survey no chimneys were in use. Any chimneys that you do not propose to use should be capped and ventilated to prevent dampness.

Fireplace

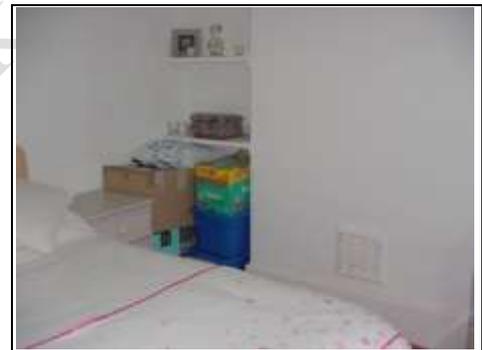
Vent to rear chimney

Possible chimney removed

ACTION REQUIRED: We recommend you meet with your next door neighbour to see if they have a chimney on their side as this could affect your property. We are more than happy to return if they do.

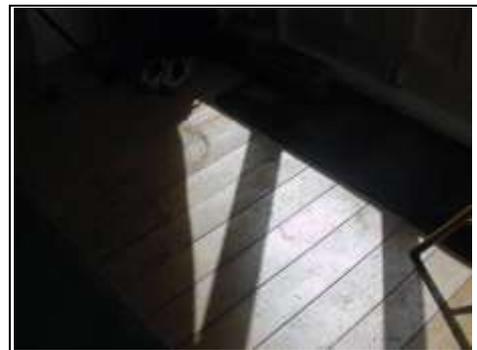
There is a suspended timber floor to the property, which require air movement underneath to minimise wet rot, dry rot and woodworm. The timber floor is a modern, thinner board than we would have expected to originally find.

Timber floor

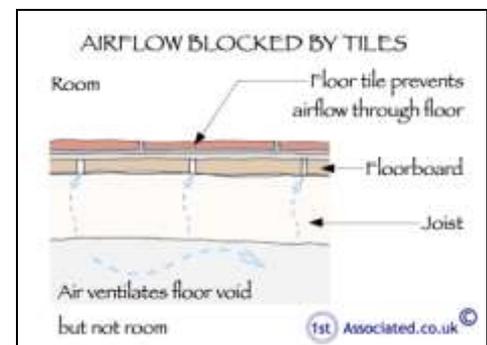
Floor tiles in kitchen and utility room

Whilst the floors have a tile finish they are a suspended timber floor which requires air movement underneath to minimise wet rot, dry rot and woodworm. Our concern where floors are tiled is that we physically cannot see the floors. Our other concern is that a hard material such as a tile onto a soft floor that deflects means that ultimately the joints will start to crack and deteriorate and you will need to repoint.

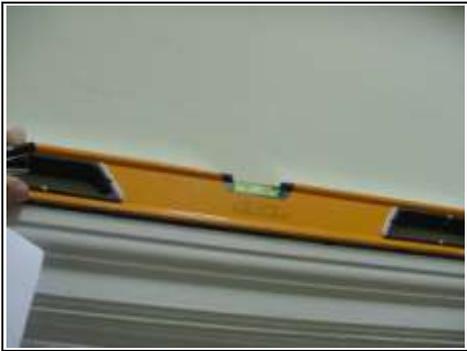
Checking door frames which are out of level

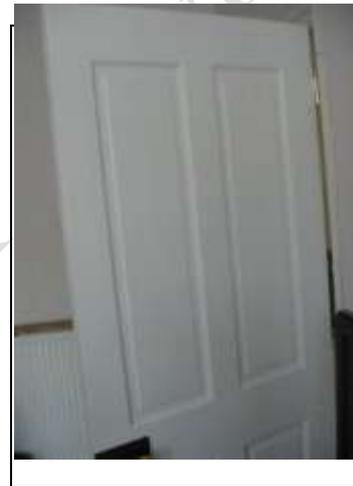
The property has a mixture of doors including panel doors and modern hollow core doors (sometimes referred to as egg box doors, as this is what the internal of them looks like when they are opened up).

Egg box door

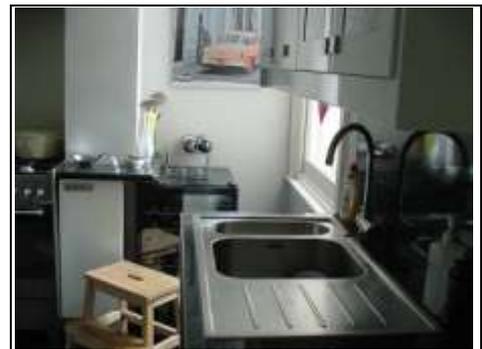
We would comment that the configuration of the kitchen is slightly unusual as the sink is not underneath the window.

Kitchen sink not under window

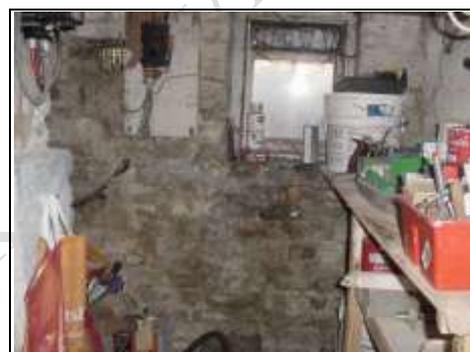
The cellar is damp as we would expect it to be.

We would comment that we didn't find a sump pump within the cellar. It is generally considered more and more likely to have flooding in cellars today due to the way we have developed our building.

Cellar

ACTION REQUIRED: Please see our comments in the Executive Summary.

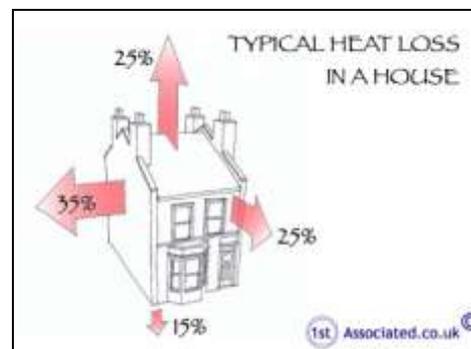
Some roof insulation was present although not to current Building Regulations requirements of 300mm. In this instance there was 200 to 300mm.

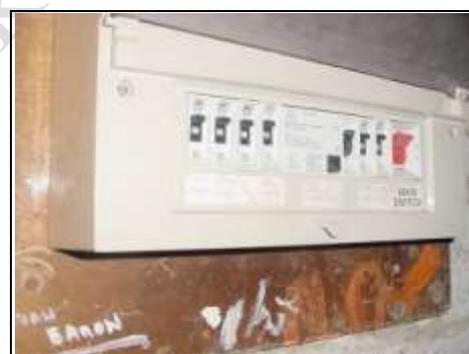
The electric fuses and consumer units were located in the basement. The fuse board looked 1970's/1980's and better are now available. We recommend that the fuse board is replaced.

Fuse board

ACTION REQUIRED: Replace fuse board. As the fuse board is dated there are likely to be electrics that are dated as well. As the

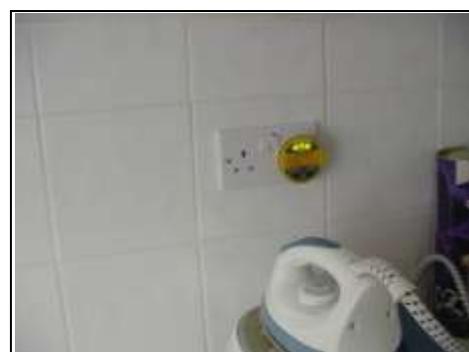
We carried out an earth test in the utility room to the socket point that is normally used for the kettle, this proved satisfactory.

Earth Test

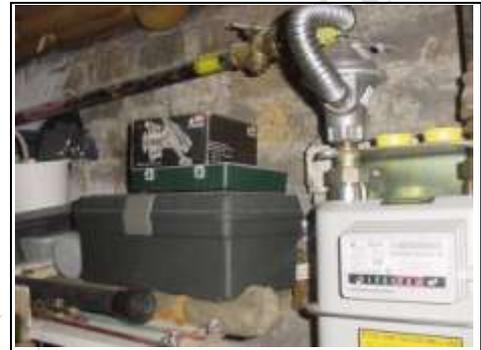
We are advised that the property has mains gas. The consumer unit is located in the cellar.

Gas

ACTION REQUIRED: As a matter of course it is recommended that the entire gas installation is inspected and made good, as necessary, by a Gas Safe registered contractor. Thereafter the installation should be serviced annually.

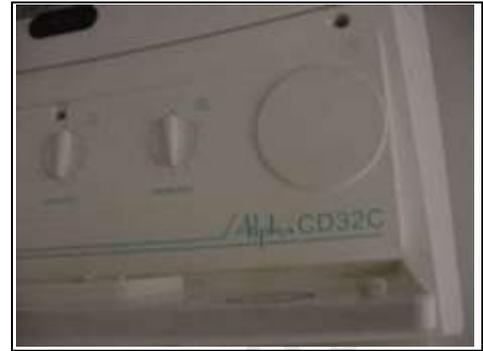
The boiler was located in the cloakroom within the utility room, it is manufactured by Alpha and the model type is CD32C. This boiler is one that we don't come across very often and it may be difficult to obtain spare parts.

Boiler

Our limited inspection of the hot water and central heating system revealed no evidence to suggest any serious defects but we would nevertheless recommend that the system be tested and overhauled before exchange of contracts and that a regular maintenance contract be placed with an approved heating engineer.

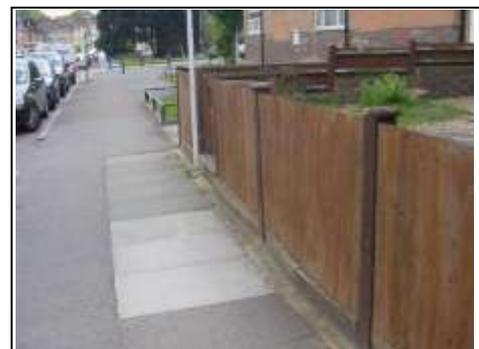
There is a small garden to the front with shingle. The fences to the front and side would benefit from staining.

Front fence

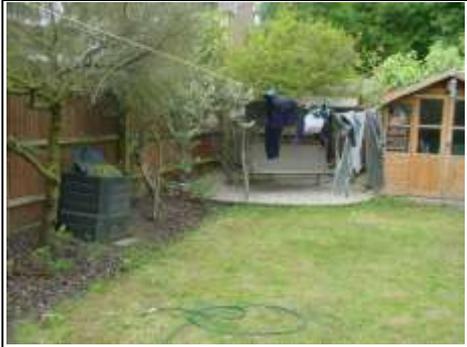
The fence would benefit from staining and some repair.

Rear garden
