JOB REFERENCE: RBS/RM

RESIDENTIAL BUILDING SURVEY

**A Converted Victorian Chapel, Hammersmith and Fulham,
London, W14**

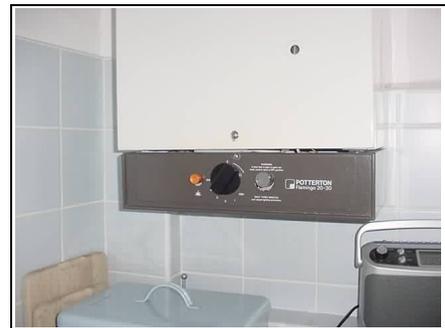
The boiler is dated and coming to the end of its natural life.

You specifically asked if you could put it outside. Whilst this is possible it is highly unusual, particularly at high level and may well require Planning Permission (it also needs to be easily accessible, under Health and Safety Regulations!). It is much more common to put boilers at high level out of direct sight; however they do need to be vented to external air.

ACTION REQUIRED: We would look at ways of hiding the boiler in cabinets etc. We suggest you go and meet some of the other residents of the property who may well have already thought of a good way of resolving this issue.

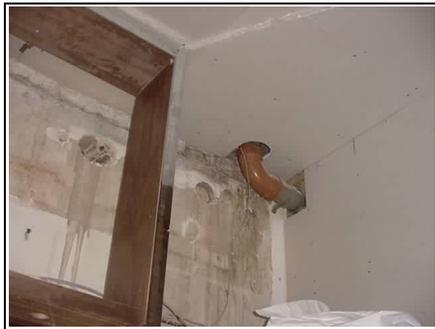
Your drainage pipe coming into the flat below (flat three).

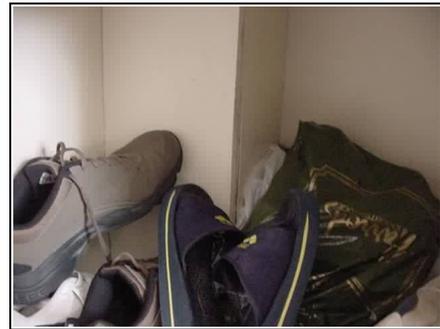
Where it is hidden within the cupboard in the en suite room

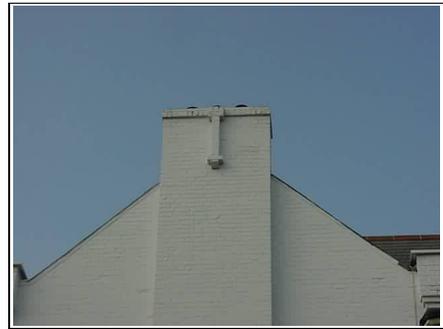
Chimney Two - Left Hand Side Front

This chimney also has a painted brick finish with, from what we could see, a lead flashing and no chimney pots, although again our view was limited particularly as the chimneys are so high.

When the high level work is carried out next the chimneys need to be inspected closely and repairs carried out as necessary. We are concerned that the paintwork may be hiding defects.

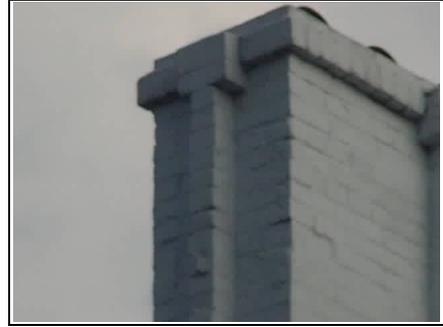
Chimney Three – Rear Left Hand Side

This chimney has a painted brick finish. From our close up photo it does look to be starting to weather on the joints and would benefit from repointing. Again, we were unable to see the flashings or flaunchings properly and therefore cannot comment upon them.

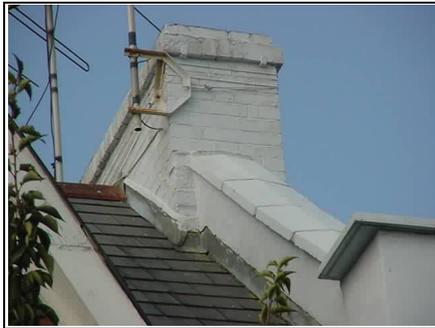
Rear Parapet Wall

There are various painted brick parapet walls to this property; although the view was difficult as everything on the property has been painted. We were pleased to see lead flashings and also a coping stone.

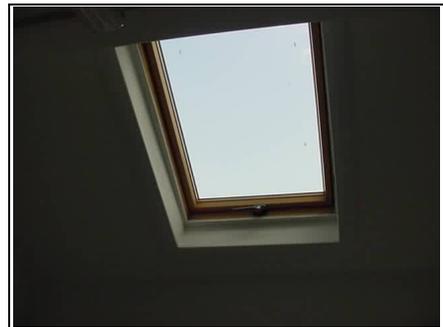
There is a modern timber roof window giving light to the staircase. There were not obvious signs of staining around it. However, it does seem inevitable with roof windows that they will sooner or later leak!

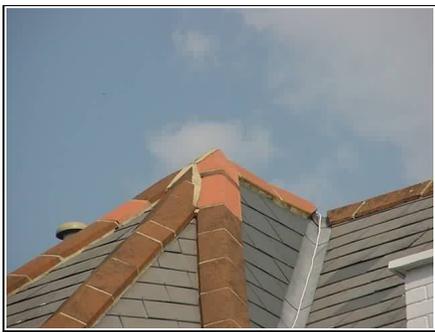
Note the poor valley gutter and also the repairs to the slates on the left hand side.

Valley gutters are generally considered to be problem areas, which is why we have made a specific mention of them.

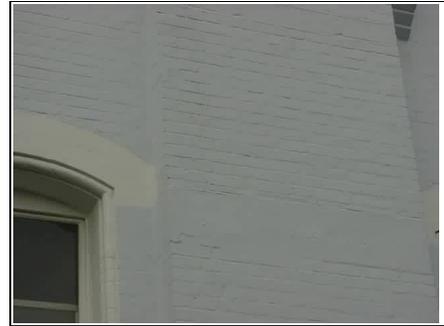
The property is brick built, which has been painted. The brickwork is built in Flemish bond brickwork, which has had the original lime mortar repointed in cement. Often this is carried out to try and reduce dampness.

Generally Flemish Bond brickwork is liable to penetrating dampness internally, dependent upon the condition of the brickwork and the exposure to the weather. In this case the external faces are in reasonable condition, although we did note areas where spalling to the brickwork has occurred. It is essential that external faces be kept in good condition.

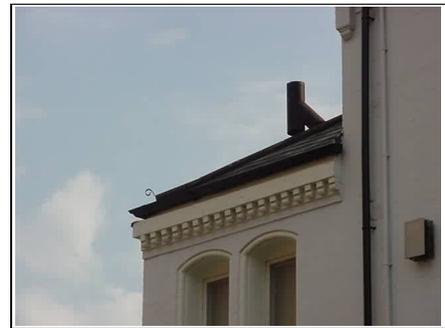
We believe the fascia is hidden behind the guttering in this instance, as we could not see it. There is decorative brickwork at high level, sometimes known as a 'string course' and we have also known it to be called 'dragon teeth'. This type of detailing can cause a problem because any leaks from the gutters soak into the brickwork below and then come into the properties below. In this instance we have not been able to gain access to the upper properties, although we did knock on their doors twice at the time of our survey, with no response.

ACTION REQUIRED: Your Legal Advisor needs to specifically ask if there are any problems with the top floor apartments with regard to damp coming in as this is quite a common problem.

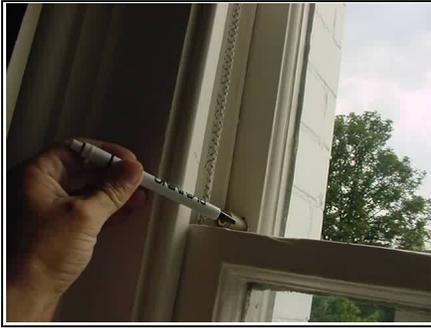
The property predominantly has painted timber sliding sash windows, which are single glazed. They are in average condition but need some repainting / repair. We noted that the sash cord to the stair window had seen better days, and this is typical of the sort of things that are left when a property is poorly managed.

A close up of the sash window in your lounge with the security guard on it.

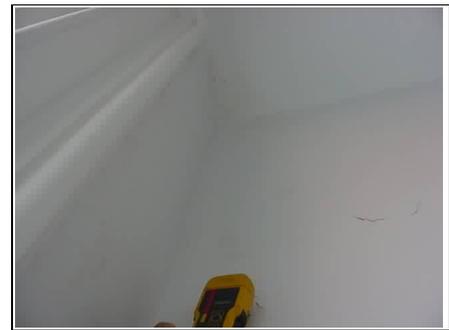
We did note some minor discolouration to the wallpaper at high level and got slightly higher damp meter readings; we are concerned that some dampness is getting into the wall around the hopper heads for example; often lead is added behind these to prevent dampness and this has happened in some areas on the building and not in others.

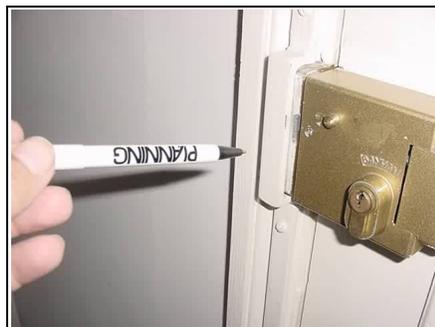
A London Security Bar

Any doors leading into a high risk area, which is what the access corridor is considered to be, should have a half hour fire resistance. In this instance, although we think the doors are fire resistant, we would expect them to have a door closer on. We spoke to the people that are modernising flat number three and they are including door closers on all their doors.

We noted a London security bar on the main door, which really does make the doors hard to get in through.

ACTION REQUIRED: We would recommend that door closers are added.

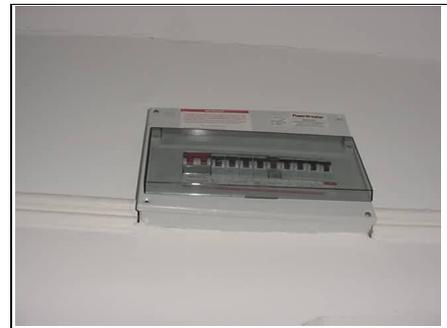
Fuseboard

The electric fuses and consumer units were located in the corridor. We would date the fuseboard as being from the 1990s and, whilst not the best now available, it is reasonable.

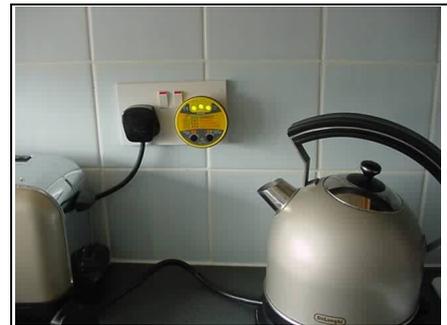
Earth Test

We carried out an earth test in the kitchen area to the socket point that is normally used for the kettle and this proved satisfactory.

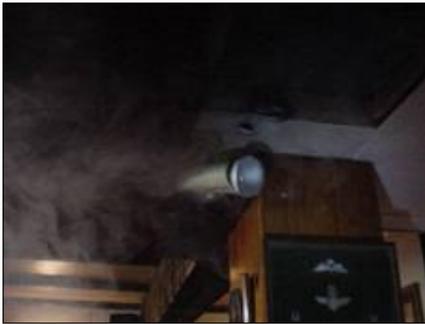
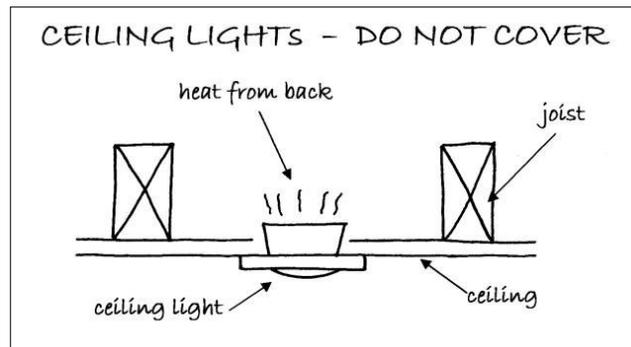
Ceiling Lights

The property has electric lights to the ceiling. In some instances these can cause problems as the heat given off has in some cases lead to outbreaks of fire; these tend to be in the older type of ceiling lights and we recommend that where ceiling lights are used that the rear of the light is not covered; this is particularly the case in rooms with a loft space above it where stored items are placed in it.

We did once turn up to carry out a survey on a public house and there was literally a fire in the floor being caused by this type of ceiling light (see photo above); even more ironic is that the property was being purchased by a fireman!

ACTION REQUIRED: Check when putting stored items into the roof that you do not cover the lights.

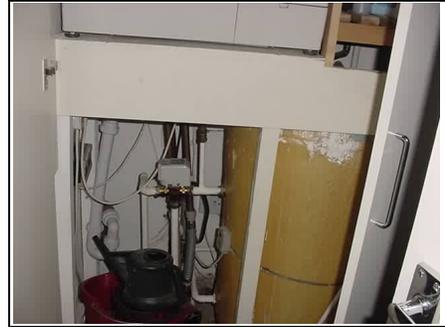
Hot Water Cylinder

The hot water cylinder is relatively new (in this case we mean in the past 30 years) as it is factory lagged. This does mean they don't tend to suddenly leak as did occur with the older style cylinders.
