RESIDENTIAL BUILDING SURVEY

Shooters Hill, London,
SE18 xxxx

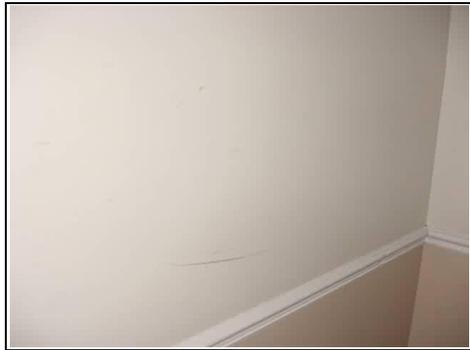
Communal stairwell
These would benefit from re-decoration

We noted that the communal areas would benefit from a re-decoration. Whilst this does not affect you much, as you do not have to walk up the stairs etc., it does give an indication of the quality of the management company.

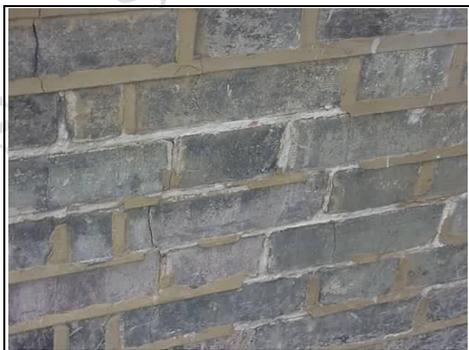
Re--pointing

Unfortunately the cement re-pointing, whilst well meaning, is not appropriate for this type of construction. A cement mortar has been used rather than a lime based mortar. We recommend you use lime mortar in any future repairs regardless of what the builders say! Using lime mortar will limit further damage to the brickwork, which is almost impossible to repair successfully. However, we would add that many, if not most, of the properties that are re-pointed are re-pointed wrongly; it is only in recent years that we have discovered the problems that can occur from it.

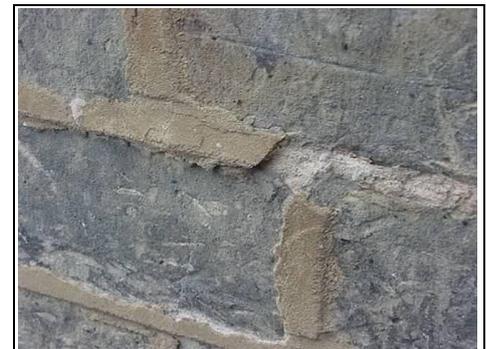
Re-pointing coming away

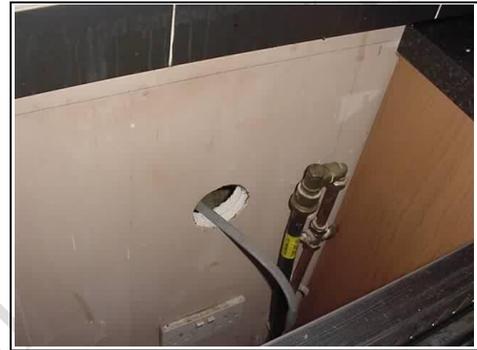
We often find that alterations and conversions such as this one often suffer from the over-use of stud work partitions. This means that you do get some noise transfer between the properties. As mentioned we did speak to one person on the ground floor and we also spoke to a neighbour on the top floor who advised that in their particular location noise transfer was minimal.

False wall / dry lining in the kitchen

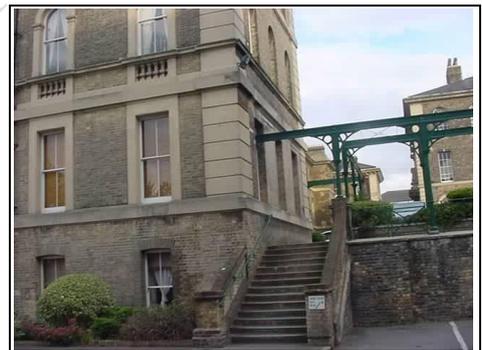
It was noted when we carried out the survey that other occupiers literally walk right past your window to the side of the property and to the rear. The entrance to the block of properties is at the rear. You need to revisit the property and make sure you are happy with this.

This is the main staircase used by a number of people. This passes by the side of your lounge

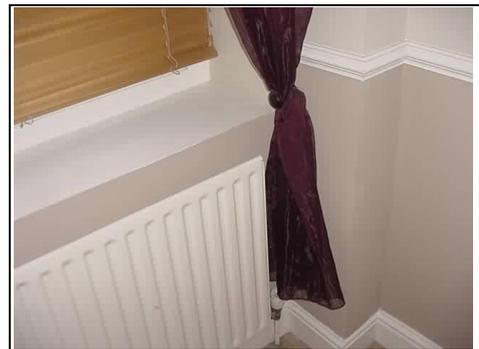
The large rooms are heated by single panel radiators which we feel may be undersized especially for rapid heating of the rooms with their large single glazed windows.

Single panel radiator

ACTION REQUIRED: We would change these to double panel convection radiators.

ANTICIPATED COST: In our experience this is a few hundred pounds per radiator if you are having a few done at once. It can be more expensive to just have a single radiator replaced. However you do need to live in the property for some time before making a decision on this; please obtain quotations.

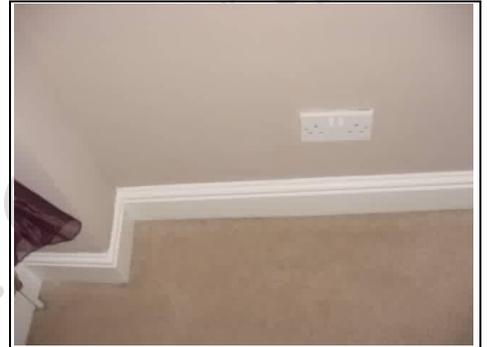
The number of electric sockets in the property is minimal.

Electric socket point

ACTION REQUIRED: You may wish to increase the number of electric sockets before you re-decorate.

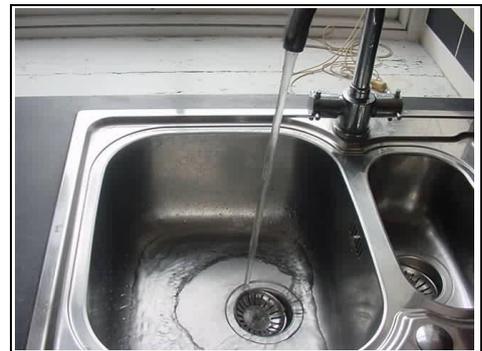
We ran the tap for 15 minutes and found that water leaked onto the floor. This may be due to the disconnection of a washing machine or similar or it may be a leak. Please see our comments in the earlier part of the report.

There was no build up or back up but the only true way to find out the condition of the drains is to have a closed circuit TV camera

Taps run for 15 minutes to check for blockages

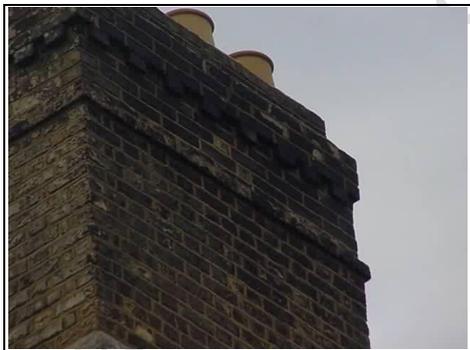
This is the chimney that should in theory lead into your property but we cannot see it so we assume it has been removed. The chimney is brick built with four or more chimney pots. We cannot see the flashing properly. From what we could see from ground level it looks to have weathered over the years

Close up of rear chimney

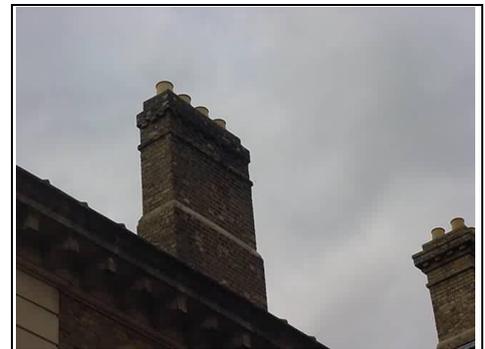
Chimney one - rear

Unfortunately we were unable to see the flaunching, we therefore cannot comment upon them.

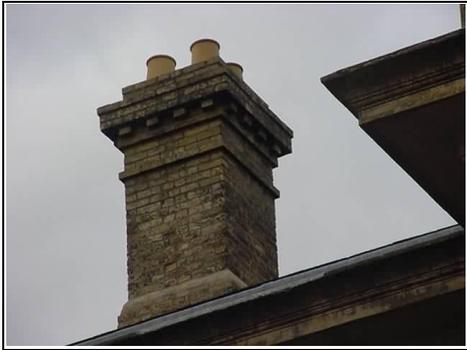
Chimney two

This chimney is also brick built and has four or more chimney pots and again we cannot see the flashing. From what we could see from ground level it looked in average condition considering its age, type and style.

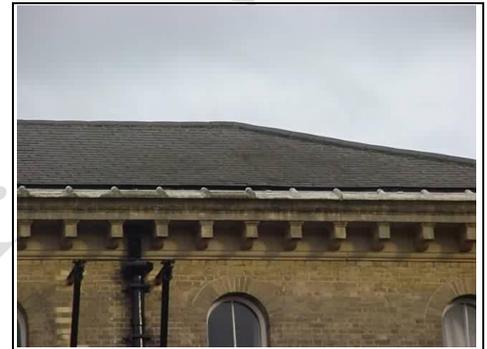
Roof

The main roof is pitched and clad with a quarried slate tile and, from ground level, this looks in average condition considering the roofs age type and style. We assume it was re-roofed in the mid 1990's when the property was refurbished. Unfortunately we have not been able to access the roof.

ACTION REQUIRED: Both you and your Management Company should carry out periodic inspections of the roof with the Management Company carrying out any maintenance that would usually be re-charged to you.

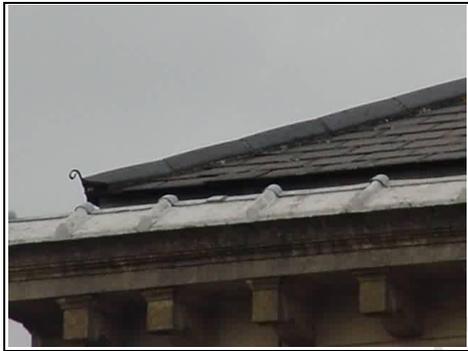
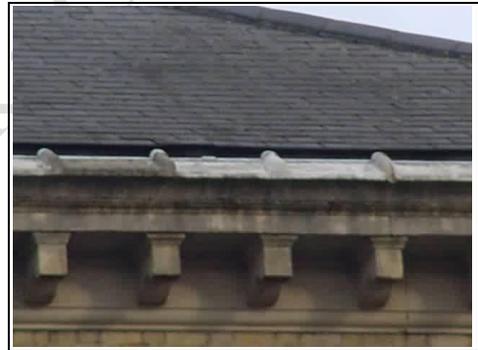
Box gutter

The box gutters are probably lead lined but we cannot be certain as we have not seen them clearly.

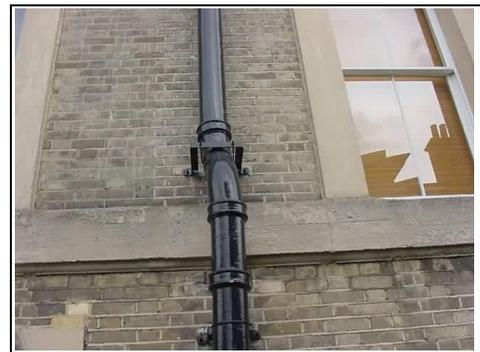
The rainwater is transferred down the downpipes which may be cast iron/ plastic and or painted asbestos. We have made comments on this within the Executive Summary.

Possibly asbestos

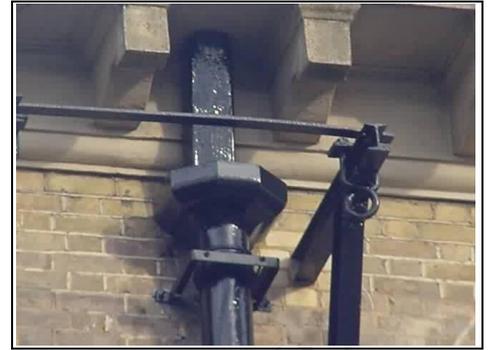
Hopper head

This appears, from its size, to be metal.

We could not see any leaks but it is not unusual to have some minor leaks but most people would be happy to live with this in this age of property.

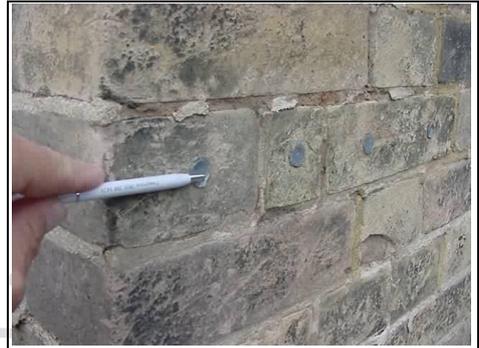
All modern properties should incorporate a damp proof course (DPC) and good building practice dictates that a differential of 150mm (6 inches) should be maintained between the damp proof course and ground levels. In this case, we can see a DPC in places. This building would not originally have had a damp proof course given it was built in 1865 but we can see it has had a damp proof course inserted after. Again this is something we would never recommend on an old Listed building such as this. It really is about allowing the brick work to breathe. Please see the sketch in the brickwork.

ACTION REQUIRED: Please see our comments within the Executive Summary.

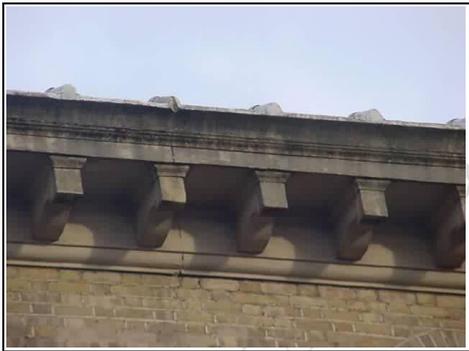
Fascias, soffits and pediments

The fascias, soffits and pediments look to be stone from ground level. We have not had a close up inspection of them.

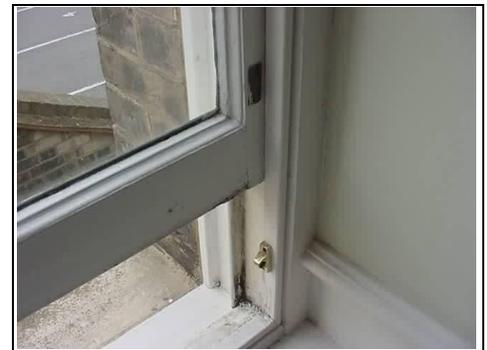
The property has single glazed timber sliding sash windows. We would specifically comment that we opened some of the windows and they opened without problems.

We opened the sash windows

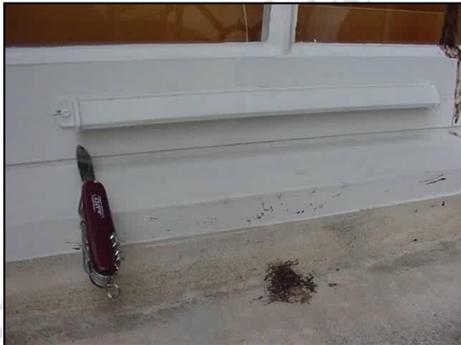
Vent in one of the windows – back bedroom

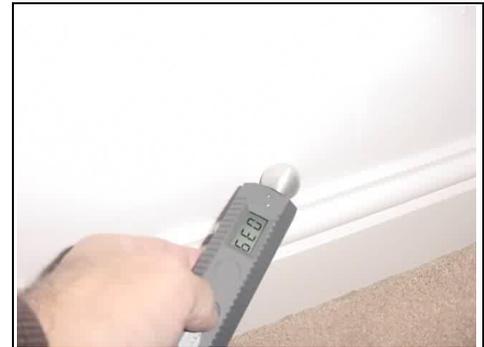
Testing for rising damp

A random visual inspection and tests with a moisture meter have been taken to the perimeter walls. In this particular case we have found slightly higher readings than usual but this is acceptable for an unoccupied property at this time of year.

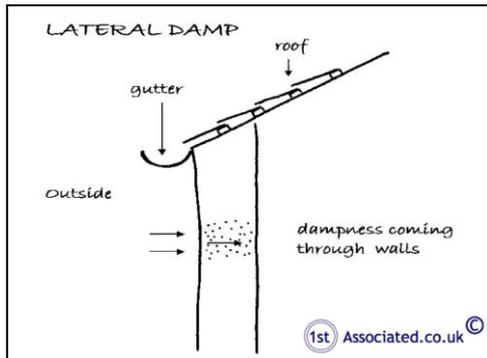
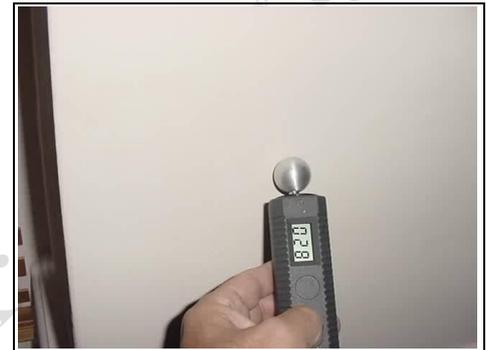
Testing for lateral dampness

We used a damp meter on the external walls. We have not found dampness. We found it to be in line with what we would expect for this age, type and style of property.

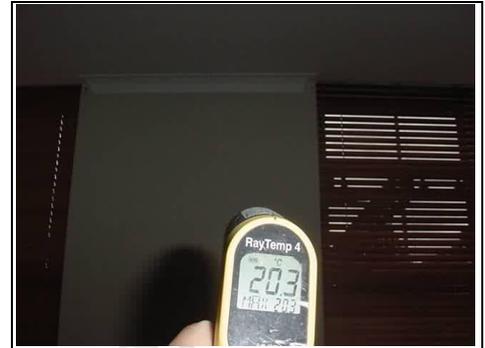
Checking for condensation

At the time of the inspection there were obvious signs of condensation including the mould in the bathroom and there also looks to be condensation on the window sills throughout the property.

ACTION REQUIRED: We would recommend humidity controlled extract fans be added to kitchens and bathrooms. You will need to agree this with your landlord/ the local authority conservation officer as we think an extract fan in the kitchen may be seen from the outside.

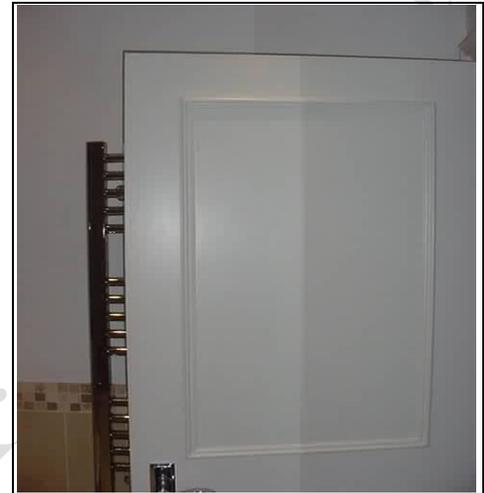
Door

The doors are painted panel doors and are in average condition.

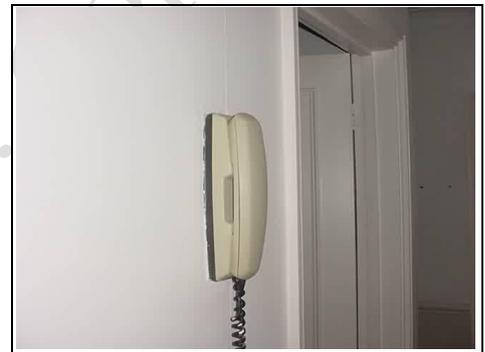
Entry phone system

We would prefer to see a video phone entry system these days and this is the sort of thing that could be budgeted for via the sinking fund.

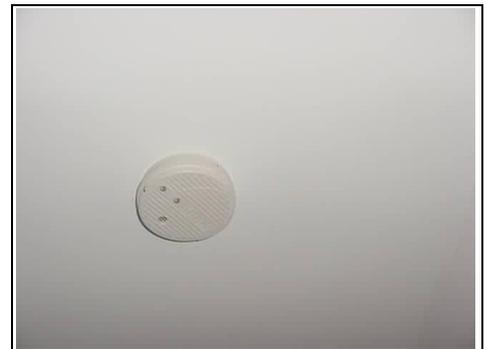
Smoke alarm

We are a strong believer that where properties are multi occupied, i.e. there are more than one resident or tenancy, that the fire alarm system should be interconnected alerting any of the properties if there is a fire anywhere within the building.

In addition to this there should be regular fire alarm drills.

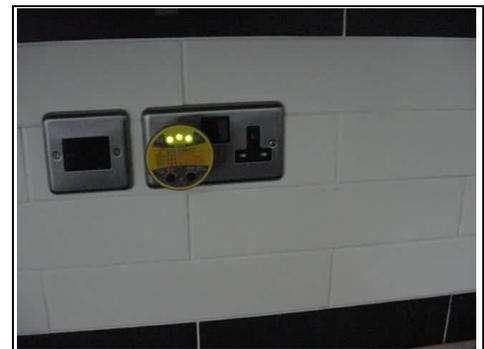
Earth Test

We carried out an earth test in the kitchen area to the socket point that is normally used for the kettle, this proved satisfactory.

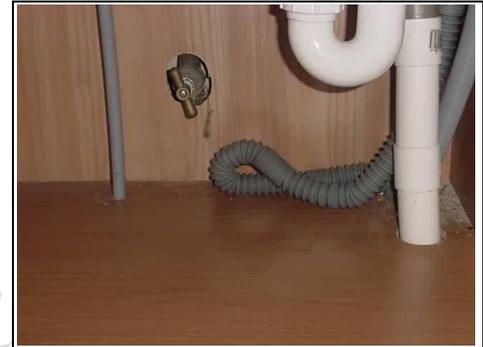
Stopcock under the sink

We found what we believe to be the controlling stopcock is located under the sink.

It is important that its presence is established in case of bursts or leaks. The stopcock and other controlling valves have not been inspected or tested for operational effectiveness.

ACTION REQUIRED: Ask the owners to show you where it is.

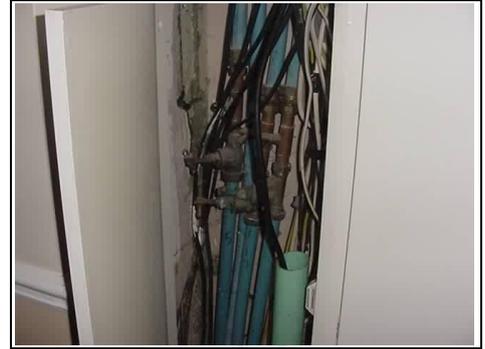
The plumbing, where visible, comprises plastic and copper piping. we are not keen on mixing plastic with copper as we tend to find that the joints suffer but we are aware that this is the way the plumbing industry is heading.

Plastic and copper pipe in communal area

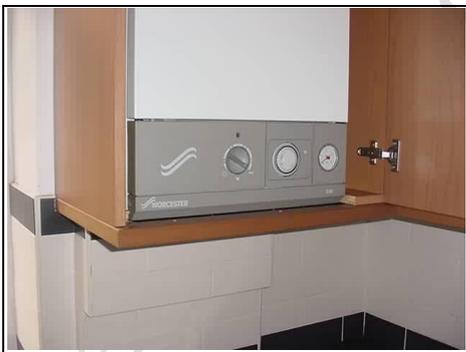
Wall mounted Worcester Boiler

The wall mounted boiler was located in the kitchen and is manufactured by Worcester.

Our limited inspection of the hot water and central heating system revealed no evidence to suggest any serious defects but we would nevertheless recommend that the system be tested and overhauled before exchange of contracts and that a regular maintenance contract be placed with an approved heating engineer.

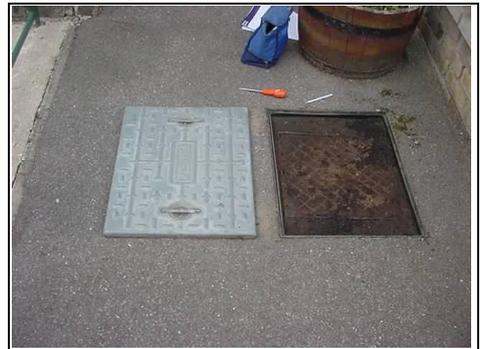
Manhole - right

When we lifted the cover we found another manhole underneath it which is most unusual. We could not lift the second manhole.

The Management Company for the property as a whole should have details of this.

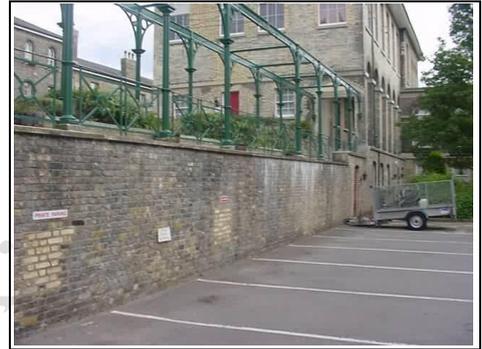
Parking area

It is likely that the property has allocated parking although we did not know where this was. We are also aware from talking to the security guard on the entrance gate that there are visitor spaces as well (one of which we used).

ACTION REQUIRED: Your Legal Advisor to check and confirm.

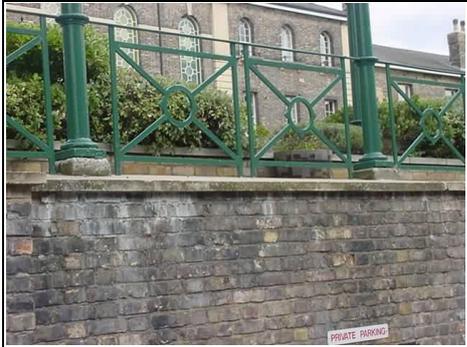
Retaining wall without weep holes

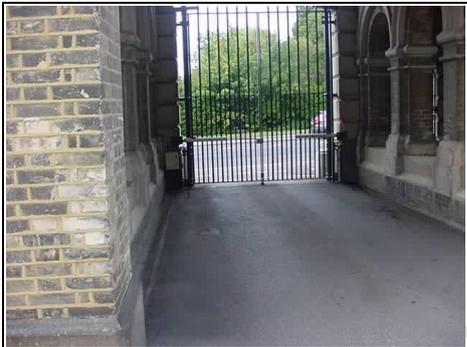
Other gated entrance for cars that we did not see used during the course of our survey. We do not know the arrangements for this.

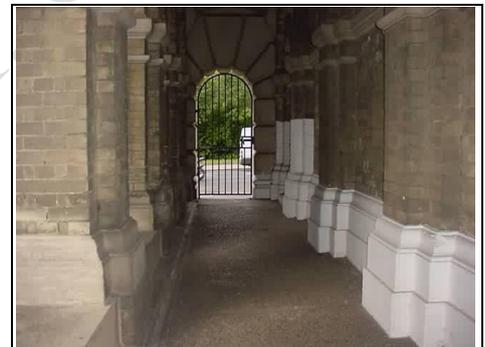
Pedestrian access that we did not see used during the course of our survey.

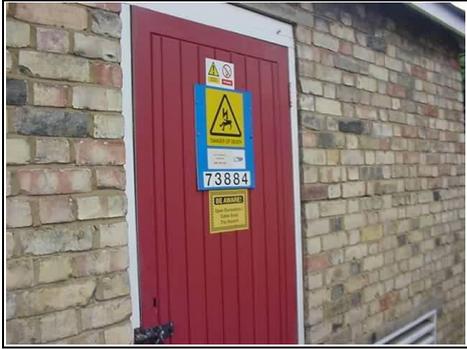
Rubbish store seems to have a generator

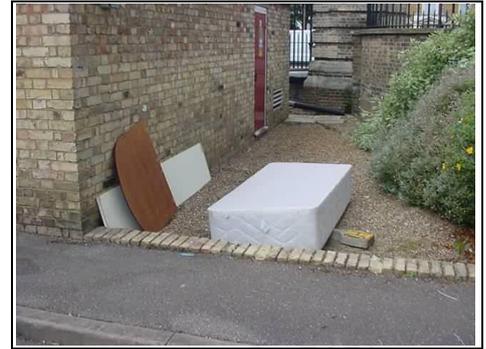
Dumped rubbish
