RESIDENTIAL BUILDING SURVEY
OF
Greetham, Nr Horncastle, Lincolnshire, LN9

FOR
Mr F

INDEPENDENT CHARTERED SURVEYORS

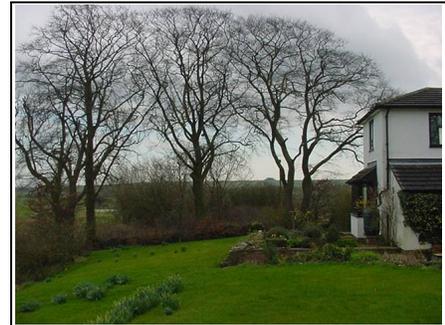
3) Trees

Without wishing to state the obvious, the property has trees surrounding it, which you will have a liability / responsibility for. From our discussions during our question and answer session with the present owners they advised that the highways authority asked them to prune back the trees approximately two years ago, this will obviously be an on-going process.

ACTION REQUIRED: We feel it would be good practice to ask an arboriculturist (not a tree surgeon) to advise on future maintenance of all the trees on the land. It would also be good to establish exactly which trees are on your land and which are not.

ANTICIPATED COST: £250 - £500 for a report and advice.

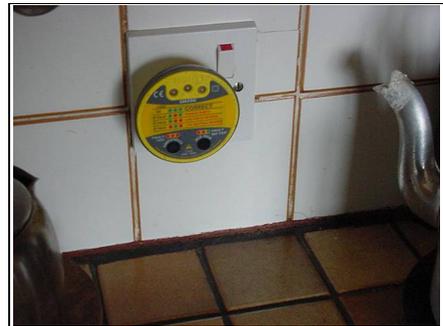
We carried out an earth test on the electrics and the circuit board tripped out, indicating that there is a fault on the system.

ACTION REQUIRED: Have an Institute of Electrical Engineers (IEE) inspection, test and report carried out by an NICEIC or equivalent registered and approved electrical contractor.

ANTICIPATED COST: £200 - £400, depending upon the faults found.

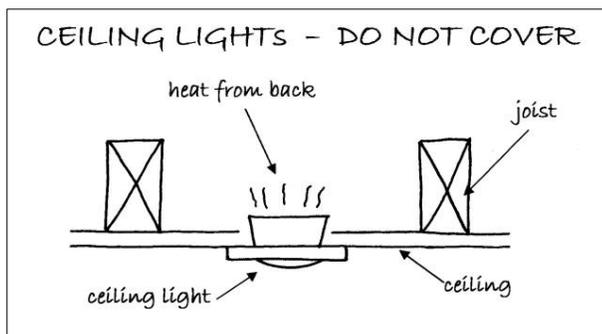
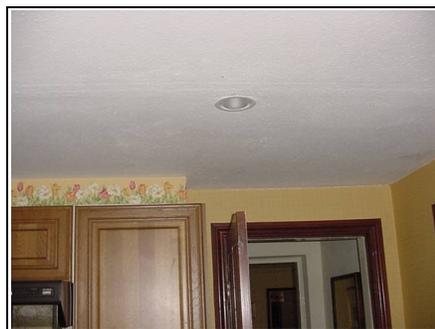
6) Older Style Ceiling Light in the Bedroom

The property has an older style ceiling light. In some instances these can cause problems as the heat given off has in some cases lead to outbreaks of fire; these tend to be in the older type of ceiling lights and we recommend that where ceiling lights are used that the rear of the light is not covered; this is particularly the case in rooms with a loft space above it where stored items are placed in it.

ACTION REQUIRED: Check when putting stored items into the roof that you do not cover the lights. You should ensure that this is incorporated in the electrical test that you have.

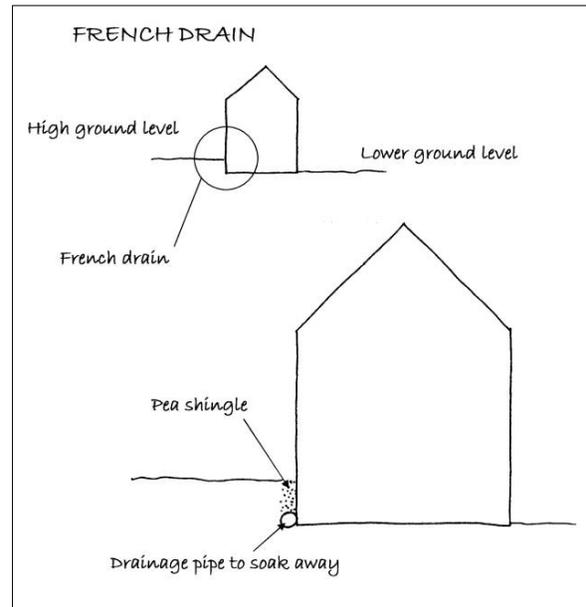
High Ground Level to the Rear

The high ground level to the rear is causing dampness, which we feel is acceptable in the property as it is at the moment, but if you wish to change its use, for example to an office, then you may wish to add a French gully to the rear.

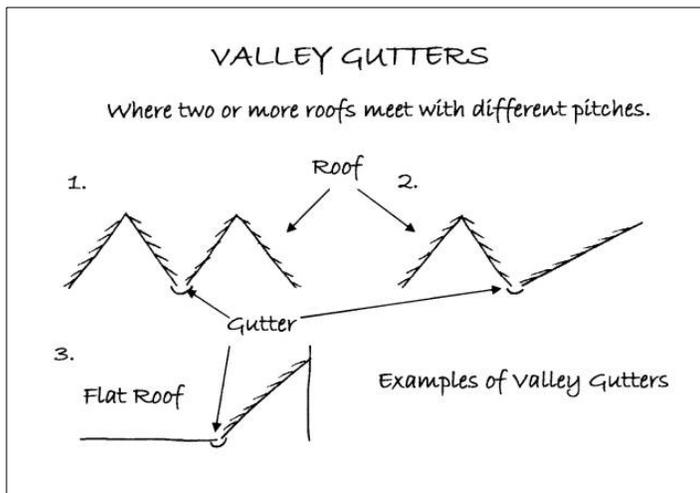
Low Level Valley Gutter

The only adverse comment we would make, and this often occurs where a property has had lots of extensions, is that you have an awkward roof layout which means you have some awkward narrow valley gutters.

ACTION REQUIRED: You will need to check periodically that these are clear of leaves etc, as if they block up and back up rainwater will get into the roof structure and eventually into the property.

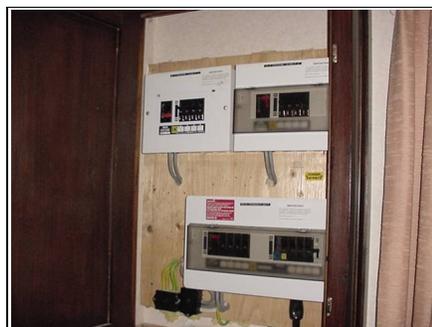
Fuse Board

The electric fuses and consumer units were located in the study. We would date the fuse board as being from the 1990s and, whilst not the best now available, it is reasonable. However, it did trip out when we carried out the earth test.

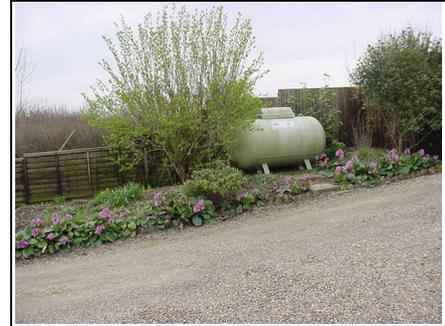
You have a tank situated to the left hand side of the property. We are advised that this is used for the Aga which in turn heats one radiator.

We feel that you will have to look at having a new heating system.

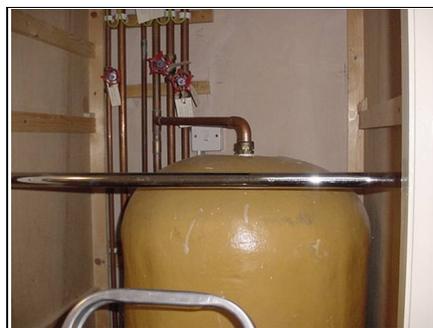
Hot Water Cylinder

We were pleased to see a factory insulated hot water cylinder, which means it is relatively new (we mean in the last 30 years in this instance), the owner advised that it was installed about 20 years ago.

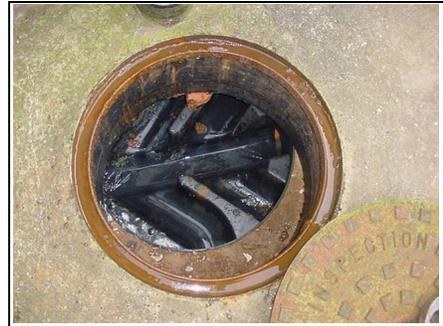
We duly lifted the cover and found it to be free flowing at the time of our inspection.

From what we could see it is pre-formed in plastic.

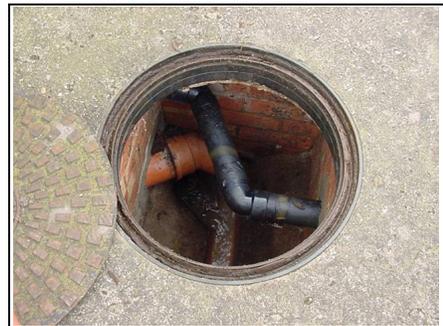
Inspection Chamber / Manhole Two – Rear Right Hand Side

We duly lifted the cover and found it to be free flowing at the time of our inspection, although it has had some rather unusual plumbing go through it.

Again, it is pre-formed in plastic.

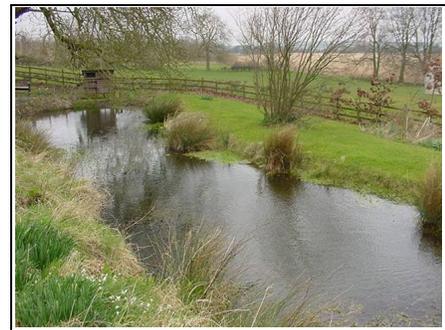
Pond

The rear and side gardens (for want of a better term), include the acreage, there is an area that is fenced that includes the pond, which is on a good fall and has many mature trees and then there is a further area that includes the concrete barn.

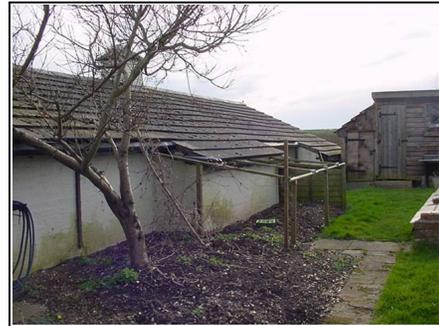
Back of Outbuilding

We discussed the issue with the higher ground level to the rear of the outbuilding; this area will be damp. If you look there are also downpipes that discharge from the gutter directly into this area. To make this watertight all of this area will need rearranging and a French gully adding. Please see our comments in the Executive Summary.

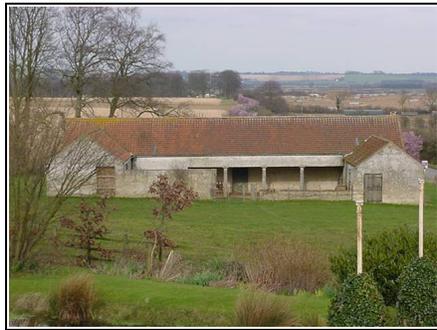
Front of the Barn

A reinforced concrete built structure with a cut timber roof with a Roman pantile on it and no underlay. The barn generally looks in acceptable condition, bearing in mind what it is. There are vertical and horizontal cracks within the concrete.

To use this property as a habitable building it will need Planning Permission for change of use and it will also need the Building Control Officers to either accept the existing construction, which is usually carried out by opening up the foundations for them to have a look at and analysing the concrete, together with structural calculations as necessary, or they may wish to have amendments to the structure. You need to look at both of these options and look at the cost of the entire operation. It may be cheaper to clear the site and put up either a traditional brick and block built property or even a steel framed structure which is then clad to look however the planners would like it to look. You also need to think about the services.
