# RESIDENTIAL BUILDING SURVEY

**Guiltsborough, Northamptonshire NN6**

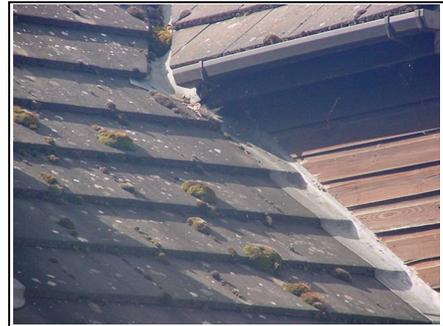
The roof is pitched and clad in a plain large concrete tile. From what we could see the concrete tiles are lying level and true and look in reasonable condition. Sometimes we find that deterioration occurs to the ridge and exposed areas such as the perimeter and so you should periodically check these areas.

Close up of main roof

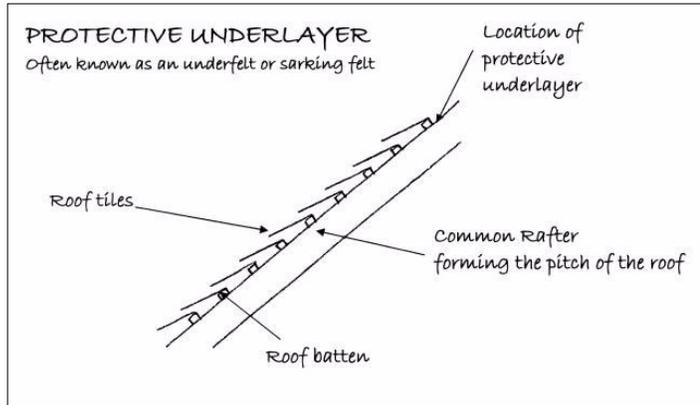
When we inspected the loft space we found a reinforced plastic protective underlayer. This type of underlayer was used in the 1970s/1980s and its use was generally stopped because it was susceptible to causing condensation unless the roofs are adequately vented, which they are usually not.

**ACTION REQUIRED:** We would recommend vents are added.

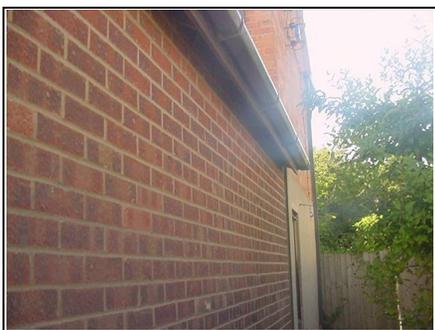
The more modern part of the property is brick finished, laid in a cement mortar in what is known as Stretcher Bond.

We believe that the Stretcher Bond was built in the mid-80's. Prior to this there were problems with wall ties in the mid-70's and, whilst this should not be a problem in this instance, we are aware that on some house extensions wall ties were used. We would typically see horizontal cracking if there are problems, which we cannot see in this instance.

Modern brickwork

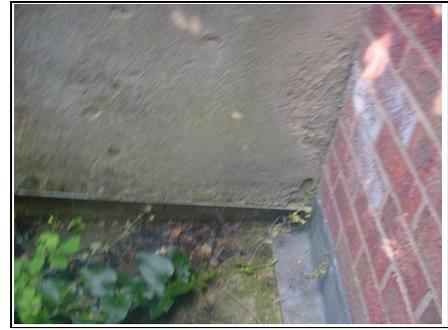
To the older part of the property it is partly rendered at low level and partly in brick. The render is unfinished, which is how we prefer render (assuming it is a waterproof render).

Render at low level meeting brickwork

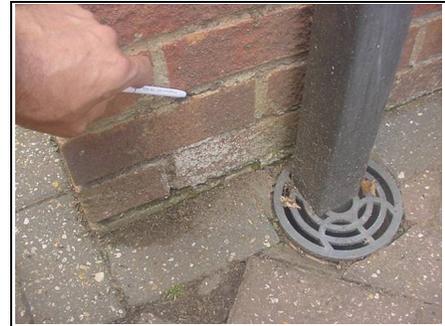
To the older part of the property we could see a DPC has been inserted.

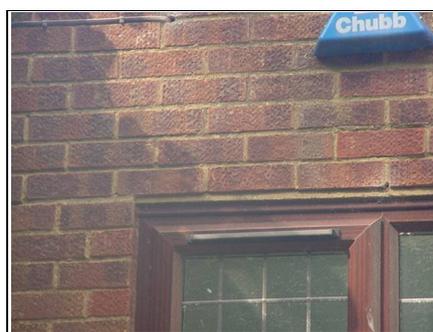
The property has plastic, double glazed windows, which generally look to be of a reasonable quality. We were pleased to see trickle vents. The owner advises that the windows are relatively new and there may be a guarantee.

Trickle vents

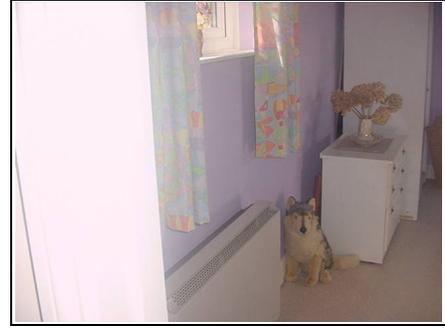
We noted that there are electric storage heaters. We were not able to carry out our usual ten minute test as storage heaters do not work that way.

Storage heater

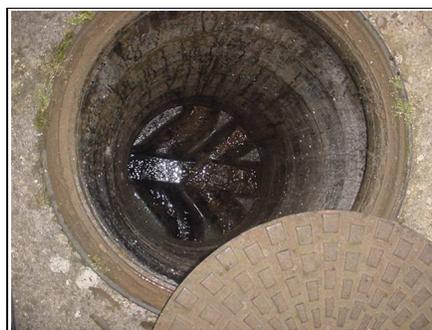
#### Inspection Chamber / Manhole One (located outside the perimeter on the left hand side)

We duly lifted the man hole/ inspection chamber cover and found the drain to be free flowing, we noted it was finished in brick.

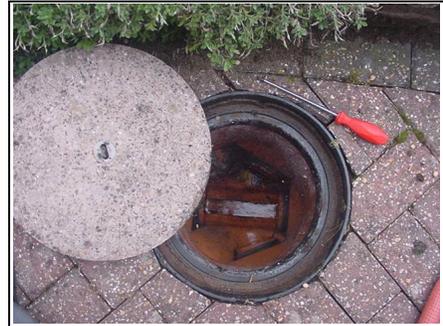
## **Inspection Chamber / Manhole Two (located centrally within the garden path)**

We duly lifted the man hole/ inspection chamber cover and found the drain to be free flowing, we noted it was finished in brick.
