# RESIDENTIAL BUILDING SURVEY

Hackney,  
London E5

Mr M and Ms H

INDEPENDENT CHARTERED SURVEYORS

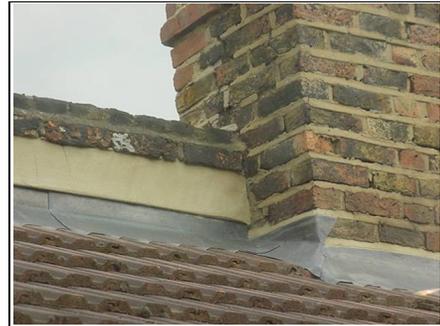
### 2) Rear Chimneys in need of Work

You can see from the adjoining close up photograph of the chimney, that there is hairline cracking and that some of the mortar has come away. This will lead to dampness getting into the property. As the property is newly painted (painted to sell) at the moment, it is difficult for us to see any such dampness.

**ACTION REQUIRED:** We would therefore recommend that the ceilings are opened up to allow access to the roof space, to see the condition of the chimneys. Please read our comments within the “Ugly” Section with regard to further access being required to view the condition of the butterfly roof.

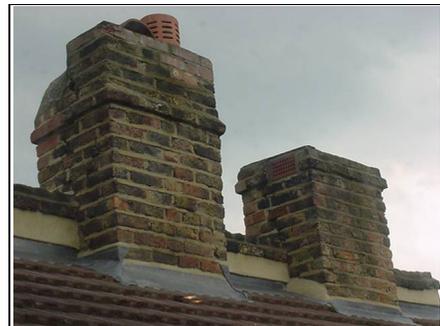
### 3) Chimney Removed?

We were surprised that all rooms did not have chimneys within them as this would have been the main form of heating when the property was built in the Georgian times. It is normally within the roof space that we can check and confirm whether chimneys should be present.

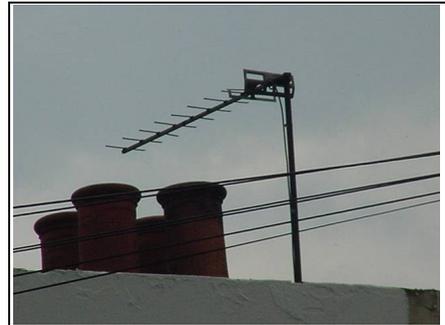
### Chimney One

We had great difficulty in seeing this chimney although expect it to be in a similar condition to the others if not possibly worse, due to difficult of access. We would add that as the property has a butterfly roof, from this type of design it is not always possible to see the chimneys from ground level. They have to be accessed through the roof space (which of course we do not have in this instance) to see them.

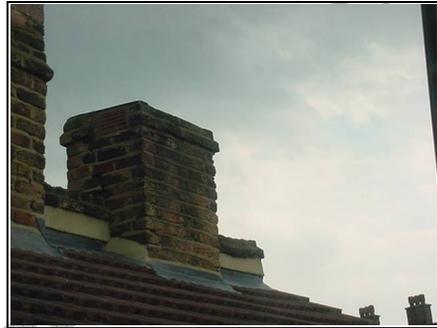
We would make similar comments as with chimney two. This chimney has been vented but nevertheless looks in need of repointing.

**ANTICIPATED COSTS:** Again this is likely to be costly due to scaffolding. The sum of £2,000 to £3,000 is inclusive of both chimneys, but you will of course need quotations, as scaffolding can vary in price. We would also add as mentioned, that we need to get into the roof space to see the condition of the chimney beneath.

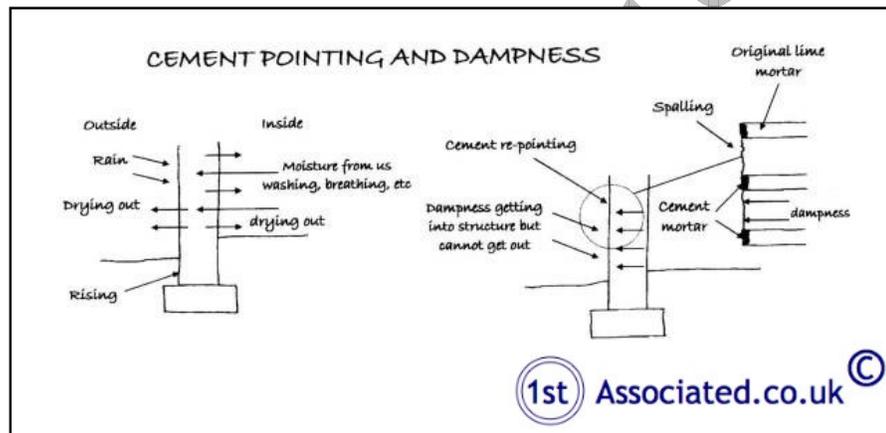
Generally Flemish Bond brickwork is liable to penetrating dampness internally, dependent upon the condition of the brickwork and the exposure to the weather. In this case dampness was found in the rear of the property. It is essential that external faces be kept in good condition.

Please see our comments in the executive summary. We do not believe that the work which has been carried out by the builder will resolve the damp problem.

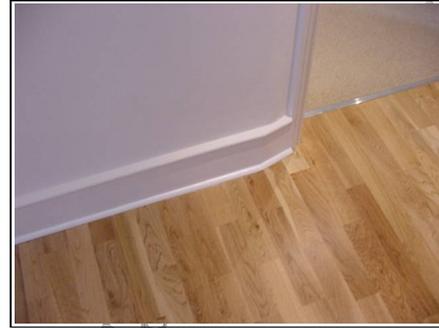
Laminated Floor

We were unable to see the floor due to the laminated floor covering however; given its age it is likely to be a joist and floorboard construction. The timbers are likely to be embedded in the walls, which mean that some wet rot is likely without opening the floors up we cannot comment further. Unfortunately we cannot say which way the joists run without lifting and exposing the floor.

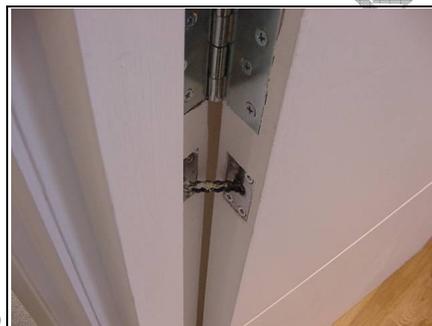
Within this property there should be fire doors. Fire doors are generally half hour resistant for this type of layout and, in addition, they should have door closers, in this instance they have Perco (trade name) door closers, these are positioned in the middle of the door.
