# RESIDENTIAL BUILDING SURVEY

Harrow, Middlesex HA1

FOR  
**Mrs H**

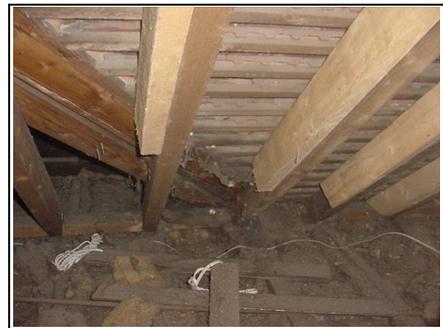
The main roof has the original clay tiles. There is no protective underlayer (often known as a sarking felt). This means that wind driven rain may well get into the roof.

We are surprised that the addition of a new sarking felt was not carried out when the loft conversion took place. This leads us to believe that the loft conversion is therefore from the cheaper end of the market.

Looking at the back of the roof tiles

**ACTION REQUIRED:** You need to budget for the possibility of a new roof and we would expect a discount on the purchase price in the region of £10,000 for the inconvenience and appending additional costs.

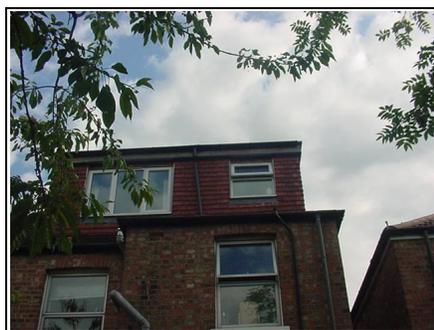
Flat roof over master bedroom

**ACTION REQUIRED:** We recommend an access hatch is made into the roof to allow inspection. We have checked random areas of the perimeter of the ceiling beneath the flat roof and have not found any dampness, however it does look in areas as if something has been painted over?

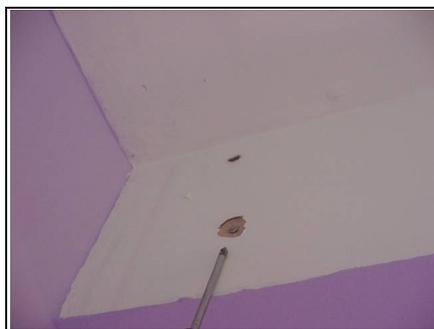
In this case we are slightly concerned because popping is occurring to the plasterboard which is adjacent to the flat roof which can indicate that dampness is getting in. We would be more than happy to comment upon photos that are taken and forwarded on to us.

Popping below hidden flat roof indicating dampness is getting in

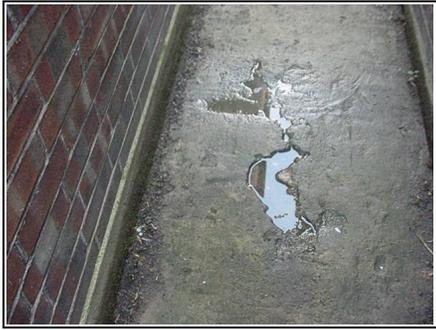
To the walls, particularly the left hand gable wall adjacent to the stairs, there is an above average amount of blown plaster. This we believe is due to the gable walls getting wet when it rains and as it is so close to the adjoining property not having a chance to dry out due to sunlight not getting in properly or air to vent the area.

Damp access to left hand side of property

**ACTION REQUIRED:** This is very difficult to resolve. You need to check periodically that the pointing is in good condition. You may need to carry out some re-plastering when carrying out redecoration work.

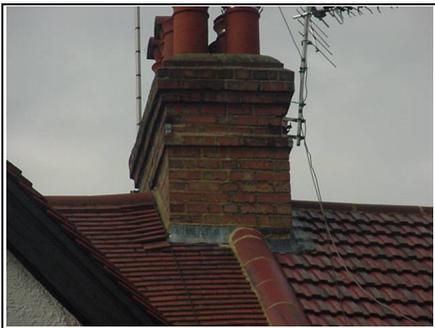
Chimney

This chimney is brick finished with four chimney pots with a cement flashing to the side and lead flashing to the front, which is quite unusual. From what we could see the chimney looks in average condition. We were unable to see the top of the chimney known as the flaunchings and therefore are unable to comment on its condition. We can see that the chimney pots have mesh on them; we assume this is to stop birds from nesting in them.

**ACTION REQUIRED:** We would like to view the chimney close up from the flat roof when the opening has been added, as we have recommended. Cement flashings are notorious for leaking as they are brittle and crack. There are also some tiles displaced around the chimney which is another reason we would like to inspect it close up.

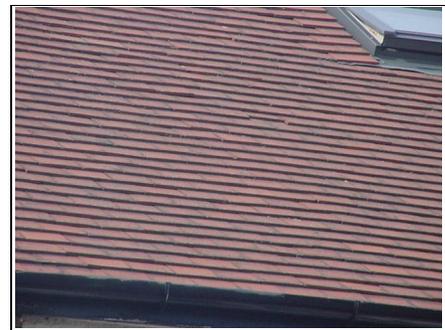
The roof is pitched and clad with a small clay tile and, from ground level, this looks in average condition (see our comments in the Executive Summary) considering the roofs age type and style. With this age of roof there will usually be a few missing or displaced tiles; this is nothing unusual.

Close up of clay tiles

**ACTION REQUIRED:** Please see our comments in the Executive Summary.

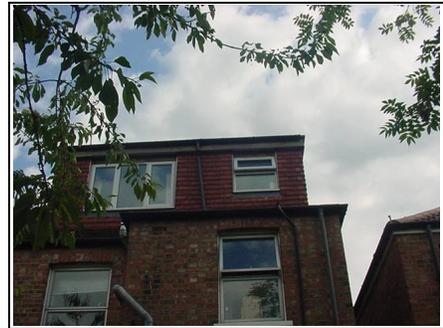
Roof extension

Unfortunately we cannot see the flat roof. We were advised that the extension was carried out in 2003. Typically flat roofs have a life of 10 to 15 years but this does depend upon the materials used and the quality of the workmanship.

**ACTION REQUIRED:** We would like to have access to view this roof which is why we have recommend a roof light be put in. We would be more than happy to comment on photos that are taken.

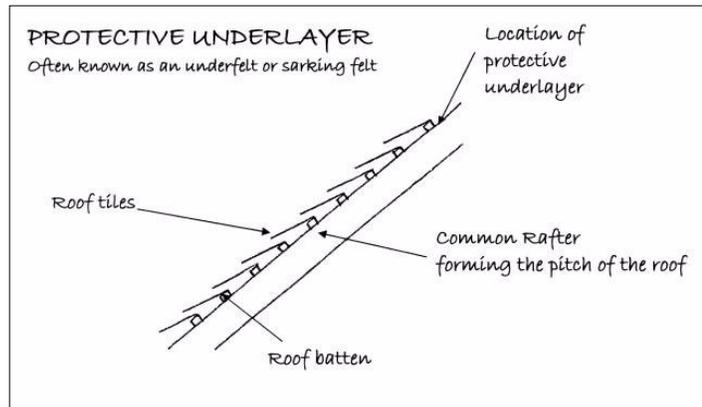
When we inspected the loft space we found there was no underfelt and it is therefore possible that during periods of heavy and prolonged driving rain some water penetration could take place through the roof coverings.

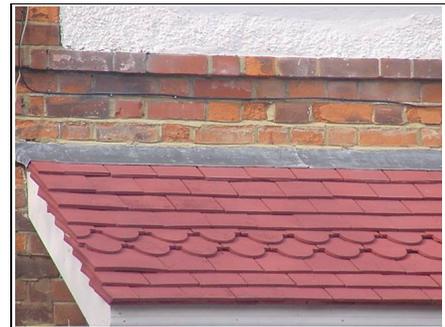
Front porch roof

There is a decorative tile roof over the porch which looks in reasonable condition and we were pleased to see a lead flashing, although it does look like some cement mortar is coming out of it. We would re-bed this using a lead wedge and lime mortar and/or manmade sealant or some equivalent sealant product.

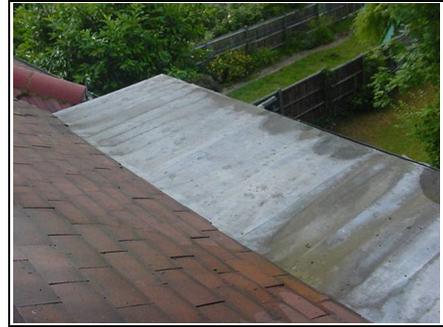
Rear flat roof

There is a metal flat roof. At first we thought it was lead but the sections look too large for lead. This is over the bathroom area and may mean the area is more prone to condensation.

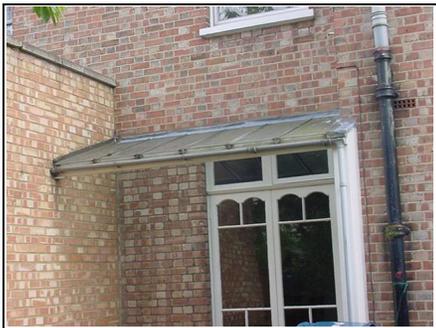
Low level glazed canopy

There is a low level glazed area which has Georgian wired polished plate glass. We note that one of these is broken and needs replacing. This gives a good covered sitting out area to the rear which is protected from the rain.

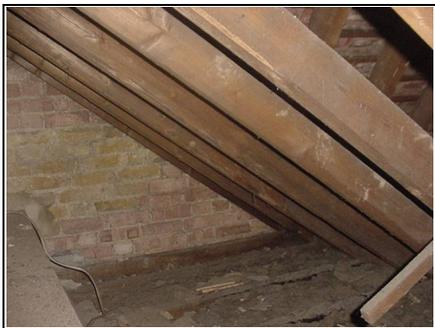
This gave us a view into the front of the roof. Here we able to see there was no protective underlayer and that the timbers forming the loft conversion had been added to the existing timbers rather than new replacement ones.

General view to front of roof

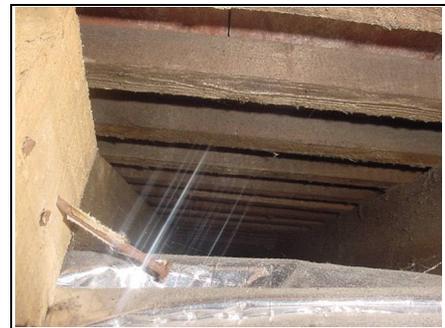
We were also able to see a small amount of insulation by looking between the common rafters (the ones that form the pitch of the roof).

Common rafters with silver insulation to bottom of photo

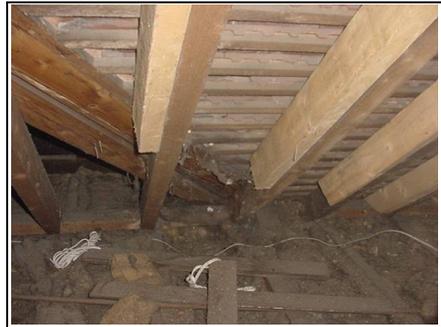
In the adjacent photo you can see the darker original timbers with the lighter newer timbers that have been added to help form the roof structure, which we rarely see.

Old and new timbers

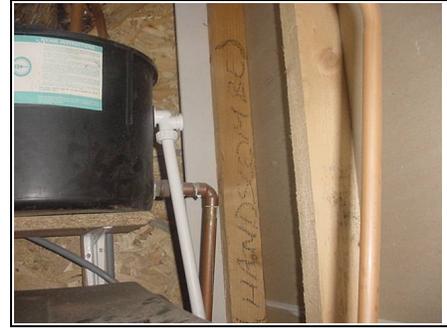
Water tank

A plastic water tank was visible to the front left hand side of the roof space (all directions given as you face the property).

We would always recommend that water tanks be drained down and cleared of any debris etc. (we have seen dead birds and other unmentionable things in these tanks). As you are cleaning your teeth with this water it is best that it is as clean as possible!

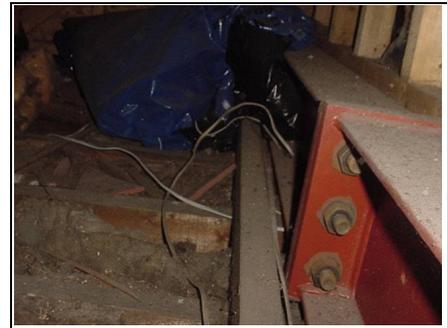
As is common with many loft conversions that we have seen, steel “I” beams have been added into the structure. This is to take the extra weight and has to be allowed for when converting a ceiling to a floor. As mentioned in the Executive Summary this can create point loads which in turn can cause movement within the structure.

Metal “I” beam

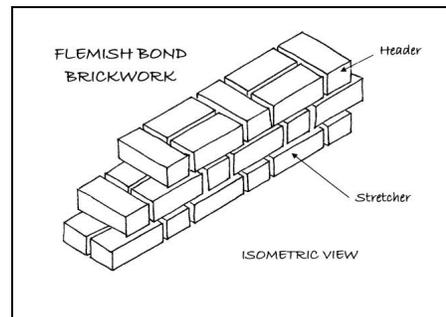
Soft red brick deteriorating due to cement mortar and also lack of sunlight in the area

Generally Flemish Bond brickwork is liable to penetrating dampness internally, dependent upon the condition of the brickwork and the exposure to the weather. In this case it is essential that external faces be kept in good condition.

**ACTION REQUIRED:** Careful repointing is need, removing the cement mortar with a soft brush where it is loose and repointing in a lime mortar. This can be carried out over a number of years, gradually returning the brickwork back to its original characteristics, where although it gets damp it does then dissipate the dampness through the brickwork.

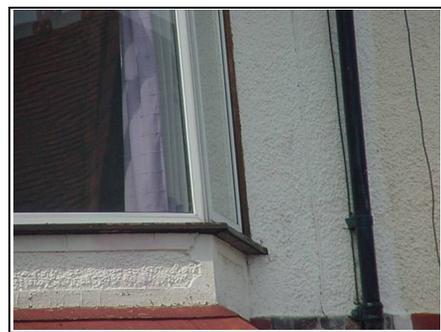
The top of the walls to this property are finished in a pebbledash painted render. The walls are in average to slightly below condition. We suspect this is due to the leaking of the gutters and downpipes.

Close up of pebbledash render

**ACTION REQUIRED:** Before the winter of 2011 you need to check via a long ladder that there are no hairline cracks to the render. Based upon what you find you should then carry out repair work in the summer of 2012. We have done our best to identify significant hairline cracks from ground level and could not see any major ones, but this does not stop them from opening up in the different seasons.

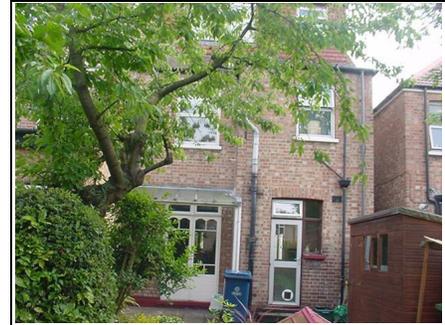
There are some trees in the surrounding area, some of which are just about within what we would term as influencing distance, or coming into influencing distance, of the property. We do not believe at present they are causing any problems, although please be aware that we have not been able to check the drains, which is a common place where tree roots grow down into as a supply of free drinking water. This is why it is important to have a closed circuit TV cameral report, as mentioned in the Executive Summary.

Tree in rear garden

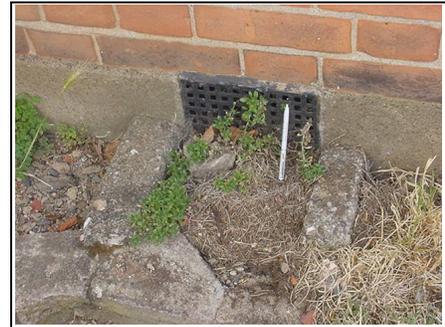
We noted air bricks at the front of the property, and rear and side. which indicates a suspended floor.

Air brick to front

**ACTION REQUIRED:** You need to ensure the air vents are kept clear to vent the floor.

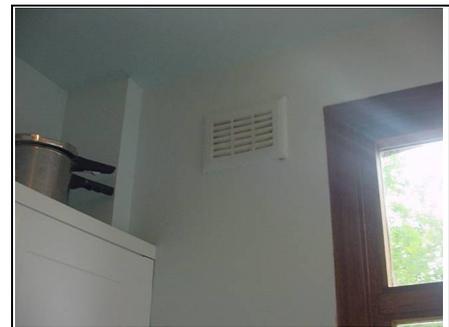
We noted some high level air bricks. These are often added to help reduce condensation, or vent a room with a boiler. In this case we found one in the kitchen so we believe it is for both.

High level vent

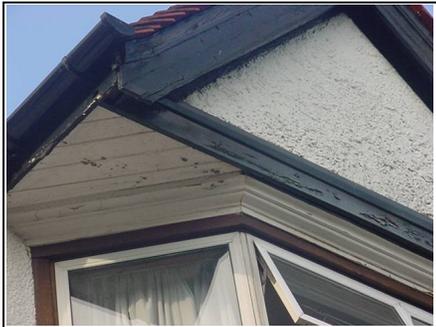
The gutters are not in the best of condition which usually means the fascias and soffits will need some repair and then painting.

View of soffits and fascia board to bay window

**ACTION REQUIRED:** Redecoration of fascias and soffits. Please see our comments in the Executive Summary.

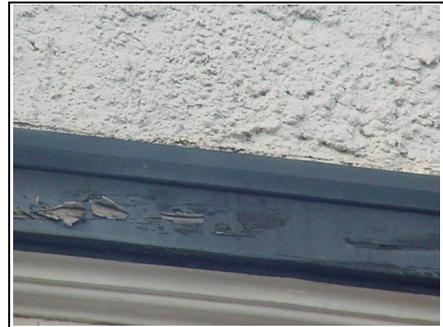
Close up view of the paint flaking to the fascia board

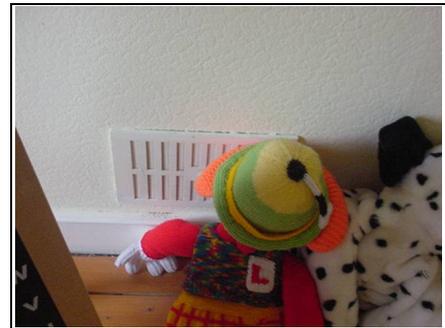
The chimney breasts are located on the right hand side (all directions given as you face the front of the property). We were pleased to see vents which help stop sulphate attack occurring within them where the sulphur acts like blotting paper, drawing in dampness and then transferring this through the brickwork and causing damage.

Vents to chimney

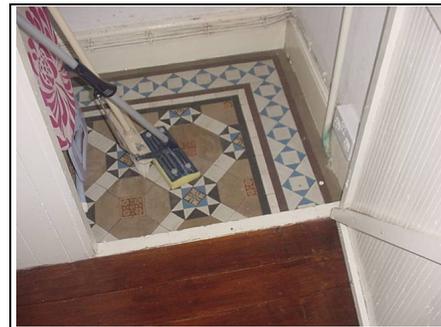
We noted that the wooden floors had additional timbers placed on them, as per adjacent photo.

Floor hidden underneath wooden floor in entrance hall

**ACTION REQUIRED:** Ensure that the air vents are clear. Ideally we would open up a section of the floor to check the timbers underneath.

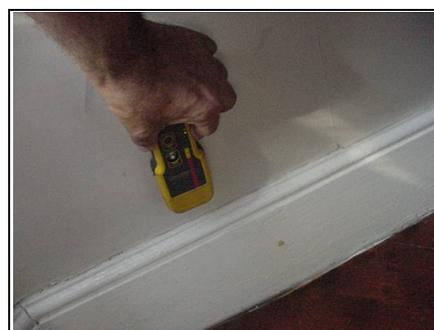
We carried out tests with an electronic damp meter and found average dampness considering the condition of the property.

Checking for rising damp

**ACTION REQUIRED:** We recommend work is carried out to make the building water tight and then reviewed.

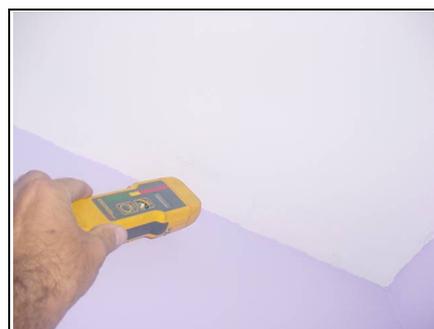
A visual inspection was carried and tests were taken with an electronic conductivity meter at selected points to walls. No significant penetrating/lateral dampness was seen or detected considering the properties age type and style.

Testing for lateral dampness 51

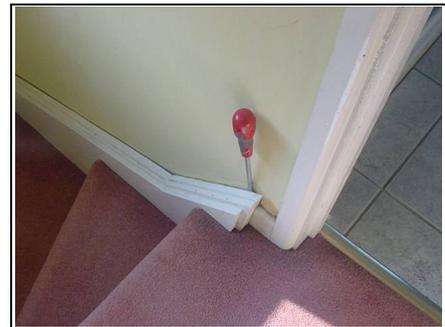
We noted that the underside of the staircase was partly lined, we recommend all of it is lined to help reduce the spread of fire. There has been some movement in the structure that can be seen in the staircase area.

Stairs area

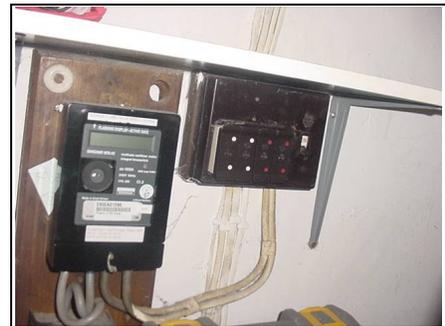
The electric fuses and consumer units were located in the kitchen. We would date the fuseboard as being from the 1960s. Re-wireable fuses are now superseded. Far better fuse boards are now available.

Fuseboard

**ACTION REQUIRED:** Replace the fuseboard as soon as possible and please see our comments in the Executive Summary.

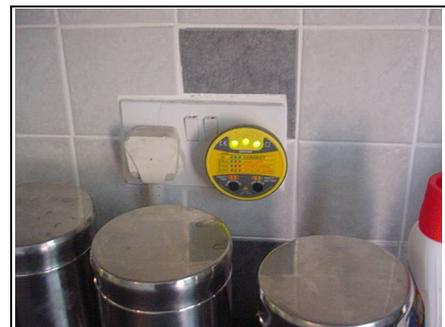
We carried out an earth test in the kitchen area to the socket point that is normally used for the kettle, this proved satisfactory.

Earth test

**ACTION REQUIRED:** As the property is changing occupancy an IEE report should be carried out by a NICEIC registered and approved electrical contractor.

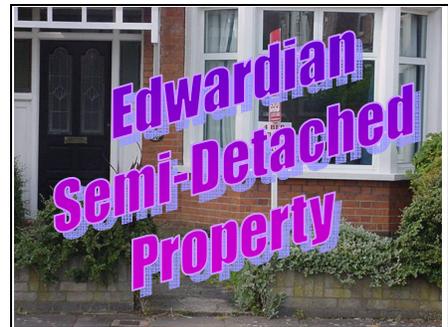
A small garden, slightly overgrown.

Front garden

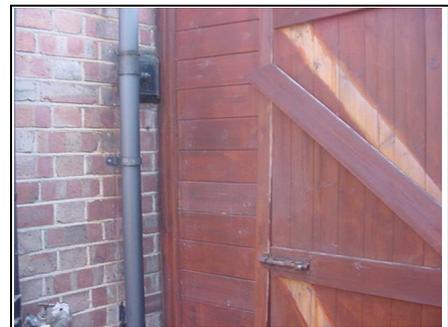
Some work is required to the fences and the gate, which has seen better days,

Rear gate has seen better days
