# RESIDENTIAL BUILDING SURVEY

**Heath and Reach,  
Nr Leighton Buzzard,  
Bedfordshire,  
LU7**

**Mrs A**

**INDEPENDENT CHARTERED SURVEYORS**

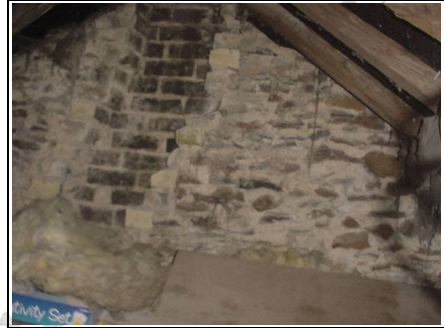
Chimney within the roof left hand side removed below

**ANTICIPATED COST:** In the region of £2,000 to £6,000, depending upon the amount of work required. Please obtain quotations.

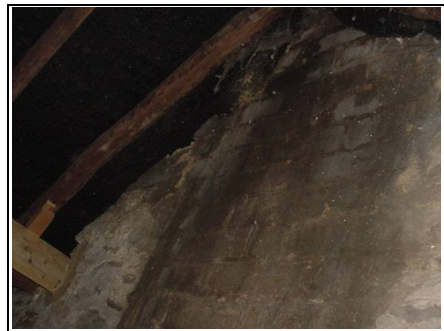
Dampness coming into chimney

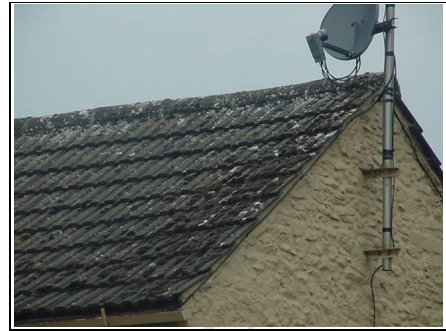
The property has a concrete tile roof, replacing the original roof which is likely to have been tiles or slate. The concrete roof is much heavier than the original roof and as such there is additional weight on the roof.

Chimney within the roof left hand side removed below

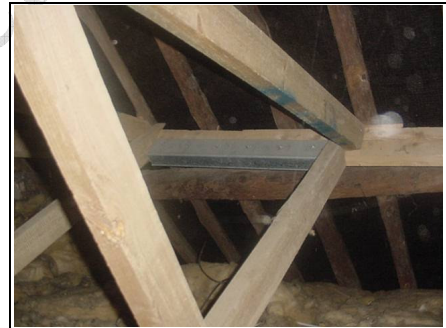
The roof timbers are very old; in some areas we have what is known as pole timbers and quartered timbers, in other areas we have timbers that are much smaller than we typically see in roofs such as this. In addition to this we can see woodworm.

To the right hand side of the property the roof has had additional structural support added. This also needs to be added to the left hand side of the property. We would add that our view to both roofs was very limited as we could not get proper access.

Structural supports added to right hand side of roof

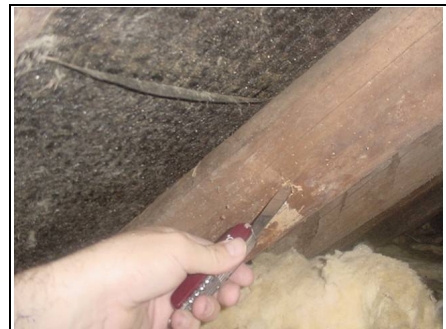
In addition to this, the roof needs to be vented to discourage the condensation and woodworm. We would reiterate our access was limited and we viewed the roofs mainly from the access hatches.

Woodworm on timber

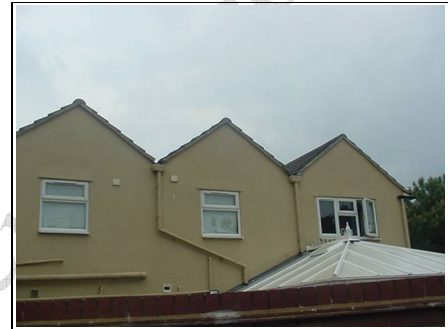
The property has hidden valley gutters which can cause problems. We have not been able to view or access them but from our general knowledge of this type of construction they do tend to block.

Valley gutters

**ACTION REQUIRED:** We recommend a roof window is added to the main roof to allow viewing and access to the valley gutters for maintenance.

**ANTICIPATED COST:** In the region of a few hundred pounds to add the roof windows; please obtain quotes.

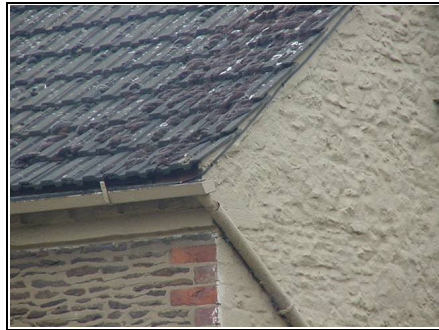
The front gutter you have an unusual metal guttering that is rusting in places and also has a 50mm downpipe rather than a 100mm, which means it is likely to overflow during any reasonably heavy rain and discharge down the front of the property, which is why there is lateral dampness to the front of the property (or we are sure we would get readings for it if there was no dry lined wall – more about this later on in the report).

Metal front gutter

**ACTION REQUIRED:** Replace the guttering and downpipe with a deep flow gutter and 10mm downpipe.

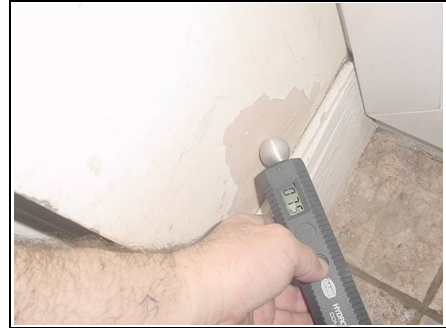
You have dampness throughout the property. This is for a combination of reasons:

1. We have already mentioned the smothering of the sandstone.
2. Lack of a damp proof course, which is common on this age of property.

Checking for dampness

The main dampness we can see to the left hand side of the property.

**ACTION REQUIRED:** We recommend with this age of property that a French drain is added. Please see our article in the Appendices.

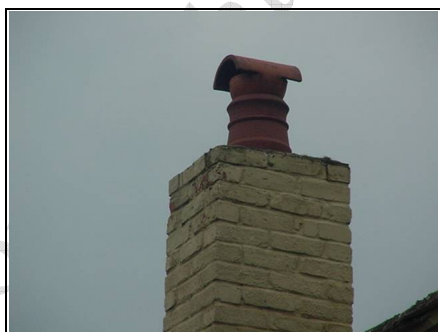
The one chimney that we can see is brick built with a lead flashing and one chimney pot. From what we could see from ground level it looked in average condition externally considering its age, type and style, however internally it looks as if there is dampness getting in one way or another.

Close up of top

**ACTION REQUIRED:** This chimney needs to be closely inspected. Please see our comments in the Executive Summary.

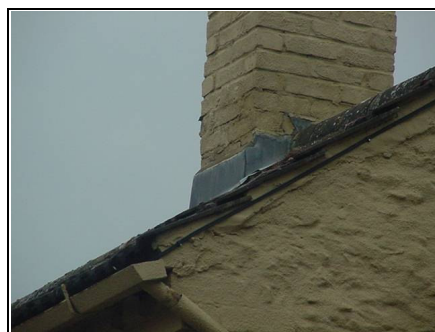
Close up of base

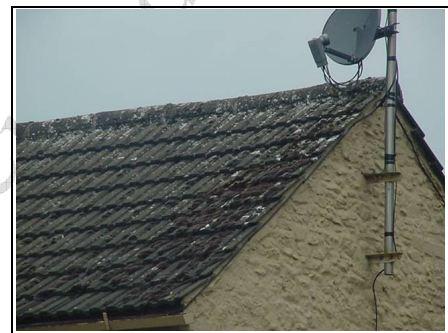
The main roof is pitched and clad with concrete tiles and, from ground level, this looks in average condition. We would imagine the original roof was slate and was replaced with this concrete roof in the 1960s/1970s; this type of roof is much heavier than the original roof.

Concrete roof tiles

**ACTION REQUIRED:** Please see our comments in the Executive Summary about structural problems with regard to the roof.

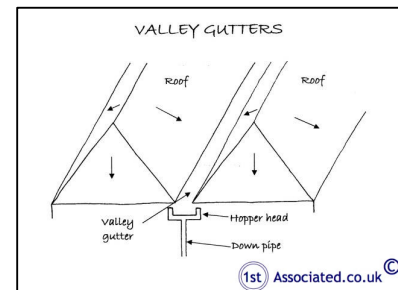
The property has two valley gutters. Please see the adjacent sketch of the valley gutter. We cannot detect any problems with these but then the walls are dry lined so this would effectively be hiding any problems.

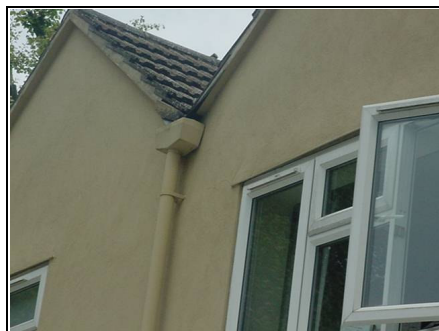
Close up of valley gutter

**ACTION REQUIRED:** Please see our comments in the Executive Summary where we recommend roof windows are added to allow the viewing of the condition of the valley gutters.

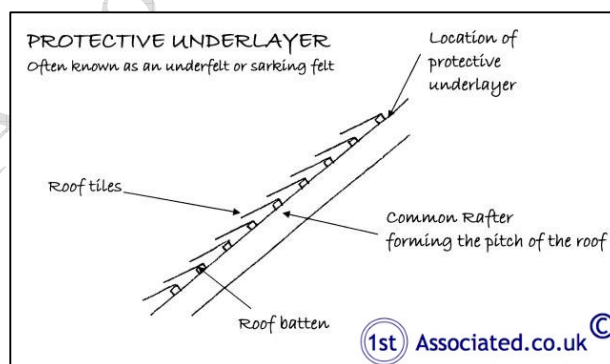
When we inspected the loft space we found a Hessian base Bitumen membrane. This type of membrane has been used since the 1960s. We generally found it to be in average condition, with damage in some areas which is what we typically find.

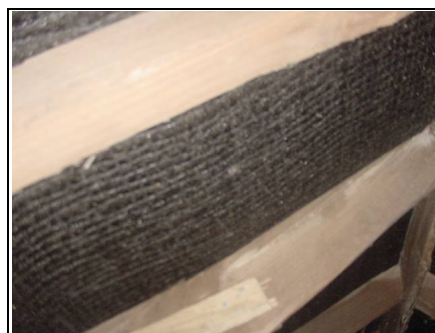
This photo shows the common rafters (the ones that form the pitch of the roof) and the dark area between is the protective underlayer

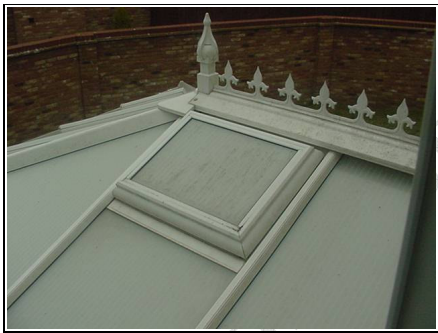
This conservatory has a polycarbonate roof which looks in average condition, although we do find that these polycarbonate roofs do tend to leak sooner or later, particularly where they are against an older property such as this, where there is some movement in the property which is part of the natural process in an older property.

Polycarbonate conservatory roof

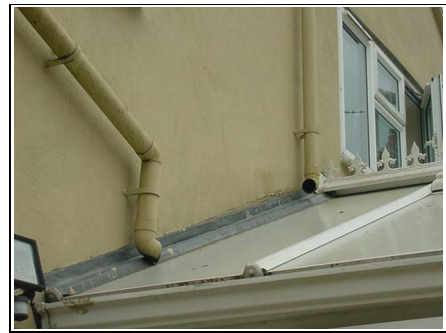
A conservatory has been added to the rear of the property. We were pleased to see that there was a lead flashing where it met the main building and there were no obvious signs of dampness getting through internally, although we would comment that there was a lot of rainwater going on to the roof from the main roofs. We often find this is the case where properties have been amended and extended, where there has been little thought as to how the rainwater gets away from the roof.

Gutter may overflow if too much water gets on to the roof

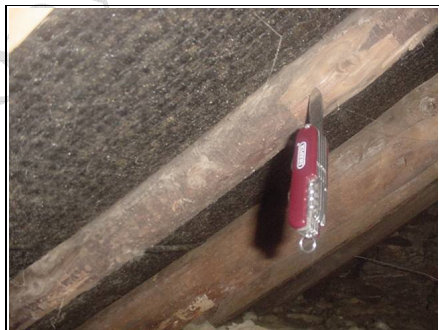
This property has an older style roof structure. Many of the timbers are from times before we cut and squared our timbers properly; we can see many of the timbers in the roof have bark on them still, known as pole timbers, and we can also see many quartered timbers.

Bark on the timber  
– known as pole timbers

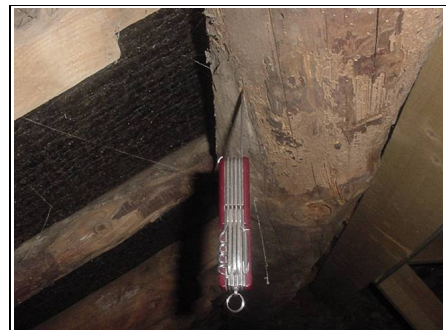
Quartered timbers

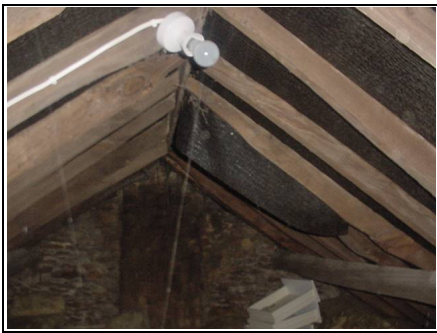
General view of left hand roof

**ACTION REQUIRED:** We would refer you to our comments in the Executive Summary – these roofs are in poor condition. Ideally we would recommend the entirety of the concrete roof is removed, the timbers are checked and replaced and repaired as necessary and a new lightweight roof is put on, such as a slate roof or manmade slate roof.

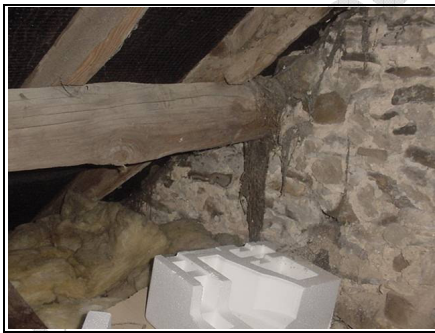
Close up of timbers, additional supports already added

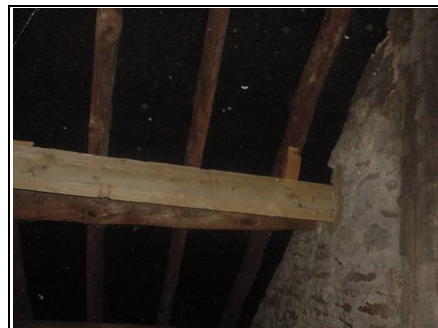
There have been replacement cut timbers added over the years, together with structural supports added to the right hand roof.

New purlins

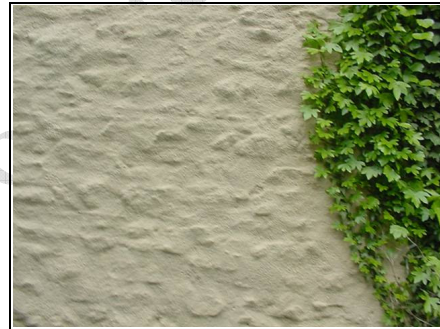
Some of the sandstone has been painted over.

Close up of painted sandstone

**ACTION REQUIRED:** Please see our comments in the Executive Summary.

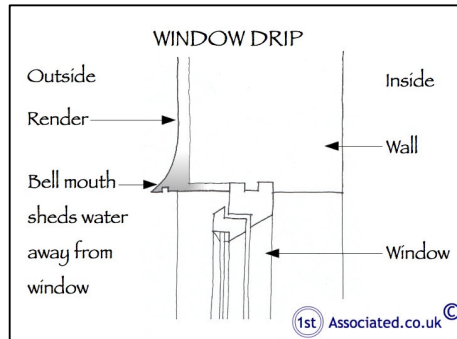
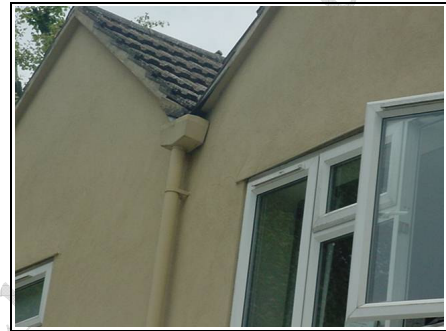
In this case we found a drip detail over the windows.

Drip detail over window

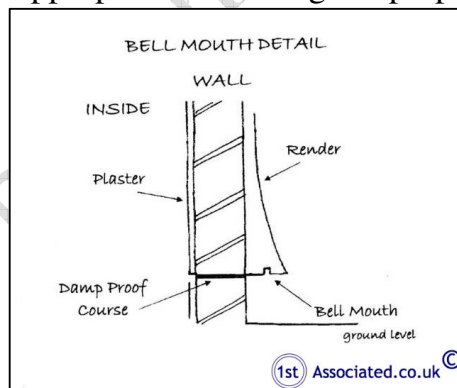
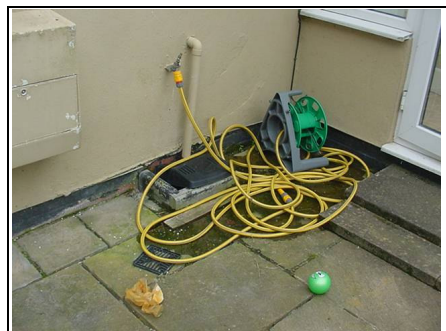
To the base of the render there was a bell mouth detail. It is not ideal as it does not turn up as much as would like but is certainly better than nothing. Overall the rendering is well detailed, unfortunately it is in a hard cement mortar which is not appropriate for this age of property.

Bell mouth detail

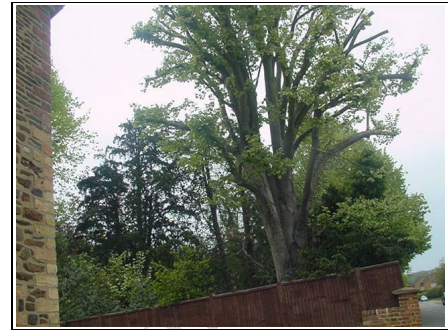
There is a substantial tree to the right hand side which may be within what insurance companies refer to as influencing distance of the property. We as a surveyor do not feel the tree roots are likely to have significant affect on the property providing the tree is maintained, however insurance companies may have a different view on this.

Tree across access road

**ACTION REQUIRED:** Contact the insurance company; ideally stay with the existing insurance company.

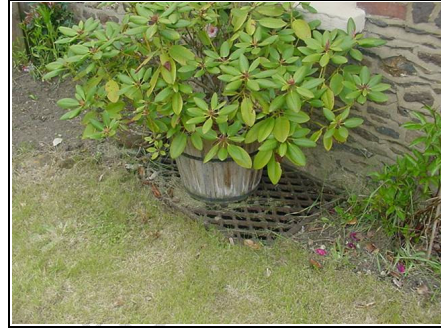
The cellar is vented. Cellars will always be damp as they are below ground and therefore ideally there should be a vent on several sides of the cellar. This has been blocked in years gone by the rear extension. We would suggest opening up a vent within the left hand side of the property, although as stated elsewhere within this report we would not recommend buying this property so it is academic.

Air vent to cellar

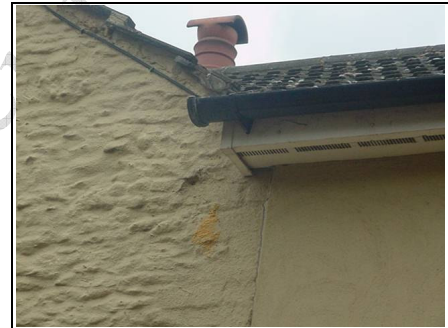
You have a mixture of fascias and soffits, which also help us date the property. To the front we have a traditional fascia and soffit, to the rear we have a vented fascia and soffit that have been in existence for approximate thirty years so you should be able to find details with regard to the rear extension of the property.

Vented soffit on extension

**ACTION REQUIRED:** Make sure gutters and downpipes are watertight before carrying out any work on fascias and soffits.

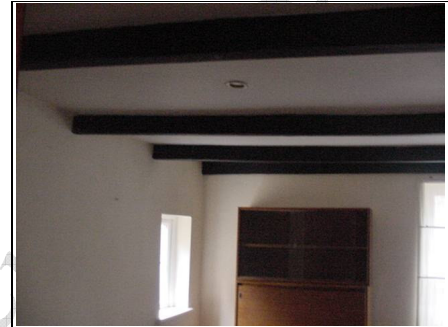
Beams on ceiling in right hand reception room

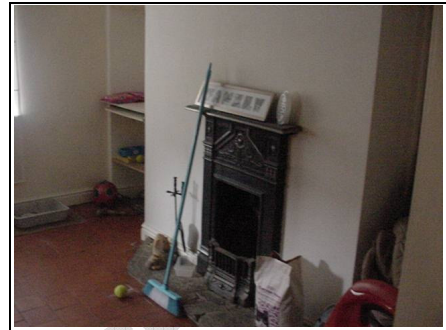
You only have one chimney at the top of the property but at one time all the rooms would have had chimneys and chimney breasts to keep them warm. We believe that some of the chimneys have been removed without being fully removed.

Central fireplace – we were told this does not work

**ACTION REQUIRED:** You need to investigate each chimney in turn to check that it is still all in place. We suspect the chimneys on the left hand side have been partially removed and need to be fully removed.

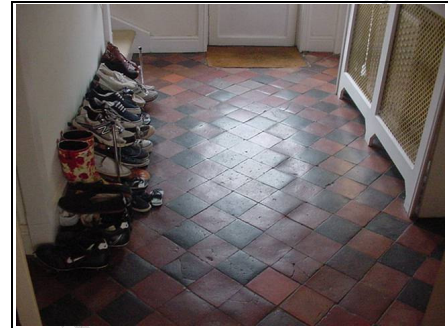
There are terracotta tiles in many areas indicating this property is pre-Victorian. The newer areas are firm under foot, assumed to be a concrete floor.

Old quarry tiles

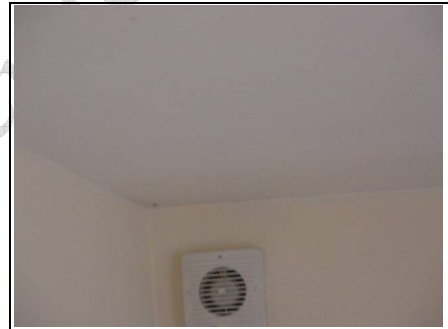
Although there are extracts in some of the humidity creating areas we would recommend larger extract fans within the kitchen, bathroom and the en-suite shower room. Humidity controlled extract fans are a way of helping to reduce condensation is to have good large extract fans within the kitchens and bathrooms which are moisture generating areas.

Extract in lounge

**ACTION REQUIRED:** We would recommend humidity controlled extract fans be added to kitchens and bathrooms.

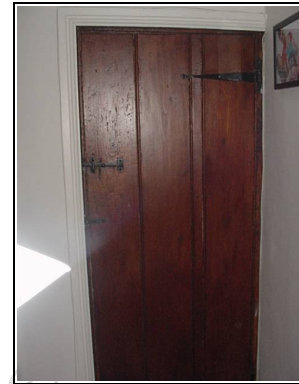
Plank door to cellar

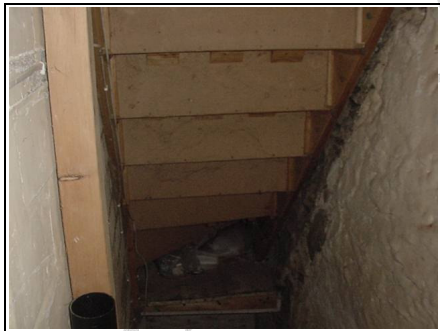
Old stairs left hand side closed off. We can see the back of these going into the cellar

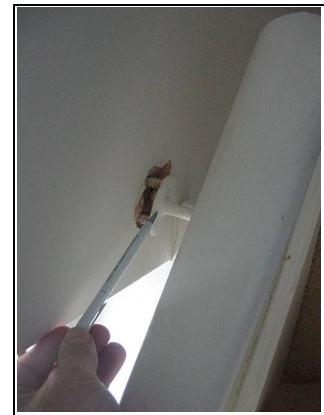
There are two staircases to the property; one of them is hidden and can be seen as you go down into the cellar, the other one is the central modern staircase, which is lined. We could see general maintenance is needed as the handrail needs to be put back on.

Hand rail coming away

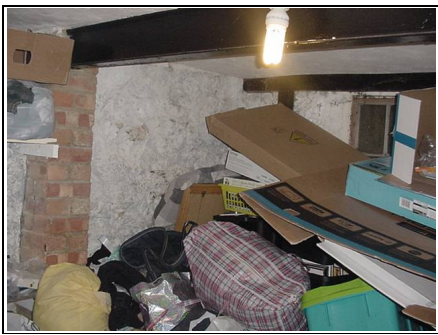
Cellar full of stored items

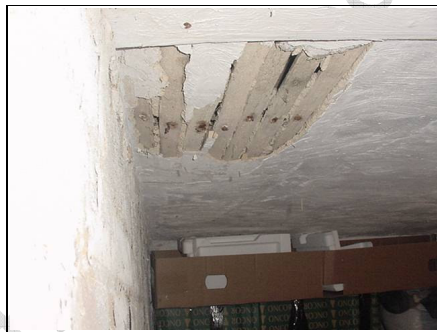
Part of lath and plaster ceiling coming down

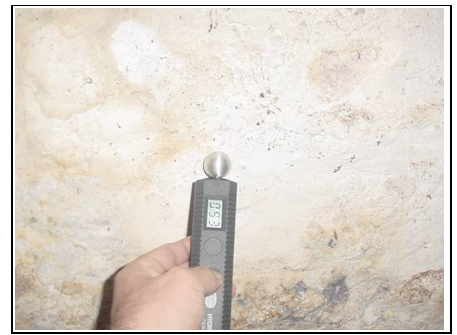
Obtaining damp readings of 93

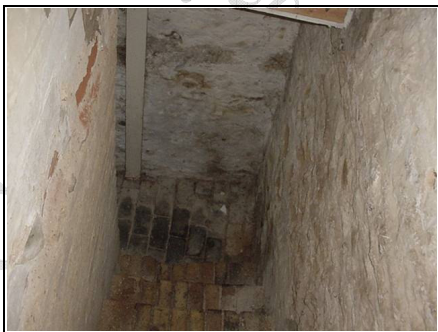
Briquettes on floor

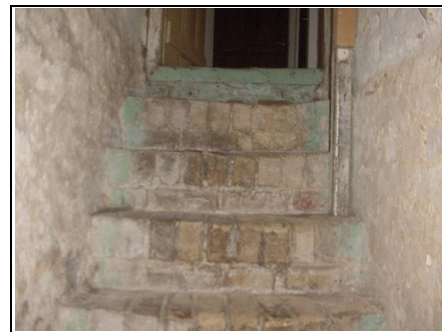
Brick steps coming out of cellar

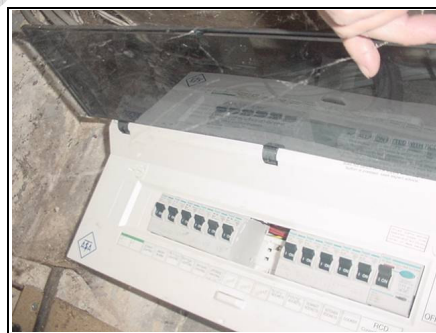
The electric fuses and consumer units were located in the front left hand reception room and look to be from the 1990s and far better are now available.

Fuse Board

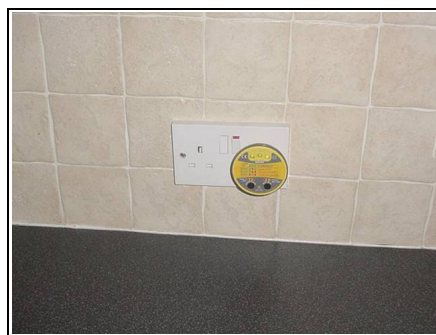
We carried out an earth test in the kitchen area to the socket point that is normally used for the kettle, this proved satisfactory.

Earth Test

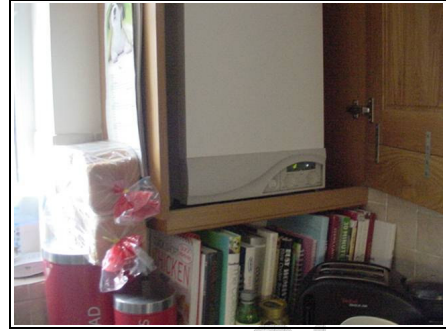
The wall mounted combi boiler was located in the kitchen cupboard, it is manufactured by Ideal.

Our limited inspection of the hot water and central heating system revealed no evidence to suggest any serious defects but we would nevertheless recommend that the system be tested and overhauled before exchange of contracts and that a regular maintenance contract be placed with an approved heating engineer.

Ideal wall mounted boiler

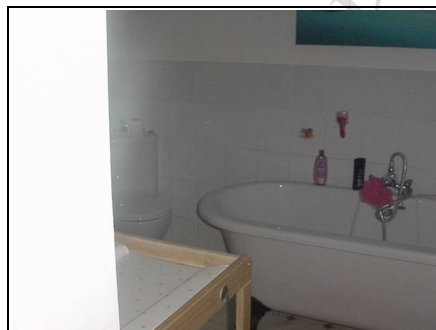
The property has a four piece bathroom suite bathroom suite, consisting of a bath, wash hand basin and WC, together with an en-suite shower room to the master bedroom. They are both relatively new. At the time of our inspection they had just been used and there was a lot of condensation in the area.

Bathroom

Please see our comments about large humidity controlled extract fans.

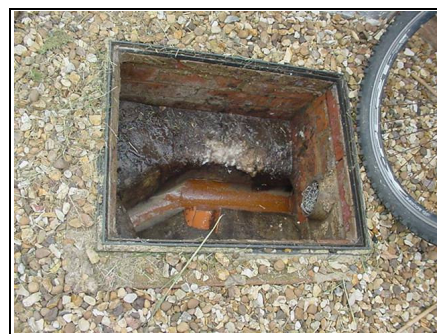
Manhole

We duly lifted the cover and found it to be free flowing at the time of our inspection.

From what we could see it is brick built.

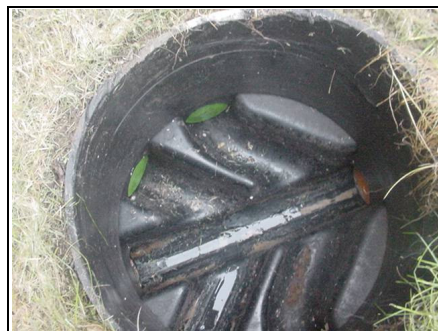
Manhole

We duly lifted the cover and found it to be free flowing at the time of our inspection.

From what we could see it is plastic. We assume this has been added relatively recently.

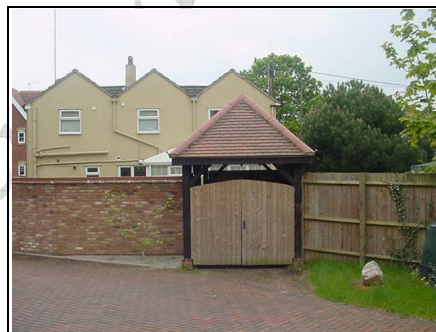
There is off road parking via the car port to the rear, although at the time of our survey it was full of stored items.

Car port

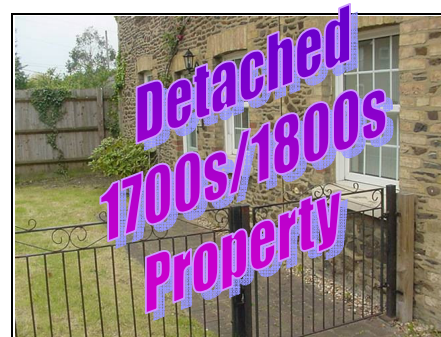
Front Garden

The property has a small front garden. We were quite surprised how fast the traffic flows by this property.

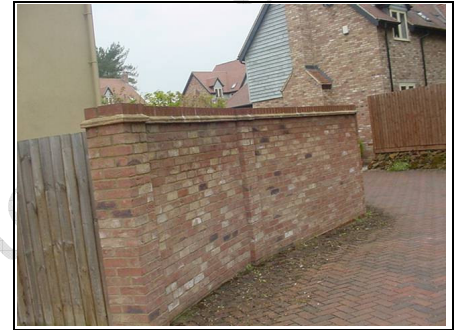
A smallish rear garden, with a patio and grassed area, surrounded by a large brick wall. We were surprised there were not any expansion joints in the brick wall and would be concerned that there may be movement to this.

Wall does not have any expansion joints in it
