RESIDENTIAL BUILDING SURVEY
OF
A 1960's Detached Property, Hemel Hempstead,
Hertfordshire

FOR
Mr M

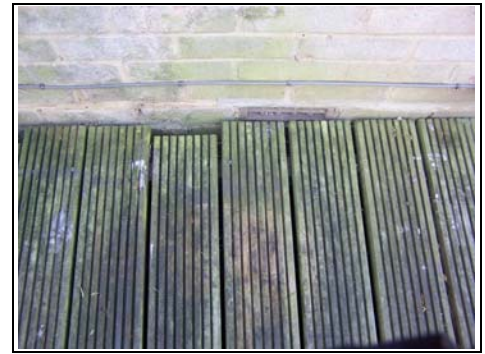
We noted that the airbricks around the property have been partially blocked in some areas by the wood decking that has been added.

ACTION REQUIRED: These vents need reopening and also to be kept clear to allow circulation under the floor, otherwise you could get wet rot or woodworm.

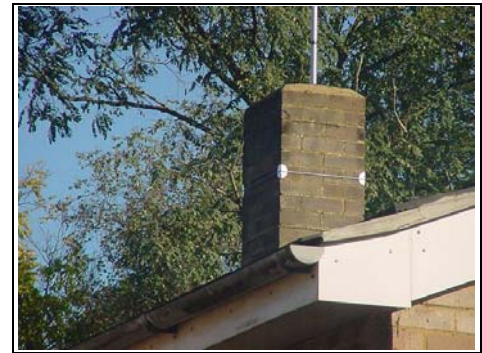
General View

The flashing looks to need repair / replacement.

ACTION REQUIRED: Carry out repointing, as soon as possible, Check flashing immediately. And replace with lead in the long term.

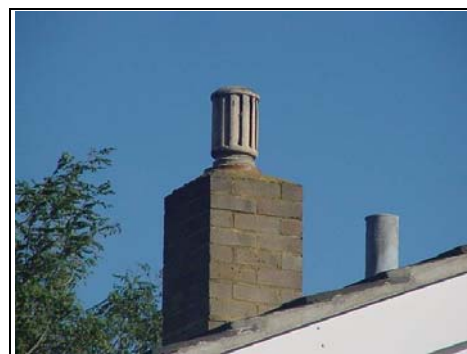
General View

This chimney is brick finished with one chimney pot and needs a close inspection, particularly the flashing, as our view was limited. We have spoken with the owner about this and he advised that dampness was getting in through this chimney but he has had a new flashing added. However, our photos do not look like a new flashing has been added. This may have been a wrong interpretation on our part or the owner's part.

We could see that repairs have been carried to the inside of the roof, but it does look like from this chimney and the previous chimney that your flashings are from the weakness in the construction.

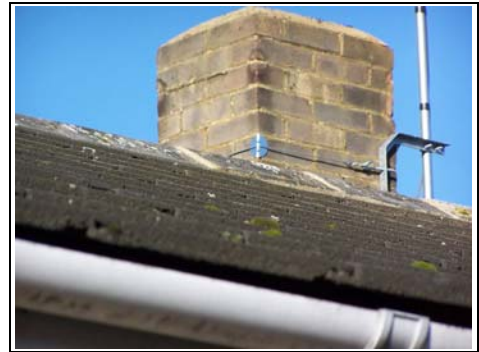
This roof has a shallow pitched, clad with concrete tiles. This type of roof was popular in the 1960/70s. Taking account of the roof's age we consider it to be in average condition. Typical problems are wind blown/driven rain getting under the tiles and rotting the battens.

In this instance we did not gain access to the main roof, it was viewed from ground level (because we did not want to put our ladder off the flat roof at the front because we thought it would damage the flat roof).

The roof was difficult to view and photograph due to its shallow angle.

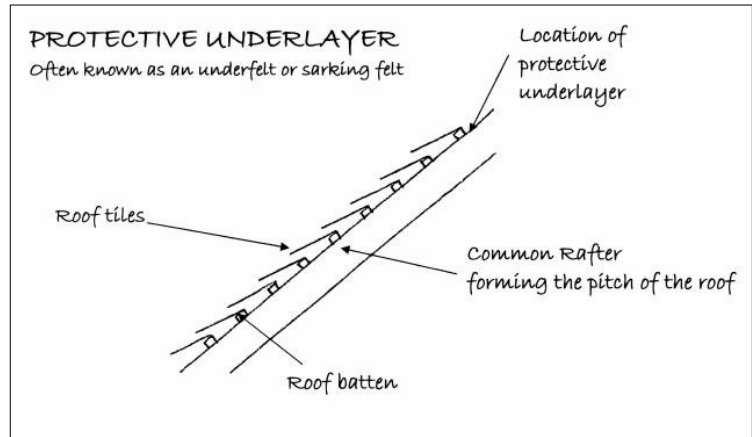
When we inspected the loft space we found a Hessian base Bitumen membrane. This type of membrane has been used since the 1960s. We generally found it to be in average condition, although it is damaged in a few places but this is not unusual considering its age. The Hessian was quite brittle, indicating to us that condensation has occurred within the roof; this is why we have recommended it is ventilated. Please see our comments in the Executive Summary.

This photo shows the common rafters (the ones that form the pitch of the roof) and the dark area between is the underlayer.

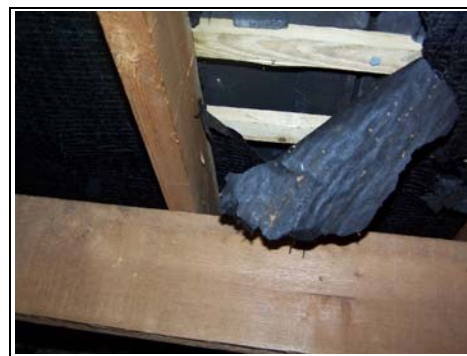
Checking the battens

We have inspected the roof structure for serious active woodworm and for structurally significant defects to the timber together with dry rot and wet rot and we found the roof to be in average condition. We would add that our examination is limited by the configuration of the roof and the insulation. As mentioned previously we do believe that the property has some condensation. We did not see any vents to the roof to help prevent condensation.

ACTION REQUIRED: Ideally add ventilation. Please see our comments in the Executive Summary.

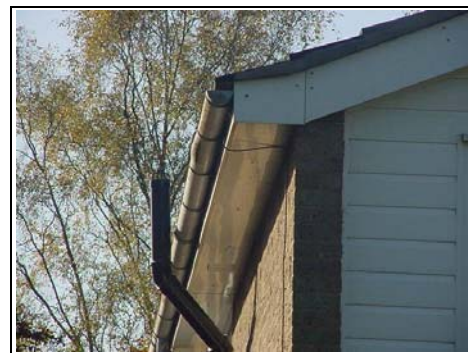
From ground level the gutters and downpipes looked to be plastic and appeared in average condition. There may be a few repairs, but we feel that most people would be happy with getting these carried out.

The plastic used is the older style which is affected by sun light and loses its colour slightly and does become brittle over the years.

Here you can see the underside of the gutters and also the soil and vent pipe.

ACTION REQUIRED: We would always recommend that the gutters and downpipes are cleaned out, the joints are checked and the alignment checked to ensure that the gutters fall towards the downpipes.

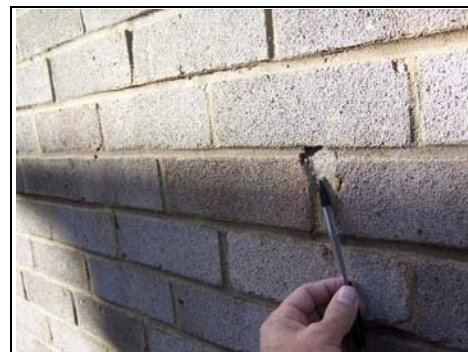
To the brickwork we could see circular marks where cement has been filled in mainly on the mortar joints. This usually indicates that either an insulation has been added or wall ties have been replaced.

Circular holes / mortar indicate that either insulation has been added, which is what the owner advised, or wall tie repairs have taken place.

ACTION REQUIRED: In both cases your Legal Advisor needs to investigate further and advise us of any findings as soon as possible (before you legally commit to purchasing the property).

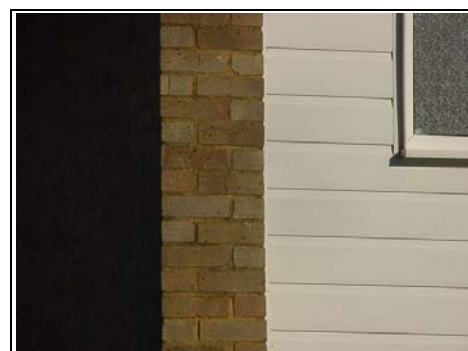
To the front and rear the property has plastic cladding; we have no way of knowing what is beneath the cladding without opening it up, which would cause damage. We would comment that the cladding does look to come from the cheaper end of the market. With plastic cladding we do find it needs a good clean from time to time, particularly where there are trees surrounding it.

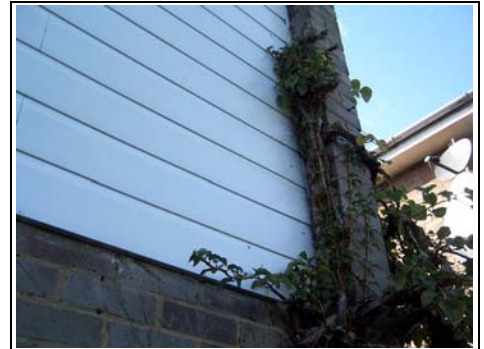
We noted that trees had been cut down around the property. Please see our comments in the Executive Summary.

We noted ivy had been cut back on the property; this does need to be kept under control.

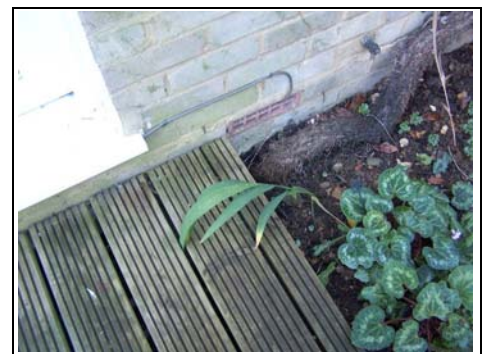
If you look closely there is an airbrick to the centre of this photo and just above it is the thickening of cement, indicating a damp proof course.

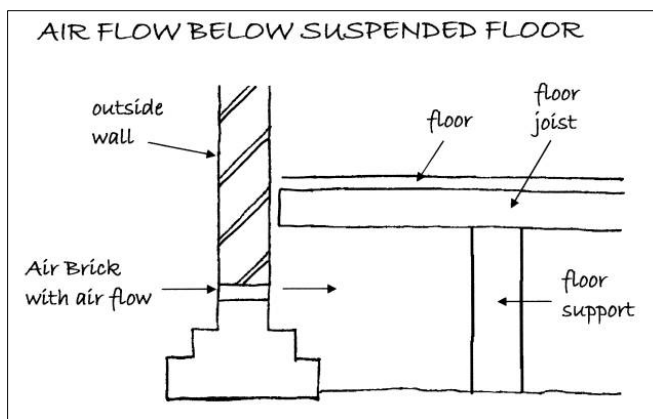
Airbrick, hidden behind the pipe.

Airbricks are visible to this property, this is usually when a suspended timber floor has been used; this would be my thoughts in this case, although often a concrete flooring is used in this age of property. However, given that the floor has had woodworm(!) we assume that it is a wooden floor!

ACTION REQUIRED: The airbricks need opening up. Please see our comments in the Executive Summary.

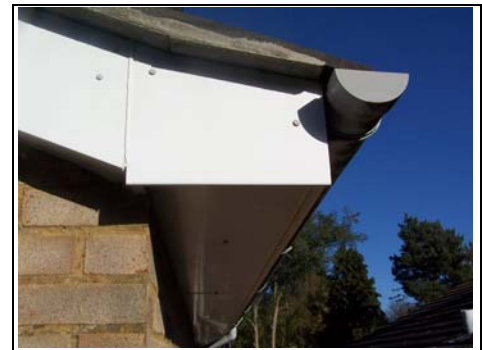
The property has plastic fascias and soffits / bargeboards. They look to be what we would term as 'over-clad', which means they may have been clad over the original timber; however, without taking them off we cannot be certain of this. You do need to check by drilling into the soffit to see if there is wood behind; if there is these need to be stripped off from the timber beneath, if they are not we are recommending that a vent be added to the soffit, so in due course they will need to be taken off and replaced.

ACTION REQUIRED: Ideally add a vent to the soffit, which will allow ventilation to the loft space and help to prevent condensation forming.

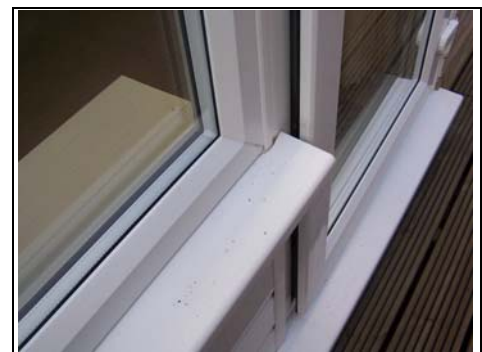
We noted that the seals around the windows to the double glazing has been cut short in many instances; this in turn leads to the double glazing failing earlier than would normally be expected.

The property has plastic, double glazed windows, which generally look to be of average quality, although we did not see any trickle vents which does lead us to comment further that they are probably from the cheaper end of the market.

We would draw your attention to the fact that sealed double glazed units can fail, particularly as a result of poor workmanship during installation. Failure of the seal leads to condensation between the two panes of glass and simply replacing the affected units may not provide a satisfactory long-term solution. In this case they are in average condition.

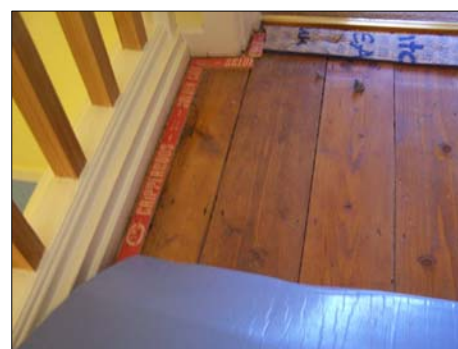
We have assumed that the first floor construction is joist and floorboards as this is typical in this age of property. We have only been able to see a small section of it on the landing.

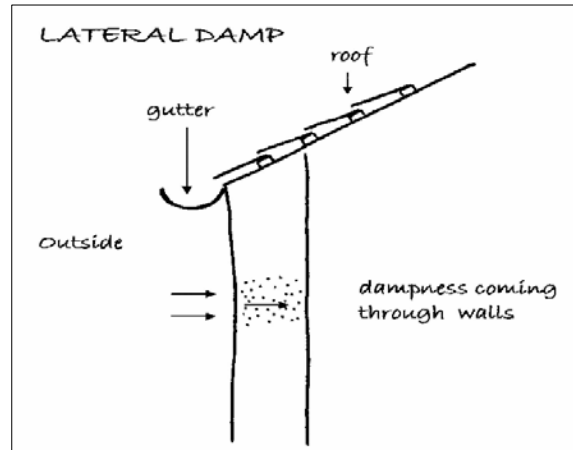
Tests were taken with a moisture meter at random points to internal walls, floors and other surfaces. No evidence of any significant penetrating/lateral dampness was detected.

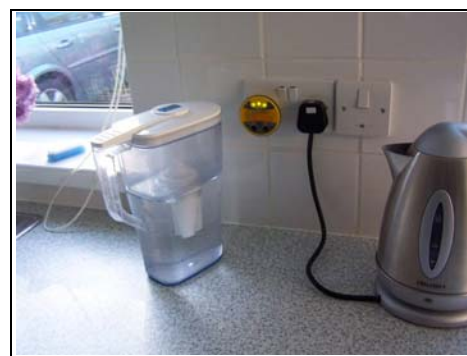
We carried out an earth test in the kitchen area to the socket point that is normally used for the kettle and this proved satisfactory.

ACTION REQUIRED: As the house is changing occupancy an IEE report should be carried out by a NICEIC registered and approved electrical contractor.

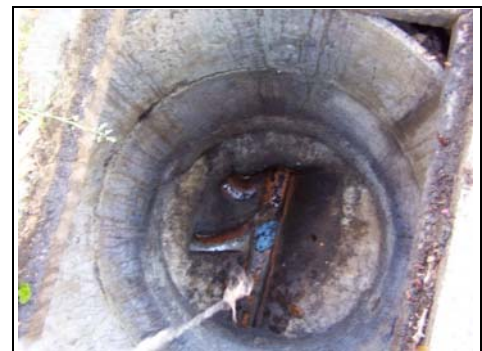
We found one inspection chamber/ manhole to next door's driveway.

We duly lifted the cover and found it to be clear with no roots etc. It looked to have been built from pre-cast concrete ring manhole sections.

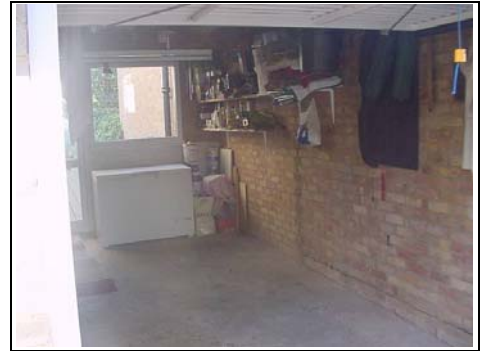
You have an adjoining garage to the property with a flat roof over it.

Please see our comments in the Roof Coverings Section with regard to the condition of the garage roof. It is not ideal but we have seen worse.

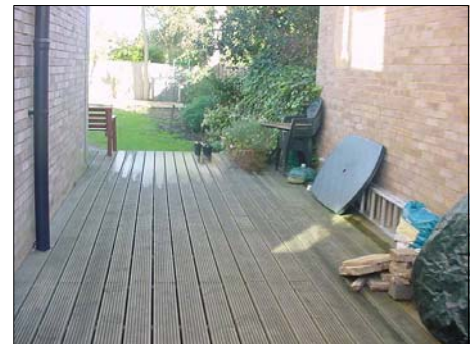
No evidence of any significant rising dampness was detected in the random areas checked. It is not unusual in this type of property for some minor dampness caused by the fall towards the house at the front and often also caused by raised levels of earth around the property. In this instance we think also that the decking may cause future issues.

The rear garden is fairly level and laid to lawn to the rear with decking down the side. Please see our comments with regard to how this decking is covering up the airbricks.

ACTION REQUIRED: We would therefore recommend that the earth level is reduced around the building and that the decking is cut a fraction further away from the property.
