# RESIDENTIAL BUILDING SURVEY

Henlow, Beds

**INDEPENDENT CHARTERED SURVEYORS**

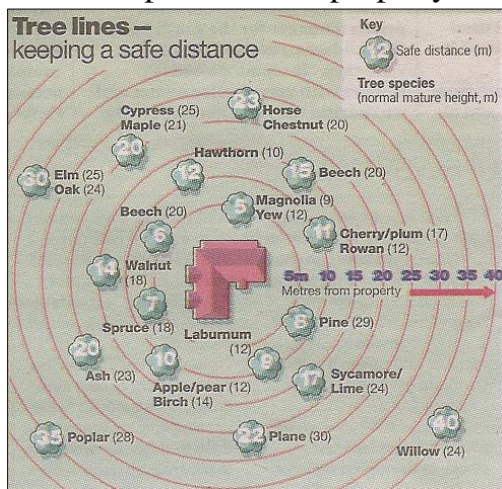
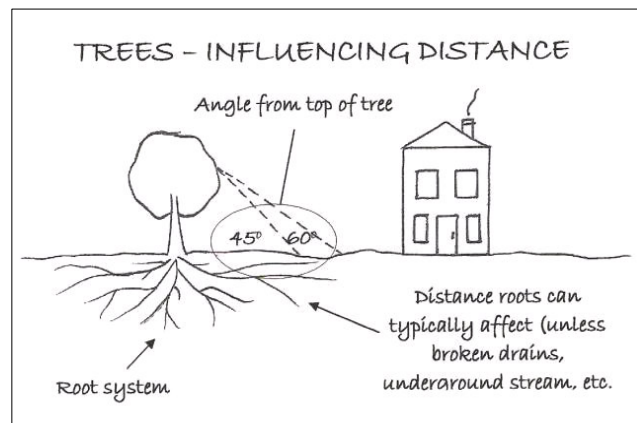
Large oak tree

The tree is in what we would term influencing distance meaning that it can affect the property however in modern properties such as this it should have been allowed for with the foundation design. It is essential you establish who owns the tree and therefore who is responsible for maintenance of it. We noted there is a locked gate to the right hand side of the garage, we spoke to the owner during the question and answer session and they were unsure as to who owned it, you do need to establish this before you purchase the property.

**ACTION REQUIRED:** Your solicitor to specifically request details from seller's solicitor/Building Control Department as to the depth of the foundation and then we will advise as to whether we feel this is sufficient. We are slightly concerned with this property having a suspended floor as this does indicate to us that it may well be a clay soil area and the suspended floor has been put in to allow for any movement in the ground level. If this is the case it would mean that we would have to insist on more information regarding the foundations before you purchase the property.

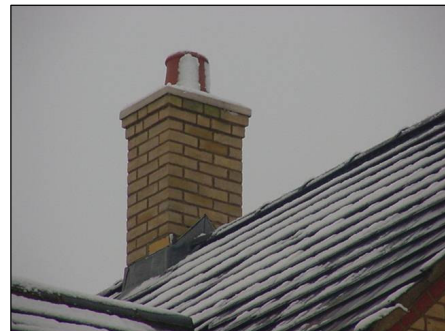
This property has one chimney, which is located at the front of the property on the left hand side (all directions given as you face the property). The chimney is brick with a lead flashing in average condition.

Brick chimney

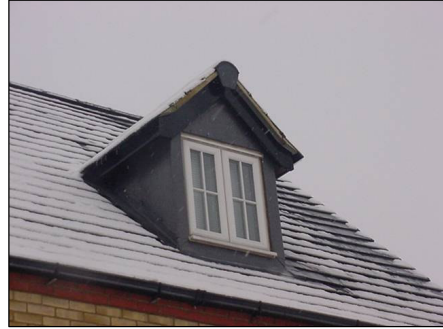
The roof is clad with tiles, the cheeks/sides are in metal or as this is a modern property it could be Glass Reinforced Plastic (GRP). In reasonable condition, as viewed from ground level again subject to us viewing it in the snow.

Dormer windows

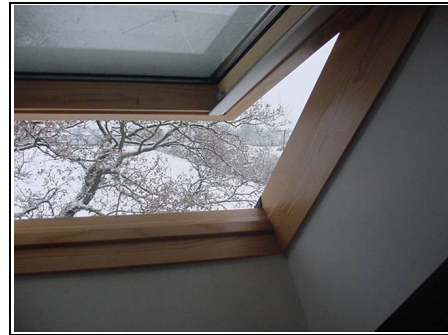
The property has a metal (externally) and timber roof window. We have checked this the best that we can from ground level and also from within. It is difficult to be 100% certain with roof lights, as much is hidden. We believe they are in average condition.

Roof light

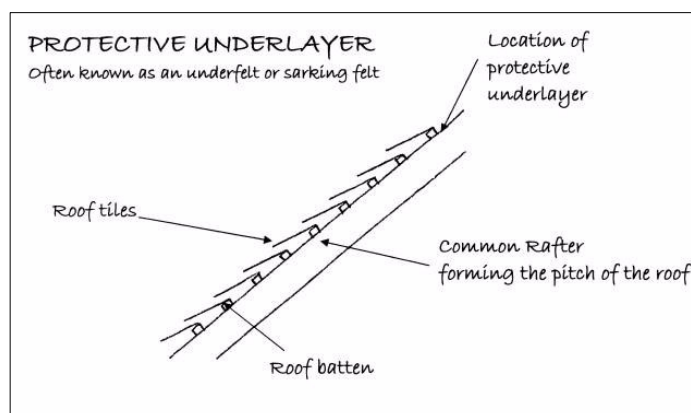
The roof has what looks to be a modern breatherable felt, although they are typically white and this one is black

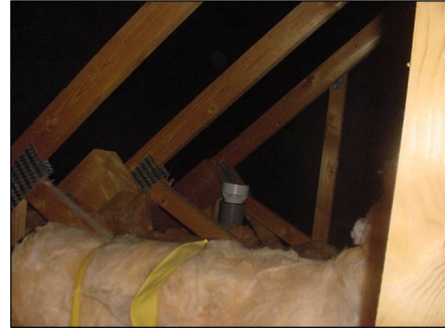
This photo shows the common rafters (the ones that form the pitch of the roof) and the dark area between is the underlayer.

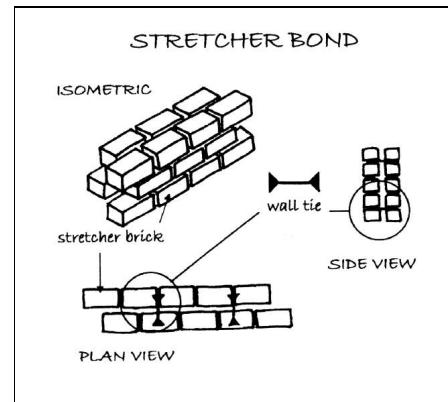
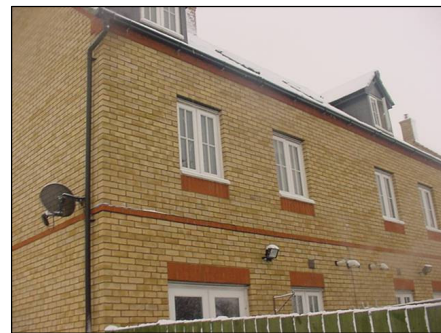
Brickwork

We generally found the brickwork and pointing in average condition.

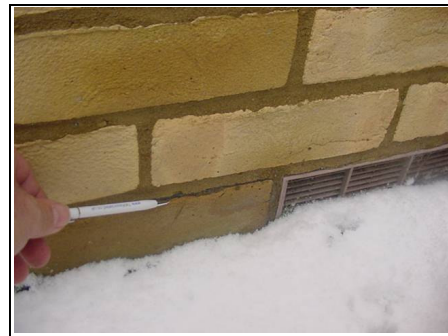
Damp proof course

All modern properties should incorporate a damp proof course (DPC) and good building practice dictates that a differential of 150mm (6 inches) should be maintained between the damp proof course and ground levels. In this case, we could see a damp proof course to the property in some areas.

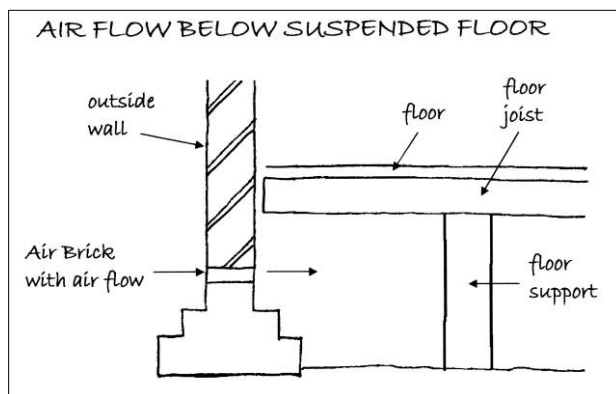
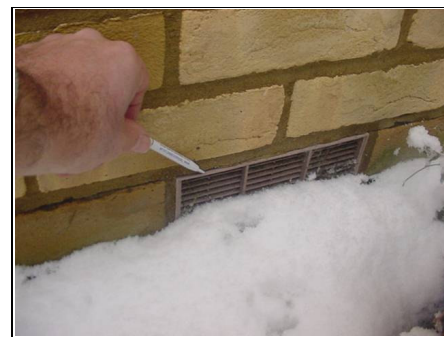
Airbrick

We noted air bricks at the front and the rear of the property which indicates a suspended floor. From what we could see, providing the air bricks are kept clear you have adequate ventilation.

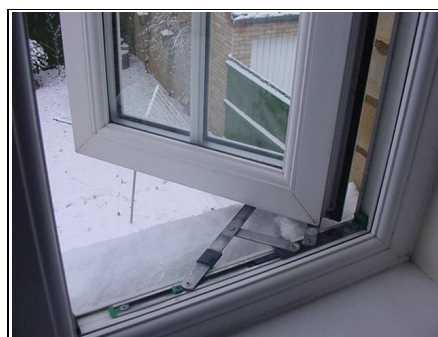
We would draw your attention to the fact that sealed double glazed units can fail, particularly as a result of poor workmanship during installation. Failure of the seal leads to condensation between the two panes of glass and simply replacing the affected units may not provide a satisfactory long-term solution. In this case they are in average condition.

Double glazed window

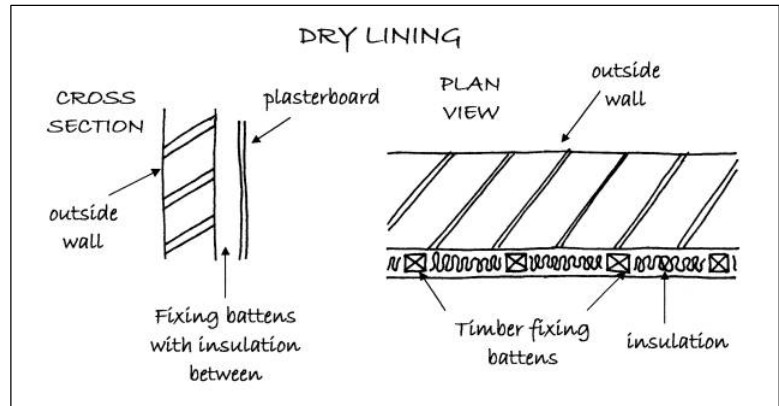
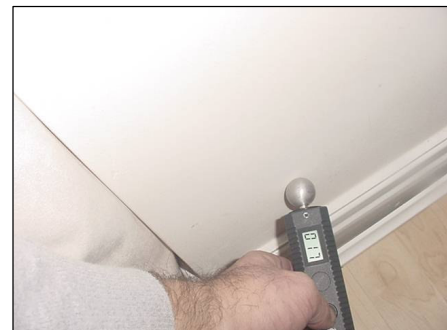
We would normally carry out tests with an electronic damp meter. However, as your property is dry-lined we were unable to do this. We therefore carried out a visual inspection and did not find any signs of significant dampness coming through.

Checking for dampness –  
readings less than 20 indicates  
dry lined wall

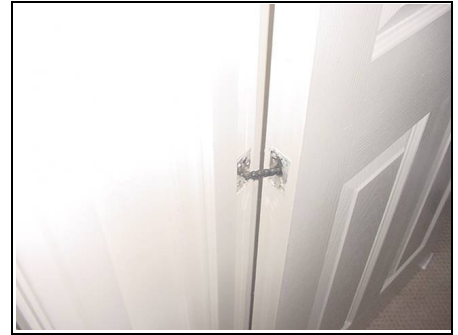
Internal door

The property has hollow core doors (sometimes referred to as egg box doors, as this is what the internal of them looks like when they are opened up), which have a pressed and painted finish. We noted that some of the doors had Perko door closures which helps in the case of a worst case scenario of a fire as the doors are pulled closed therefore stopping the fire spreading.

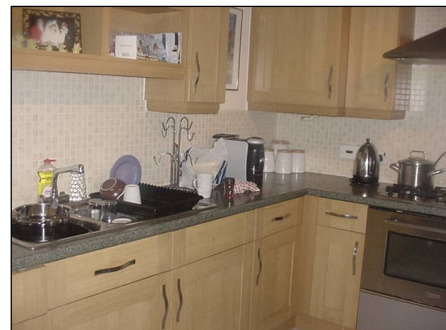
Kitchen

From our cursory visual inspection the kitchen looked in reasonable condition, although it has suffered from some general day-to-day marks. We have not tested any of the kitchen appliances.

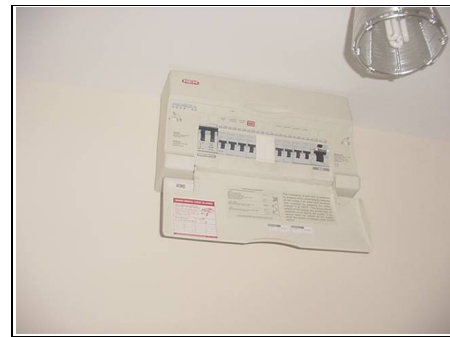
Fuse board

The electric fuses and consumer units were located in the kitchen. We would assume it is the original fuse board and is a 2000s make and model.

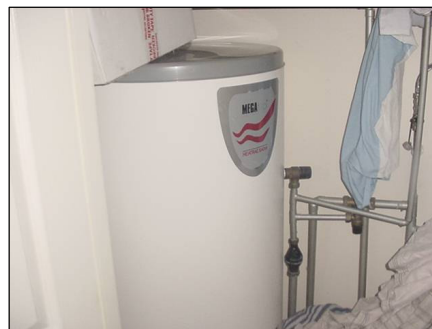
There is a mega-flow water cylinder we have found these from personal experience to be very efficient.

Mega-flow water cylinder

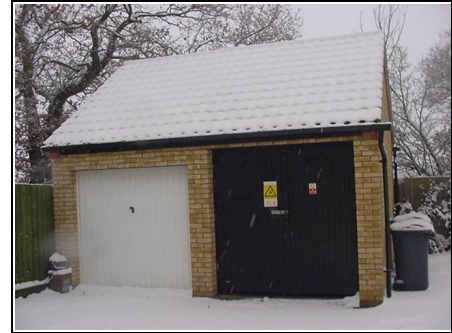
The property has a garage with an electricity sub station adjoining it. Please see our comments in the Executive Summary with regard to the electric sub station.

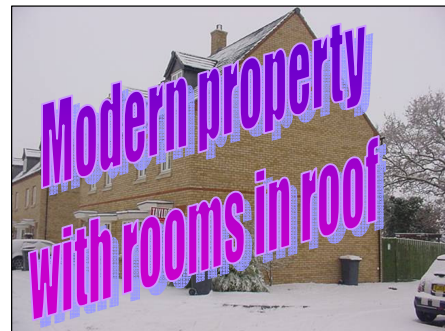
#### Front Garden

Small front garden covered in snow at time of our inspection so our view was limited.

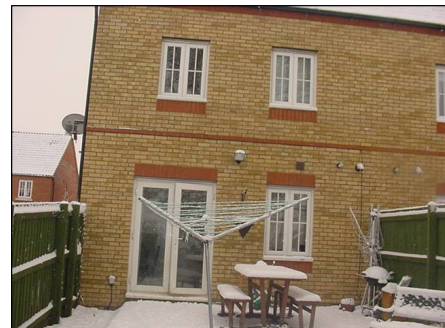
#### Rear Garden

Rear garden covered in snow at time of our inspection so our view was limited.
