RESIDENTIAL BUILDING SURVEY

A Converted Terraced Property, Hitchin, Hertfordshire SG4

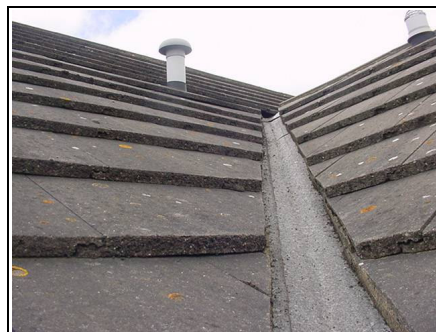
The roof is pitched and clad in a large interlocking concrete tile. From what we could see the concrete tiles are lying level and true and look in reasonable condition considering their age. Sometimes we find deterioration to the ridges and the perimeter, so you should periodically check these areas.

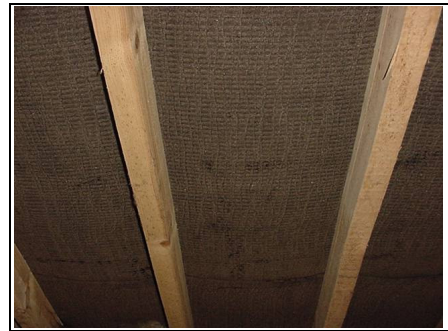
When we inspected the loft space we found a Hessian base Bitumen membrane. This type of membrane has been used since the 1960s. We generally found it to be in average condition, although it is damaged in a few places but this is not unusual considering its age.

This photo shows the common rafters (the ones that form the pitch of the roof) and the dark area between is the underlayer.

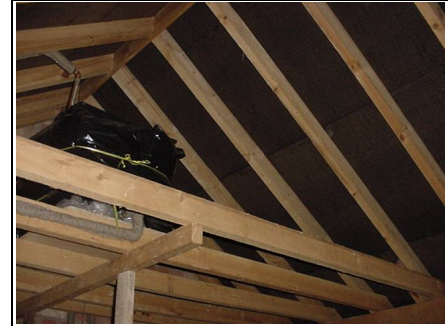
The main roof is accessed via the loft hatch located at the entrance to the property. There is no loft ladder, roof light or secured floorboards. We recommend that these be added, as it will make the loft space safer and easier to use. The loft has been viewed by torch light, which has limited our viewing slightly.

This type of roof structure has, what is known as, a cut timber roof, which is a roof that is purpose made and hand built on site. Without the original design details we cannot categorically confirm that there are no defects; however it is in line with what we typically see.

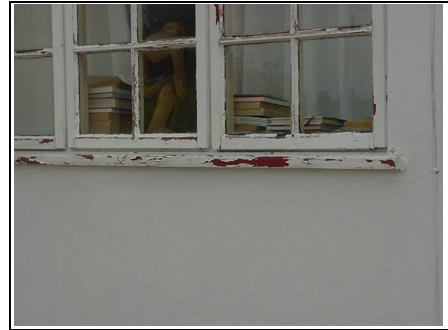
We did note that your downstairs neighbour still had wooden windows and indeed they had not been decorated. This may be a sign of a bad neighbour or indeed an uncooperative neighbour. They certainly looked unsightly.

We would draw your attention to the fact that sealed double glazed units can fail, particularly as a result of poor workmanship during installation. Failure of the seal leads to condensation between the two panes of glass and simply replacing the affected units may not provide a satisfactory long-term solution. In this case they are in average condition.

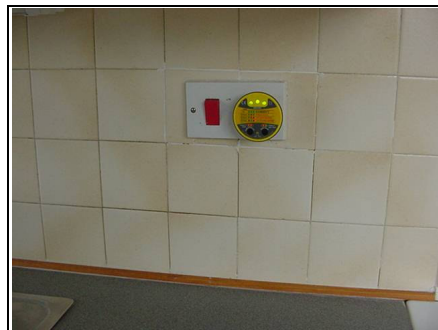
We have not been able to see / find the electric fuseboard and consumer units. We assume they are located at the bottom of the stairs.

We carried out an earth test in the kitchen area to the socket point that is normally used for the kettle and this proved satisfactory.

ACTION REQUIRED: If there is no record of an electrical test having been undertaken within the last five years, it is recommended that the installation be tested by a competent electrician (NICEIC registered) and all recommendations implemented. Thereafter, the installation should be re-tested every five years.

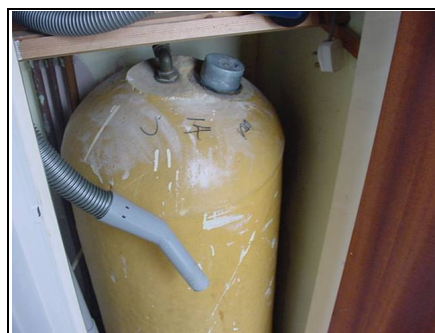
The hot water cylinder is relatively new (in this case we mean in the past 30 years) as it is factory lagged.
