**RESIDENTIAL BUILDING SURVEY
OF
Horbling, Lincolnshire NG34**

FOR

Mr F

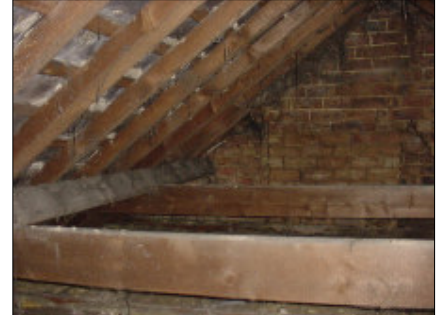
This would be fairly difficult due to the type of roof, which is an 'A' frame – you can see in the photo the timbers would get in the way of any decent room space. The difficult part would be getting the right head room. You could possibly use dormer windows, although this would mean they overlook next doors gardens, which could be objected to.

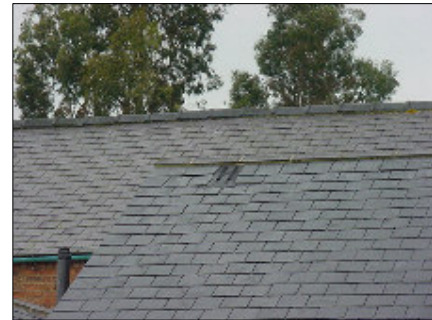
Main Roof

The main roof is pitched and clad with, possibly, the original slate. This photo was taken with a zoom lens.

Unfortunately we were only able to see approximately 75 percent of the roof from ground level via our ladder or via any other vantage point that we managed to gain. We have made our best conclusions based upon what we could see, however a closer inspection may reveal other defects.

As a general comment on the roofs as a whole, as viewed from ground level, the roof coverings showed nothing out of character for their age and type, albeit there are some cracked and slipped tiles, as we would expect.

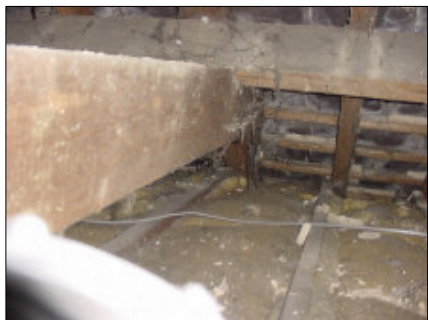
A view underneath the purlins.

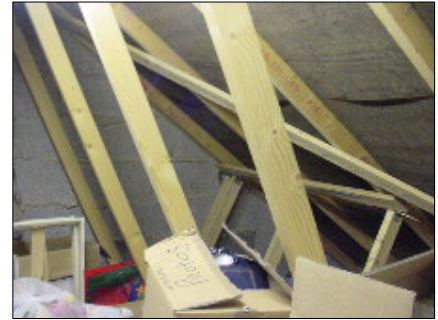
General view of the roof. The trussed rafter is visible and you can also see the sarking felt between the rafters and all the stored items sitting on the ceiling joists.

An area that did concern us was the ceiling lights that have been used as the heat from these can cause fires. We noted that some of the ceiling lights have been cut around and in some areas the insulation had started to cover them.

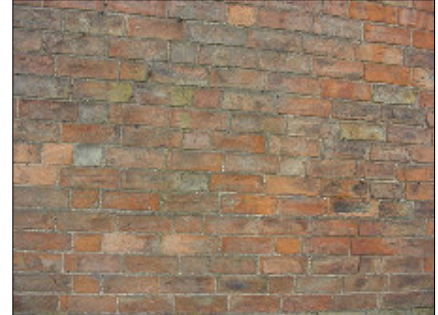
Brickwork to Original Property

This property is brick finished with a cement lime mortar, which was originally bedded (we assume) in lime mortar. The brickwork is what is known as Flemish bond pattern, although there also looks to be some English bond pattern to the gable end, which may have been used for decorative purposes.

The solid external walls may be liable to penetrating dampness internally, dependent upon their condition and their exposure to the weather. External faces should be kept in good condition.

ACTION REQUIRED: In this case, we believe, some re-pointing is required, particularly to the gable end. We recommend you use lime mortar in any future repairs regardless of what the builders say! Using lime mortar will limit further damage to the brickwork, which is almost impossible to repair successfully.

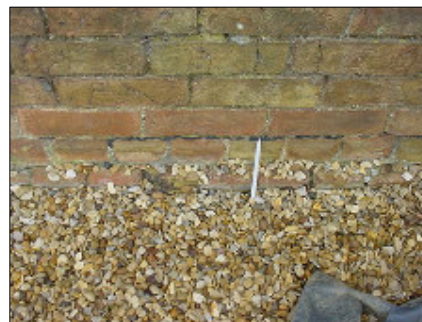
All modern properties should incorporate a damp proof course (DPC) and good building practice dictates that a differential of 150mm (6 inches) should be maintained between the damp proof course and ground levels. In this case, we could see a damp proof course to parts of the older part of the property, for example the gable wall. Ironically we could not see one to the newer part of the building. In this photo the pen indicates the height of the damp proof course, which should be two bricks from the ground level.

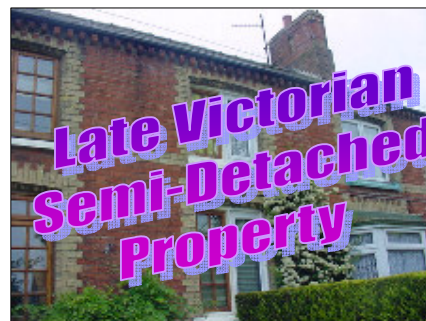
The property predominantly has casement windows; these are stained timber and double glazed. They look relatively new, although the present owner advises us that they did not put them in. The timber looked to be of good quality.

Having seen the double-glazing to next door, we think this is a good advert for timber windows.

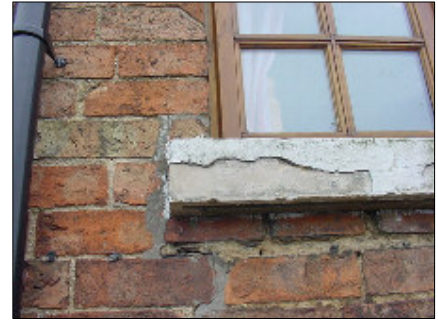
We would suggest with regard to the windowsills that the paint is left to come off, as it is much better to have the sills unpainted as it allows them to 'breathe'.

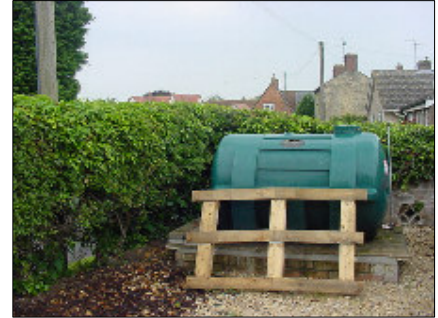
We were pleased to see the property has a plastic oil tank. We were advised that this is only a few years old. These are typically double lined and are now used to replace the old metal tanks that can rust or leak.

All appliances, pipework and flues should be subject to an annual service by a competent engineer.

ACTION REQUIRED: Unless evidence can be provided to confirm that there has been annual servicing, we would recommend that you commission such a service prior to use to ensure safe and efficient operation.

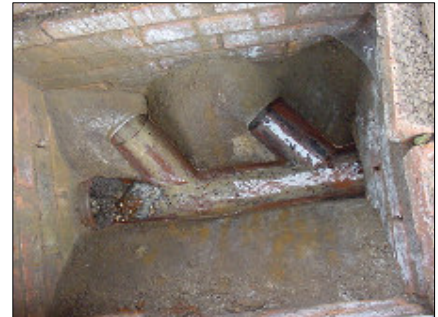
Manhole One (to the left hand corner of the original property)

This manhole is brick built and a reasonably neat and tidy job has been made of the benching. We duly lifted the cover and found it to be free flowing at the time of our inspection.
