**RESIDENTIAL BUILDING SURVEY  
OF  
Horbling, Lincolnshire NG34**

**Mr F**

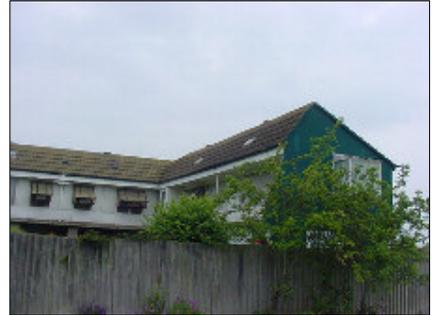
Just in case you have not noticed, next door there is a two-storey birdhouse, for want of a better description, which is literally Travel Inn size. We have never seen anything quite like it before. We went round to talk to the neighbours, but unfortunately there was no one in at the time. You need to ensure that you are happy to live with this and we assume that it could also have a change of use into residential housing fairly easily.

This is the largest bird house we have ever seen in someone's garden.

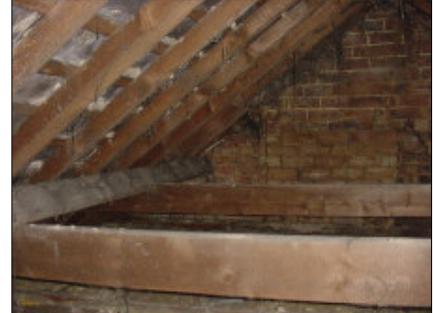
This would be fairly difficult due to the type of roof, which is an 'A' frame – you can see in the photo the timbers would get in the way of any decent room space. The difficult part would be getting the right head room. You could possibly use dormer windows, although this would mean they overlook next doors gardens, which could be objected to.

The other difficulty would be adding a staircase in without losing a bedroom. We often find with this sort of alteration, you maybe gain a bedroom, which isn't ideal, but you'd lose also a bedroom with the stairs area. We would be more than happy to discuss this further with you.

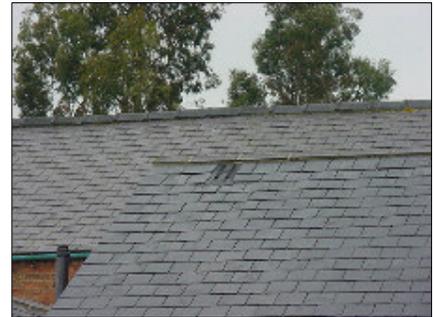
In this photo the new roof (low level roof) is in the foreground, you can see a vent at the ridge area and in the background is the old roof.

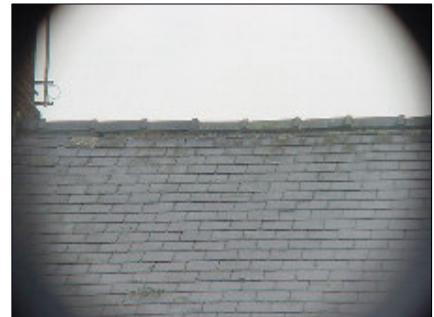
## **Main Roof**

The main roof is pitched and clad with, possibly, the original slate. This photo was taken with a zoom lens.

Unfortunately we were only able to see approximately 75 percent of the roof from ground level via our ladder or via any other vantage point that we managed to gain. We have made our best conclusions based upon what we could see, however a closer inspection may reveal other defects.

As a general comment on the roofs as a whole, as viewed from ground level, the roof coverings showed nothing out of character for their age and type, albeit there are some cracked and slipped tiles, as we would expect.

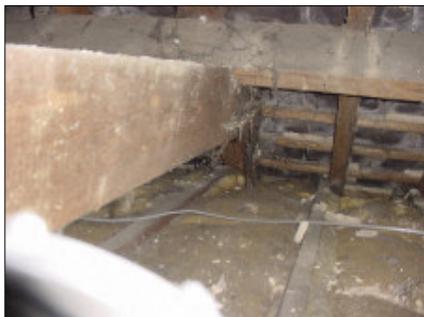
A view underneath the purlins.

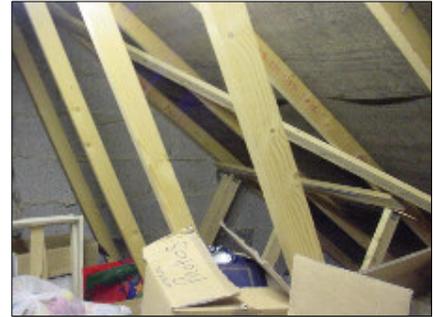
General view of the roof. The trussed rafter is visible and you can also see the sarking felt between the rafters and all the stored items sitting on the ceiling joists.

An area that did concern us was the ceiling lights that have been used as the heat from these can cause fires. We noted that some of the ceiling lights have been cut around and in some areas the insulation had started to cover them.

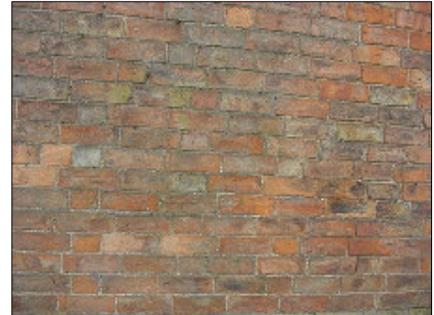
## Brickwork to Original Property

This property is brick finished with a cement lime mortar, which was originally bedded (we assume) in lime mortar. The brickwork is what is known as Flemish bond pattern, although there also looks to be some English bond pattern to the gable end, which may have been used for decorative purposes.

The solid external walls may be liable to penetrating dampness internally, dependent upon their condition and their exposure to the weather. External faces should be kept in good condition.

**ACTION REQUIRED:** In this case, we believe, some re-pointing is required, particularly to the gable end. We recommend you use lime mortar in any future repairs regardless of what the builders say! Using lime mortar will limit further damage to the brickwork, which is almost impossible to repair successfully.

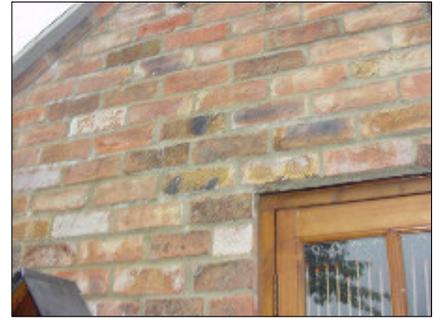
## **Brickwork to New Property**

The brickwork to the new property is in a stretcher bond and is common with cavity walling. The pointing and brickwork looked in reasonable condition.

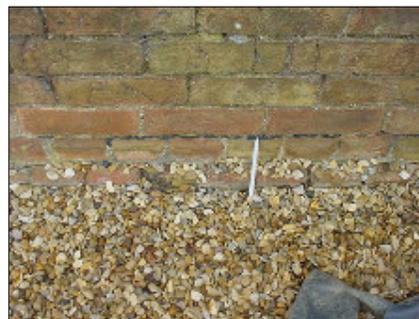
All modern properties should incorporate a damp proof course (DPC) and good building practice dictates that a differential of 150mm (6 inches) should be maintained between the damp proof course and ground levels. In this case, we could see a damp proof course to parts of the older part of the property, for example the gable wall. Ironically we could not see one to the newer part of the building. In this photo the pen indicates the height of the damp proof course, which should be two bricks from the ground level.

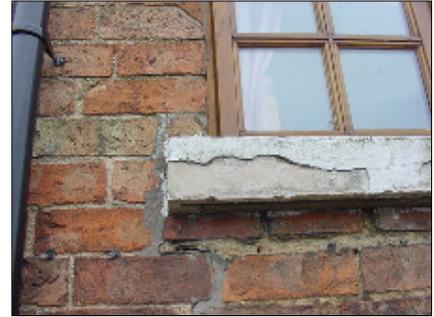
As mentioned, the windows are fitted with double glazed units. We would draw your attention to the fact that sealed double glazed units can fail, particularly as a result of poor workmanship during installation. Failure of the seal leads to condensation between the two panes of glass and simply replacing the affected units may not provide a satisfactory long-term solution. In this case we could not see any problems. Enquiries should be made as to the existence of any transferable guarantees.

We would suggest with regard to the windowsills that the paint is left to come off, as it is much better to have the sills unpainted as it allows them to 'breathe'.

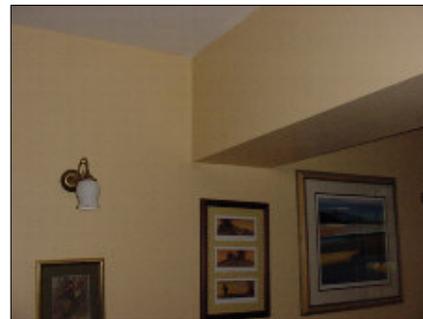
Beam to the Living Room.

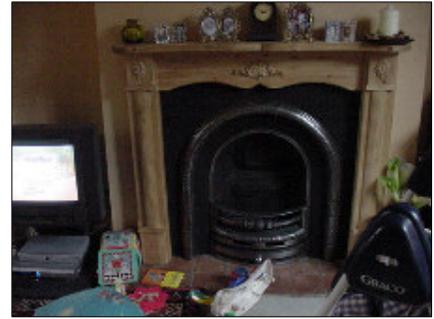
We would add that there are some very nice fireplaces in the property. The owner advised during our question and answer session, that he had added the one to the ground floor.

At the time of the survey no chimneys were in use. Any chimneys that you do not propose to use should be capped and ventilated to prevent dampness.

Finally, it is strongly recommended that flues be cleaned and checked for obstruction prior to use to minimise the risk of hazardous fumes entering the building.

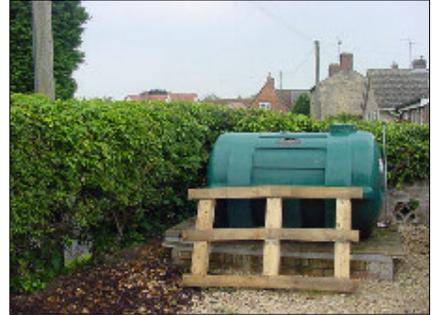
We were pleased to see the property has a plastic oil tank. We were advised that this is only a few years old. These are typically double lined and are now used to replace the old metal tanks that can rust or leak.

**ACTION REQUIRED:** Unless evidence can be provided to confirm that there has been annual servicing, we would recommend that you commission such a service prior to use to ensure safe and efficient operation.
