# RESIDENTIAL BUILDING SURVEY

Houghton Regis, LU5

**GEM Associates Limited**

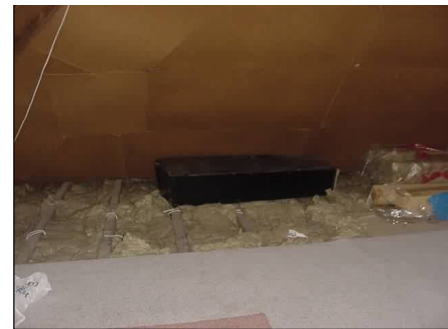
The roof has a nibbed concrete tile and unfortunately it does not have a protective under layer that would be commonly used today which is a secondary protection against any rain getting in. What this means is you will generally get wind driven rain in and some staining on the timbers that may relate to this.

Roof lined with board

**ACTION REQUIRED:** It is very expensive to add a protective under layer (often known as a sarking under felt) as it does mean re-roofing the property. We recommend leaving re-roofing until such time as there is some major deterioration with the roof.

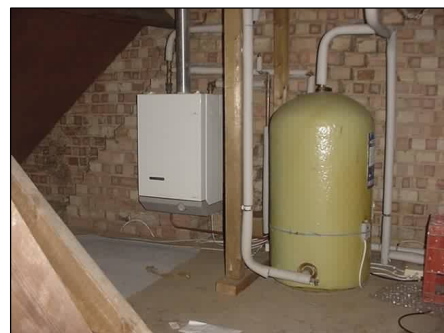
Boiler and cylinder

**ACTION REQUIRED:** We noted there is a ladder in the roof space although it is obviously not fixed it should be fixed next to the water tank!

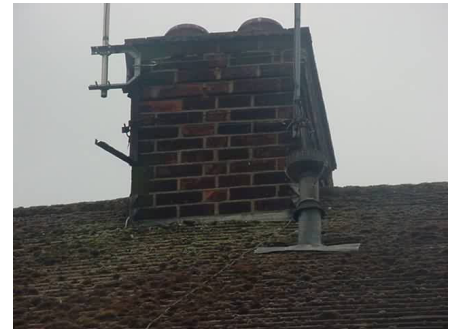
This chimney is brick finished with small chimney pots and looks to have lead flashings. From what we could see from ground level the chimney looks in average condition.

Chimney

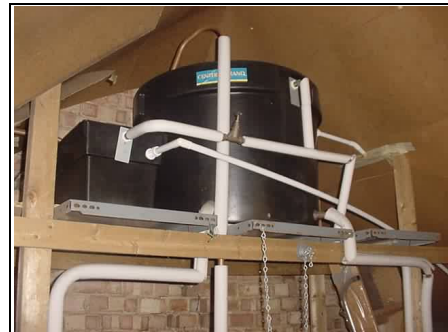
The water tanks are formed in plastic (without insulation) and we therefore assume they are relatively new (in surveying terms, in this instance, that is the last 30 years). The water tank has no lid, which stops anything getting in it, particularly important if you clean your teeth with the water.

Water tanks

**ACTION REQUIRED:** Clean and add lid

We would always recommend that water tanks be drained down and cleared of any debris etc. (we have seen dead birds and other unmentionable things in these tanks). As you are cleaning your teeth with this water it is best that it is as clean as possible!

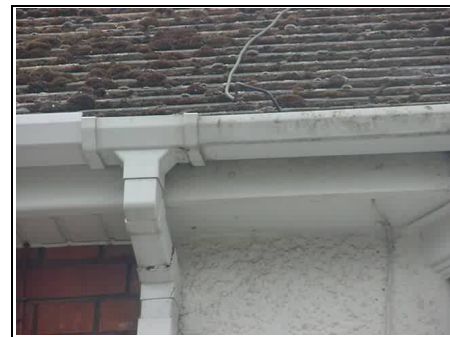
From ground level the gutters and downpipes looked to be newer style profile plastic (profile means shape), which does get brittle with age and sun light, at present it is in reasonable condition. There may be some minor leaks, but we feel that most people could live with these.

Gutters and downpipes

**ACTION REQUIRED:** We would always recommend that the gutters and downpipes are cleaned out, the joints are checked and the alignment checked to ensure that the gutters fall towards the downpipes.

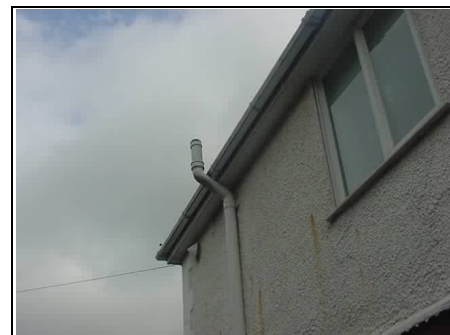
A mixture of plastic and cast iron which looked in reasonable condition.

Soil and vent pipe

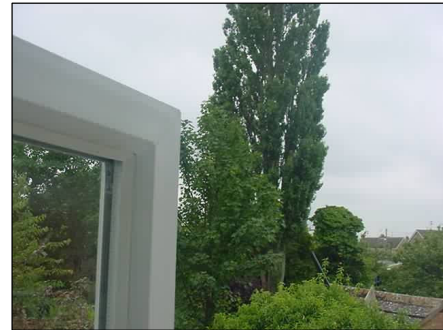
Poplar tree to rear of the property can have very long roots

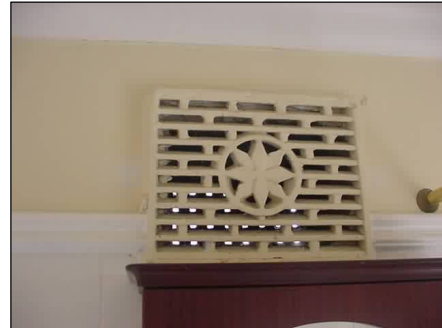
Decorative air brick

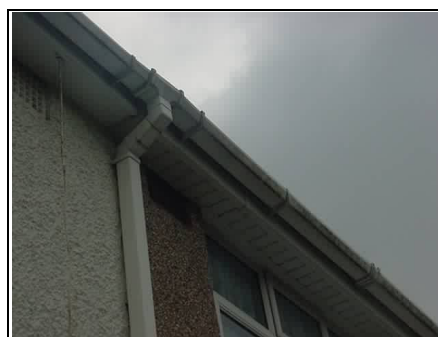
The property has painted timber fascias and soffits; these are in average condition.

Fascias and soffits

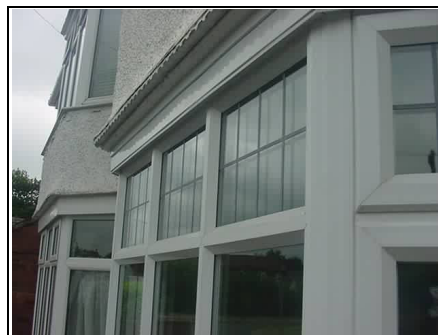
The property has plastic, double glazed windows, which generally look to be of an average quality for the year made. We did not see any trickle vents. Indicating the windows are pre 1990s as they tend to be a fairly standard part of modern double glazed windows.

Plastic double glazed windows

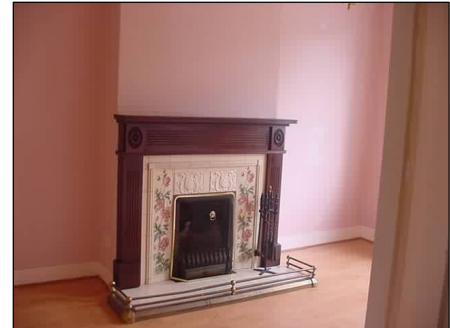
You have some decorative fireplaces.

Fireplaces

**ACTION REQUIRED:** You need to ask the previous owners when they were last used, whether they have been swept and if they have been relined.

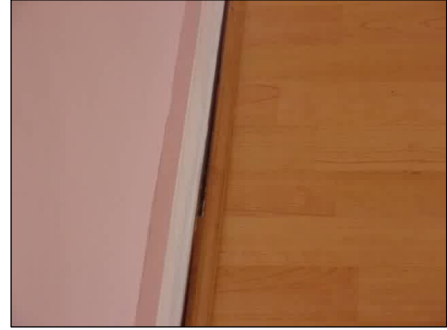
Finally, we have not been able to view the actual floors themselves due to them being covered with fitted carpets, floor coverings, laminated flooring etc. The comments we have made are based upon our experience and knowledge of this type of construction. We would emphasise that we have not opened up the floors in any way or lifted any floorboards.

Laminate floor covering

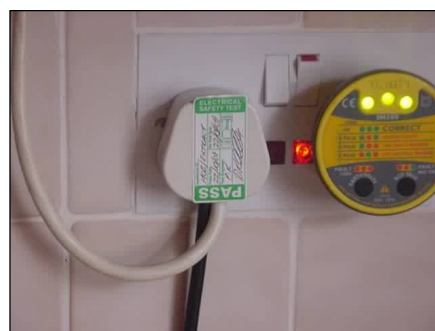
We carried out an earth test in the kitchen area to the socket point that is normally used for the kettle, this proved satisfactory.

Earth Test PAT test can be seen

**ACTION REQUIRED:** As the property is changing occupancy an IEE report should be carried out by a NICEIC registered and approved electrical contractor.

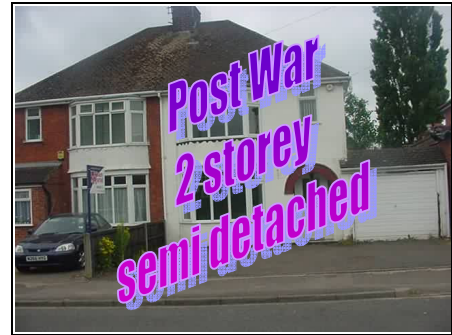
Please see our comments below regarding parking and garage.

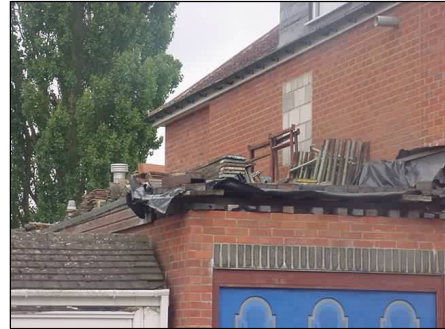
Right hand neighbour

Also knocked on the door and no one responded. From the material stored on the roof and in the back garden that we could see it looks like it is owned by a builder.
