# RESIDENTIAL BUILDING SURVEY

Hounslow, London TW4

## **INTRODUCTION**

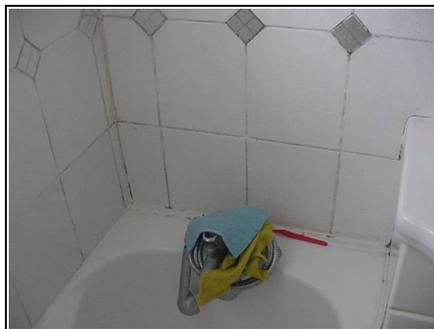
Bathroom (showing the mould)

**ACTION REQUIRED:** We would recommend that the bathroom, cloakroom and kitchen all have extract fans added which are thermostatically controlled.

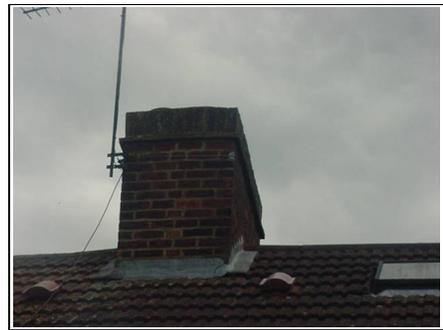
This chimney is brick finished with lead flashings. From what we could see the chimney looks in average condition. We were unable to see the top of the chimney known as the flaunching but we would comment that it looks in an average condition.

Chimney

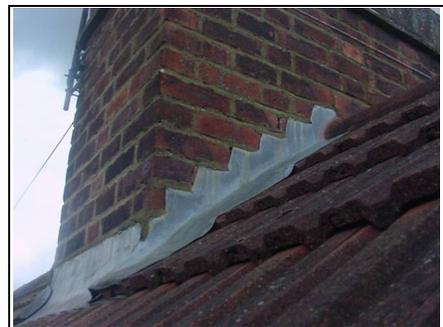
Close up of Chimney

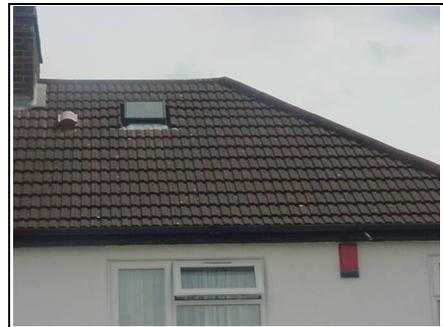
It seems inevitable with roof windows that they will sooner or later leak. If this doesn't occur then they seem prone to condensation. Keep a cloth handy!

Roof Window

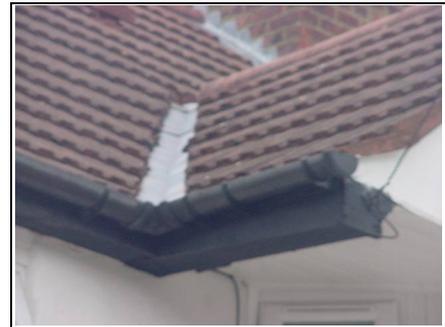
The roof is pitched and clad in a concrete tile. From what we could see the concrete tiles are lying level and true and look in reasonable condition. We were pleased to see that the main roof had been vented which reduces the chances of condensation.

Main Roof

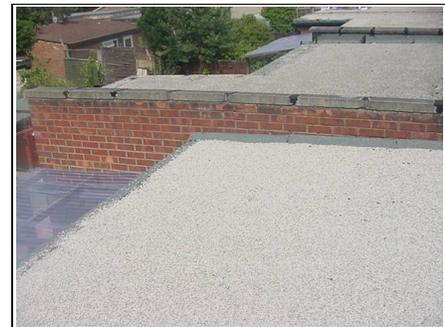
The property has a felt flat roof which has been covered in chippings. This type of roof typically has a life of between 20 and 30 years, depending upon the quality of workmanship, materials and decking, although some roof manufacturers do claim longer. In this case we believe that it is approximately 5 to 10 years into its life. It is always difficult to comment upon the quality of workmanship due to it being covered in shingle.

Rear flat roof

Important areas are the flashings in this case the flashings are a mixture of felt and lead. The area looks to have been bitumen repaired in the past.

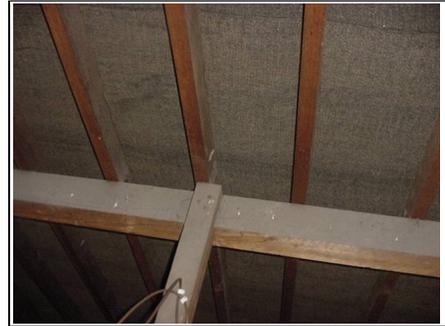
Roof Timbers

Our examination was limited by the general configuration of the roof, the insulation and stored items. What we could see was generally found to be in average condition considering its age. It is, however, feasible that there are problems in the roof that are hidden.

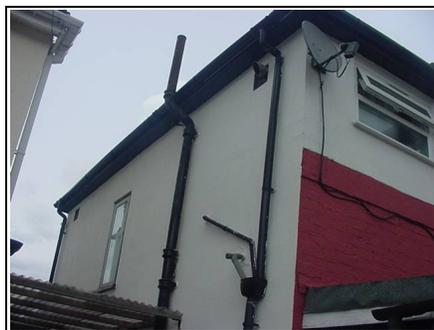
We noted predominantly plastic gutters and downpipes although there may be some cast iron remaining.

Gutters and Down Pipes

**ACTION REQUIRED:** We would always recommend that the gutters and downpipes are cleaned out, the joints are checked and the alignment checked to ensure that the gutters fall towards the downpipes.

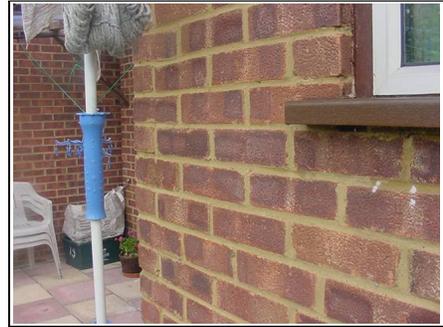
Stretcher Bond Brickwork to the rear of the property

We generally found the brickwork and pointing in average condition.

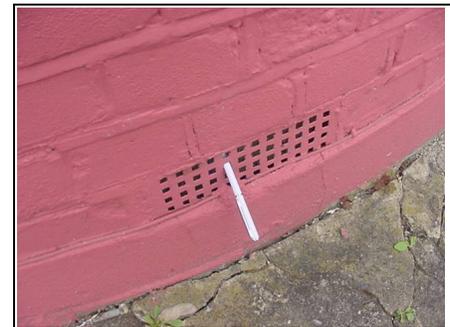
We noted air bricks at the front and rear of the property. Which indicates a suspended floor. From what we could see, providing the air bricks are kept clear you have adequate ventilation.

Airbrick to the front of the Property

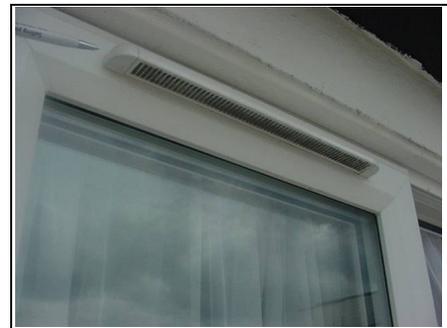
You have a range of windows in this property with different styles and quality however, some of them are starting to deteriorate. We noticed that you have the most modern type of window with a trickle vent.

Window showing Trickle Vent

**ACTION REQUIRED:** You may wish to replace and improve these. You can pay as much or as little as you wish for a new double glazed window.

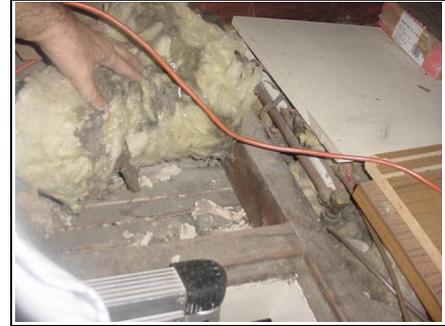
As should be expected with a building of this age, the ceilings have been finished in a variety of ways. From within the roof we could see lath and plaster although we would expect plasterboard in the newer extensions and alterations.

Lath and Plaster ceiling

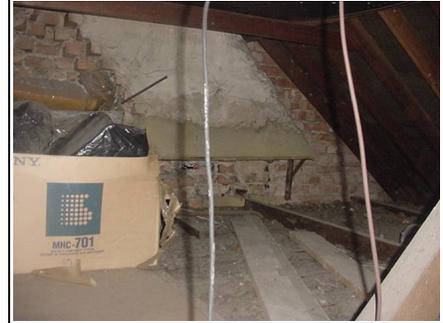
Building Regulations Approval should have been obtained and your legal advisor should confirm that works were completed in accordance with statutory requirements. However, in the real world, it is very unlikely the permission or even professional advice has been sort.

Unsupported Chimneys

**ACTION REQUIRED:** Please refer to our comments within the Executive Summary.

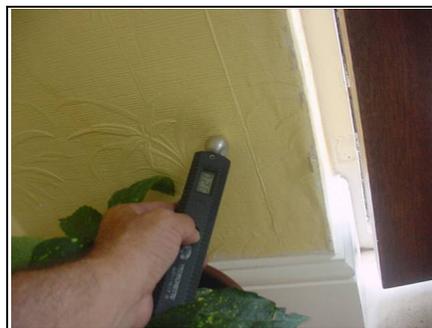
A random visual inspection and tests with a moisture meter have been taken to the perimeter walls and some internal walls. We carried out tests with an electronic damp meter and found minimal dampness. We considered that this may be condensation bearing in mind our comments with regard to the steam cooking and lack of extract fans throughout the property.

Checking for Damp

**ACTION REQUIRED:** Add extract fans to the kitchen and the bathroom areas as soon as possible, ideally with humidity controlled thermostats.

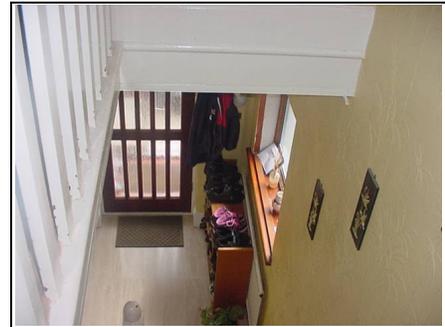
We noted that the underside of the staircase was lined where we could see it, however, part of the stairs is hidden from view. All stairs need lining for fire regulations.

Staircase

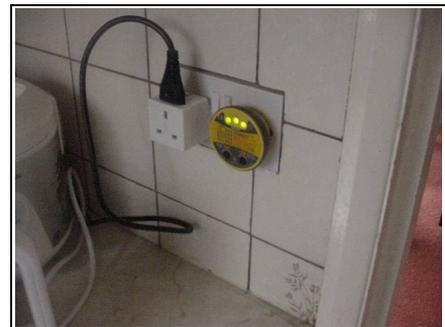
We carried out an earth test in the kitchen area to the socket point that is normally used for the kettle, this proved satisfactory.

Earth Test

**ACTION REQUIRED:** The property has tenants and should therefore have the services regularly checked, both legally and for insurance. In addition to this your Legal Advisor is required to make full enquires with the owners to establish if any electrical installation work has been carried out and to provide suitable certification for any works carried out after 1<sup>st</sup> January 2005. Any comments made within this report or verbally do not change this requirement.

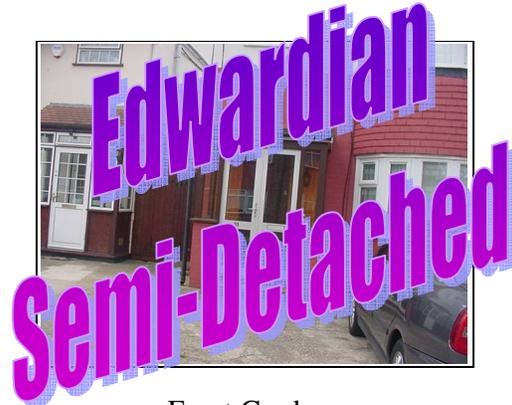
The front garden has been converted to a parking area.

Front Garden
