RESIDENTIAL BUILDING SURVEY

Hertfordshire, SG12

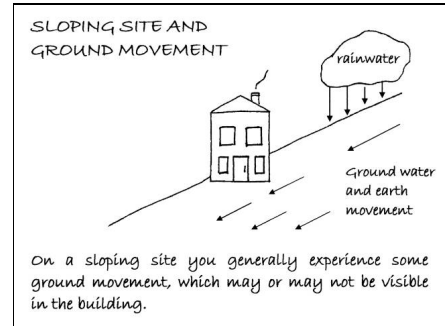
1) **Sloping site**

The property sits on a sloping site and is an old property and therefore is more susceptible to dampness. You need to allow the property to breathe.

ACTION REQUIRED: You need to move back earth around the property and ensure that only lime mortars are used to repair the property.

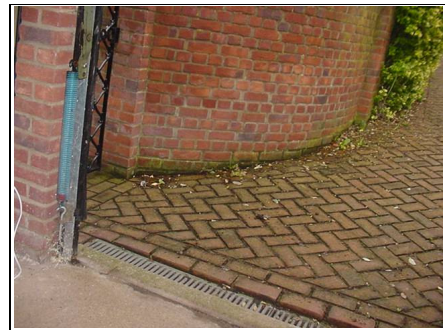
Moss at the base of the driveway and also running gully which is part of the sloping site

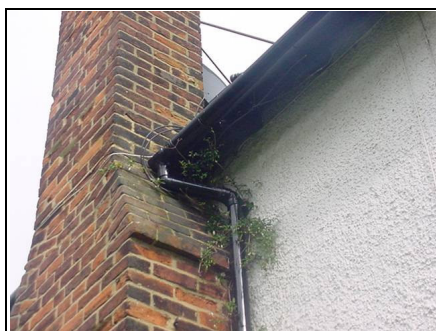
Chimney Two

There is a second chimney to the rear of the property on your neighbour's side. It doesn't appear to be your chimney, but our view was difficult so therefore unable to confirm.

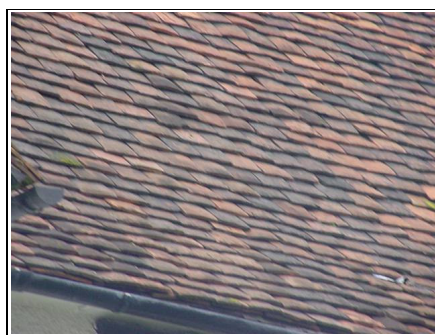
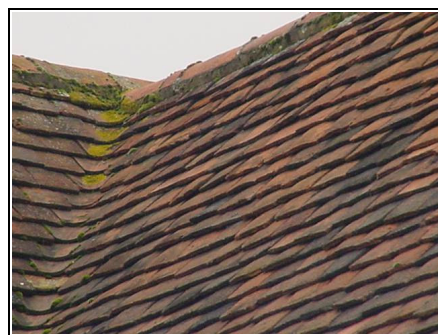
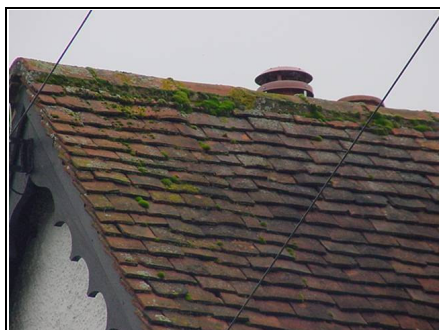
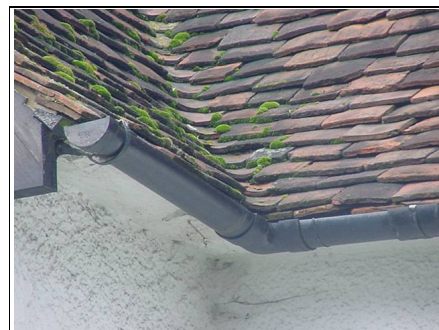
Roof tiles

The roof is pitched and clad with a small clay tile possibly a peg tile which would have been original or this has possibly been replaced with a nibbed tile. It is difficult to confirm without seeing the back of the tiles. From ground level the main roof looks in average condition considering the roof's age, type and style. With this age of roof you would expect to have some tiles that need repair during a typical year. This is one of the joys of owning an older property.

ACTION REQUIRED: Carry out periodic inspections and maintenance of the roof, as required.

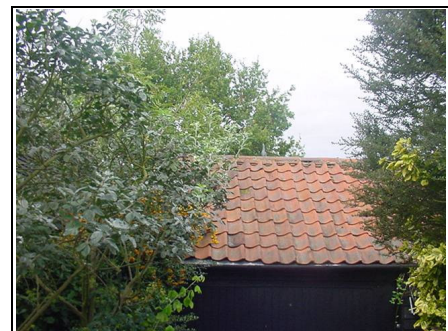
Garage roof

The garage, barn/oil storage area have pitched pantiled covered roofs which looked in reasonable condition although our view was restricted by the surrounding trees.

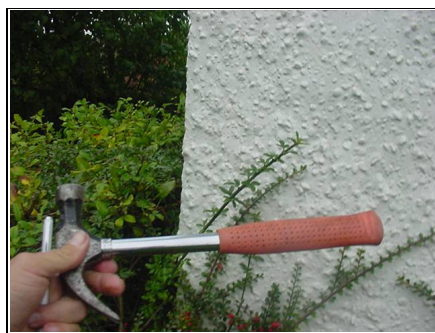
We have carried out a tap test to the render at low level (literally hitting the render with the back of a hammer to try to establish if there are any hollow areas). We have found some areas but this is typical for this age of property. Please see our comments in the

Checking render by tap testing 30

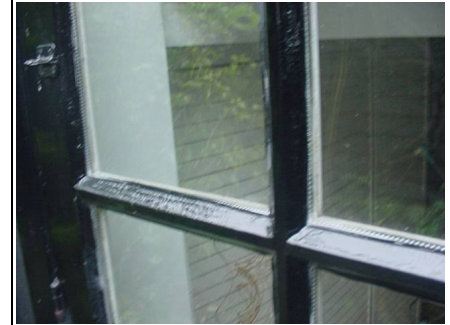
The property predominantly has painted timber casement windows, which are single glazed. Generally we consider the windows in below average condition, and require painting as flaking paintwork can be seen. As with any timber window it will require repair and repainting periodically.

Double glazed unit on window, majority of windows are single glazed

ACTION REQUIRED: Please see our comments about redecoration in the spring/summer of 2011 in the Executive Summary.

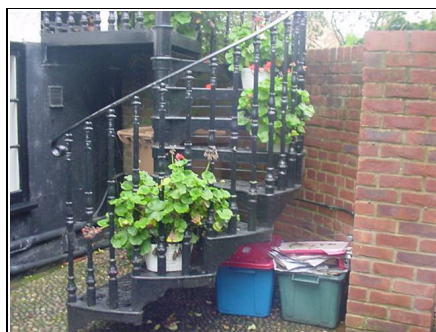
Spiral staircase leading into garden

We noted the spiral staircase externally which is a nice feature to bring you down from the kitchen to the garden area.

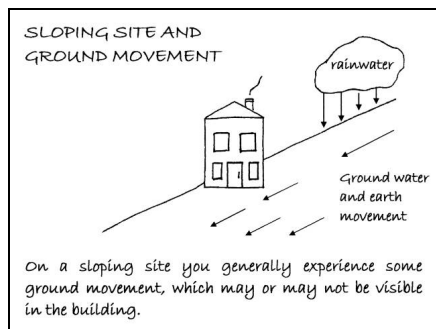
As the drive slopes towards the road we would advise in a worse case scenario the garage may get water into it. Also remember that water is trying to get from the top of the site to the bottom of the site therefore it is important to ensure the ground levels are not too high.

Any property on a sloping site is more susceptible than one on a flat site. Ground water will travel from the top to the bottom of the sloping site and will affect the property making it more susceptible to movement.

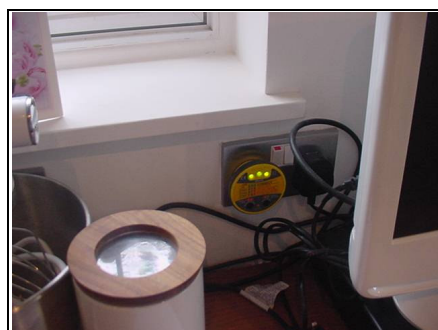
We carried out an earth test in the kitchen area to the socket point that is normally used for the kettle and this initially failed and tripped the fuse board then on re-testing proved satisfactory.

Re-test of Earth test

ACTION REQUIRED: If there is no record of an electrical test having been undertaken within the last five years, it is recommended that the installation be tested to IEE standards by a competent electrician (NICEIC registered) and all recommendations implemented. Thereafter, the installation should be re-tested every five years.

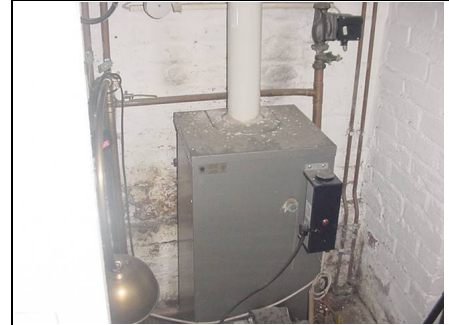
Oil boiler

The oil boiler is located in the lower ground floor basement. You need to obtain certificates with regard to its service history.

The oil tank is hidden in the adjacent sheds and we could see approximately ten percent which looked in reasonable condition with minimal rust however we are not keen on metal tanks, we much prefer plastic tanks. You do need to remember this is a one-off inspection and although there are no obvious signs of problems, i.e. oil ponding in the floor, we would recommend replacement with a plastic tank.

ACTION REQUIRED: Have the oil tank checked by an independent OFTEC registered heating engineer prior to committing to purchase the property. You may have to replace with a plastic tank.

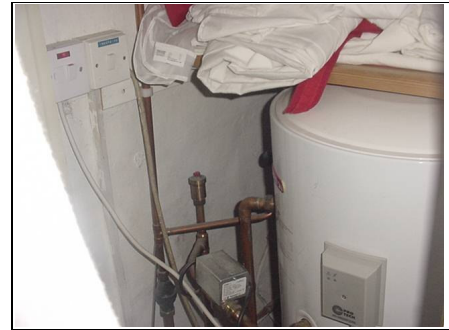
Hot water cylinder

We noted an Ariston cylinder, these are modern heat efficient hot water cylinders, it is located in the first floor rear bedroom.

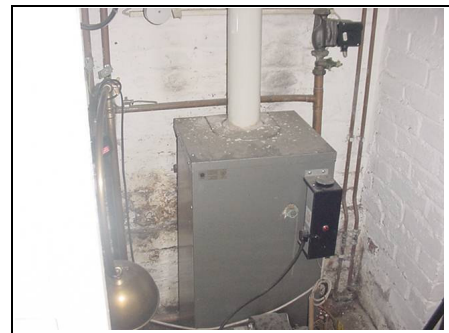
Oil boiler

We noted an oil boiler on the lower ground floor. We would recommend that the system be tested and overhauled before exchange of contracts and that a regular maintenance contract be placed with an approved heating engineer.

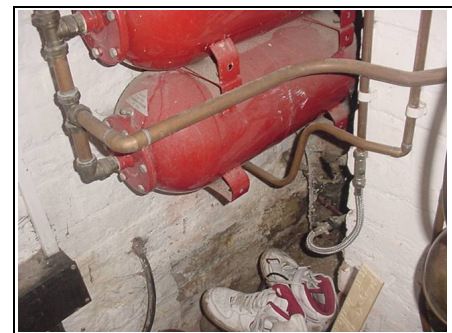
Pressure units

We noted pressure units, these are normally used in taller residential properties although we don't see this style very often.

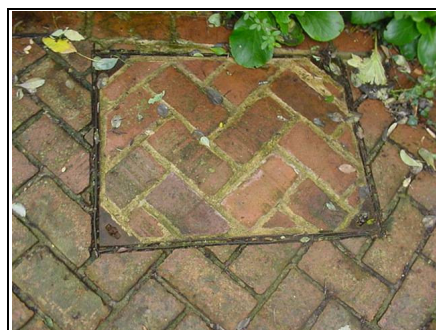
Inspection Chamber / Manhole One located in the driveway near the garage

We have been unable to lift the brick paved man hole cover. In our experience they often get stuck. We ran the water for fifteen minutes without any build up or back up and we did this using the cold tap in the first floor bathroom.

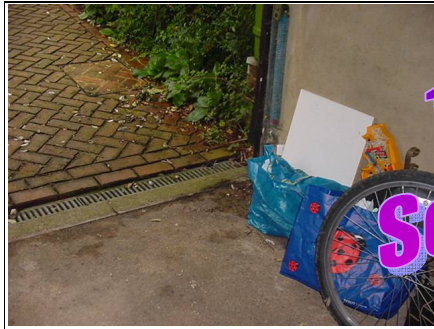
Running gulley to the edge of the garage
