RESIDENTIAL BUILDING SURVEY

Islington, London N1

GEM Associates Limited

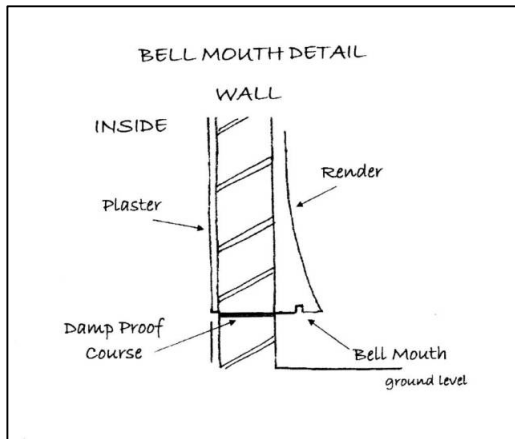
A photo of the downpipe discharging to the base

This is an air venting system that does not tend to work. We would recommend that a bell mouth detail is added to the base of the render

ACTION REQUIRED: Your solicitor to check and confirm if there is any budgeted planned maintenance work generally, or specifically, relating to dampness. To put this into perspective, to reduce the dampness could cost many thousands of pounds, therefore it is essential that you check to see whether the work is being carried out.

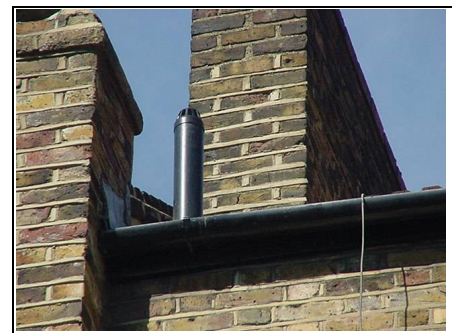
We believe that the majority of the flues are internal, which is unusual for this age of property. It was probably amended when the property was converted, although we have no way of knowing. We were only able to see the flue at roof level and then a very small proportion, as you can see in the adjoining photo. Given the height of the building our view was not that good, but what we could see was in average condition.

Plastic flue

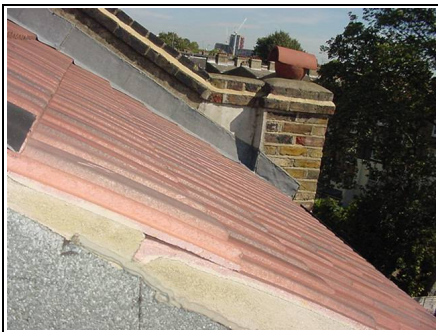
The roof is pitched and clad in a small nibbed concrete tile. From what we could see the concrete tiles are lying level and true and look in reasonable condition.

Close up of roof tiles

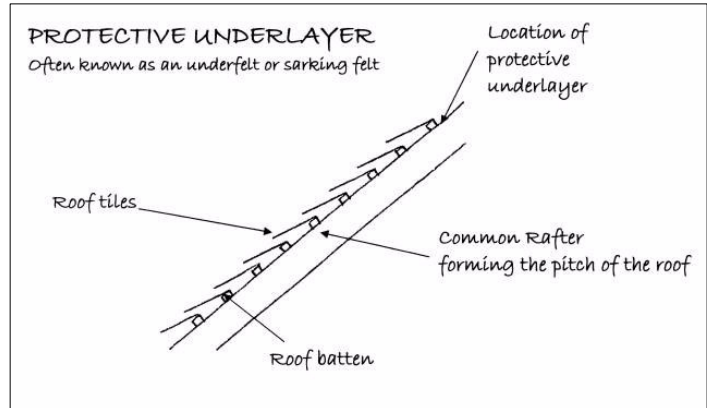
When we inspected the loft space we found a Hessian base bitumen membrane. This type of membrane has been used since the 1960s. We generally found it to be in average condition, it is damaged in a few more places than we normally find.

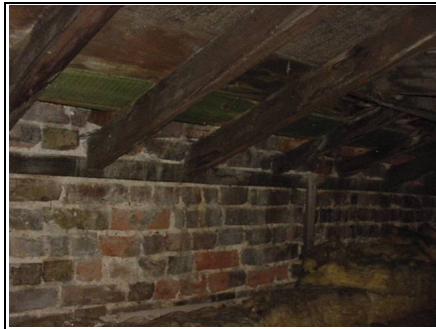
Front roof

We found the roof timbers generally in slightly below average condition considering their age. We found dampness, which we believe to be due to the original poor condition of the roof. We have inspected the roof structure for:

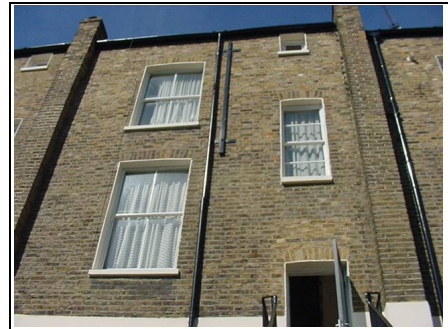
Flemish Bond brickwork to the rear

Unfortunately, without opening up the structure, we are unable to confirm if this is the case. Generally Flemish Bond brickwork is liable to penetrating dampness internally, dependent upon the condition of the brickwork and the exposure to the weather. In this case it is essential that external faces be kept in good condition.

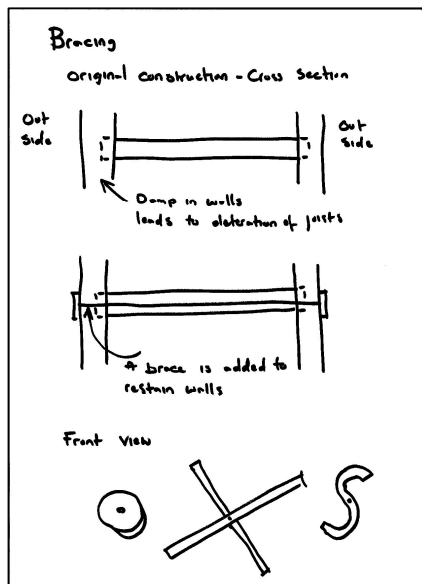
The property has tie bars, these have been added to resist movement in the structure.

Tie bars to rear

ACTION REQUIRED: Please see our comments in the Executive Summary.

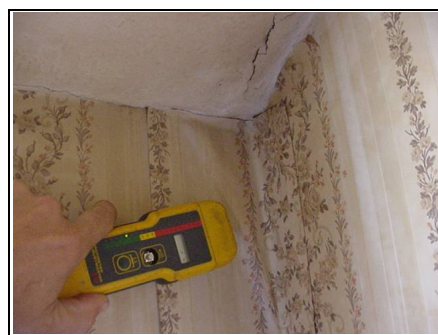
Tests were taken with a moisture meter at random points to internal walls, floors and other surfaces. Our readings were in line with what we would expect for this age of property, i.e. minor dampness. We found some dampness coming through on the parapet walls sides, but much of the staining to the paper was old dampness patterns. Unfortunately the only way to be absolutely sure whether there is dampness coming through is to redecorate and see what dampness comes through.

Checking for lateral dampness

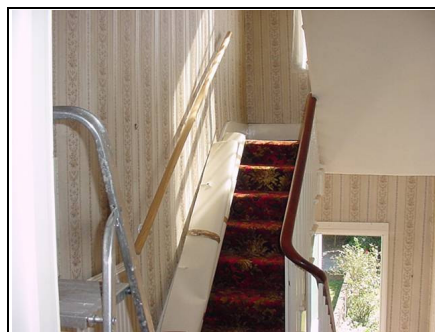
Staircase

To the staircase area we can see some movement to the surrounding floor this is because the timbers are embedded into the walls, which deteriorate over time. Please see our comments in the Floor Section of the Report.

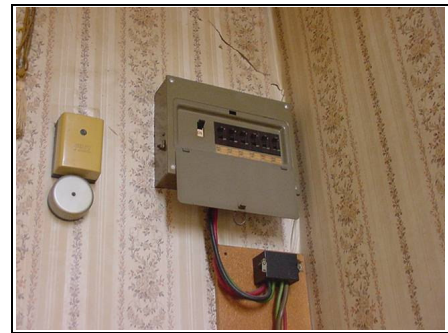
The electric fuses and consumer units were located on the half landing. We would date the fuseboard as being from the 1960s/1970s. Re-wireable fuses are now superseded. Far better fuse boards are now available.

Fuseboard

ACTION REQUIRED Replace the fuseboard as soon as possible.

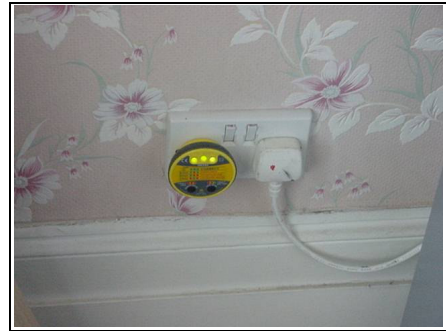
Earth test in kitchen, which failed

Earth test

ACTION REQUIRED: It is recommended that the installation be tested by a competent electrician (NICEIC registered) and an Institute of Electrical Engineers (IEE) report carried out and all recommendations implemented. Thereafter, the installation should be re-tested every five years.

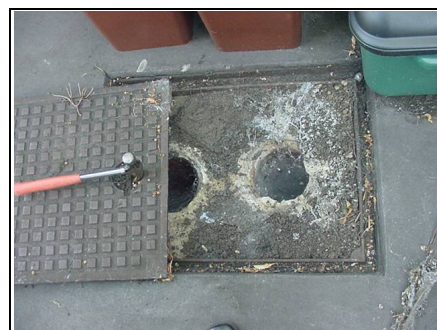
We duly lifted the cover to find what we believe to be a rodding eye rather than a manhole, so we ran the taps for slightly longer than we normally would.

From what we could see it is concrete built.

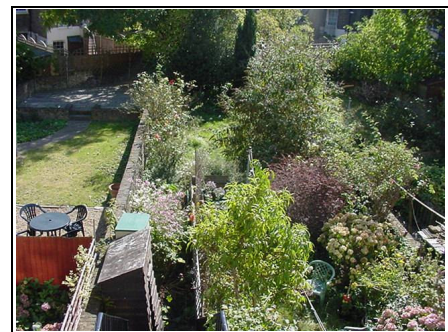
To the rear we believe you have your own garden, although we did not access it, as discussed with yourself.

ACTION REQUIRED: Your legal adviser needs to check and confirm this.
