RESIDENTIAL BUILDING SURVEY

London N19

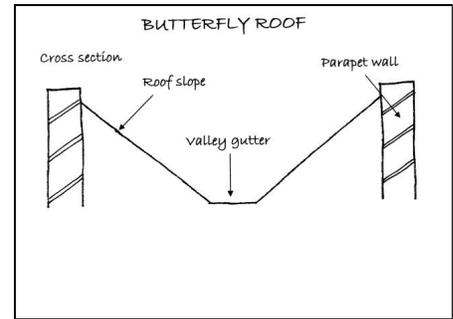
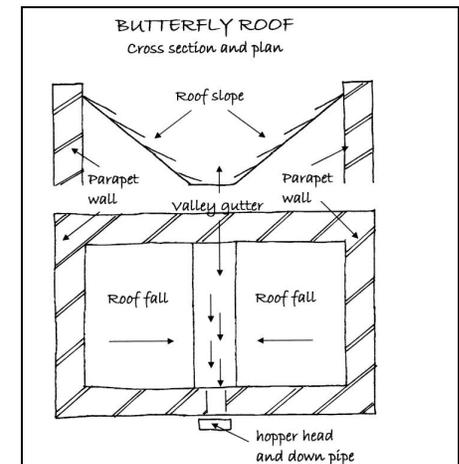
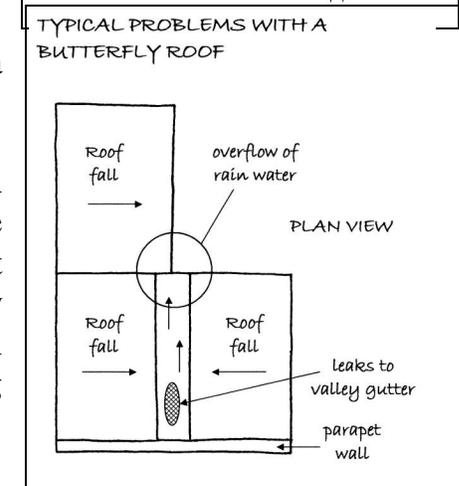
The property has a butterfly roof, these are renowned for being problematic particularly the central valley. From within the roof space (you have two roof spaces to the front butterfly roof and one to the rear roof) we can see that several repairs have been carried out to the valley gutter. We can see in the rear roof the timbers are in a poor condition and in fact additional timbers have been added to help support the roof.

ACTION REQUIRED: You need to vent the roofs which have been insulated beyond appropriate for an older property. Condensation is occurring in the rear roof in particular to the condition of the timbers, some of these timbers will need replacing. It is difficult to tell whether the timbers are damp from condensation and/or from dampness coming in via the roof parapet wall or from a leaking valley gutter. We suspect it is a mixture of all of these factors.

Dampness coming from a leaking parapet wall

ANTICIPATED COST: As mentioned previously we were unable to gain access onto the roof due to the padlocked roof light. We suggest you set aside the sum of £5,000 - £7,000 to carry out this work; quotations required. As this is high level work there may also be some scaffolding necessary.

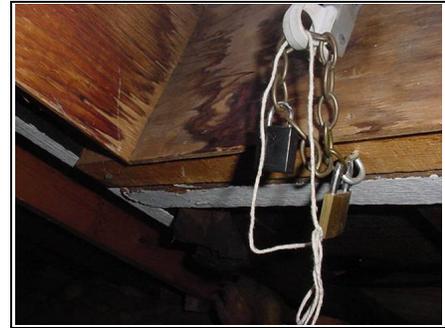
As mentioned earlier there was a lock on one of the roof lights so we couldn't get onto the roof as we would expect and therefore our view has been limited to viewing it through the roof light.

Locked roof light

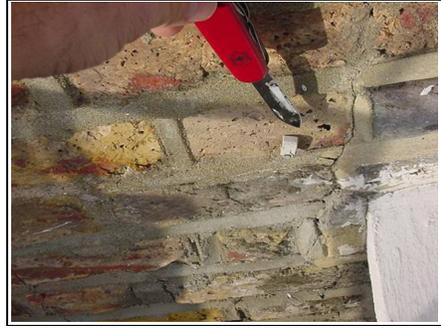
The walls have been inappropriately repointed with a cement mortar which should have been a lime mortar. This will ultimately cause deterioration to the brickwork.

Cement mortar that has been put heavily on brickwork

ACTION REQUIRED: You need to set up a programme of gradual replacement of the cement mortar.

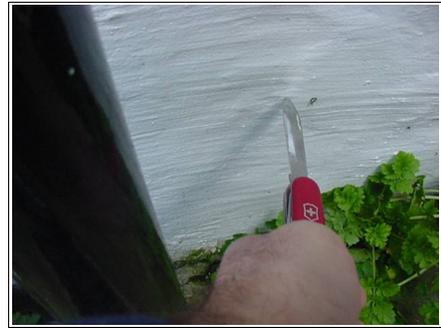
There is a white painted render to the rear of the property. This has been incorrectly detailed and taken to the floor. This will cause dampness into the property.

Render that goes to the ground

ACTION REQUIRED: You need to hack back the render at the base and form a bell mouth drip detail.

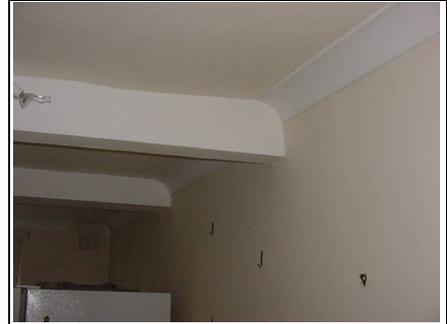
We noted structural supports in the kitchen/breakfast room area which haven't got any piers. It is likely that there is no building regulations approval for them. As they support an extension above you need to get this checked and confirmed.

ACTION REQUIRED: Your solicitor needs to check and confirm whether building regulation approval has been obtained.

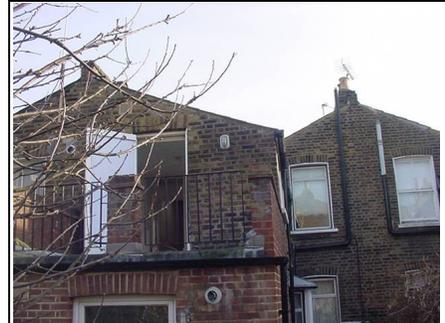
In general we feel the security to the property can be improved in the form of an alarm system and bars to the main entrance door. We also noted that the rear door at first floor level that goes onto the balcony was mainly glass. This may cause a security problem.

ACTION REQUIRED: Depends on how far you wish to go security wise, it is very much personal issue.

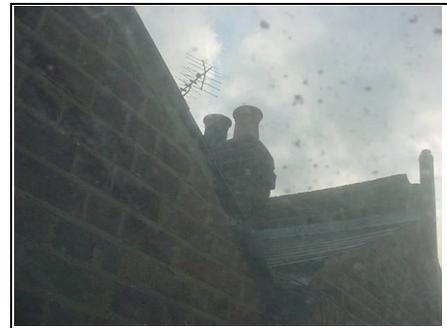
Chimney one – taken from rear roof light

Our view was very limited in this case, it was literally through both roof lights. From the condition of the timbers within the roof we suspect that dampness is getting in around the chimney.

ACTION REQUIRED: This needs to be checked, we would be more than happy to return when the roof light is unlocked.

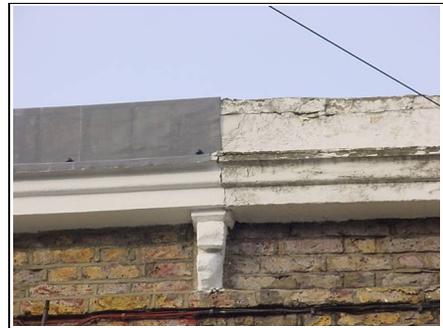
Front parapet wall

We generally find this type of brick parapet wall allows water in which we think has been happening in this case which has caused damage and deterioration in the roof as can be seen within our photos in the Executive Summary.

ACTION REQUIRED: Very much as with the chimneys, you need to access the roof as soon as possible to establish the condition of these areas. We carried

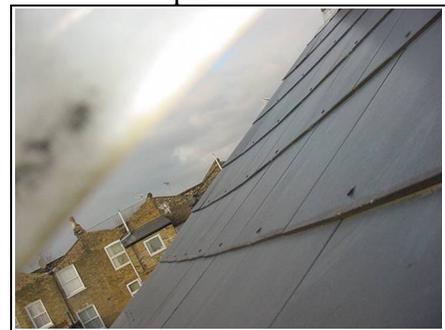
Unfortunately we could not see the roof properly. We have only been able to view it through the roof light which was locked. The adjacent photos have literally been taken through a gap in the roof light. From this we can see that the roof has a modern man made slate that looks in reasonable condition where we can see it sitting flat and level although the slates have been cut unusually as you can see in photo one.

Close up of manmade slates taken through the gap in the roof light

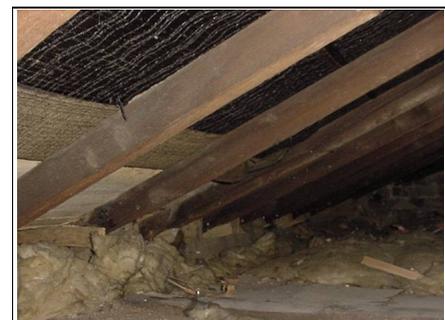
When we inspected the loft space we found a Hessian base Bitumen membrane. This type of membrane has been used since the 1960s. We generally found it to be in average condition, it is damaged in a few places but this is not unusual considering its age.

This photo shows the common rafters (the ones that form the pitch of the roof) and the dark area between is the underlayer.

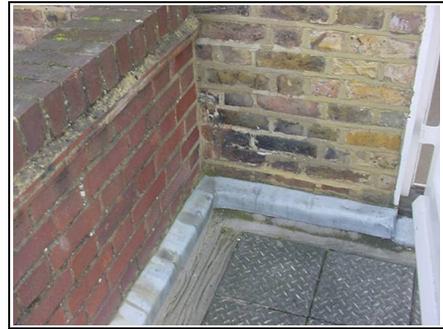
Close up of rear flat roof

Asphalt is very much the rolls royce of flat roofing. The rear balcony is asphalt covered, we can see this is starting to deteriorate; its life could be extended by having some repairs carried out.

ACTION REQUIRED: General repairs to the asphalt.

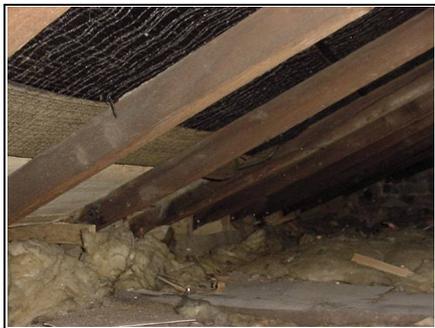
Left hand side roof looking towards the front

This roof is a poor example of what we typically see but saveable. Typical problems are timbers rotting, brick nibs spalling.

ACTION REQUIRED: When re-roofing the timbers need checking - we showed you the condition of the timbers in the neighbouring property

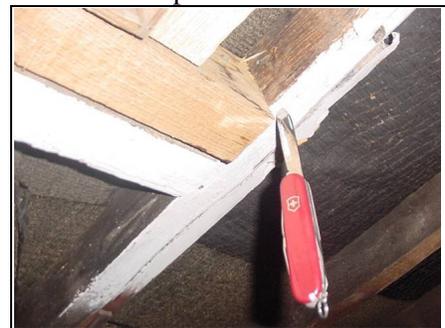
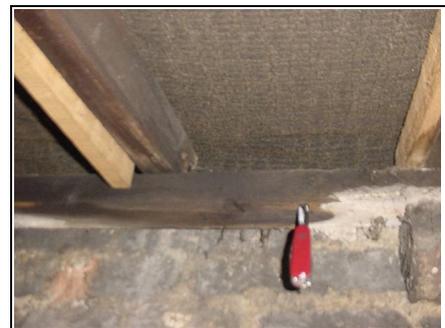
Dampness in timber

Checking timber in rear roof

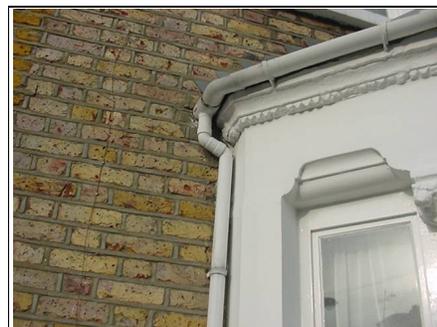
Predominantly the gutters and downpipes are plastic however in this type of construction there is a central valley gutter that we always fear is a problem and the hopper heads to the rear of the property.

Gutters and downpipes showing small downpipe to the front bay window

ACTION REQUIRED: We would always recommend that the gutters and downpipes are cleaned out, the joints are checked and the alignment checked to ensure that the gutters fall towards the downpipes.

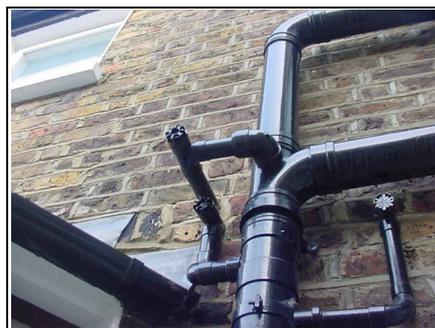
Generally the waste pipes and soil stack appear to be satisfactory where a surface inspection is possible, although for the most part they run in ducts and cannot be inspected.

Soil and vent pipe original cast iron to the lower sections with plastic to the high sections

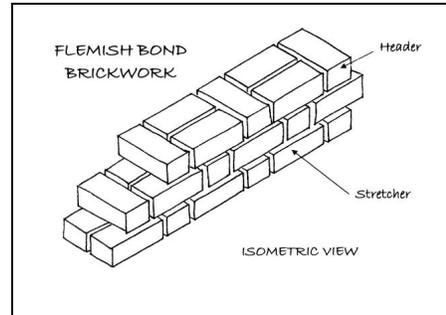
The property is built in a yellow brick originally in a lime mortar in what is known as Flemish bond brickwork, which has been repointed in a cement mortar. Whilst it has been done to a neat standard it is inappropriate for an old building. In this case the proud pointed cement mortar can be generally removed and replaced with a lime mortar. However we would add that we do see this error of using the wrong sort of mortar in an older property in about eighty per cent of all cases.

Cement mortar that has been put heavily on brickwork

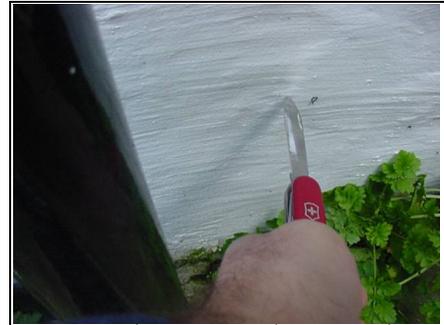
Unfortunately there is no bell mouth. The render to the base in this instance goes down to the ground. Unfortunately this will help dampness get into the structure using capillary attraction.

Render goes to the ground

ACTION REQUIRED: Form a bell-mouth to the base of the render.

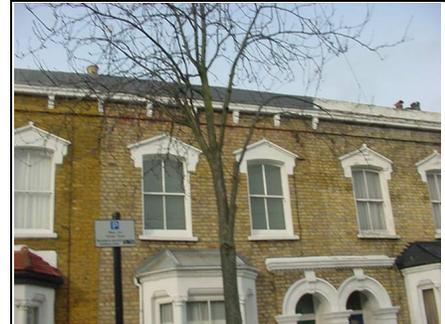
We noticed a relatively small tree to the front of the property which we believe is owned by the Local Authority. Interestingly there may have been a larger tree here at an earlier stage which did affect the property. This is why it is worth specifically getting your solicitor to ask for the history behind the underpinning. Most Local Authorities are aware of their responsibilities, but have many pressures on a limited budget.

ACTION REQUIRED: Contact Local Authority if trees not regularly maintained and ask your solicitor to specifically ask in writing about the structural issues.

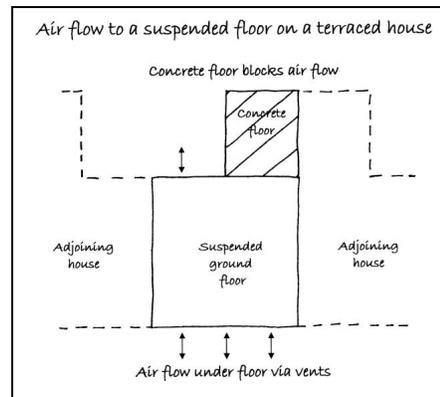
Airbricks to front

We noted air bricks at the front of the property although some of them are blocked and we noticed one to the rear of the property which we feel would benefit from more air vents. Ideally these need to be placed within the property allowing through air ventilation.

ACTION REQUIRED: We recommend that all existing vents are cleaned and additional vents are added. This can be carried out by a vent strip hidden under the stairs or one running along the skirting area. We also recommend the air bricks are kept clear so you have adequate ventilation.

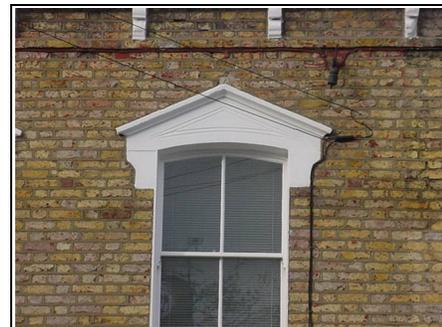
ACTION REQUIRED: Some of the aluminium windows are misting over and some of the timber is starting to become slightly soft. Please see our comments in the Executive Summary.

Front sliding sash window

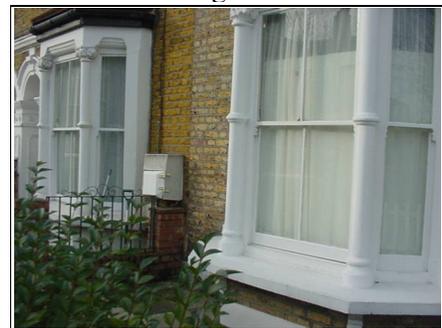
Original front sliding sash window to the bay

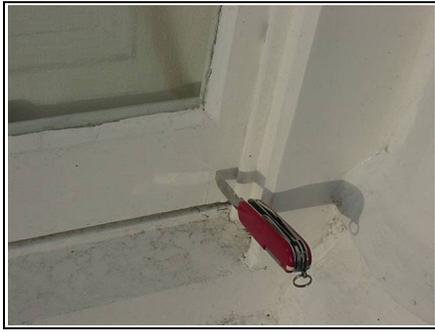
Checking front sliding sash windows

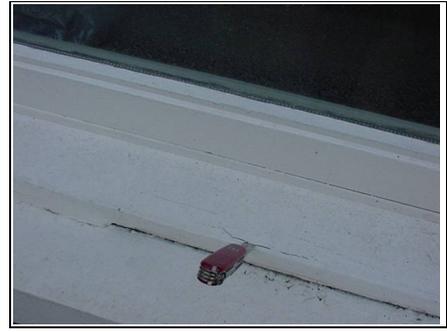
Checking rear casement windows

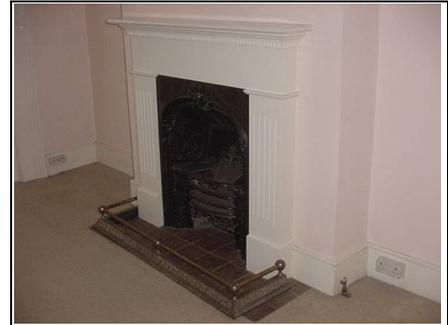
Fireplace which is nice feature

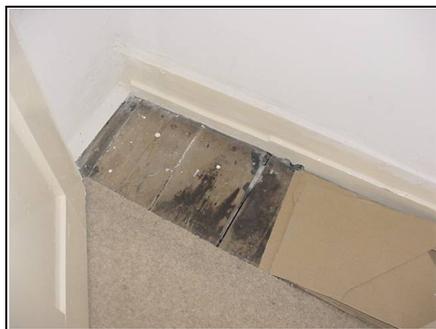
Joist and floorboards with embedded timbers, please see the sketch and the photo below. There is some undulation in the floor but only slightly more than we would expect in this age of property.

Joists run from front to the rear of the property

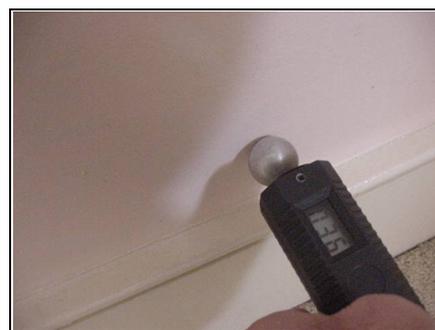
We have carried out tests with an electronic damp meter to a selection of areas and we obtained readings slightly above the average. We would expect readings to be typically in the thirties up to sixty for this type of wall. We obtained readings in the early sixties. This may be because the house has been unoccupied for some time however we feel in areas this is also due to the lack of ventilation, etc.

Checking for rising damp

ACTION REQUIRED: Please see our comments in the Executive summary.

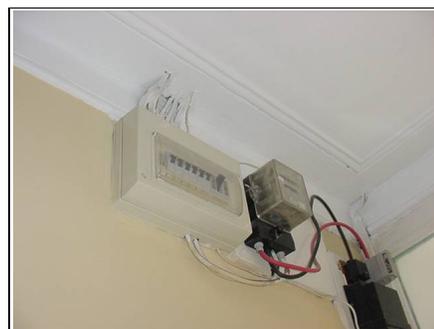
Fuse Board

The electric fuses and consumer units were located in the hallway behind the entrance door. We would date the fuse board as being from the 1980s and, whilst not the best now available, it is reasonable.

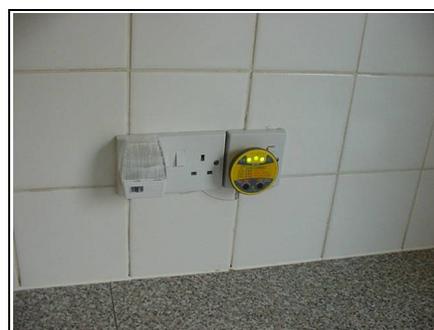
We carried out an earth test in the kitchen area to the socket point that is normally used for the kettle and this proved satisfactory.

Earth test

ACTION REQUIRED: If there is no record of an electrical test having been undertaken within the last five years, it is recommended that the installation be tested by a competent electrician (NICEIC registered) and all recommendations implemented. Thereafter, the installation should be re-tested every five years.

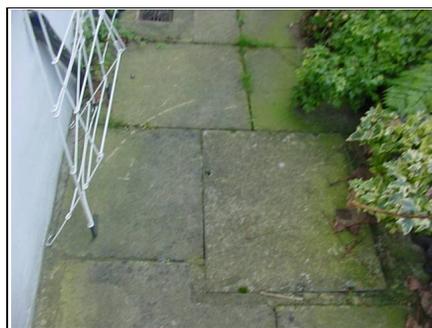
Inspection Chamber / Manhole One located to the rear of the property

We have been unable to lift the man hole cover which is often the case with this type of inset man hole with a concrete cover.

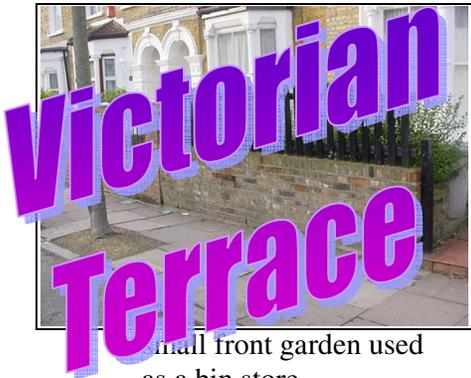
Front Garden

Small front garden used as a bin store.

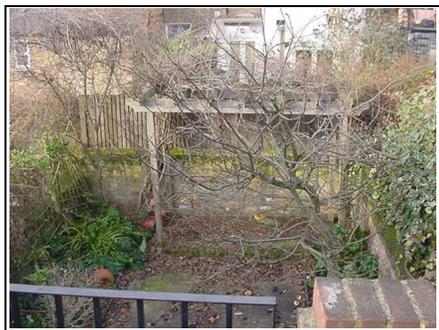
Rear Garden

Please note our comments in the Executive Summary about the retaining wall
