RESIDENTIAL BUILDING SURVEY

Kempston,
Bedford,
Bedfordshire.
MK42 XXX

INDEPENDENT CHARTERED SURVEYORS

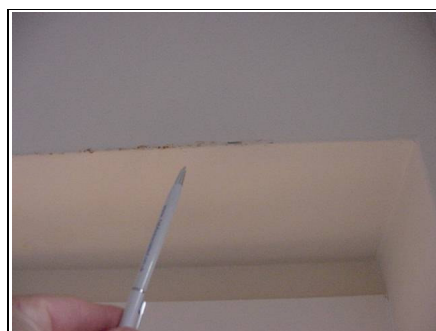
The ground floor cloakroom/shower room has suffered from condensation partly because it is an external structure with three outside walls and also as it is a relatively high humidity generating area (from the shower). Although the cloakroom/shower room has a small extract fan this does not seem to be sufficient to remove the moisture. We can see that the plaster angle bead above the door has started to rust for example.

Cloakroom/shower room dampness

ACTION REQUIRED: Add a

larger extract fan which is humidity controlled.

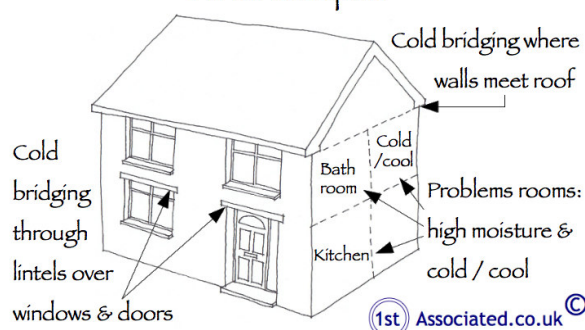
Potential cold bridging area where there is part of the roof within the room (where the timber is)

COLD BRIDGING / CONDENSATION - A few examples

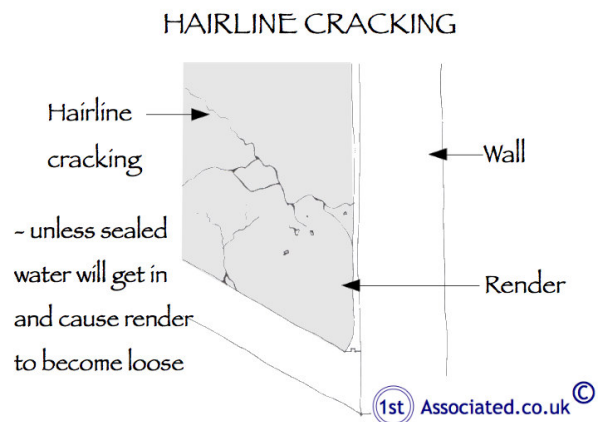
Hairline cracking

There is hairline cracking in the property which is visible in the ceilings and some of the walls which has come about due to the relatively high moisture content in the house and also what looks to be a skim coat of gypsum plaster to the walls over the original plaster or cement.

ACTION REQUIRED:

You need to reduce the humidity and condensation in the house although in our experience this problem will never go due to the incompatibility of modern gypsum plaster with older rendered cement.

Re-decorating and filling, a few hundred pounds; please obtain quotations.

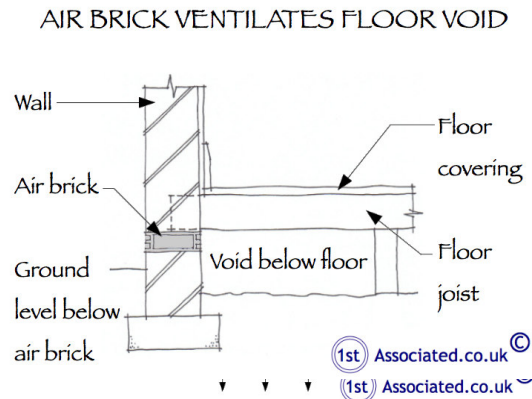
Unfortunately this the laminate flooring hides the entirety of the ground floor which from an inspection point of view means we cannot see the suspended timber floor. The area that we would normally look under the stairs was surprisingly concreted over.

ACTION REQUIRED: Ideally you need to open up a section of the floor to check its condition, at the very least you need to add air vents to make sure that there is a through flow of air although this may well have been blocked by the extension.

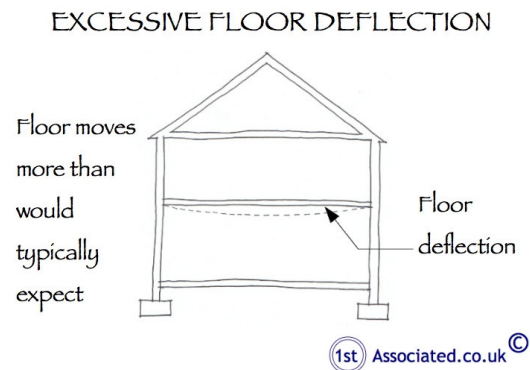
To the front and rear bedrooms there is more deflection than we would expect in the floors, a modern house would not have so much deflection.

ACTION REQUIRED: You need to make sure that you are happy with this.

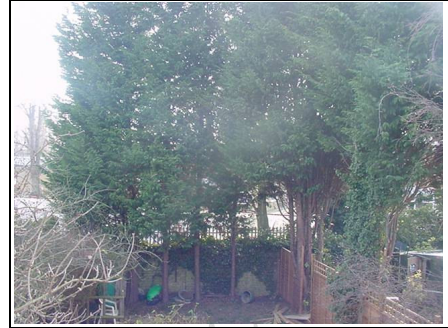
Conifer/fir trees to rear

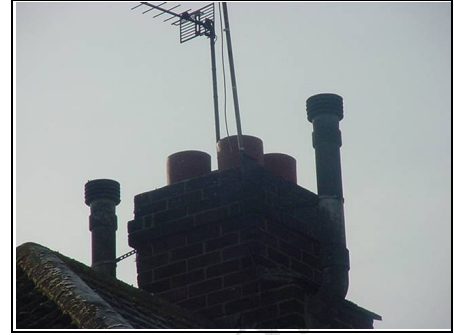
This chimney is brick finished with a lead flashing flashing and several chimney pots, asbestos flues and television aerials. From what we could see from ground level it looked in average condition with the exception of the asbestos flues that have been added considering its age, type and style. Unfortunately we were unable to see the flaunching, we therefore cannot comment upon them.

Asbestos Flues

We would recommend this is removed prior to you purchasing the property. Please note that we are not asbestos surveyors.

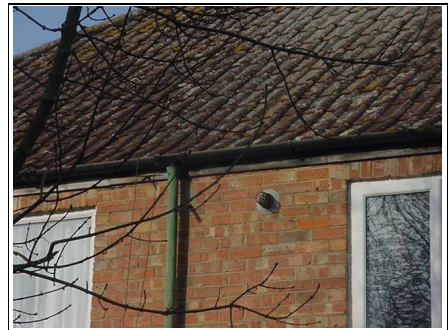
Leaking gutters

Green cast iron downpipe to the rear of the property

ACTION REQUIRED: We would recommend you stand outside the property next time it rains heavily and see how well the drains cope with the rainwater particularly looking at the guttering and the joints. We would also recommend that the gutters and downpipes are cleaned out, the joints are checked and the alignment checked to ensure that the gutters fall towards the downpipes.

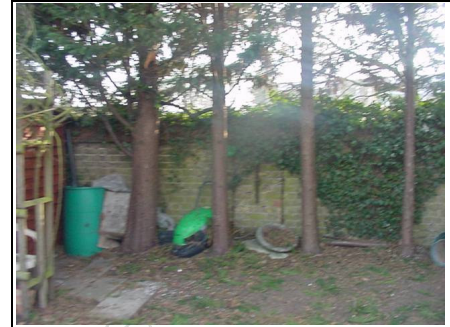
There are conifer/fir trees within what we would term as influencing distance of the property.

Conifers

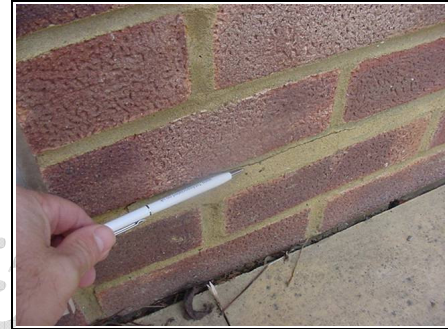
All modern properties should incorporate a damp proof course (DPC) and good building practice dictates that a differential of 150mm (6 inches) should be maintained between the damp proof course and ground levels. In this case, we can see a damp proof course although it is slightly low.

Damp proof course

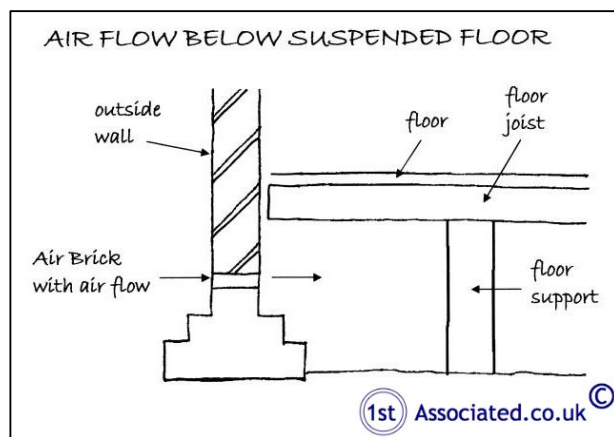
Air bricks are essential to have a through flow of air as this helps to reduce the chances of wet rot, dry rot and woodworm. We are concerned that there are not enough airbricks and they may have been blocked by the rear extensions.

Air brick

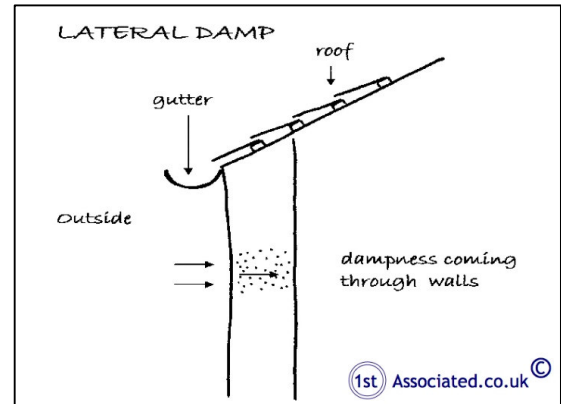
We used a damp meter on the external walls. We have found minor dampness which we believe is due to the property being empty.

ACTION REQUIRED: Please see our comments in the Executive Summary.

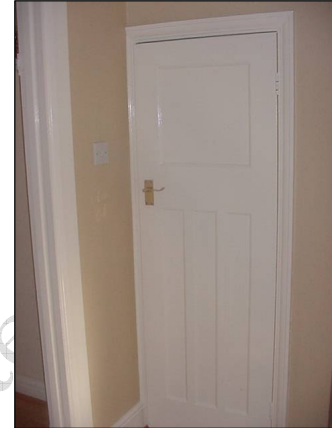
Panel door

The doors look to be original wood panel doors, sometimes the paint is stripped off these and they can have quite a good affect (in our opinion).

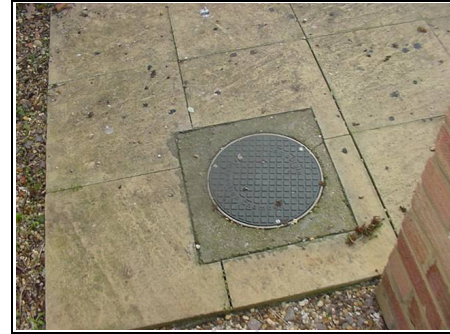
We did notice a rodding eye.

Rodding eye to rear

ACTION REQUIRED: Your legal advisor to check with the existing owners what alterations and modifications they have made to the drainage.

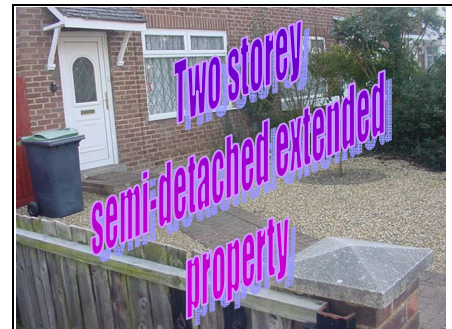
Front Garden

The garden to the front of the property has a paved path to the front door and is predominately shingle covered.

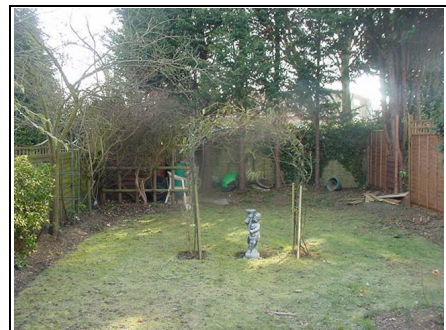
Rear Garden

The garden to the rear is laid mainly to lawn and has some large conifer trees.

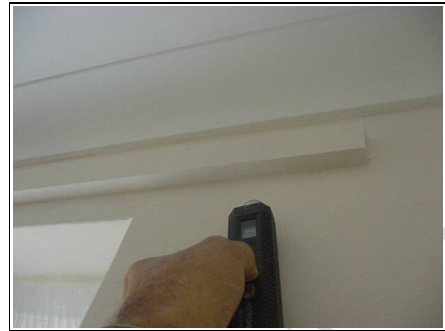
Dampness and condensation around
the concrete window lintel
