RESIDENTIAL BUILDING SURVEY

Kentish Town
London,
NW5 xxx

INDEPENDENT CHARTERED SURVEYORS

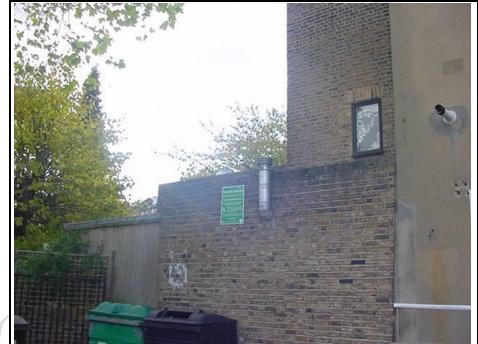
Rear extension

Having said all of the above there is no obvious defect in the quality of the construction from our visual inspection. Nevertheless the Local Authority could make you:

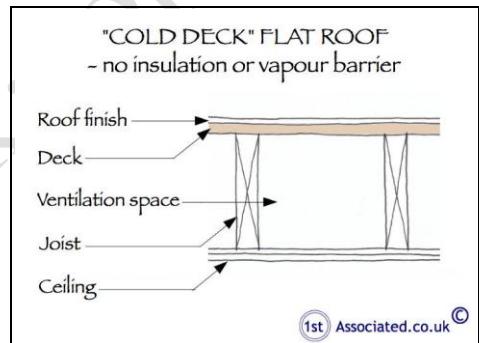
Cold roof

We could see some pattern staining down the right hand side indicating that there are flat areas around the roof window and flashing area. In our experience most people forget about the flat roofs until problems occur.

ACTION REQUIRED: This will need to be cleared regularly to avoid a build-up of leaves and debris.

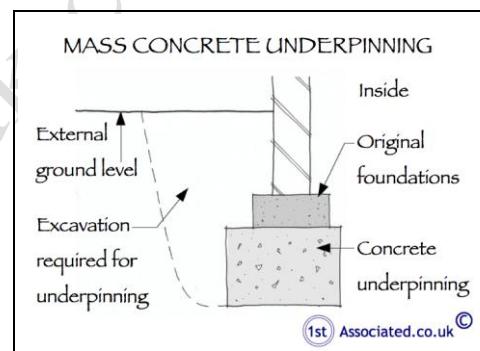
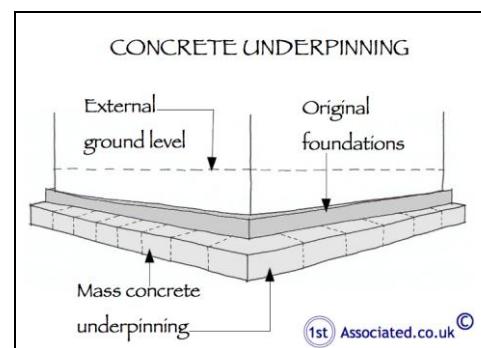
Concrete underpinning

Your instruction advises that underpinning has taken place to this building. Underpinning is the adding of a foundation underneath the existing foundation. In this age of property it is originally likely to have had a stepped brick foundation, as shown in the sketch, to which a foundation has been added underneath as you can see in the mass concrete sketch.

The quality of the underpinning depends upon who did the work, how it was supervised and the year that it was carried out. For example, and from what we understand, in the 1970's too much concrete was used in the underpinning of foundations. We believe this related to the contractors being paid by the metre (of concrete poured). In more recent times the amount has been reduced for underpinning and indeed small piles are often used today. We have also included our sketch of an asymmetric of a property which shows the underpinning and what underpinning is.

An important thing about underpinning is although technically it solves the foundation problem (assuming the underpinning has been carried out correctly) it can also have an adverse effect on the value.

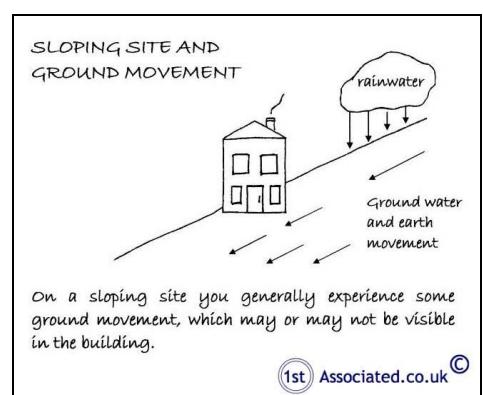
Sloping site

We also note the property is on a sloping site.

Unfortunately from a one off inspection we cannot be one hundred percent certain that the gable end wall is stable. The Building Research Establishment (BRE) typically recommends that this type of wall is monitored for a year. With the other various other factors that we will discuss we feel this is a medium to high risk purchase.

ACTION REQUIRED: The only way we know of to limit your liability would be for the existing owners to place an insurance claim advising that a survey has been carried out and possible movement to the gable end has been noted. If the insurance company confirms in writing that they are willing to monitor the possible movement you can then take over the insurance claim in most cases.

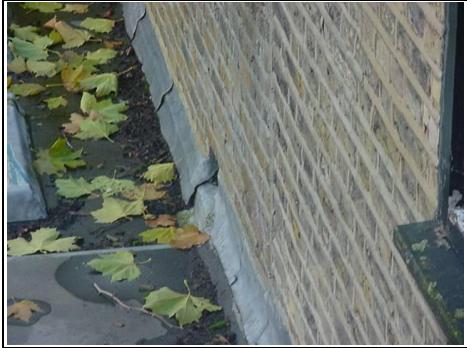
Leaves on flat roof

Just a reminder of what we have said earlier you will find there is a constant battle removing the leaves falling off the trees onto the flat roof and gutters (if you do not want it to become blocked). There was also a stack of leaves that we had to clear in the garden to view the rear of the property.

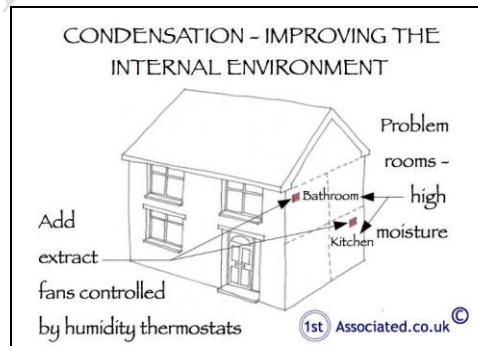
It should be noted that this type of property with an internal bathroom and part internal kitchen can suffer from cold bridging.

Cold bridging is caused by a colder element in the structure allowing coldness to pass through the structure much quicker when warm moist air is present in the property, often caused by things like having a shower or a bath, cooking or washing, particularly if you are drying washing on the radiators. This is also caused by the general climate which results in condensation on the element.

ACTION REQUIRED: We would recommend that large humidity controlled extract fans are added.

ANTICIPATED COST: £250 to £750 dependent upon the wiring required for the extract fans. We would also add extract fans in any rooms that you intend to carry out the drying of clothes; please obtain quotations.

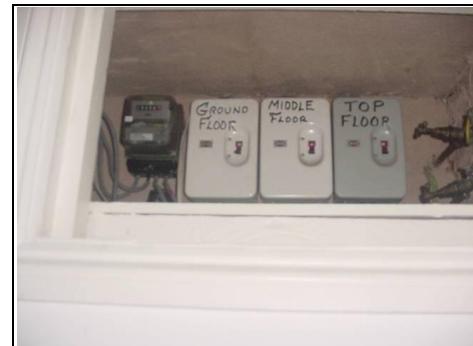
Fuse board

The fuse board is dated, circa 1960's/1970's, possibly earlier, and better fuse boards are now available.

ACTION REQUIRED: We would recommend changing the fuse board. The electrics should be tested to the Institute of Electrical Engineers (IEE) standards and carried out by an NICEIC registered and approved electrical contractor or equivalent.

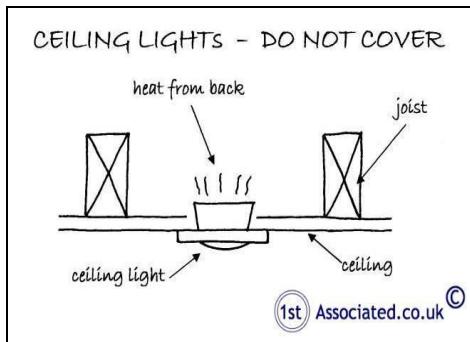
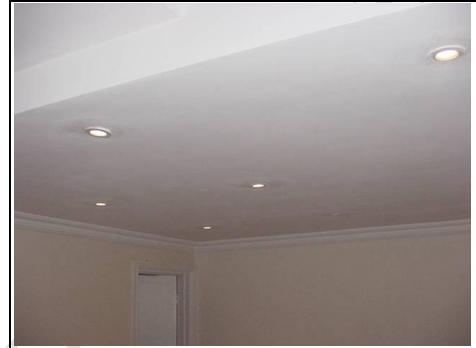
Ceiling lights in lounge

In the lounge there are a large number of ceiling lights. If the extension has not been carried out correctly and these lights are not covered properly then they can become a fire risk.

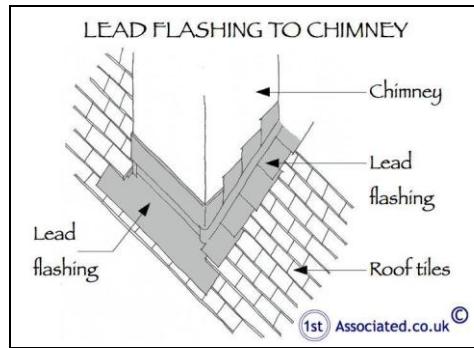
Lead flashing

Unfortunately we were unable to see the flaunching, we therefore cannot comment upon them and it must be said we had a limited view of the flashing.

ACTION REQUIRED: Periodically inspect the chimney. This is typical of the sort of thing that should be included in a planned maintenance schedule as a shared cost for everyone

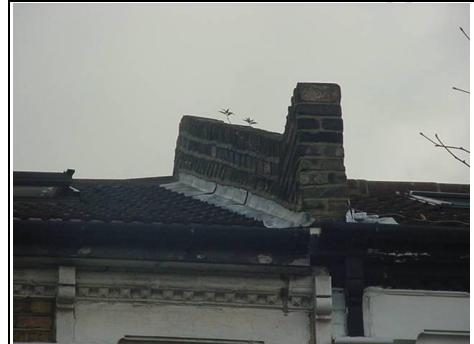
Rear parapet wall

The rear parapet wall is a brick parapet wall with a lead flashing. We noted some moss to the top of the parapet wall indicating dampness may be coming in down through the parapet wall.

ACTION REQUIRED: We would recommend adding a coping stone to the parapet wall.

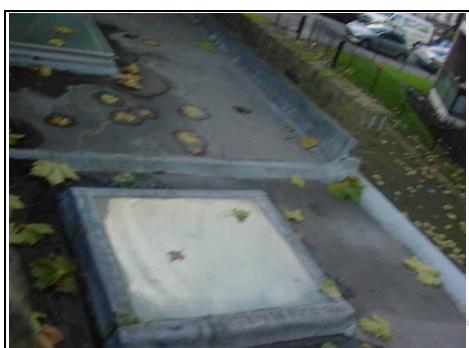
Roof window - middle

One of the windows looks to have been repaired with Flashband which we consider to be a temporary material.

ACTION REQUIRED: Please see our comments within the Executive Summary regarding the flat roof. We would recommend a close inspection of the roof windows is carried out and the replacement of the Flashband with lead flashing.

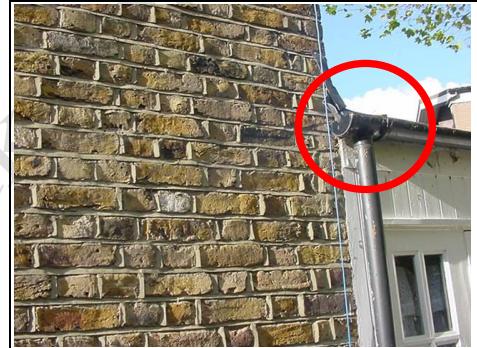
Gutter and downpipe

The problem that you may have with the guttering to the flat roof is the leaves, branches and debris from the trees will constantly block it.

ACTION REQUIRED: We would always recommend you stand outside the property next time it rains heavily and see how well the drains cope with the rainwater particularly looking at the guttering and the joints.

We would also recommend that the gutters and downpipes are cleaned out, the joints are checked and the alignment checked to ensure that the gutters fall towards the downpipes.

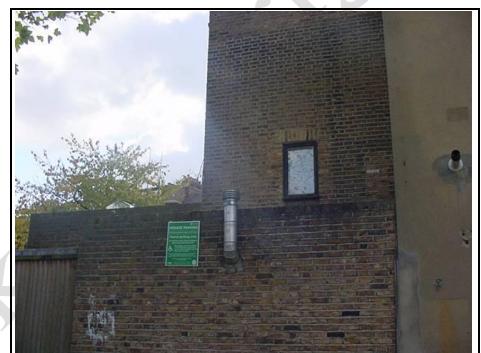
Side brickwork

Unfortunately the re-pointing, whilst well meaning, is not appropriate for this type of construction. A cement mortar has been used rather than a lime based mortar. We recommend you use lime mortar in any future repairs regardless of what the builders say! Using lime mortar will limit further damage to the brickwork, which is almost impossible to repair successfully. However, we would add that many, if not most, of the properties that are re-pointed are re-pointed wrongly; it is only in recent years that we have discovered the problems that can occur from it.

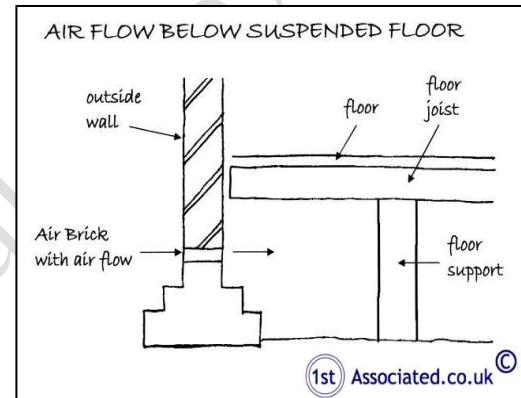
Under the floor is
a suspended floor

ACTION REQUIRED: You need to lift up a section of the decking checking if there are air bricks. If there are you need to ensure they have a clear airflow. If they are not present then you need to add them.

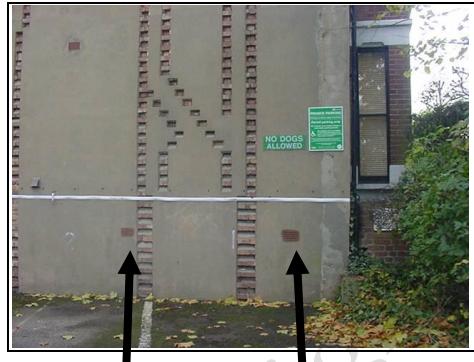
Air bricks in gable wall

We did note some airbricks to the side of the property on the gable wall however we could not see any in the extension area. This may be because there is a concrete floor underneath the timber floor but unfortunately we cannot be certain.

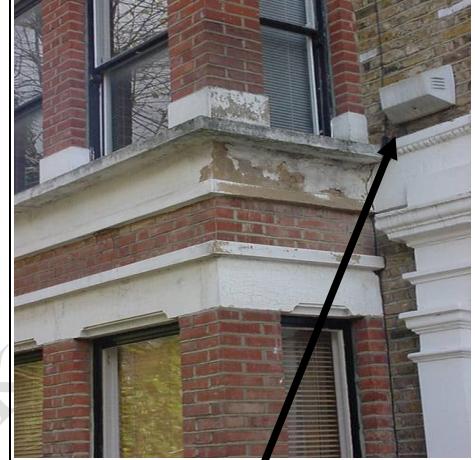
There is an alarm box externally but we did not note a security system inside. A good alarm system should not only help reduce break-ins but also your insurance. We are not experts in this field and therefore cannot comment further.

Video entry door system

Alarm box

ACTION REQUIRED: The owner to advise if there is a security system in place.

We would recommend a video entry system is installed as they are relatively cheap and of course far more secure.

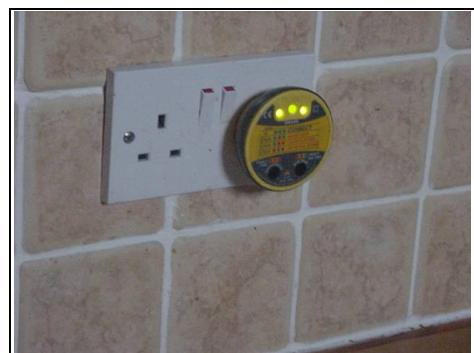
Earth Test

We carried out an earth test in the kitchen area to the socket point that is normally used for the kettle, this proved satisfactory.

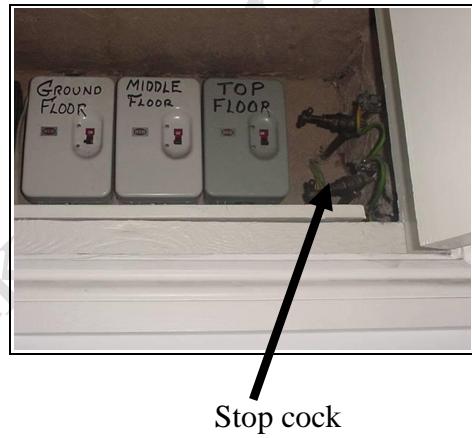
We believe that the controlling stopcock is located in the hallway. The water was not turned on at the time of our survey. We do not turn it on because of the possibility of leaks occurring.

The stopcock and other controlling valves have not been inspected or tested for operational effectiveness.

ACTION REQUIRED: Ask the owners to confirm where it is.

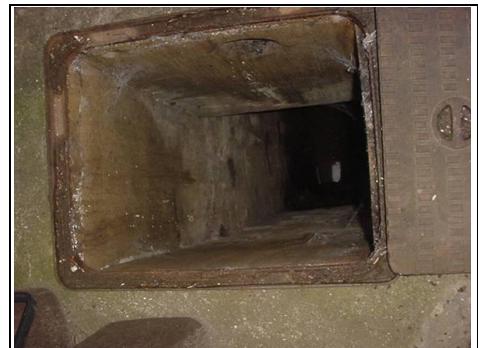
Manhole - front

We duly lifted the cover and found it to be free flowing at the time of our inspection.

This is a very deep manhole. From what we could see it is built from concrete rings indicating it is relatively new.

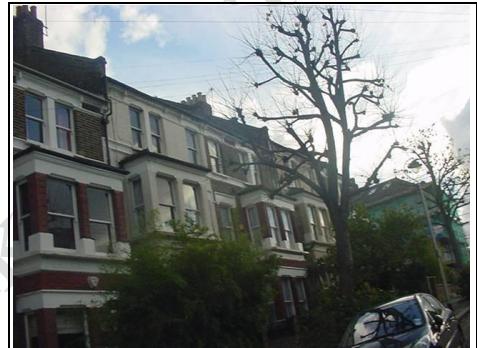
Parking is roadside

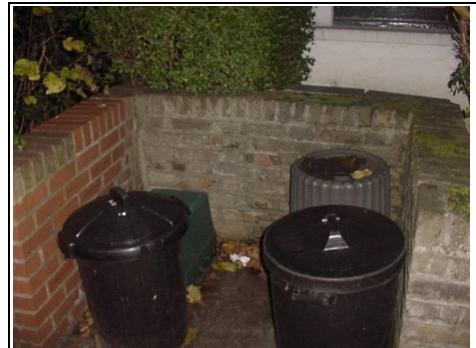
Bin storage

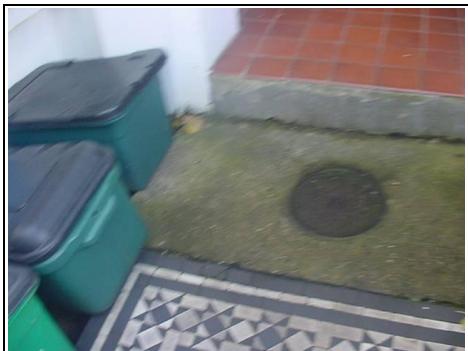
Old coal chute

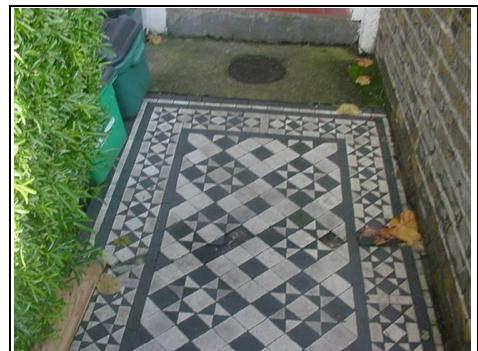
Front tiled pathway is dipped

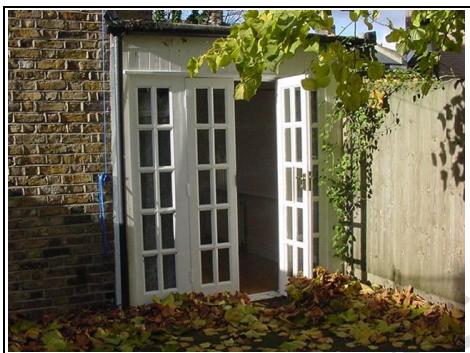
Rear garden

The garden to the rear has a decking area, a shed (not inspected) and mature trees. The fencing would benefit from some maintenance.

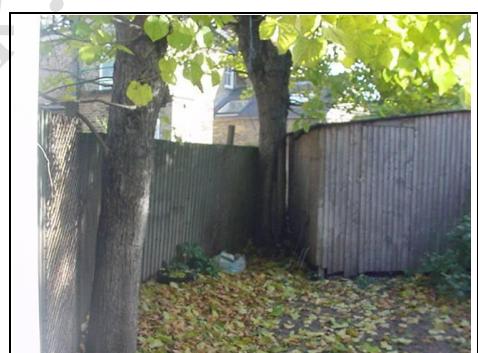
Mature trees

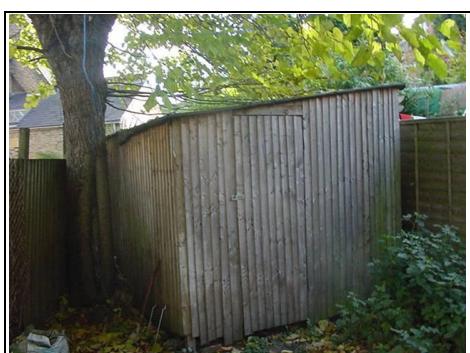
Shed in the garden (not inspected)
