RESIDENTIAL BUILDING SURVEY

Aldwincle, Kettering,
Northamptonshire. NN14 XXX

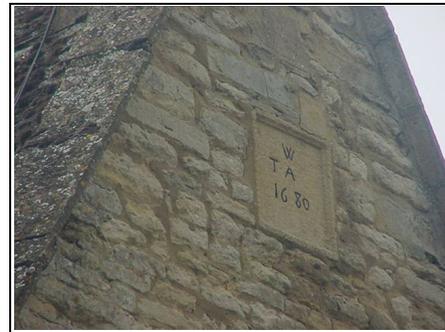
Listed building reference is 1618 the date plaque that we could see looks to say 1680 we are not sure if either of them are true. This property has been subject to extensive refurbishment.

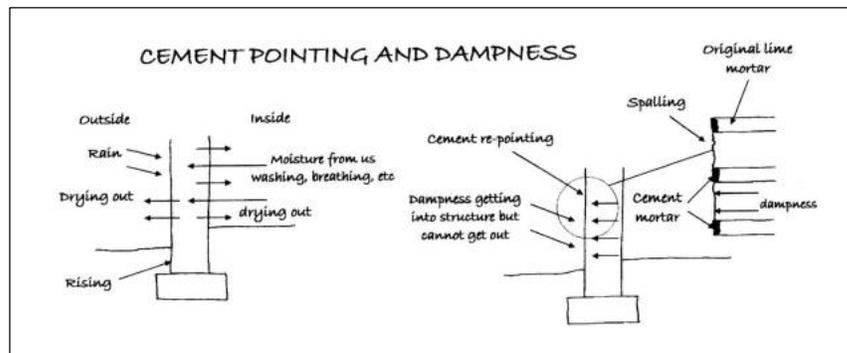
Again this is causing problems with the timber lintels which will ultimately lead to spalling to the surface of the brickwork.

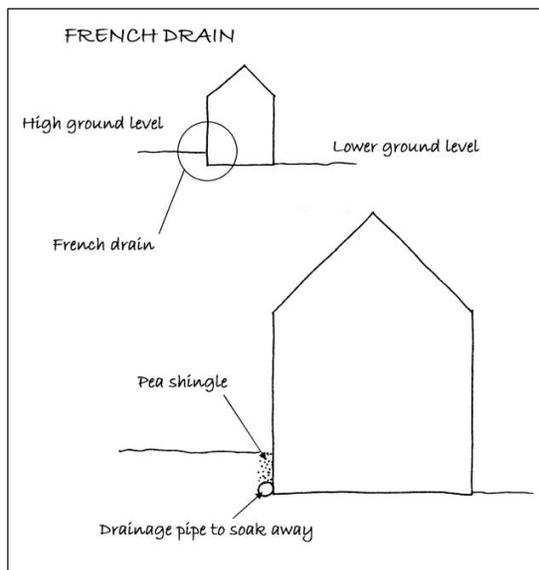
The outside ground level is higher than the inside ground level in many areas which causes dampness both in the form of dampness in the walls and dampness in the floors.

Threshold too low

ACTION REQUIRED: We recommend you live in the property through the winter and we feel that it is likely that you will need to add a French drain around the whole of the property. Before you carry this work out please experience living in the property for a year.

In the immediate future we recommend taking back the earth away from the walls to reduce dampness in the structure. Please note as this is an old property it has not been possible to bring up to modern day standards and dampness, we would say, is a characteristic of the building. You need to ensure you are happy to live with this.

ANTICIPATED COST: In the region of £5000-£10,000 dependent upon how easy it is to get into the drains; quotations required.

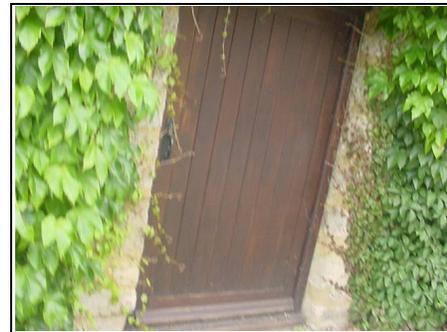
Door to nowhere, very low ground

ACTION REQUIRED: We would request copies of any drawings of alterations that have been carried out by the present owners. You need to check and ensure that the alterations have had Local Authority Approval for Listed Building Consent, Building Regulations and Planning Approval.

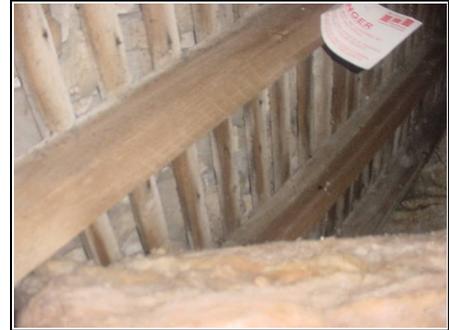
We would say that there is an inappropriate level of insulation added to the roof without any thought for condensation problems (i.e. they are not vented appropriately).

We would particularly draw your attention to the front left hand roof (all directions given as you face the property) over the en suite bathroom area where mould can be seen in the common rafters (the ones that form the pitch of the roof). This is partly due to the plastic sheet that is used as a protective under layer which was common many years ago (1970s/1980s) but has now generally stopped being used. The problem has been exasperated by the use of all the insulation and of course the area being over then suite bathroom.

Mass of insulation in main building roof

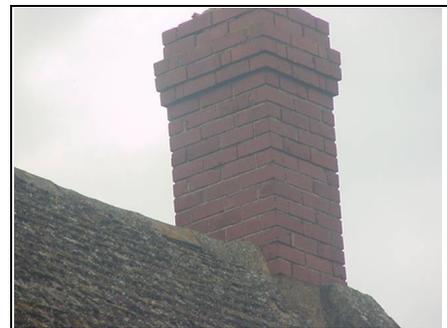
Front right hand side chimney

This chimney is brick built and would benefit from some re-pointing and checking of the flashings as mentioned in the Executive Summary.

ACTION REQUIRED: Carry out re-pointing and check flashings, ideally before the winter of 2012.

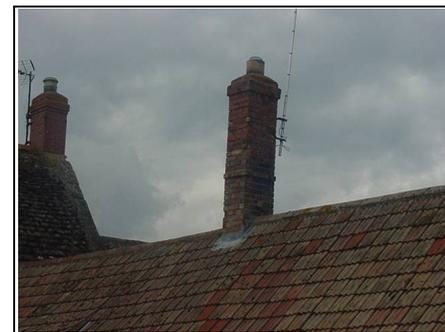
Chimney three to outbuilding

This is a relatively speaking large thin brick chimney which would benefit from some re-pointing. We were pleased to see it has a lead flashing however it does need checking as it has a large aerial on it which is fixed by wires which can cut into the chimney like cheese wire into cheese.

ACTION REQUIRED: As previously described.

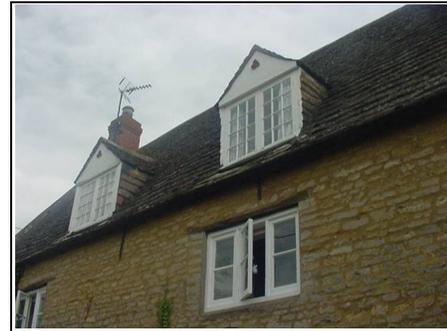
you can literally carry this out literally standing on the pavement or on steps. But we find that the high level windows tend to get left out. It is now time to carry out work to the high level windows and we believe that they are saveable. We would splice in new timber rather than use a plastic putty/wood.

Dormer windows to the front of the main property

ANTICIPATED COST: Set aside the sum of £1500-£2000 as it will require scaffolding to carry out work at this high level; quotations required.

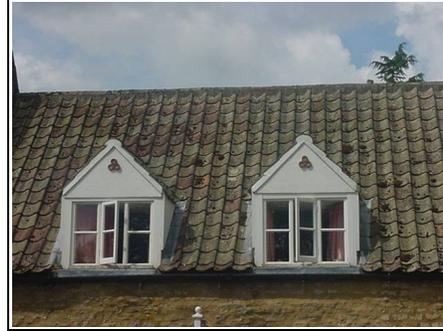
Rear Dormer windows

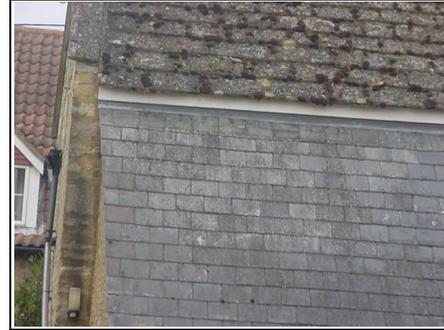
The natural slates sat true this is known as a cat slide extension where a main roof has been extended and generally looks in average condition.

Slate roof beneath main roof

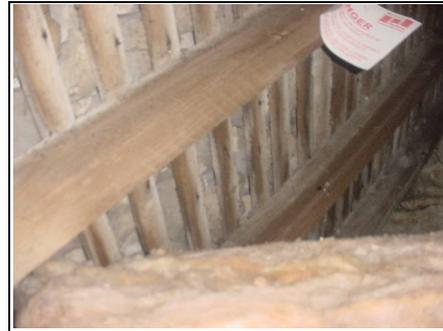
Within these roofs we did not find any protective under layer which is a blessing in one way as it means the roof can breathe because there has been a mass of insulation added to the roof inappropriately. Please see our earlier comments.

Mass of insulation and no protective under layer

ACTION REQUIRED: We recommend adding ventilation. The only way to be 100 per cent certain is to have all the roof cleared of insulation and then checked.

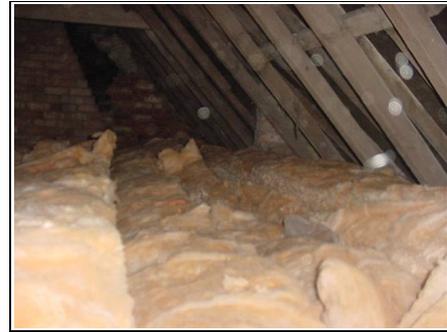
Here we could see a hessian based protective under layer however there was a mass of insulation

Mass of insulation

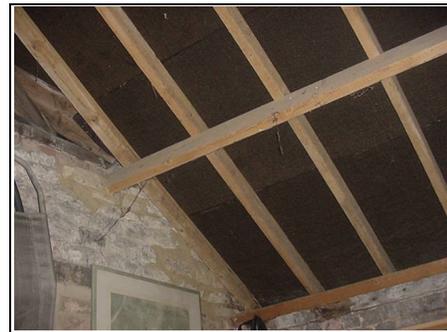
The old bakery area has a shallow pitched roof. This roof has a protective under layer which is visible from within the store room area. We were pleased to see a hessian based felt under layer.

Hessian based protective under layer

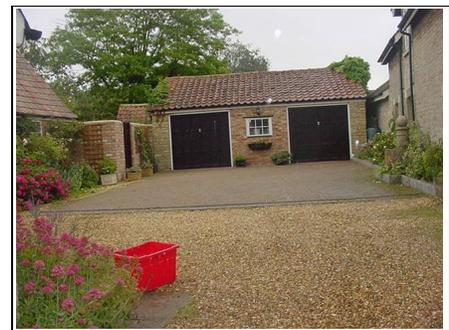
Unfortunately we were unable to gain access to the garage area therefore we cannot comment.

Garages to the left hand side

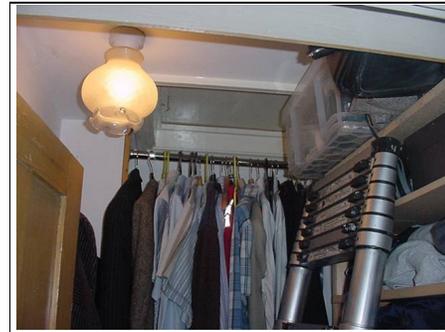
Roof accessed via clothes storage cupboard over bathroom between master bedroom and en suite

With all but access five we have had a head and shoulder view of the roof using torch light which is not ideal, we do like to access the roof wherever possible and are unhappy to do it in this instance due to the conditions.

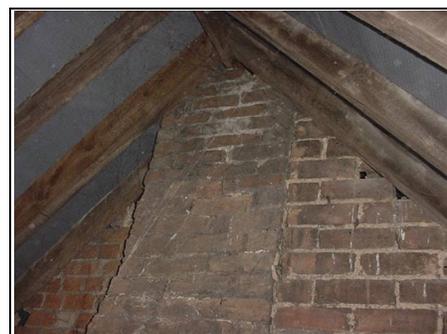
The property has one brick firewall which is visible from the en suite bathroom roof and is formed in brick. There are other fire breaks in the property which are formed in stone.

Brick firewall

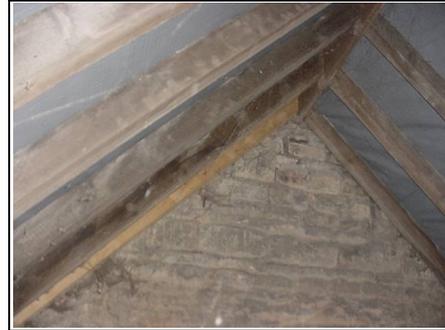
Stone fire break

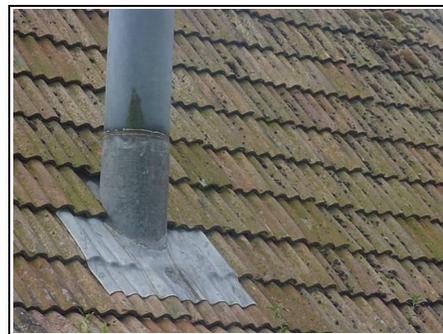
The property has a mixture of metal and plastic soil and vent pipes, they are internal and are visible at roof level. There is an air inlet valve commonly known by its trade name Dago within the workshop areas of the outbuilding which looks to have lots feeding into it so there may be some build up or back up from time to time dependent upon the

Soil and vent pipe

ACTION REQUIRED: Open service duct and inspect

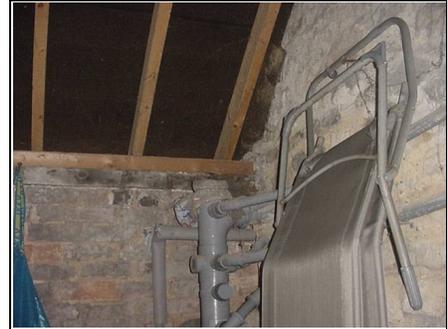
Air inlet valve store room/tack room

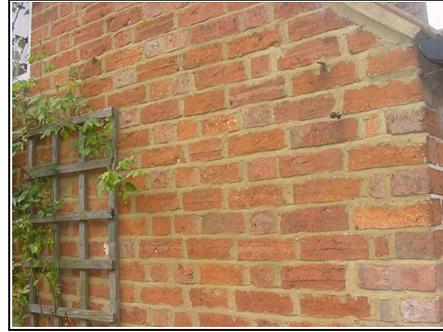
The property has areas of brickwork for example to the end of the family lounge. It is not of any particular bond which is often the case on older walls.

Brickwork to Lounge/Family room outbuilding

ACTION REQUIRED: Carry out ad hoc re-pointing in a lime mortar where appropriate.

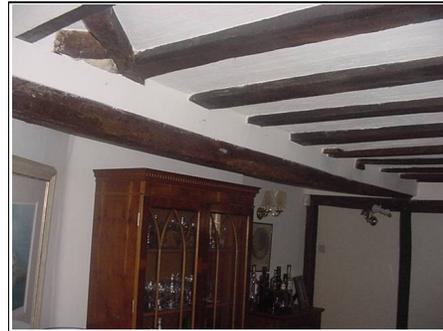
Ground floor ceiling with exposed beams

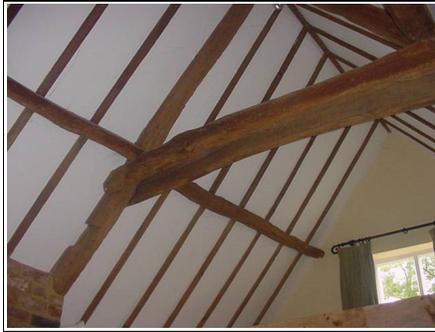
Lounge/Family room outbuilding ceiling

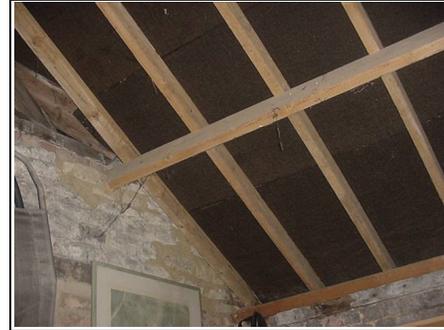
Store/tack room ceiling

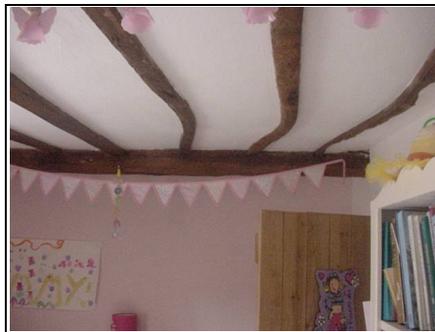
The twist that we could see to the ceiling timbers at first floor level we would normally say indicates movement in the property. However we cannot see any other signs of this which may mean that they have been covered over and the movement is historic. We certainly cannot see a craftsman of years gone by putting the timbers in as they are in their twisted format.

Twist in ceiling first floor level

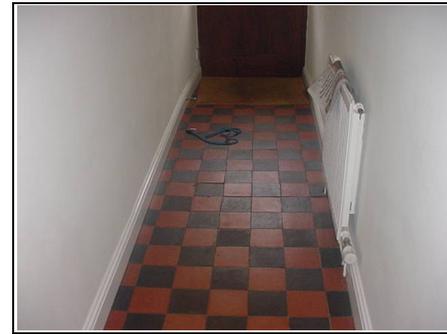
The floor is solid underfoot we think in this age of property it is likely to be a mixture of finishes from tile on earth and possibly a suspended timber floor area. Unfortunately we could not be 100% certain without opening up the floor to confirm.

Ground floor tiles hallway

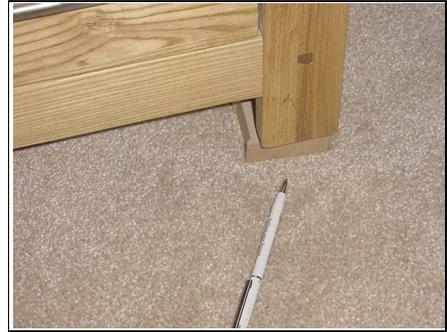
As previously commented however the floor is uneven in places.

Packing to furniture on first floor level indicating uneven floor

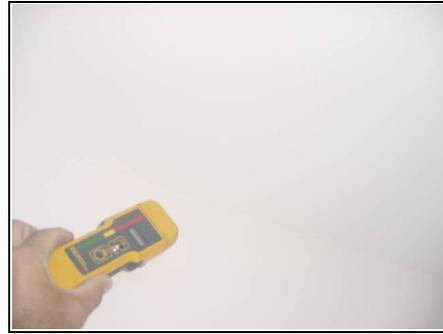
A visual inspection was carried. No significant penetrating/lateral dampness was seen.

Testing for lateral dampness

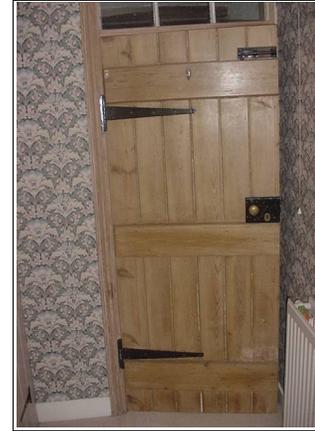
Plank door

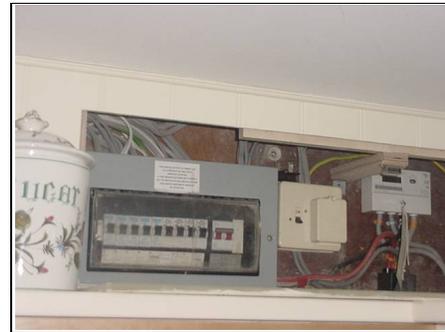
The electric fuses and consumer units were located hidden in the larder. We would date the fuse board as being from the 1990s and, whilst not the best now available, it is reasonable.

Fuse board

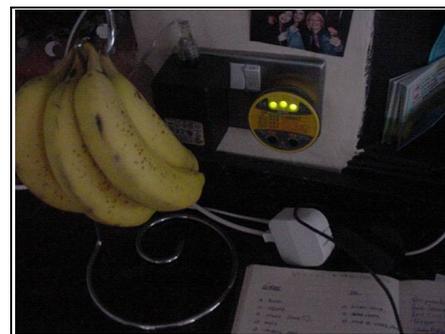
We carried out an earth test in the kitchen area to the socket point that is normally used for the kettle, this proved satisfactory. Neither of these indicators, can give certainty as to the condition of the rest of the wiring

Earth Test

ACTION REQUIRED: If there is no record of an electrical test having been undertaken within the last five years, it is recommended that an IEE report on the installation be tested by a competent electrician (NICEIC registered) and all recommendations implemented. Thereafter, the installation should be re-tested every five years.

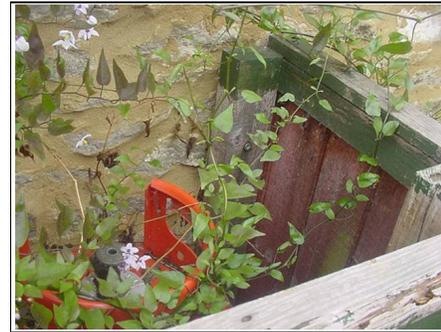
Hidden gas tank

ACTION REQUIRED: You need to have a discussion with the owners to check that you are happy with this.

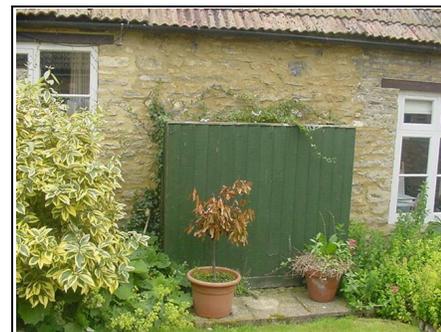
Hidden area for gas tanks

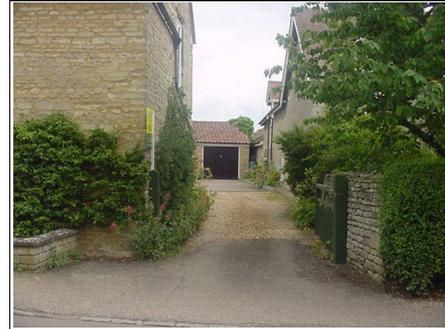
Access to garage at left hand side

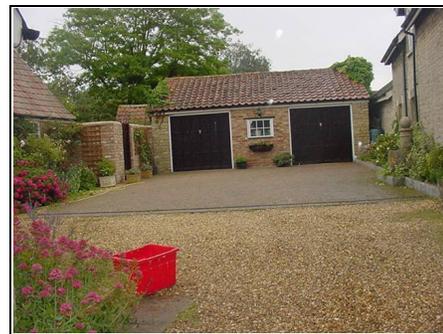
Garages

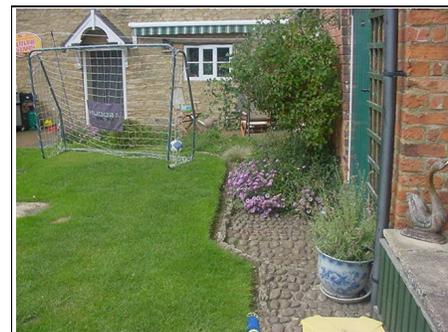
Garden

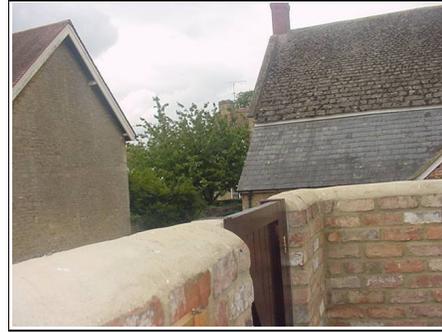
Unusual concrete capping

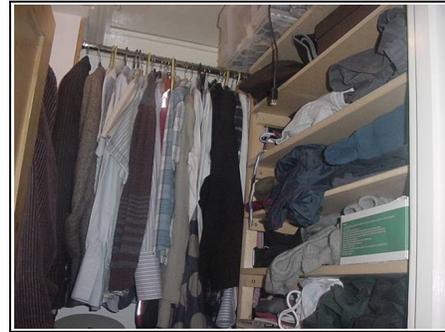
Unfortunately in this instance our inspection has been very limited due to the mass of insulation in the roof space, not opening up the floors, the mass of stored items and packing boxes together with only briefly meeting the current owner and not being able to carry out our question and answer session.

Storage cupboards full

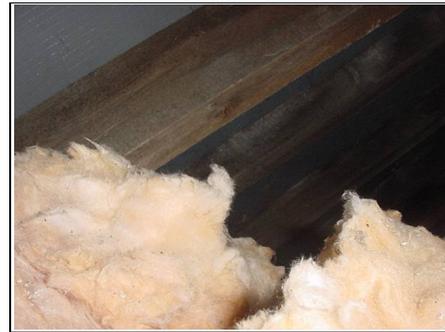
Mass of insulation

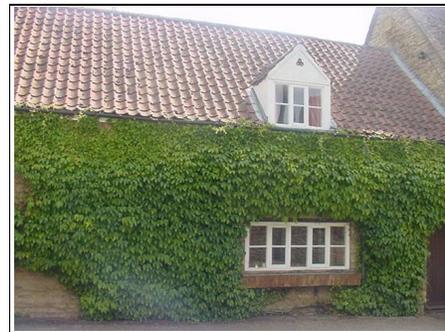
During the summer period plants cover much of the property walls making it hard to view them and dampness will be reduced due to the warm weather.

Property covered in vegetation

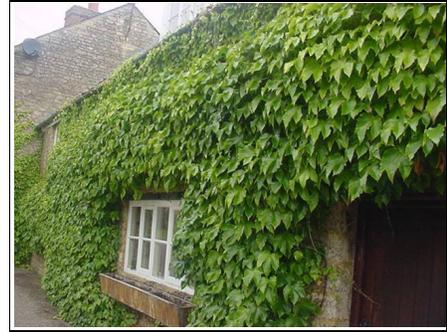
Close up of vegetation
