RESIDENTIAL BUILDING SURVEY
OF
Edwardian Terraced Property, Letchworth, Hertfordshire,
SG6

FOR
Mr A

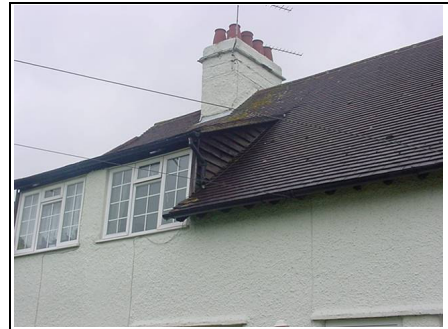
Party Wall

Earlier we spoke about the chimney, which sits upon the Party Wall.

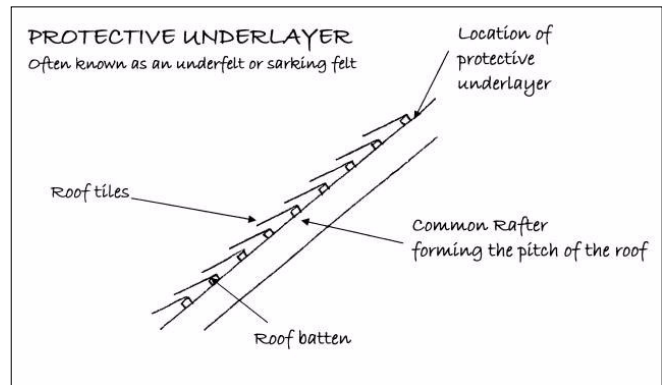
The property has a Hessian based bitumen underlayer. This type of underlayer has been used since the 1960s, which is possibly when the property was re-roofed.

This photo shows the common rafters (the ones that form the pitch of the roof) and the dark area between is the underlayer.

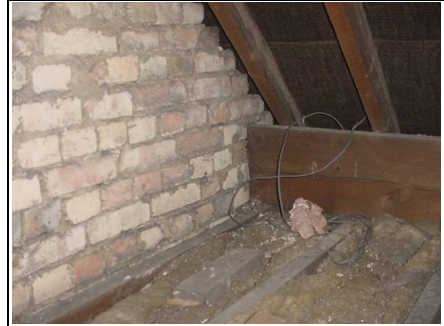
Firewalls help prevent the spread of fire through roofs and are a relatively recent Building Regulation requirement. In this instance the firewalls are built of brickwork, but are not complete in some areas.

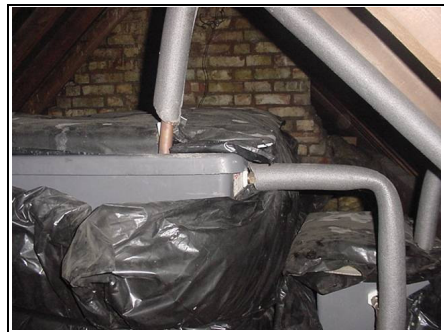
Water Tanks

The water tanks are insulated and, from what we could see, they looked to be formed in plastic. We therefore assume they are relatively new (in surveying terms, in this instance, that is the last 30years). Care has to be taken with roofs and water tanks to allow some warm air so that they don't freeze.

We would always recommend that water tanks be drained down and cleared of any debris etc. (we have seen dead birds and other unmentionable things in these tanks). As you are cleaning your teeth with this water it is best that it is as clean as possible!

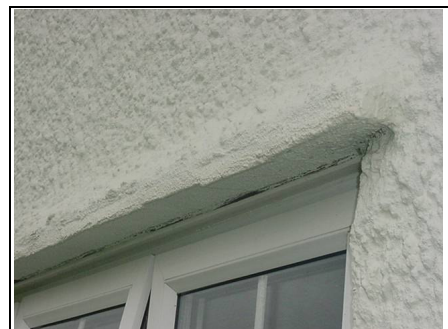
The windows have a nicely formed render drip detail.

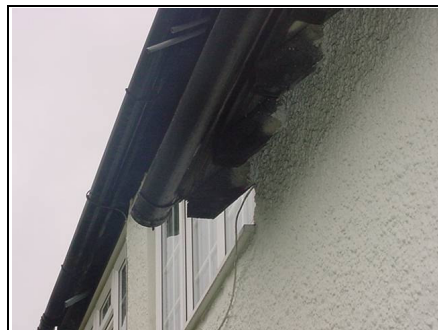
The fascia and soffit detail includes exposed rafter feet. We generally find that due to the awkwardness of these they do not get painted as often as they should and you may find rot if they are closely examined.

ACTION REQUIRED: Paint / Stain in the next three years

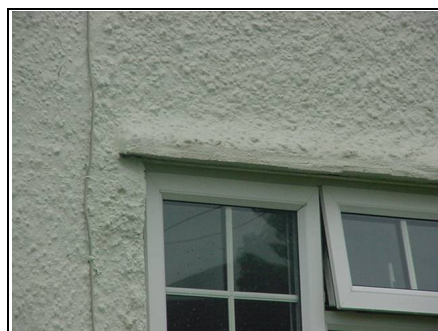
We would draw your attention to the fact that sealed double glazed units can fail, particularly as a result of poor workmanship during installation. Failure of the seal leads to condensation between the two panes of glass and simply replacing the affected units may not provide a satisfactory long-term solution. In this case they are in average condition.

ACTION REQUIRED: Legal Adviser to check if any transferable guarantees are available and, if so, to transfer. Generally it is considered that double glazed units have a life of about ten years.

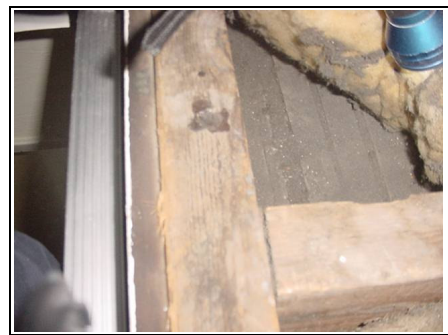
The ceilings are formed in lath and plaster; please see sketch below. In this age of property, you would expect some minor hairline cracking to the lath and plaster and possibly areas where the plaster has lost its key or bond to the ceiling, which is usually due to old age and possibly minor dampness.

If you look very closely you can see the laths to the top right hand side of this photo.

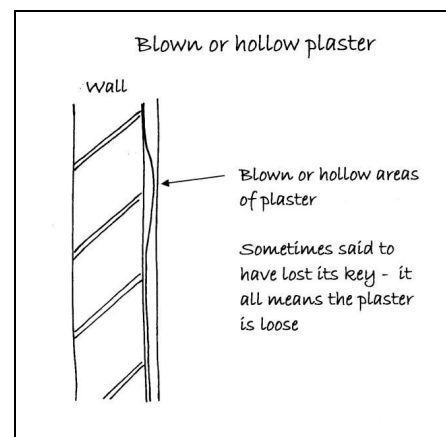
To some areas the plaster is 'blown'. This term is used where the plaster is no longer sticking to the wall and is sometimes known as 'losing its key'. The plaster to the walls is in below average condition; this is nothing to be overly concerned about, you simply need to do some re-plastering when you redecorate.

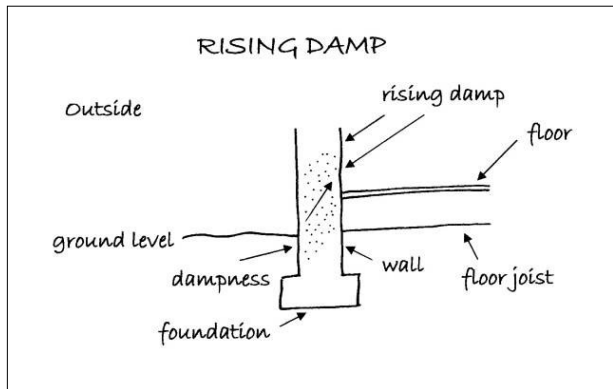
We have carried out tests with an electronic damp meter to a random selection of areas and we found rising damp. Please see our comments in the Executive Summary.

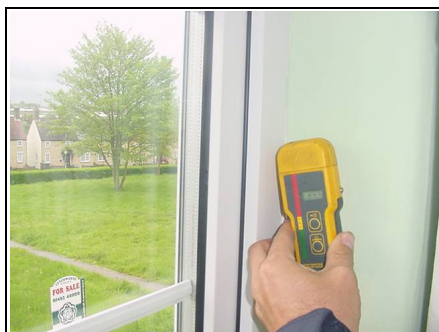
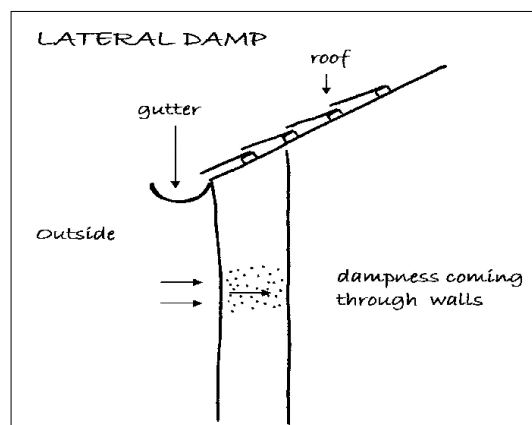
Tests were taken with a moisture meter at random points to internal walls. Our readings were in line with what we would expect for this age of property, i.e. minor dampness. No evidence of any significant penetrating/lateral dampness was detected.

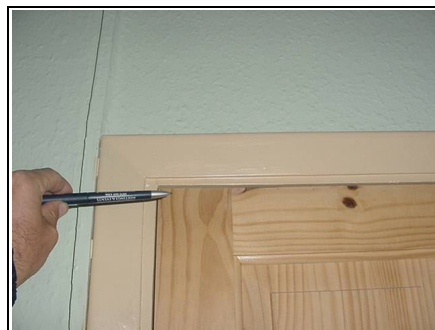
Checking the structure for movement.

You have stripped timber doors that fit into their frames well. This is a good sign, showing there has been minimum movement in the property.

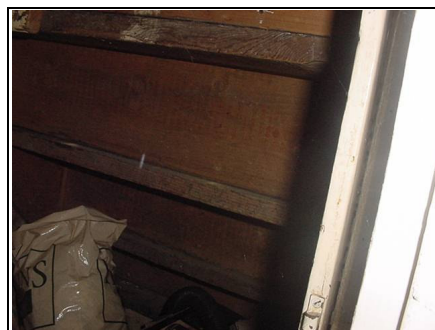
We noted that the underside of the staircase was exposed. It is more normal today to have a half hour fire barrier to stop fire spreading from the ground floor to the first floor in a worse case scenario. You may wish to take a view on whether you add this.

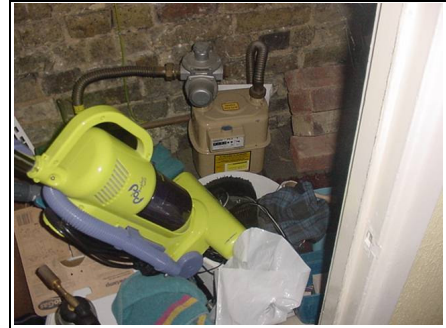
We are advised that the property has mains gas. The consumer unit is located under the stairs.

ACTION REQUIRED: As a matter of course it is recommended that the entire gas installation is inspected and made good, as necessary, by a CORGI registered contractor. Thereafter the installation should be serviced annually.

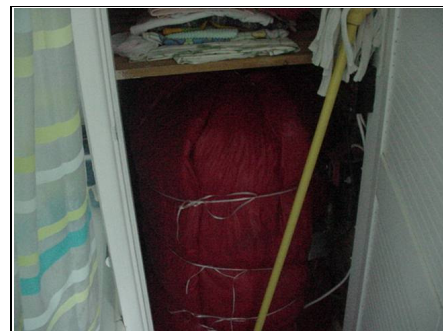
The hot water cylinder is dated (in this case we would estimate over 30 years). In our experience, in this age of hot water cylinder defects can start to occur and, unfortunately, hot water cylinders rarely give any proper warning before they leak/bust!

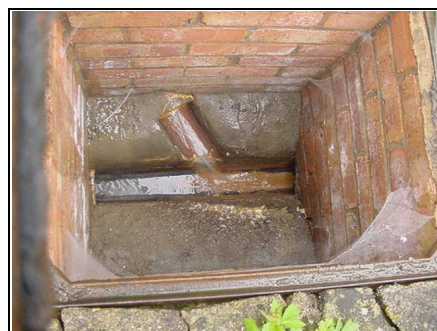
We have identified one inspection chamber / manhole located to the rear of the property. We have duly lifted this to check to make sure it was not blocked.

From what we could see it is brick built.
