RESIDENTIAL BUILDING SURVEY

London
South East

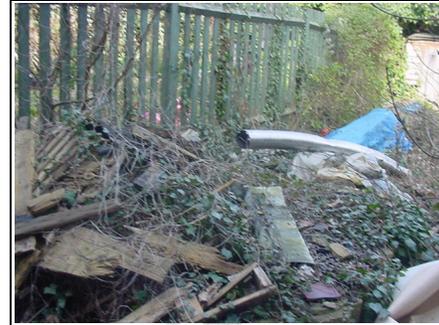
Rubbish to the side needs clearing

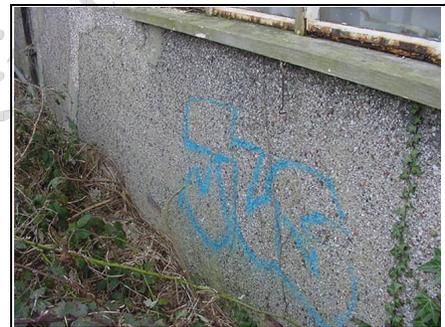
As an aside, there is also graffiti to the rear which needs cleaning which is difficult on pebbledash render.

Graffiti

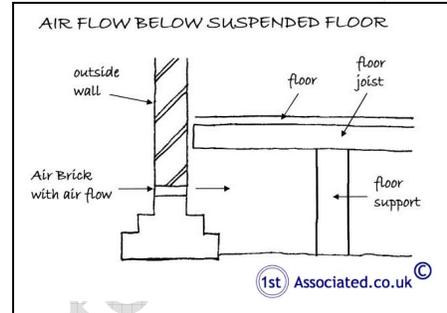
The ground floor is a suspended timber floor. With the dampness in the structure there may be some deterioration to the flooring. It didn't feel to deflect that much during the course of our inspection under our impact test (literally jumping up and down).

ACTION REQUIRED: The only way to be certain is to open it up and check.

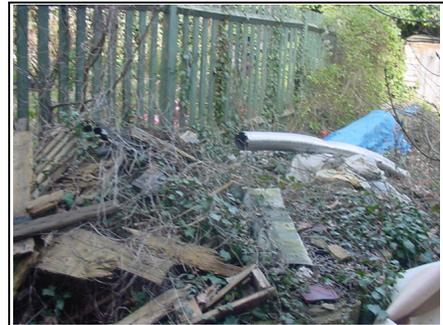
Generally the garden needs clearing. We would estimate it will take a few skips. Recently we have been surprised at the cost of skips but also would add in this instance it will be particularly difficult to position the skip anywhere suitable due to the restrictions in the road and access.

Rubbish needs removing

ACTION REQUIRED: You are likely to need a 'white van man' to help remove the rubbish.

ANTICIPATED COST: In the region of £500 to £1,000 to clear the garden properly and tidy it up. You may find that you have particular items in the garden that need a special licence to tip. Please obtain quotations.

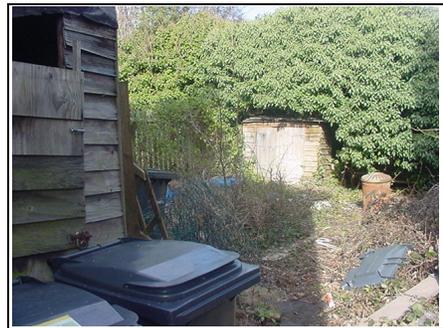
Overgrown garden

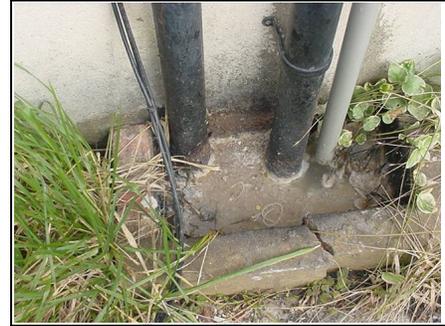
As far as we can see the drains were blocked/backing up and the outside gulleys to the front and rear. We would also add that when we turned the kitchen tap on, it ran rusty water for quite a while.

Blocked gulleys

ANTICIPATED COST: A few hundred pounds for the clearing of the drains and camera work; please obtain quotations.

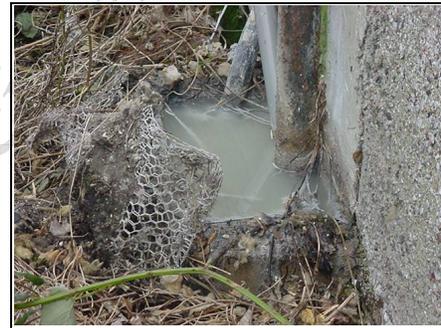
Rear drain blocked

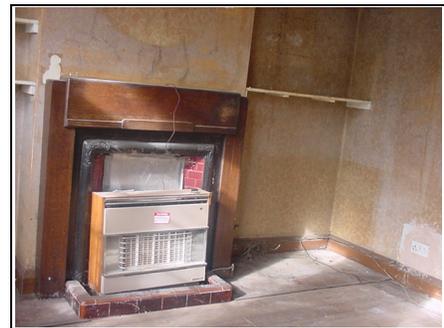
The heating was electric, we didn't test this. Whilst modern day electric heating can be very efficient and neat and tidy, this was an old style system. We noticed the condemned electric fire. It seems likely there is gas into the property. It is worth looking at a gas central heating system.

Condemned electric fire

ACTION REQUIRED: General improvements to the heating system.

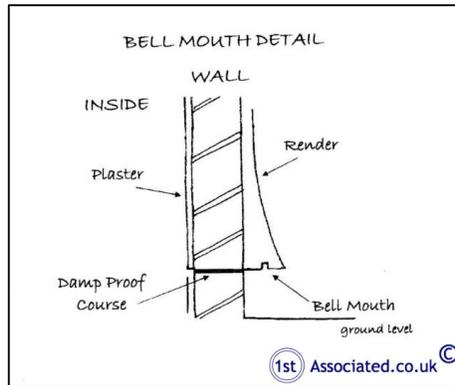
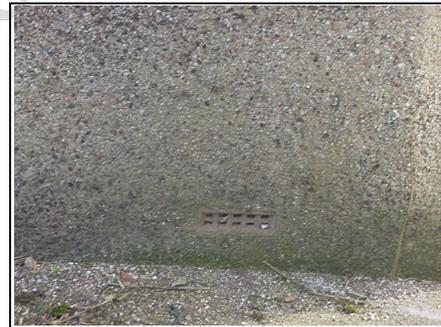
To the base of the render there was no bell mouth detail therefore it is susceptible to dampness to the base of the property.

No bell mouth

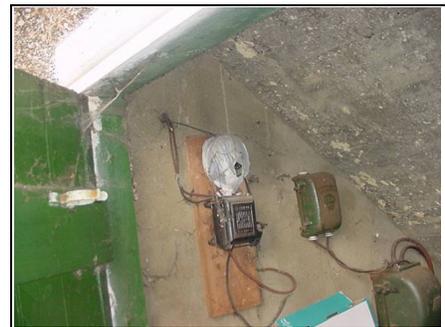
This is a good question. We cannot be 100% certain from what we have seen without opening up the structure. However the adjacent photo was taken underneath the stairs giving us an indication that the walls are concrete which means we would take an educated guess that this property has been built from reinforced concrete.

Concrete

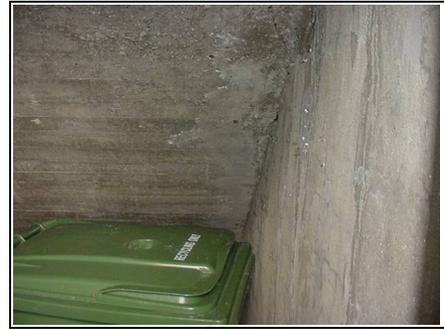
It is difficult to establish what the perimeter walls are. Again we would take an educated guess that concrete or a blockwork has been used. The only area that we could see was within the stairway which showed a concrete wall.

Concrete walls under stairway

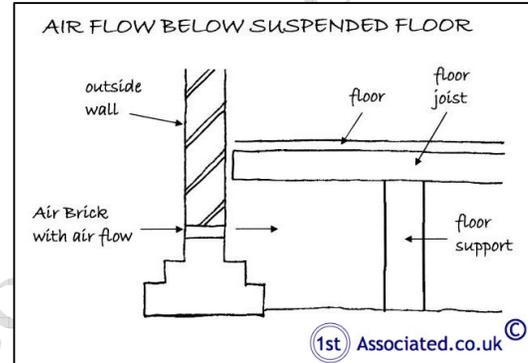
Quite surprisingly the property has a suspended timber floor. We say surprisingly although in earlier years most floors were suspended timber.

A suspended timber floor requires air movement underneath to minimise wet rot, dry rot and woodworm.

ACTION REQUIRED: We recommend you check all airbricks are clear.

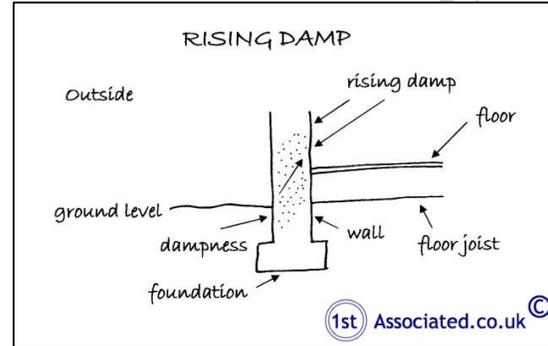
A random visual inspection and tests with a moisture meter have been taken to the perimeter walls. In this particular case we have found rising damp.

ACTION REQUIRED: Please see the Executive Summary.

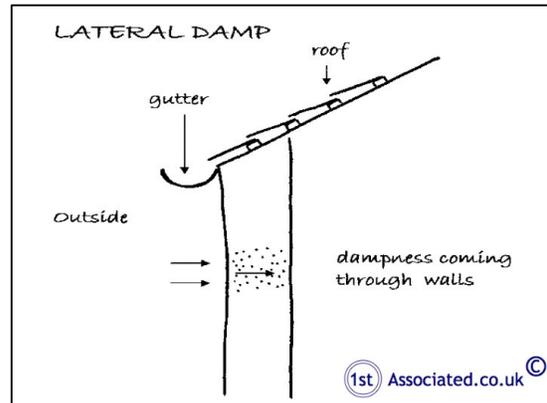
We used a damp meter on the external walls. We have found dampness.

Please see our comments in the Executive Summary.

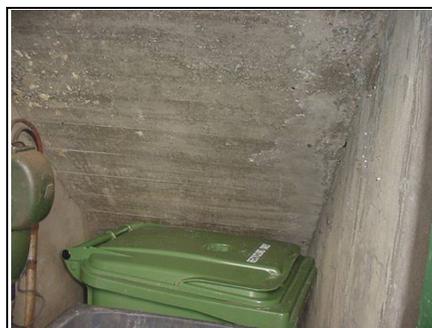
There is a staircase leading up to the upper floor flats which is formed in concrete. We can see this in the under stair cupboard. We also noted there were some old electrics which need isolating.

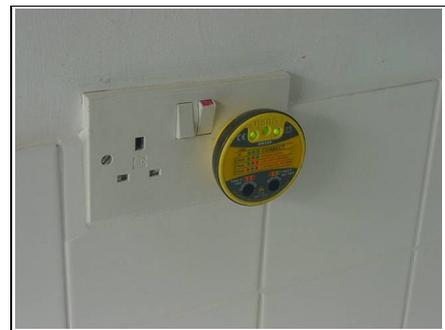
Earth test

We carried out an earth test in the kitchen area to the socket point that is normally used for the kettle, this proved satisfactory.

ACTION REQUIRED: As the property is changing occupancy an Institute of Electrical Engineers

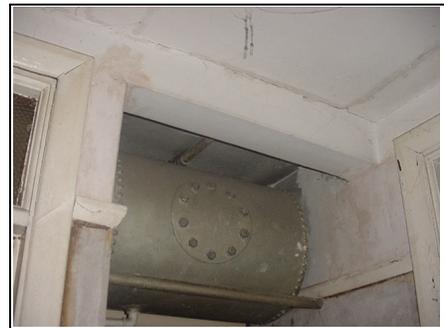
The Cold Water Cistern was located in the hallway entrance area. We are not certain whether it is still in use.

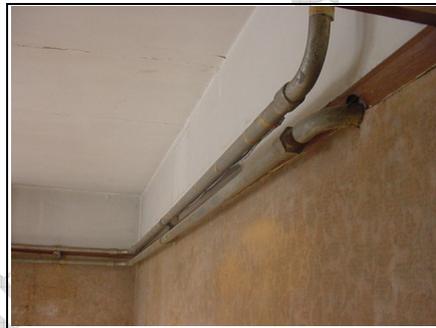
Possibly lead pipes

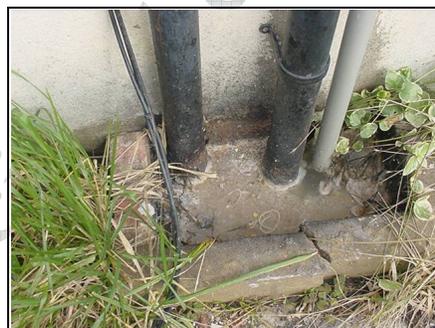
The cold taps have been run for approximately quarter of an hour in the bathroom and kitchen. The gulleys did block and back up in that time.

Gulleys blocked

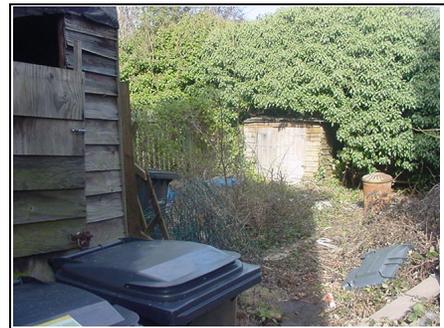
There are good sized gardens which we assume are shared. The gardens were overgrown.

ACTION REQUIRED: Your Legal Advisor to check and confirm.

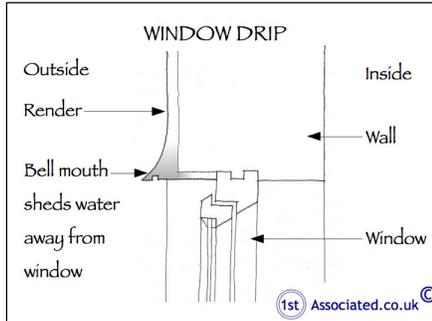
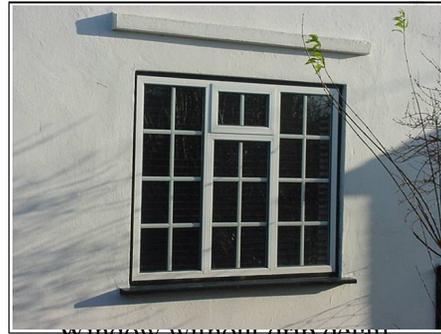
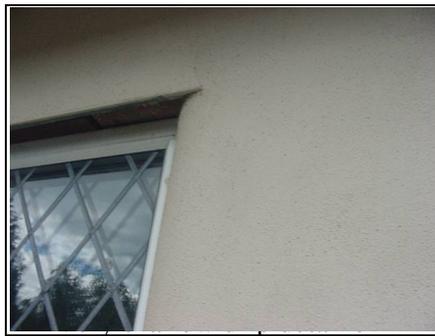
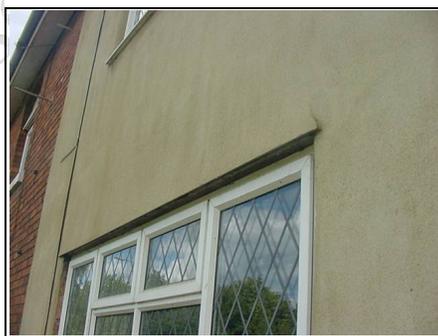
Window drip detail

A window drip detail is to keep rainwater away from the window and can often be seen on buildings with render.

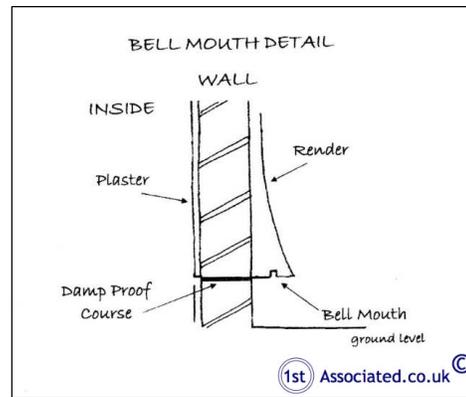
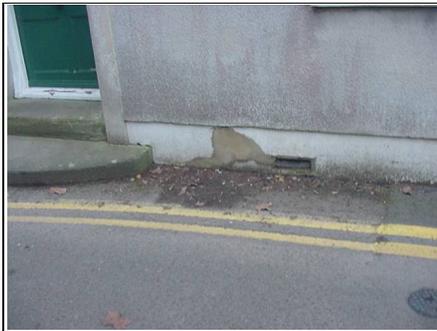
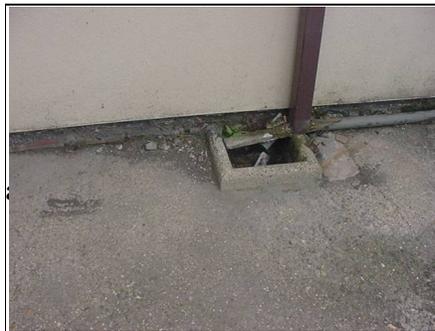
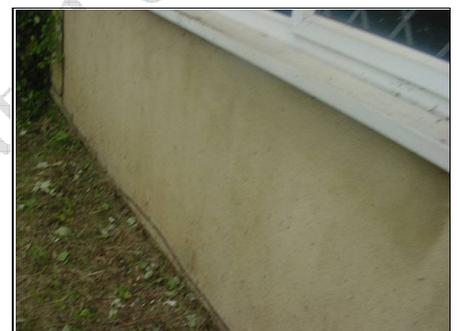
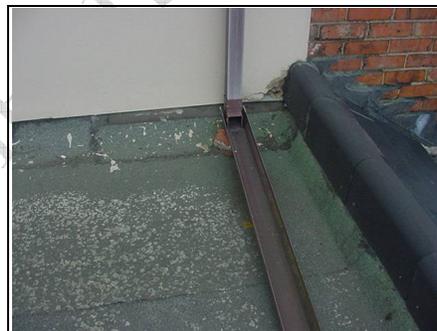
Bell mouth detail

A bell-mouth is a curve at the base of a wall which throws the water away from the structure therefore preventing dampness.

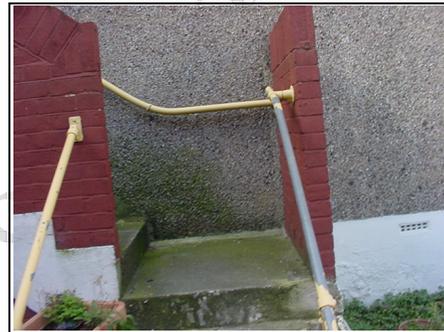
Green mould is often visible to render and sometimes black mould which is a sure sign of dampness.

Green mould to render
