JOB REFERENCE: XXXX

RESIDENTIAL BUILDING SURVEY

XXXX
Lewisham
London
SE13 XXX

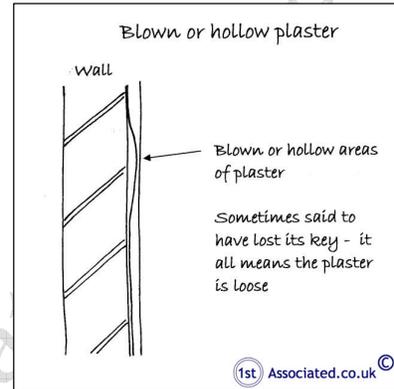
1.0) Plaster has lost its key (grip) internally

From our discussions with the present owner they are aware of this and advise that it is probably due to the poor condition of the roof in the past. Nevertheless it does mean that if you do carry out any redecorations such as stripping of any wallpaper you are likely to require to re-plaster.

We would add that the ceiling of the property may also have lost its key although the ceiling plaster did look relatively smooth and may well have been replaced.

ACTION REQUIRED: If you are going to carry out any redecoration work to the property then you need to be careful to ensure you do not have to carry out a lot of plastering work.

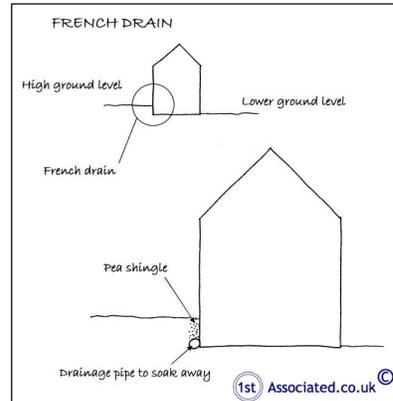
The brick pavers to the rear of the property have been added over the old ground level and as such causes a situation where dampness can get into the property. Ideally all the pavers should be lowered but this is a big task.

Brick pavers at threshold same level as ground level

ACTION REQUIRED: The pavers are surrounding mainly the kitchen area and we would suggest that if problems do occur with dampness (this is most likely to happen in the winter months) you remove the brick pavers directly next to the property perimeter. You will then need to dig down lowering the ground level and replace the pavers with a pea shingle that will allow any water that gets to this area to drain away and is what is known as a French drain. Have a look outside next time it rains heavily to see how the rainwater is around the property.

ANTICIPATED COST: £1,000 to £3,000 to have a proper French drain installed and of course you would have to find the drains; please obtain quotations.

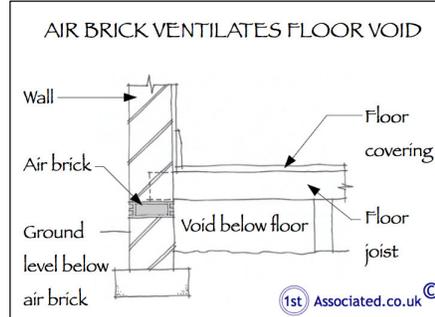
6.0) Airflow underneath the property

We noted that you have a suspended timber floor to the property, as is common, we could see airbricks to the front of the property and we were pleased to see that these were double the normal size. In addition you do need to have airbricks to the rear; we could only see two airbricks to the rear underneath the French doors but you really should have more in the step to the kitchen to allow a through flow of air.

ACTION REQUIRED: Check the airbricks are clear and add additional airbricks to the step in the floor in the kitchen.

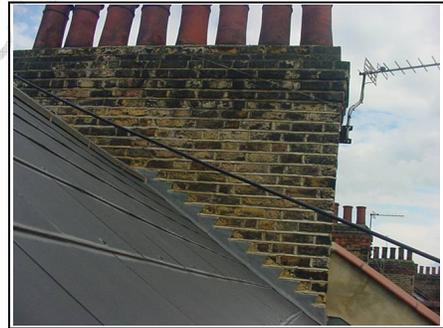
Chimney One

This chimney is brick finished with a lead flashing and eight chimney pots (although they are not all likely to be yours). From what we could see from ground level it looked in average condition considering its age, type and style. However looking at the photographs the rear chimneys look to be at a slight angle.

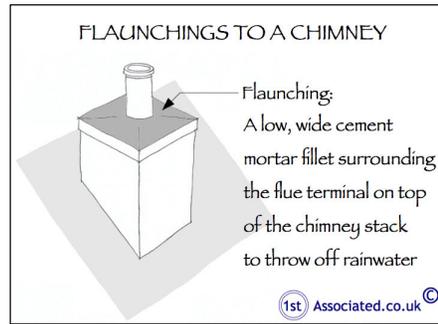
Rear Chimney

When these properties were built originally they would have had all the rooms heated via a chimney and they would normally have a chimney to the rear of the property. In this case we were pleased to see that the rear chimney was in place and we could view this chimney from the roof light within the attic space. The chimney is brick built and we can see that the chimney has been re-pointed and are pleased to see a lead flashing although we are not too keen on satellite dishes that are fixed in one point such as the one that is present as this can cause damage to the chimney.

There did look to be a slight gap between the chimney and the parapet wall.

ACTION REQUIRED: Periodically inspect the chimney.

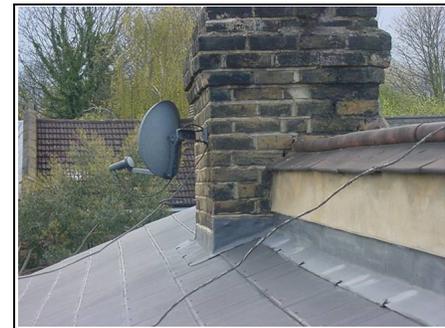
Close up of rear chimney

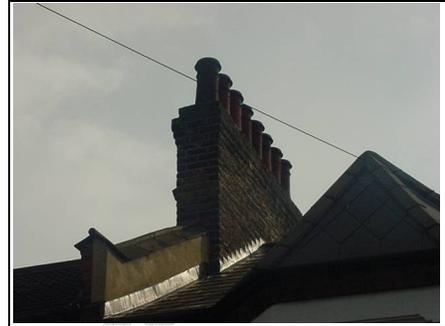
Parapet wall to left hand side with chimney

We can comment that the coping stone does not look to have been bedded on correctly as there is slight undulation and movement in the coping stones (they are actually tiles).

Our main concern with the parapet walls is the condition of the sides of the parapet walls that are not yours as these can allow dampness into the property.

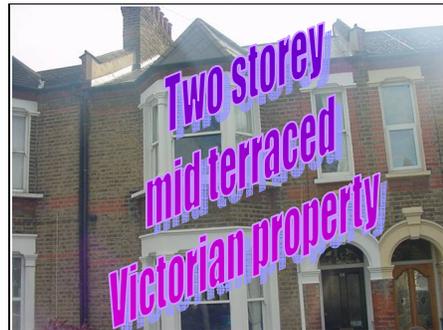
There is no access to the roof structure of the bay window roof, therefore, it is not possible to examine the supporting structure other than to inspect the underside of the ceiling directly beneath it which shows no visible signs of dampness getting through.

Bay window roof to the front of the property

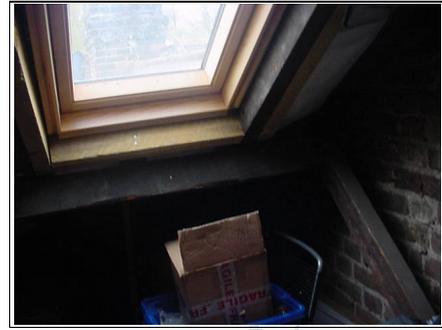
Roof window to rear

The property has a purpose made roof light, which looked in average condition. The important factor with roof lights is the flashing around them, in this instance we would comment that there are no water stains around the timber roof light.

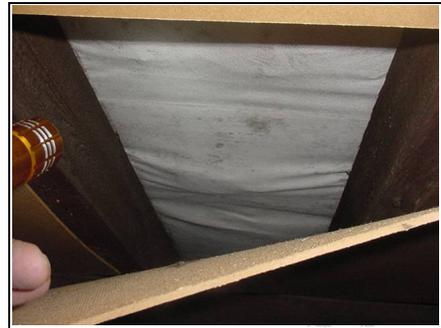
Boarding hiding back of slated areas on main roof

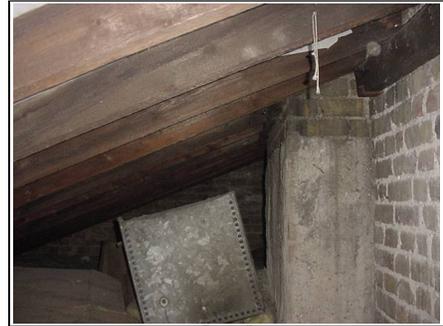
General view of inside of the rear roof

Our examination was limited by the general configuration of the roof, the insulation and mass of stored items. What we could see was generally found to be in average to below average condition for its age, type and style. It is, however, feasible that the staining we could see was formed many years ago prior to the property being re-roofed.

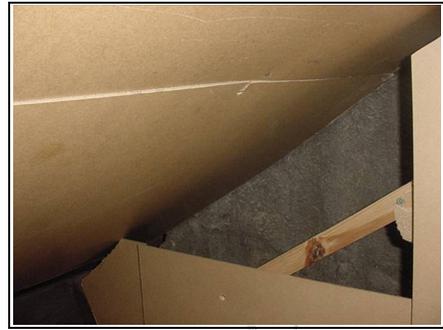
We pulled back part of the boarding in the roof space and were pleased to say we found a firewall behind the boarding.

Boarding hiding firewall

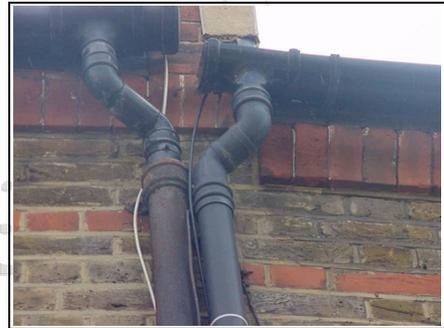
The property has a mixture of older cast iron and modern plastic gutters and downpipes. The condition is fairly typical of what we see; the plastic gutters and downpipes are in average condition and the cast iron ones are starting to rust and would benefit from a rust stop agent and redecoration.

Plastic gutter and downpipe

There may be some minor leaks but most people would be happy to live with these providing repairs are carried out within the next six to twelve months.

ACTION REQUIRED: We would recommend you stand outside the property next time it rains heavily and see how well the drains cope with the rainwater particularly looking at the guttering and the joints. We would also recommend that the gutters and downpipes are cleaned out, the joints are checked and the alignment checked to ensure that the gutters fall towards the downpipes.

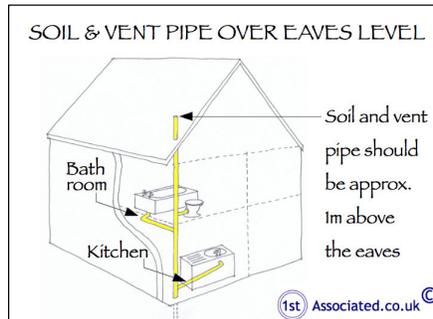
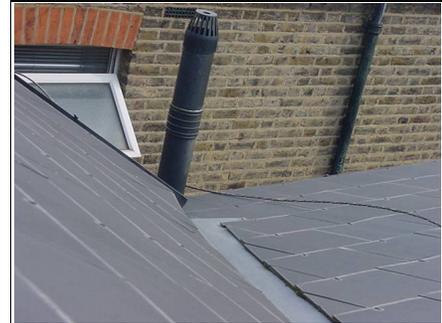
The property has plastic soil and vent pipes.

Soil and vent pipe

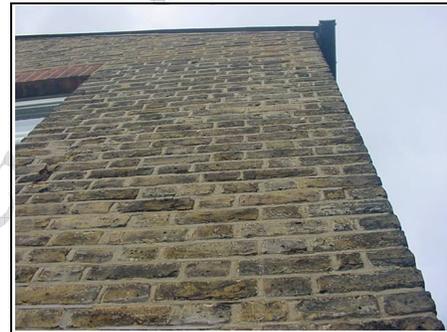
Generally Flemish Bond brickwork is liable to penetrating dampness internally, dependent upon the condition of the brickwork and the exposure to the weather. In this case it is essential that external faces be kept in good condition.

Brickwork

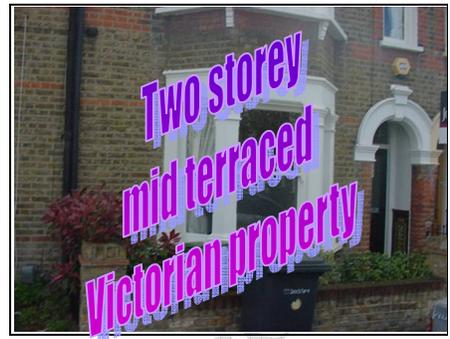
Around the windows and doors there is some stonework/render detailing painted white which looks in average condition.

There are also some soft red bricks being used around some of the windows and at roof level.

Window detailing

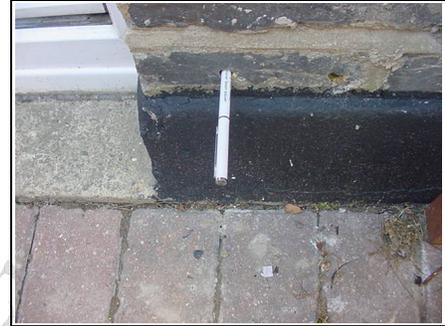
All modern properties should incorporate a damp proof course (DPC) and good building practice dictates that a differential of 150mm (6 inches) should be maintained between the damp proof course and ground levels. In this case, we can see signs that a damp proof course has been added.

Signs that damp proof course has been added

ACTION REQUIRED: Please see our comments in the Executive Summary.

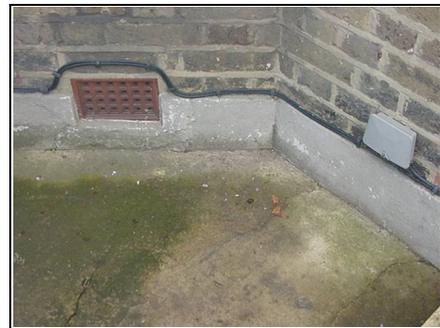
Air bricks are essential to have a through flow of air as this helps to reduce the chances of wet rot, dry rot and woodworm. We found some airbricks to the front bay window to the front of the property and a few under the French doors to the rear ideally there should be some airbricks in the step that is in the kitchen breakfast /dining room area.

Air brick to front of the property

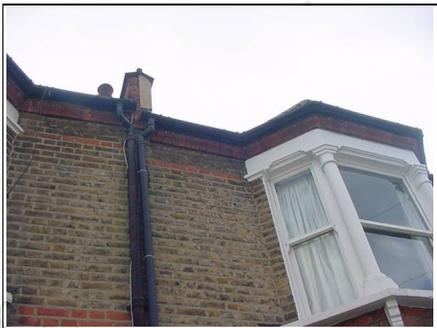
There may be fascias boards but it is very difficult to view due to the guttering. We can see fascias to the rear of the property which are in average for their age, type and style however we had a limited view due to the way that the gutters were hiding them and the brickwork detailing.

Fascias hidden at the front of the property by guttering

ACTION REQUIRED: Make sure gutters and downpipes are watertight before carrying out work on fascias and soffits.

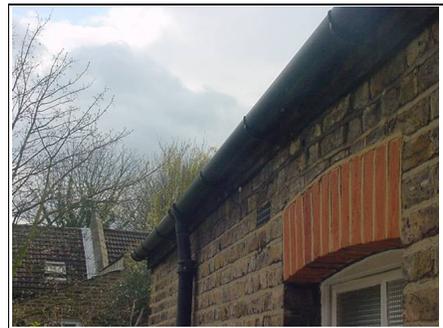
Fascias to the rear

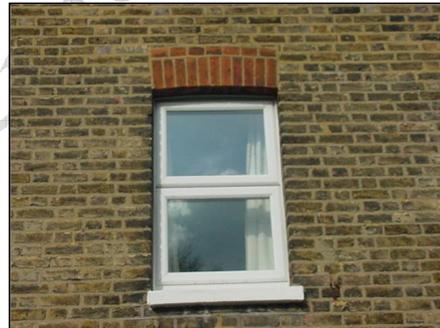
The properties plastic double glazed windows, which generally look to be of a average quality. We would draw your attention to the fact that sealed double glazed units can fail, particularly as a result of poor workmanship during installation. Failure of the seal leads to condensation between the two panes of glass and simply replacing the affected units may not provide a satisfactory long-term solution.

Rear plastic window

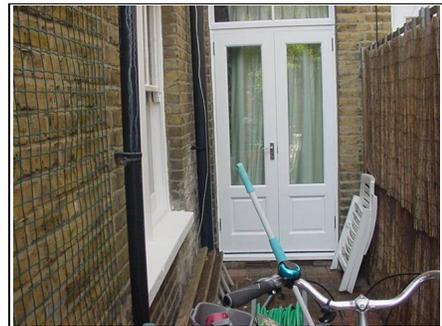
Rear patio doors

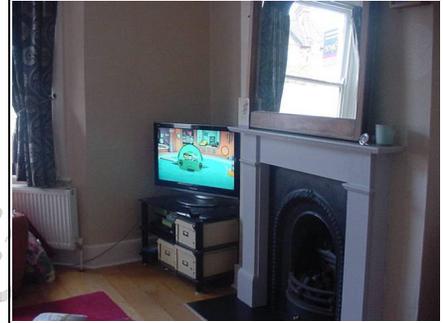
Fireplace in through lounge

It is strongly recommended that flues be cleaned and checked for obstructions prior to use to minimise the risk of hazardous fumes entering the building.

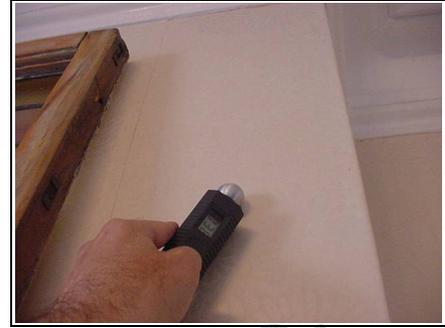
We used a damp meter on the external walls. We have not found dampness.

Testing for lateral dampness

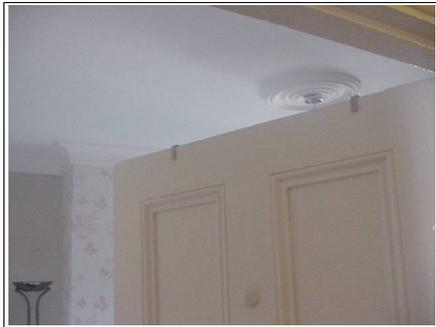
The doors are panelled doors.

Panelled door

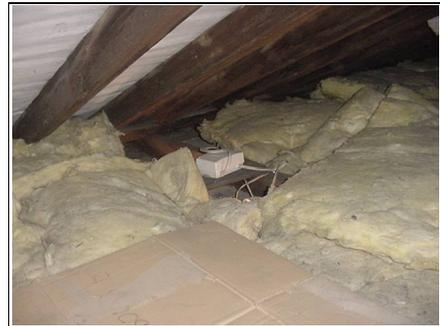
Some roof insulation was present although not to current Building Regulations requirements of 300mm. In this instance the front roof space is boarded out and they may be insulation present but it is difficult to view and in the rear roof there is approximately 200 to 300mm present.

Rear roof insulation

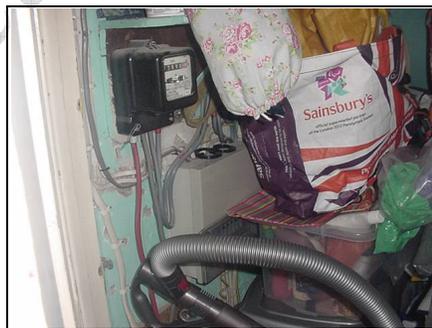
The electric fuses and consumer units were located in the cupboard under the stairs. The fuse board looked dated 1980s/1990s and better are now available.

Fuse Board hidden in cupboard under the stairs

ACTION REQUIRED: As the property is changing occupancy an Institute of Electrical Engineers (IEE) test and report should be carried out by a NICEIC registered and approved electrical contractor or equivalent.

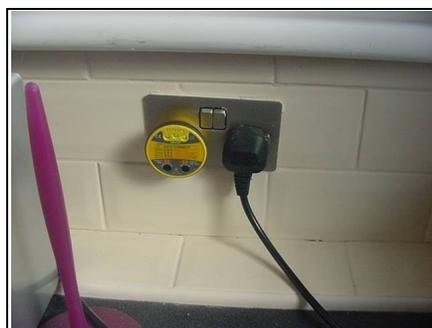
We carried out an earth test in the kitchen area to the socket point that is normally used for the kettle, this proved satisfactory.

Earth Test

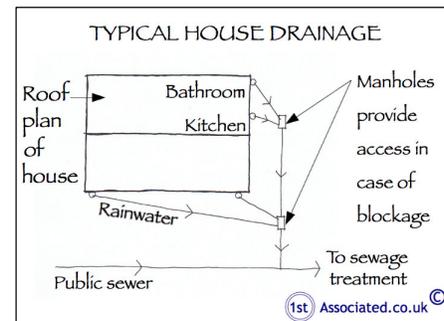
Manholes are used where there is a change in direction of pipes or new pipes join the main run. It is therefore a good location for clearing any blockages. In this case we were unable to see any manholes.

ACTION REQUIRED: We would recommend a closed circuit TV camera report of the drains.

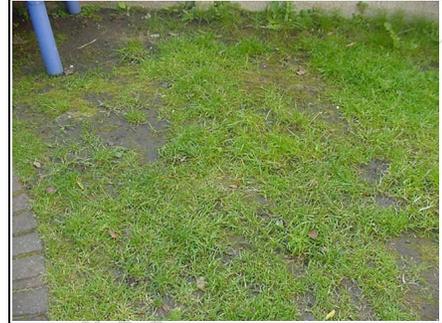
The garden to the rear is fairly small and is very damp; please note our comments with regard to minor dampness in the property and dampness to the rear of the property.

Rear Garden very damp
