# RESIDENTIAL BUILDING SURVEY

OF  
Luton, Bedfordshire, LU2

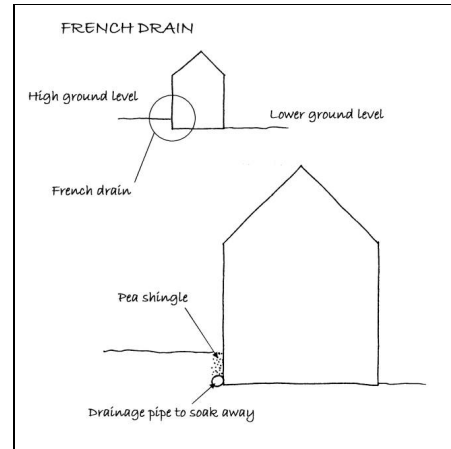
We found rising damp to the chimney on the left hand side (all directions given as you face the property from the front) within the rear lounge and also on the adjoining walls. We believe this is to do with the meeting of the suspended timber floor with the rear concrete floor which can often have areas of dampness.

**ACTION REQUIRED:** As above, you need a French gulley to stop the dampness getting in through the airbricks and also ideally opening up the floor prior to purchasing the property.

**ANTICIPATED COST:** We would expect costs to be in the region of £2,500 - £4,000 as you would need to replaster the walls to get rid of the contaminated plaster and then to redecorate. Please ensure that any damp proof company that you use has an insurance backed guarantee as part of the BWPDA; quotations required.

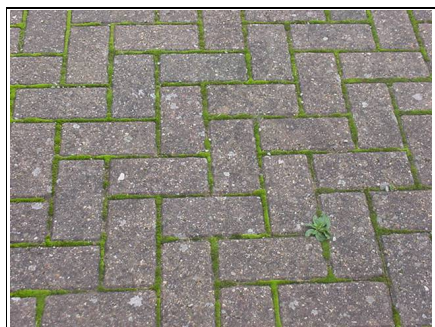
raining hard but we do believe there is a lot of water sitting in this area from the amount of moss that we can see in the blockwork pavement.

Moss in block pavings

**ACTION REQUIRED:** You need to view the property next time it is raining heavily to see exactly where the water is or isn't going. We do believe there is a problem in this area as the running gulleys have been added to the rear door area and one to the rear door of the garage as you can see in the adjoining photo.

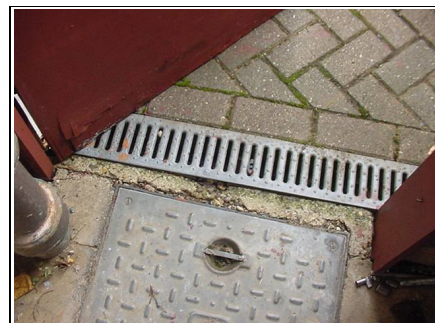
Running gully to garage

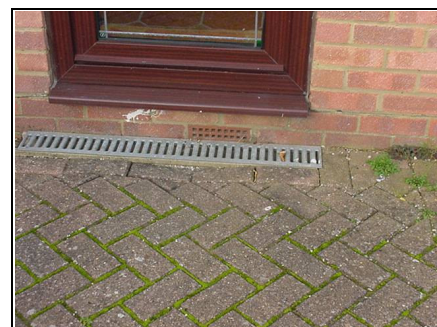
Gully to the rear door

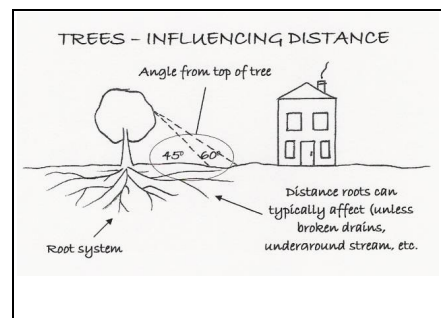
### 3) Tree cut down

We note that the tree has been cut down to the rear of the garden. We would comment that when trees are cut down often areas can have an increase in the water content as the tree is no longer taking the moisture away.

**ACTION REQUIRED:** There is little you can do when a tree has been cut down other than make preventative measures for the increase in water. Please see our comments with regards to dampness and sloping site.

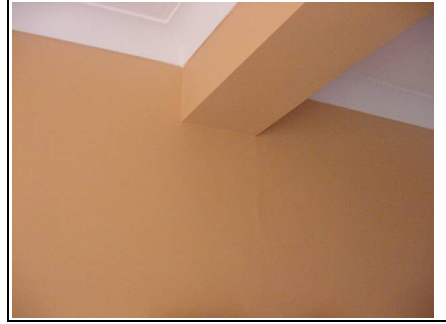
### 9) Extension without a pier support

The rear of the property where it has been extended doesn't have a pier to support one of the columns. What typically happens is that the beams are supported on the wall. Building Regulations do require a nib, the minimum that this nib can be is 300-450 depends on the year of construction. It was often not put in for aesthetics reasons.

**ACTION REQUIRED:** Your solicitor needs to check and confirm that Local Authority approval has been obtained for the rear extension.

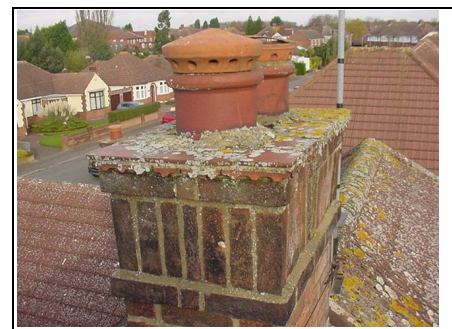
Middle chimney top

This is the chimney where we are getting dampness at the base. It is possible that dampness is getting in through the chimney. It seems the least likely of the three suggestions that we have made in the Executive Summary.

**ACTION REQUIRED:** Carry out repointing as soon as possible and check the flashing.

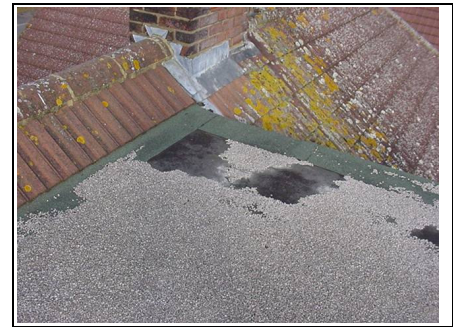
Dormer roof

There is one dormer window to the rear of the property to form the ceiling height within the first floor bedroom. The roof is clad with felt which we managed to get onto and the cheeks/sides are in vertical tiling. The roof as you can see in the adjoining picture is in reasonable condition with a mineral felt edging. It should have had a protective chipping all over it but this was missing in some areas. We believe this relates to the high wind. It is going to be a continuing problem due to the high wind levels in this area.

**ACTION REQUIRED:** You do need to redistribute the chippings to offer a protective coating against the effects of solar deterioration and the frost thaw cycle.

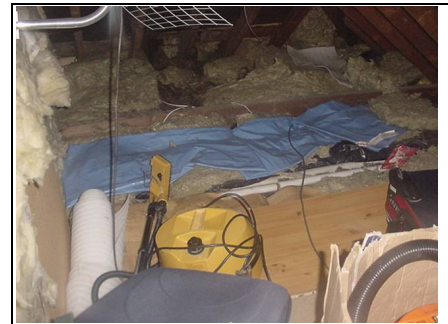
The main roof is accessed via the stairs adjacent to the first floor bedroom. The area had a lot of stored items when we viewed it which limited our view. We viewed it from torchlight and we could see some dampness that had got in here, please see our comments in the Executive Summary.

Our viewing was limited due to amount of stored items

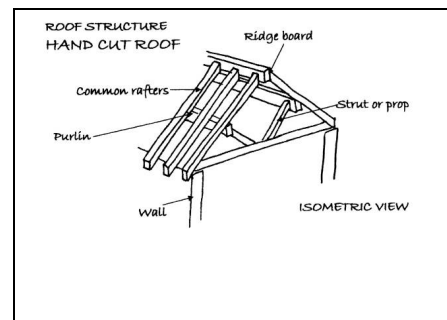
This type of roof is purpose made and hand built on site and is known as a cut roof which has been adopted to form the room in the roof. The original design however is in line with what we typically see. The original roof structure should have been strengthened by adding additional bracing, when the "new" concrete tiles were added as they are heavy.

In this instance due to the configuration of the roof we literally cannot see.

**ACTION REQUIRED:** Your legal advisor to check and confirm that the loft conversion carried out is to current building regulations and Local Authority approval has been obtained.

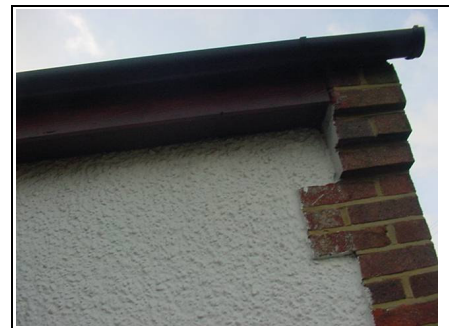
Render

The walls to this property are finished in a painted pebbledash render. With this age of render some deterioration is to be expected. We have carried out a tap test to the render at low level (literally hitting the render with the back of a hammer) to try to establish if there are any hollow areas and found it to be in average condition. It is, however, very important to keep the render in good decorative order as without this the render will deteriorate, effectively it acts as a raincoat.

**ACTION REQUIRED:** Plan to redecorate within the next two years.

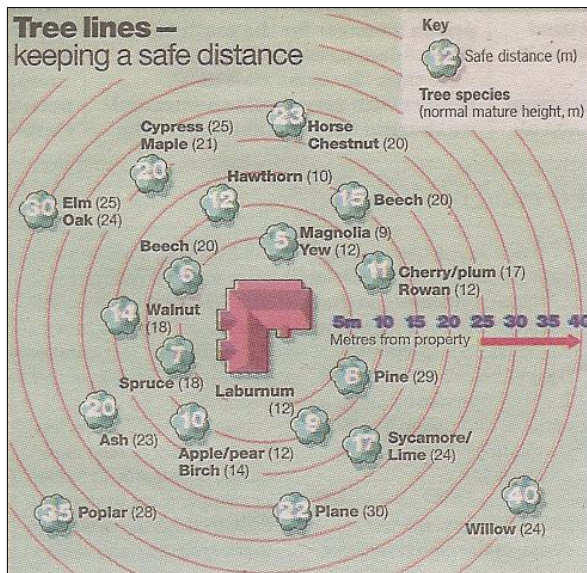
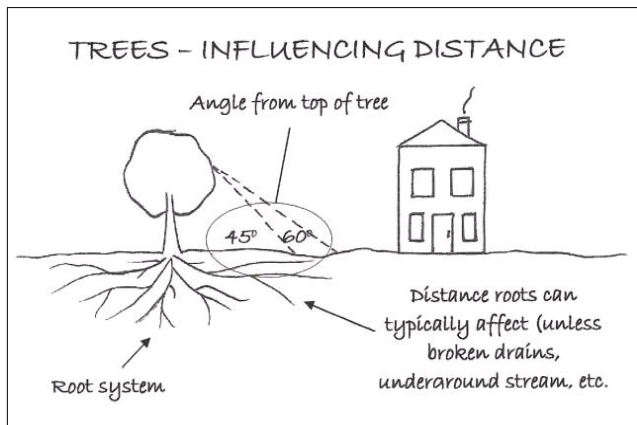
We noted a tree had been cut down near to the house. It was located to the rear garden on the left hand side, which would have been within influencing distance to the house.

**ACTION REQUIRED:** Your legal advisor to ask specifically for further comment on this and advise us for us to comment further.

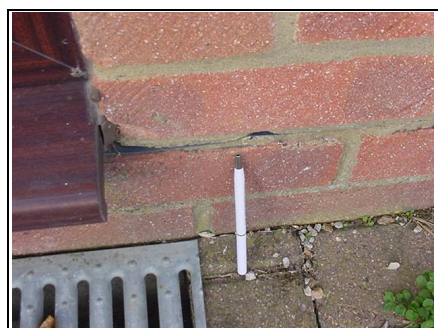
All modern properties should incorporate a damp proof course (DPC) and good building practice dictates that a differential of 150mm (6 inches) should be maintained between the damp proof course and ground levels. In this case, we could see a damp proof course to the property in some areas.

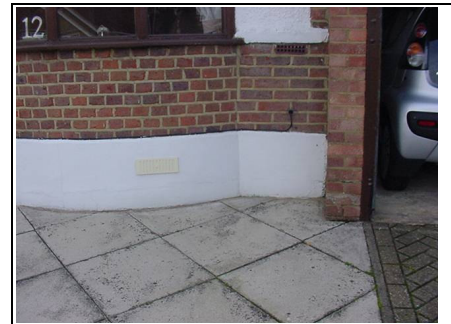
Airbrick to front of property

Without opening up the floor we cannot confirm its condition we would be very surprised if the floor did not have some rot.

**ACTION REQUIRED:** We recommend bricks are bedded around the air bricks to stop water getting into them

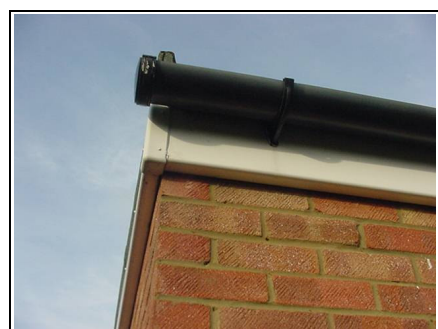
The newer areas have plastic fascia and soffits as you can see in the adjoining photo.

Plastic fascia boards

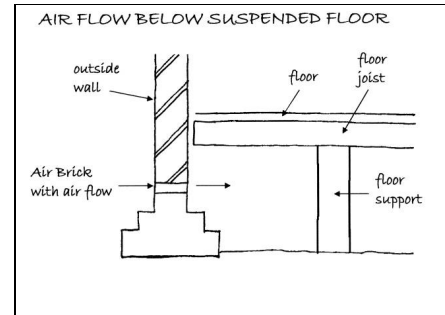
Based on our knowledge of this age of construction we believe that the ground floor construction is predominantly a suspended timber floor. This type of floor needs air circulation under it to reduce deterioration from wet rot and dry rot; please see our comments in these sections.

The remainder is solid underfoot assumed to be concrete. There are air vents on the rear of the property indicating that there may be ducts in the rear concrete section which is a best practice for construction but we rarely find that it occurs. We believe that it may well be the problem behind the dampness that we found. Please see our comments in the Executive Summary.

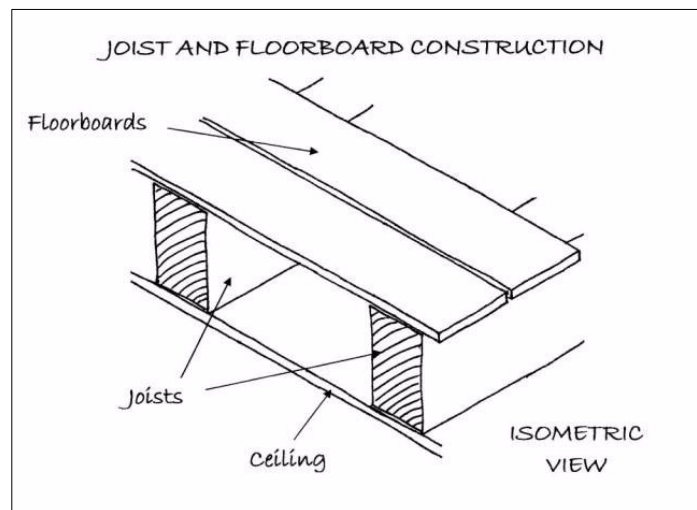
We have assumed that the first floor is joist and floorboards construction having had the original ceiling joists converted to floor joists. However as it is covered we cannot inspect it.

**ACTION REQUIRED:** Your legal advisor needs to check and confirm that Local Authority approval has been obtained for the first floor.

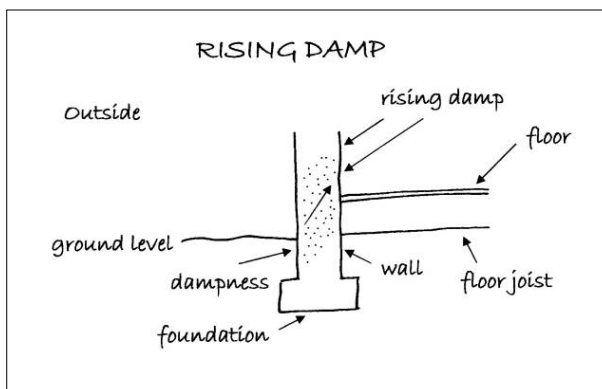
Yes rising damp was found. Please see our comments in the Executive Summary.

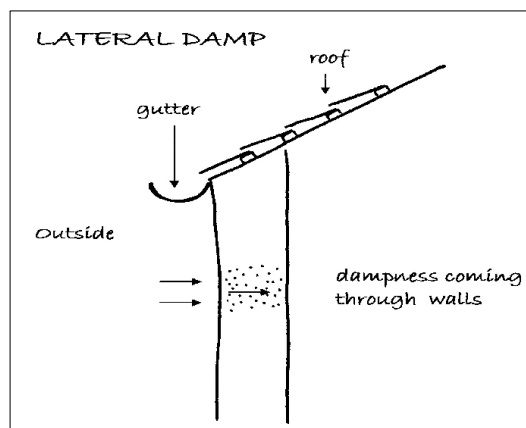
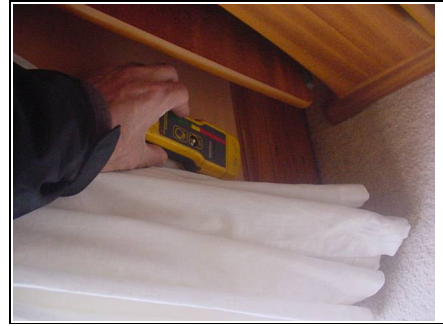
Testing for dampness

Lateral damp was in line with what we would expect for this age of property. Please note our comments with regards to ad hoc repointing being required.

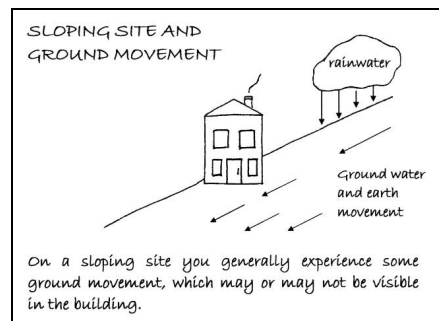
Any property on a sloping site albeit slight as in this case, is more susceptible than one on a flat site; it is simply the laws of gravity. Foundations normally allow for such occurrences, particularly in newer properties, although there can still be some minor movement.

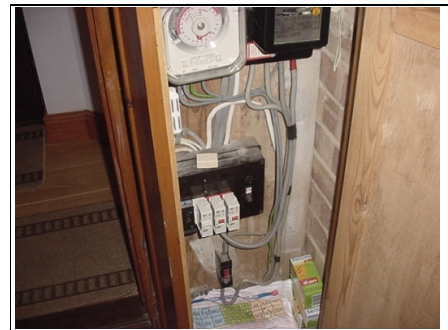
The electric fuse board is in the cupboard in the hallway.

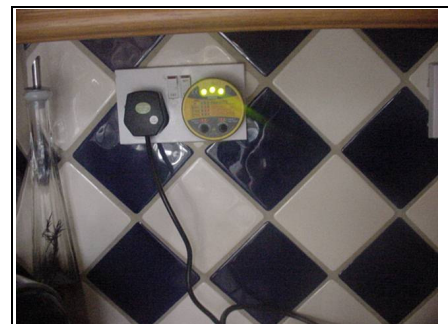
We carried out an earth test in the kitchen area to the socket point that is normally used for the kettle and this did not cause the electrics to trip.

**ACTION REQUIRED:** As the property is changing occupancy an IEE report should be carried out by a NICEIC registered and approved electrical contractor.

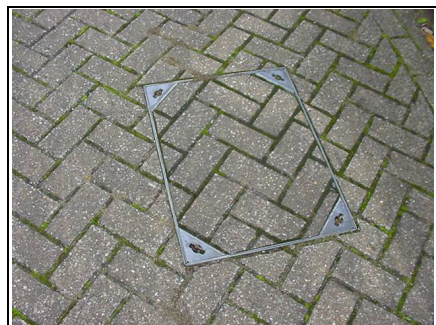
#### **Inspection Chamber / Manhole One located on the front drive just in front of the garage**

We have been unable to lift the man hole cover which is often the case with this type of inset man hole

Manhole we couldn't lift to front of property

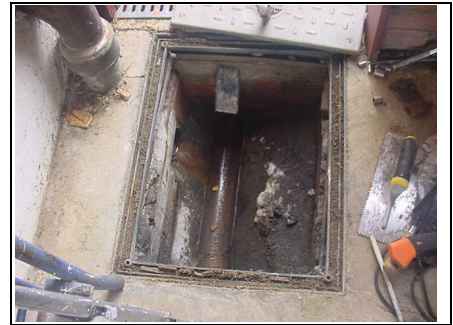
### **Inspection Chamber / Manhole Two – within the garage to the end near the door**

We duly lifted the man hole/ inspection chamber cover and found the drain to be free flowing, we noted it was finished in concrete.

Manhole we could lift

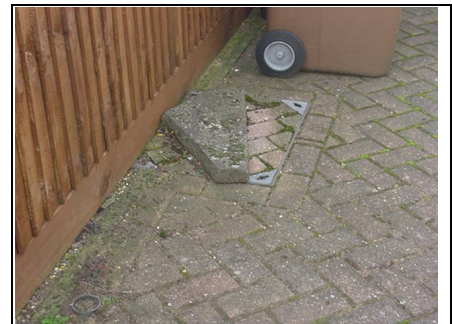
### **Inspection Chamber / Manhole Three – in the garden adjacent to the fence**

Again, we have been unable to lift the man hole cover which is often the case with this type of inset man hole.

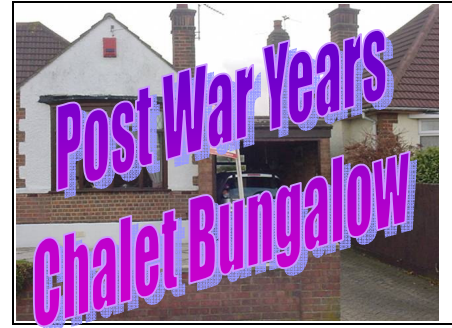
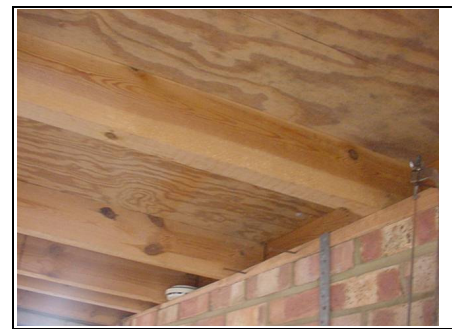
Other side of garage roof

The garage has an older style flat roof, probably 20 years into the 25 year life of a roof unless this type of roof would be able to be patch repaired.
