RESIDENTIAL BUILDING SURVEY

OF
Luton, Beds LU2

1950's
Semi-detached Property

INDEPENDENT CHARTERED SURVEYORS

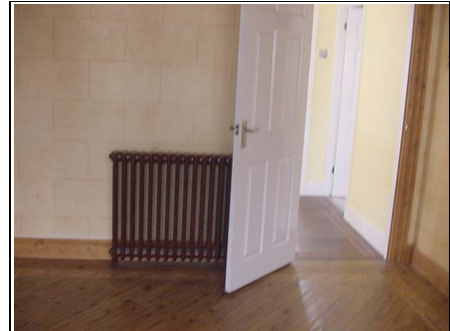
Internal Radiators

The property has internal radiators. Where internal radiators are used you have a higher than average chance of having condensation as you do not get the same amount of air flow around the property as you do when radiators are positioned underneath the windows. Where the warm air rises it meets the colder air of the window and circulates around the room.

ACTION REQUIRED: Relocate the radiators underneath the windows

ANTICIPATED COST: A few hundred pounds per radiator; quotations required.

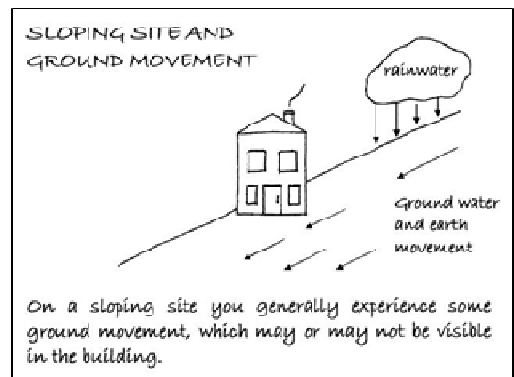
Hard standing to the front

This means that rainwater that lands on the hard standing to the front is directed towards the house and in turn the garage. Due to its position the water discharges towards the house where there are air bricks at low level which effectively act as gutters allowing rain water in underneath the suspended timber floor.

ACTION REQUIRED: You need to protect the air brick and ideally open up the floor to check its condition before you purchase the property. To elaborate further, you have a suspended timber floor which can be affected by dampness getting into it.

ANTICIPATED COST: A few hundred pounds to open up the floor and protect the air bricks. Protection of the air bricks is normally done by putting bricks on edge around them. In a worst case scenario there may already be damage to the timber under the floor; quotations required.

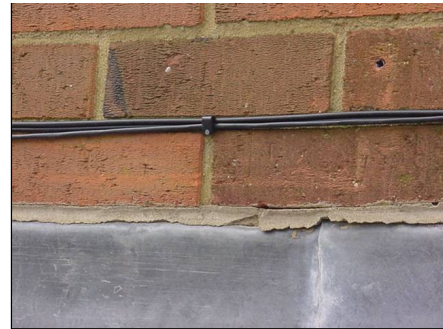
Roof tile

The garage to the left hand side has a shallow pitched large concrete tile roof. From what we can see it is in reasonable condition. However, we would comment that the angle of it is relatively low and may allow wind driven rain in and also it has a very awkward gutter detail that you need to see. The flashing is coming away as it has been wrongly pointed.

ACTION REQUIRED: Please see our comments in the Executive Summary and repair the flashing.

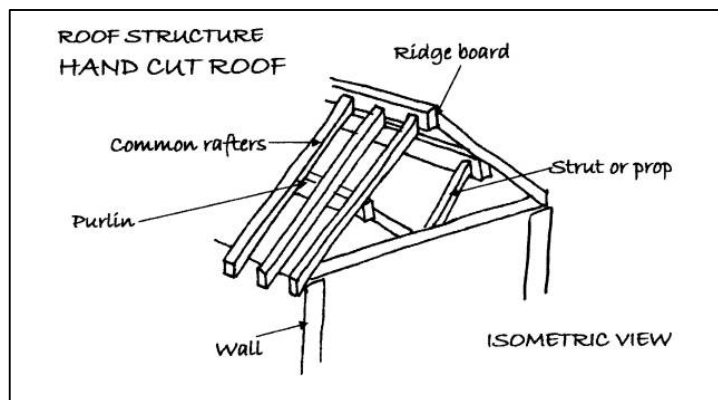
Roof Timbers

We found the roof timbers generally in average condition considering their age. There was an unusual stepped purlin detail. We have inspected the roof structure for:

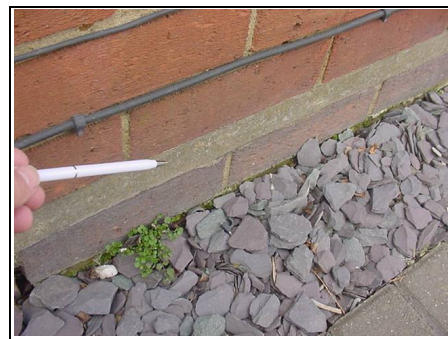
DPC – thickening of cement mortar

All modern properties should incorporate a damp proof course (DPC) and good building practice dictates that a differential of 150mm (6 inches) should be maintained between the damp proof course and ground levels. In this case we noted a thickening of the cement, which usually means a built in DPC.

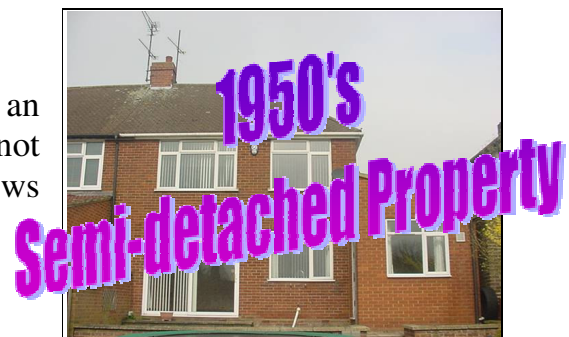
Plastic windows

We would draw your attention to the fact that sealed double glazed units can fail, particularly as a result of poor workmanship during installation. Failure of the seal leads to condensation between the two panes of glass and simply replacing the affected units may not provide a satisfactory long-term solution. In this case they are in average condition.

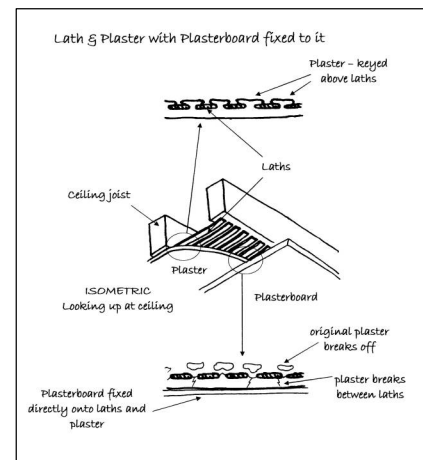
The internal walls of the property are mainly solid. We notice some hairline cracking in some of them. There could be latent defects hidden behind the decoration and we have no way of knowing.

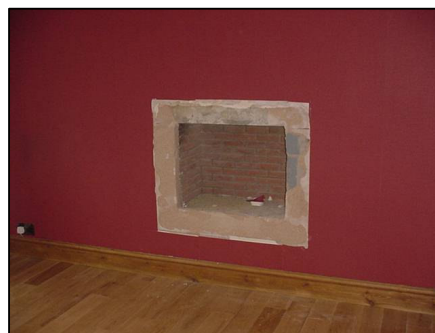
The fireplace has been removed in the main lounge but was obviously a feature of the room.

Any chimneys that you do not propose to use should be capped and ventilated to prevent dampness. In this case we have identified problems with the chimneys that need to also be rectified prior to using them. We are not able to advise whether a lining has been added.

ACTION REQUIRED: You should specifically request your solicitor asks the vendor's solicitor if any linings have been added to the chimney.

Finally, it is strongly recommended that flues be cleaned and checked for obstruction prior to use to minimise the risk of hazardous fumes entering the building.

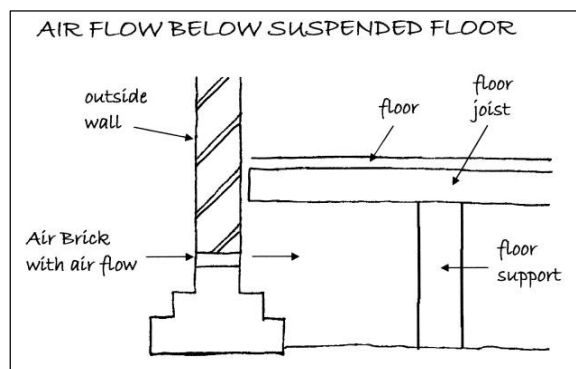
The ground floor construction is predominately a suspended timber floor. This type of floor needs air circulation under it to reduce deterioration from wet rot and dry rot; please see our comments in these sections.

The floor covering means we cannot see the floor structure.

ACTION REQUIRED: We are concerned that we are unable to see the floor timbers and the floor structure. There may be dampness beneath it due to the way the air bricks are acting as gutters to the front of the property. We strongly recommend the floors are opened up prior to purchasing the property. If they are not opened up there is an element of risk you are taking on.

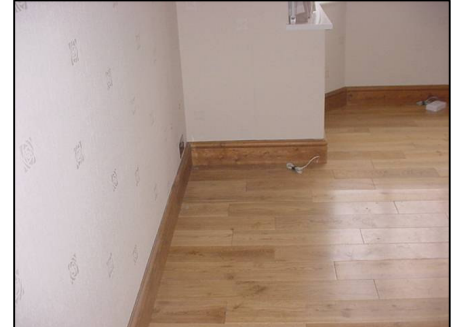
Floor covering not allowing you to see floor beneath

Finally, we have not been able to view the actual floors themselves due to them being covered with floor coverings, laminated flooring and tiles. The comments we have made are based upon our experience and knowledge of this type of construction. We would emphasise that we have not opened up the floors in any way or lifted any floorboards.

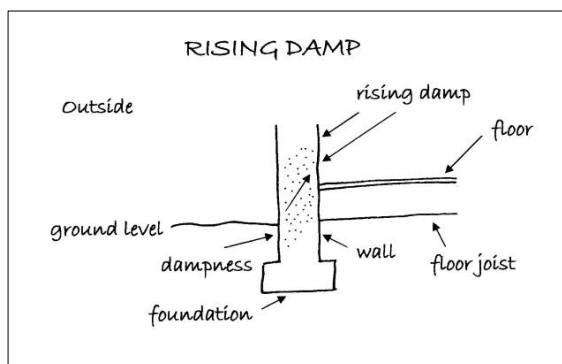
No evidence of any significant rising dampness was detected in the areas checked. It is not usual in a property of this type and age to have minor damp particularly to the front where the slope at the front discharges water against it.

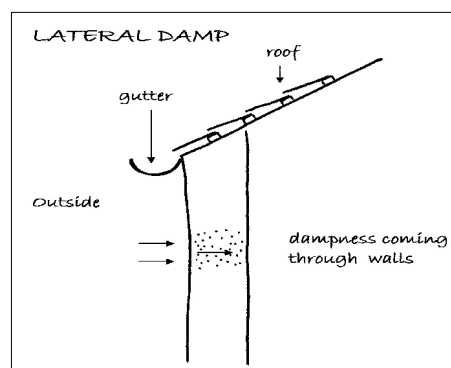
A visual inspection was carried and tests were taken with an electronic conductivity meter at selected points to walls. No significant penetrating/lateral dampness was seen or detected considering the properties age type and style.

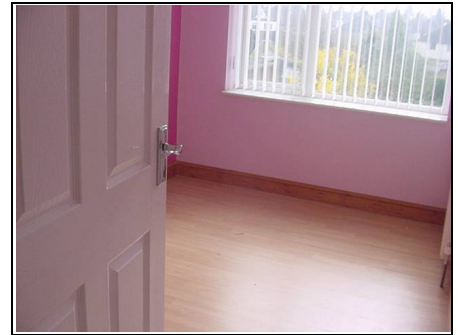
Panelled door

The property has pressed panelled doors. These are from the cheaper end of the market. Unfortunately if they get damaged they are difficult to repair.

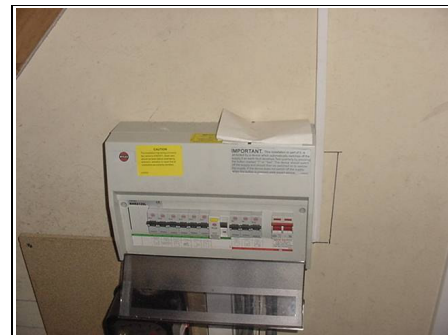
Fuse board

The electric fuses and consumer units were located under the stairs. We would date the fuse board as being from the 1990s – 2000s and, whilst not the best now available, it is reasonable.

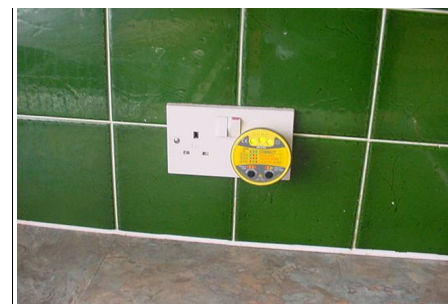
Earth Test

We carried out an earth test in the kitchen area to the socket point that is normally used for the kettle and this proved satisfactory.

Neither of these indicators can give certainty as to the condition of the rest of the wiring.

ACTION REQUIRED: If there is no record of an electrical test having

been undertaken within the last five years, it is recommended that the installation be tested by a competent electrician (NICEIC registered) and all recommendations implemented. Thereafter, the installation should be re-tested every five years.

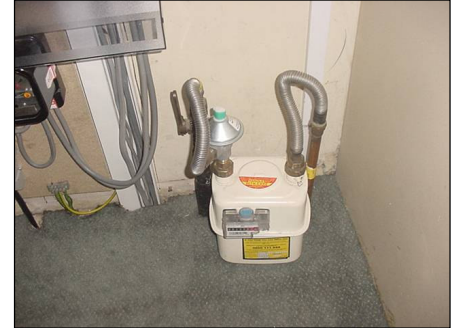
The gas meter cupboard is located under the stairs. All gas appliances, pipework and flues should be the subject of an annual service by a Gas Safe registered heating engineer; works to any gas appliance by an unregistered person is illegal. Unless evidence can be provided to confirm that there has been annual servicing we would recommend that you commission such a service prior to use to ensure safe and efficient operation.

Gas meter cupboard located under stairs

ACTION REQUIRED: As a matter of course it is recommended that the entire gas installation is inspected and made good, as necessary, by a Gas Safe registered contractor. Thereafter the installation should be serviced annually.

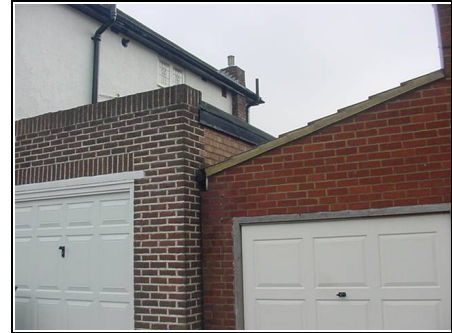
Garages are a useful addition, there was no car at the time of our inspection so it is difficult to gauge if cars can go into it and you do need to be aware that it is likely to leak.

ACTION REQUIRED: Please see our comments in the Executive Summary with regard to the roof.
