RESIDENTIAL BUILDING SURVEY

XXXXXXXXXXXXX,
Luton,
Bedfordshire,
LU3

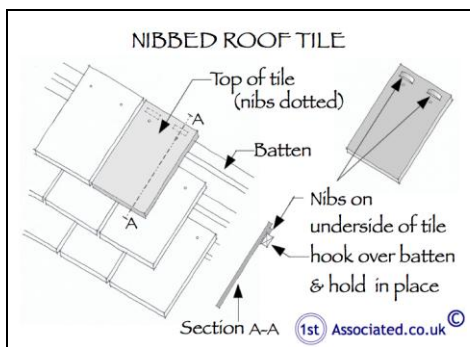
The original roof has nibbed tiles without a protective underlayer. This type of roof has been superseded by a modern roof with a protective underlayer. We would recommend that a protective underlayer is added to the roof.

Nibbed tile

ACTION REQUIRED: Within the next five to ten years we would remove the existing roof and add a protective underlayer, re-batten and add the tiles. You will probably have in the region of thirty per cent waste so you will need to replace some of the tiles.

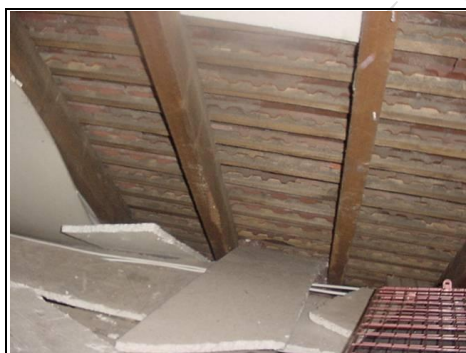
Nibbed tile with no underlayer

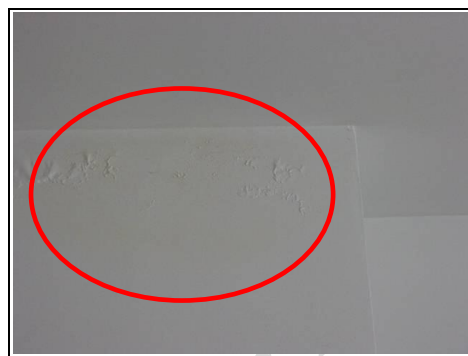
We can see in the top front bedroom sulphate attack from the chimney. This is normally caused where dampness gets into the chimney and is drawn through the soot causing damage and deterioration.

Sulphate on chimney breast

ACTION REQUIRED: Repairs are needed to the chimney. Again this is likely to require scaffolding and this will be the most expensive part of the cost

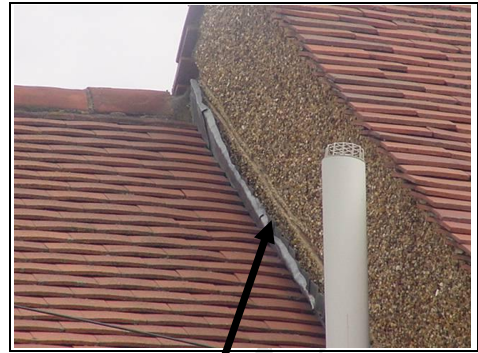
Flashing coming away where there is an up-stand between the two roofs.

ACTION REQUIRED: We would recommend a tradesman that is used to carrying out lead work is used. We prefer to see bonding in Plumbers Mate or equivalent mastic to bed the lead into the wall.

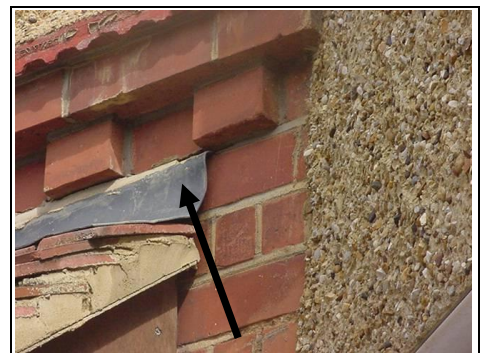
Lead coming away over front entrance

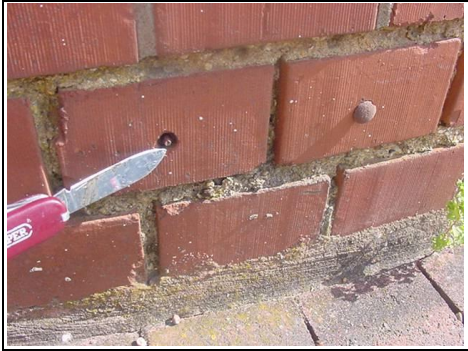
There is some dampness to the front of the property. We can see externally that a damp proof course has been added.

Inserted damp proof course in original property

ACTION REQUIRED: There has been a damp proof course inserted into the older part of the property. There may well be a guarantee with this.

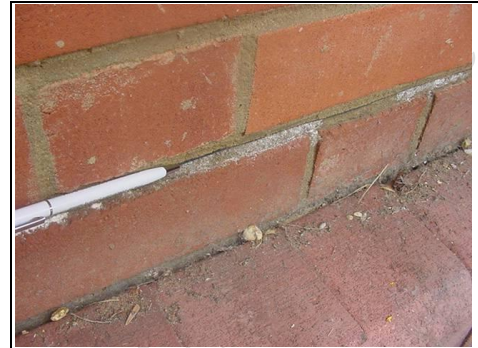
Damp proof course is too low to new extension

With regard to the damp proof course being too low, this is a general problem that we come across where brick paves are added to existing ground levels making it higher. In this case you only have one brick between the ground and the damp proof course.

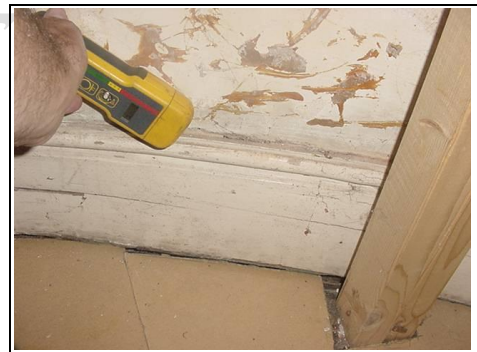
Taking damp readings in bay window area

We believe the main problem regarding the dampness is a lack of ventilation underneath the property but we cannot be certain until the floors are opened up. These do need to be opened up to check the airflow goes from the front to the rear of the property. Please see our photos below that show some of the air bricks have been covered up. These need uncovering.

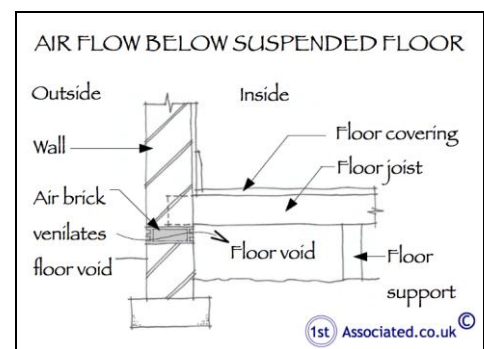
Suspended floor

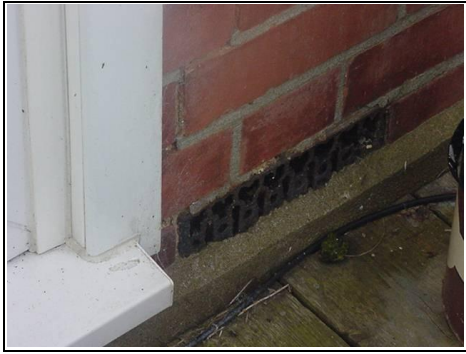
Air brick to the rear

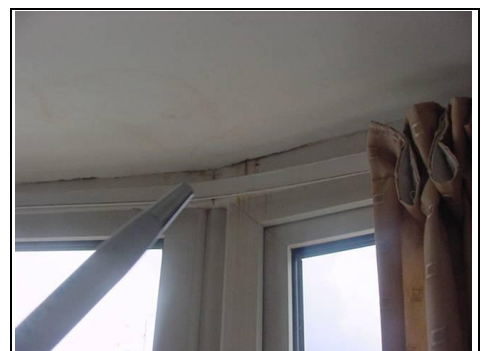
Dampness in bedroom

ACTION REQUIRED: Dampness is coming in via the fascias and soffits or the flat roof. Both need to be looked at. This is likely to need a tower scaffold to the front of the property.

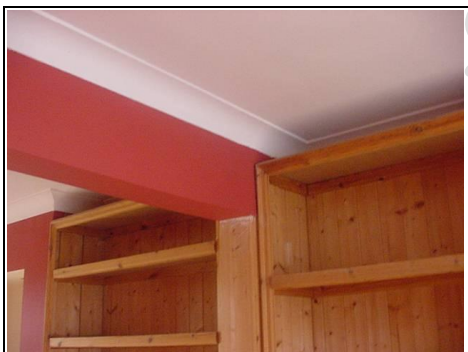
Two walls have been removed and this should have had Building Regulation approval to remove them.

Wall removed in through lounge
We cannot tell if this has been removed properly

ACTION REQUIRED: Your legal advisor to check and confirm if Building Regulation approval has been obtained.

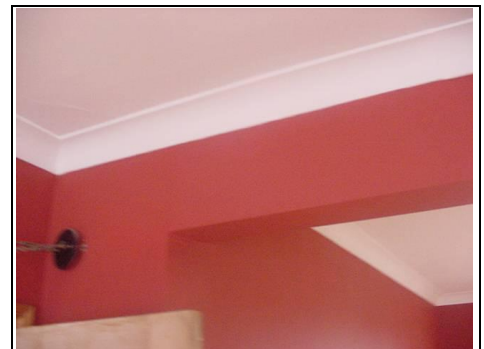
Wall removed as seen from the other side

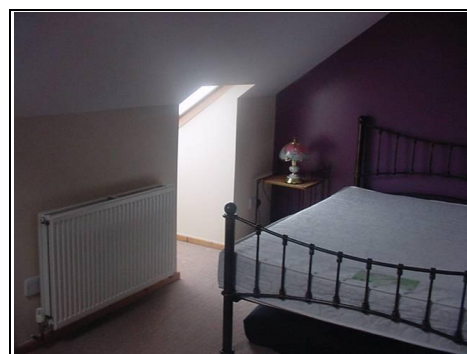
Room in the roof

The loft has been converted and from what we understand Building Regulations and Planning Permission have not been obtained. This is only useable as a storage space/ normal roof as opposed to a habitable room. To bring this up to standard you would need to get Local Authority approval.

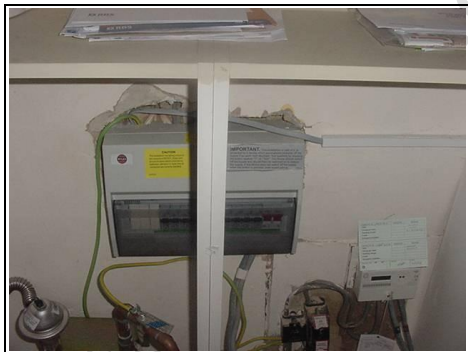
Fuse board

The fuse board looks to be dated circa 1980's/1990's and better are now available. We would suggest this is upgraded as we can see in some areas DIY electrics have been added.

ACTION REQUIRED: Have an Institute of Electrical Engineers standards (IEE) test and report carried out by an NICEIC registered and approved electrical contractor or equivalent.

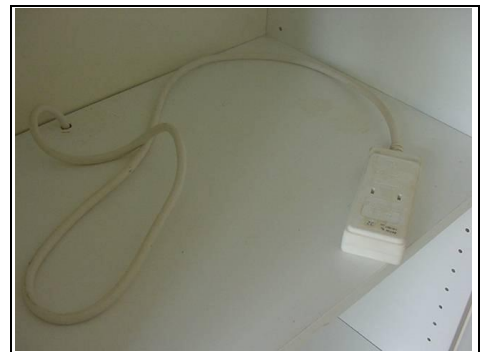
DIY electrics in cupboard in utility room

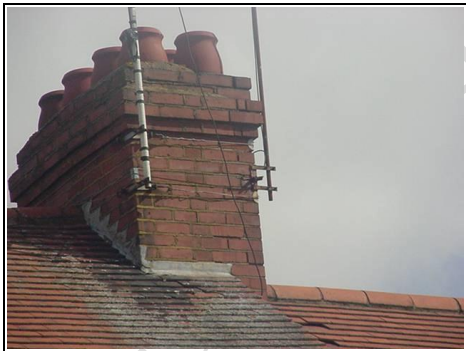
Chimney - right

This chimney is brick finished with a lead flashing and several chimney pots. From what we could see from ground level it looked in below average condition considering its age, type and style. This is based upon the sulphate attack we can see inside the property.

ACTION REQUIRED: Please see our comments within the Executive Summary. Periodically inspect the chimney.

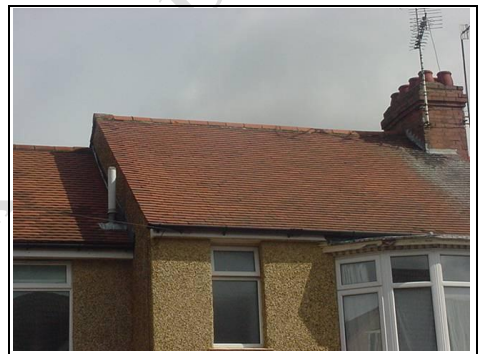
Main roof

The main roof is pitched and clad with a nibbed clay tile and from ground level, this looks in average condition considering the roofs age type and style. However from within the roof space we could see that no protective underlayer has been added.

Whilst this roof may be water tight ninety nine per cent of the time there is still the possibility of wind driven rain causing dampness. Also should a tile be damaged or displaced for whatever reason then there is no secondary protective layer as there is with a roof that has a protective underlayer.

ACTION REQUIRED: Please see our comments within the Executive Summary and carry out periodic inspections and maintenance of the roof, as required.

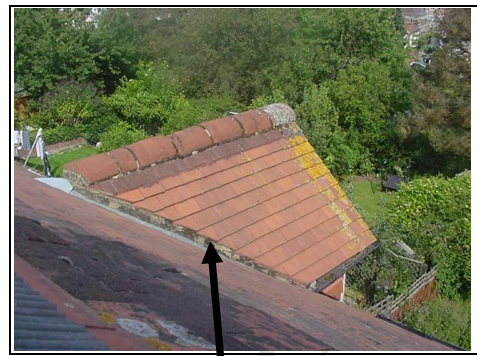
There is a valley gutter to the rear of the property around the dormer window. This appears to be made from GRP (Glass Reinforced Polyester). We do not think these have been in use long enough for us to comment as to whether it is a good material or not. We tend to prefer traditional materials such as lead is used for these important junctions as valley gutters are problem areas.

Valley gutter around dormer window

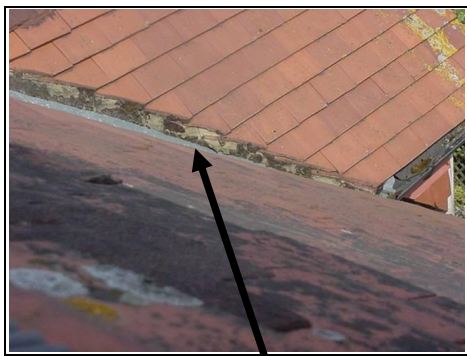
GRP Valley gutter (rear)

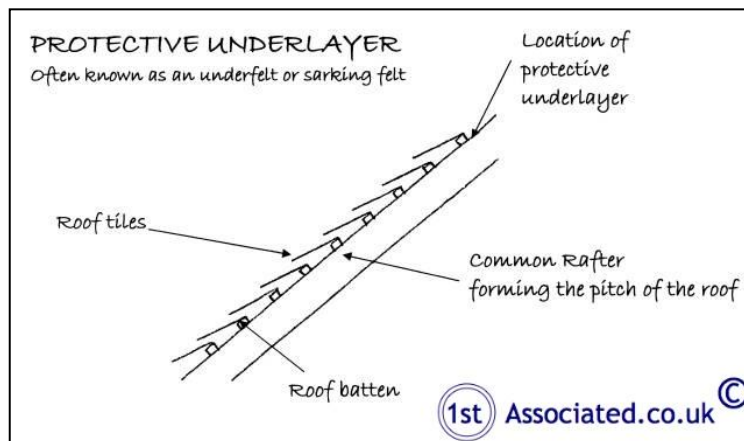
Original main roof

There is no protective underlayer to the original roof but there is one to the newer extension. This is a modern protective underlayer and looks to be a breathable variety.

ACTION REQUIRED: Please see our comments within the Executive Summary.

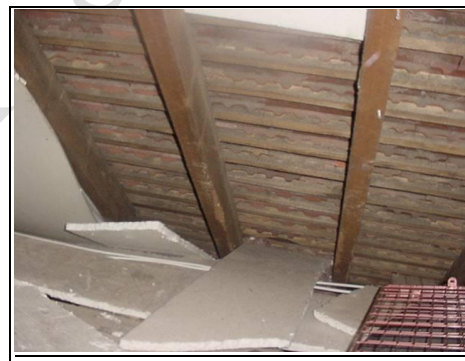
This photo shows the common rafters (the ones that form the pitch of the roof) and the nibbed tiles with no protective underlayer.

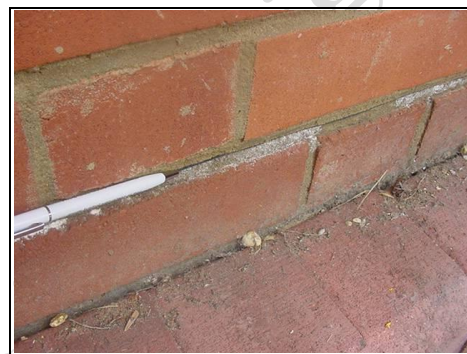
All modern properties should incorporate a damp proof course (DPC) and good building practice dictates that a differential of 150mm (6 inches) should be maintained between the damp proof course and ground levels. In this case, we can see a DPC in new extension of the property. This is slightly low. There is an injected damp course visible to the older part of the property.

Picture of DPC in new extension

ACTION REQUIRED: Please see our comments within the Executive Summary.

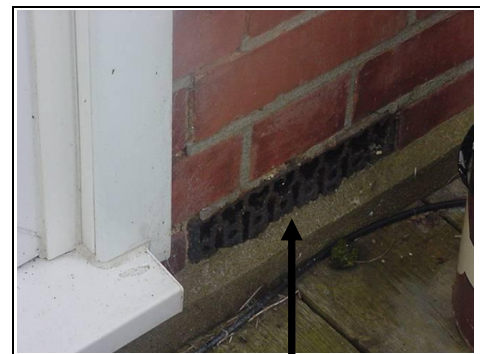
Air brick at rear, possibly blocked

ACTION REQUIRED: Please see our comments within the Executive Summary. You must have airflow underneath the property.

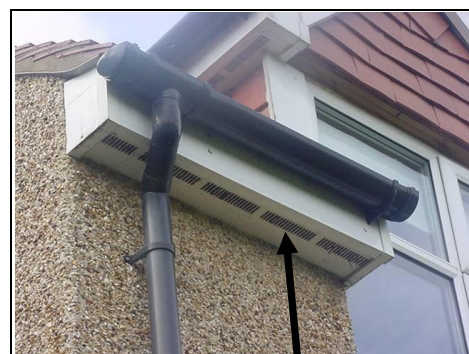
Vents in plastic fascia and soffits

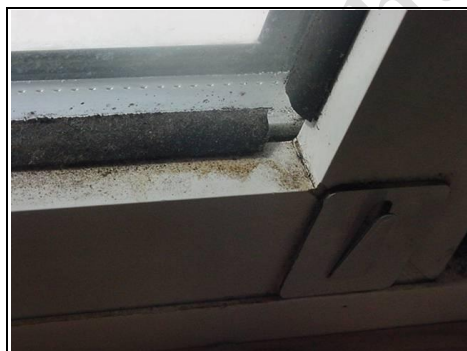
- Internal strips from the cheaper original windows have not been cut to correct size

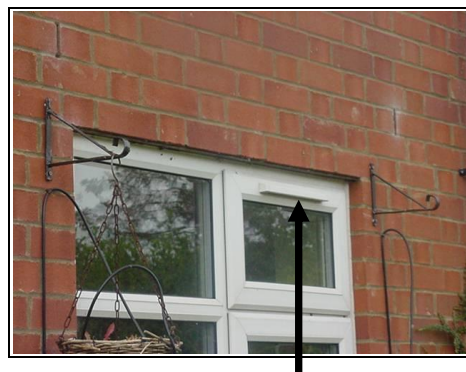
New window with trickle vent

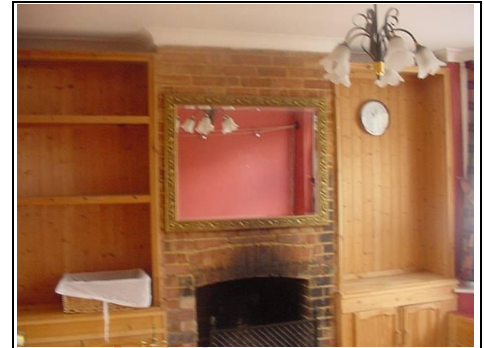
Chimney breast front of through lounge

At the time of the survey no chimneys were in use. However the chimney in the front of the through lounge appears to have been used from the blackness around it.

ACTION REQUIRED: Please see our comments in relation to the sulphate attack on the chimney within the Executive Summary.

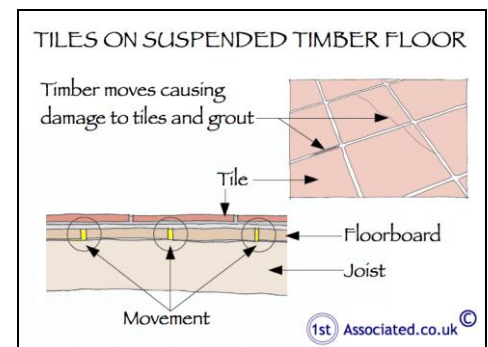
Tiles on suspended timber floor

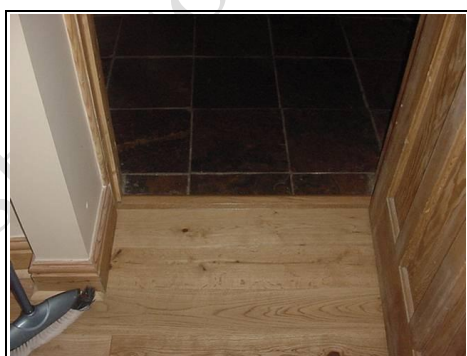
Laminate and tiles on the timber floor

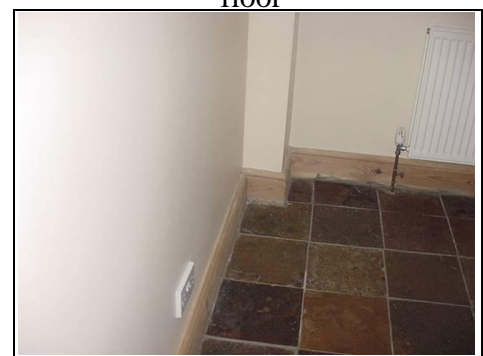
Tiles on a timber floor

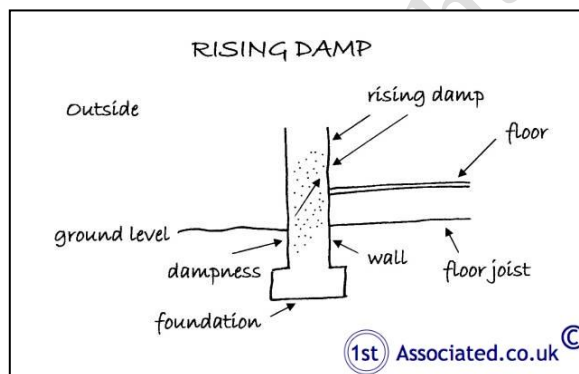
A visual inspection and tests with a moisture meter have been taken to the perimeter walls. In this particular case we have found some rising damp to the front bay although this was relatively minor.

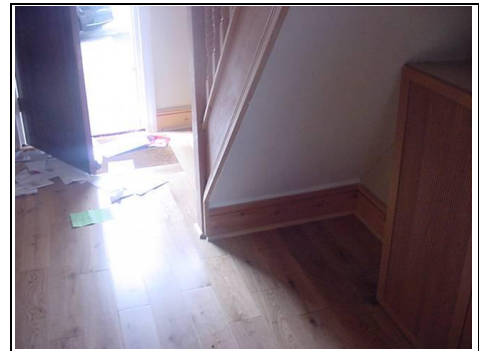
We were unable to examine the underside of the stair timbers due to it being lined, which precluded our inspection, so we cannot comment further upon the stair structure. We can, however, say that the lining gives a resistance to the spread of fire if such circumstances were to occur.

Stairs are lined

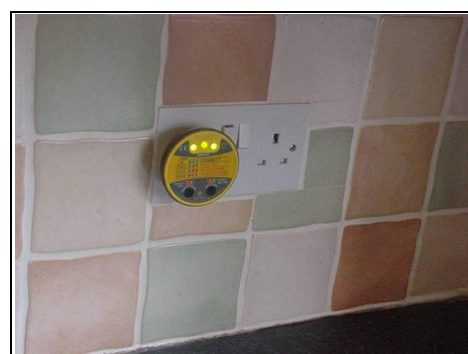
Earth Test

We carried out an earth test in the kitchen area to the socket point that is normally used for the kettle, this proved satisfactory.

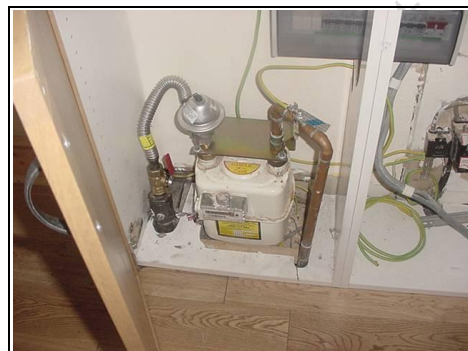
Gas in the cupboard under the stairs

ACTION REQUIRED: As a matter of course it is recommended that the entire gas installation is inspected and made good, as necessary, by a Gas Safe registered contractor. Thereafter the installation should be serviced annually.

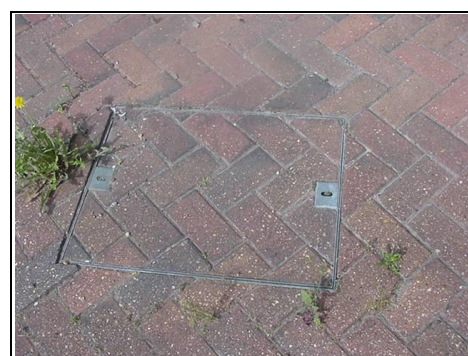
Manhole (front)

We have not lifted the manhole.

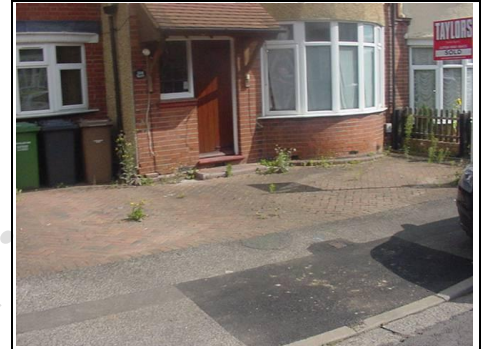
Front parking area

The front garden has been given over to parking. We were pleased to see there was a dropped curb meaning that it is an official parking area.
