RESIDENTIAL BUILDING SURVEY

Buckinghamshire

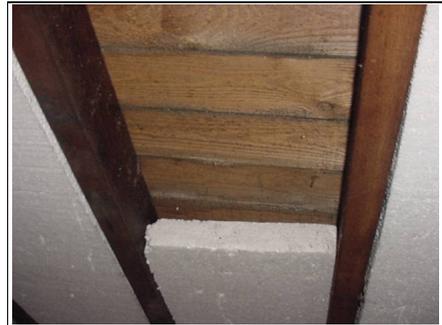
Part of the insulation removed to see the close boarding

We can see staining to the valley gutters, particularly in the roof conversion. Although we didn't obtain excessive damp meter readings we did find some in the rear right hand bedroom (all directions given as you face the front of the property).

ACTION REQUIRED: We wouldn't advise buying this property unless you are happy to carry out future repairs, possibly re-roofing in the not too distant future. The number of years is very difficult to estimate without opening up the roof, the close boarding beneath it does hide any problems (as well as making it a very strong roof) but it is the water-tightness that is in question in this instance.

ANTICIPATED COST: We feel that you should be looking for a £10,000 - £15,000 reduction in the price of the house to reflect the future risk of the roof repairs or the present owners can open up the roof or re-roof the property (note next door have a new roof). Please obtain quotations.

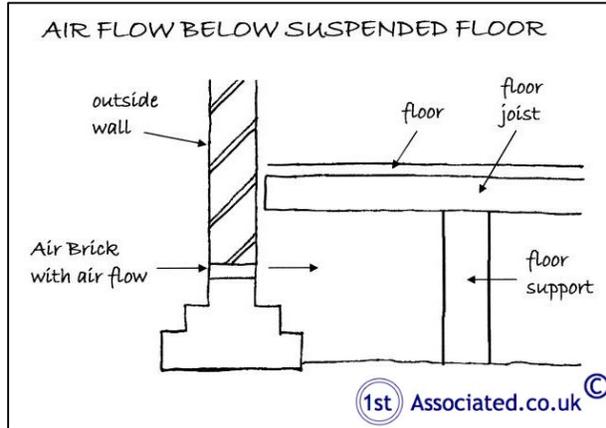
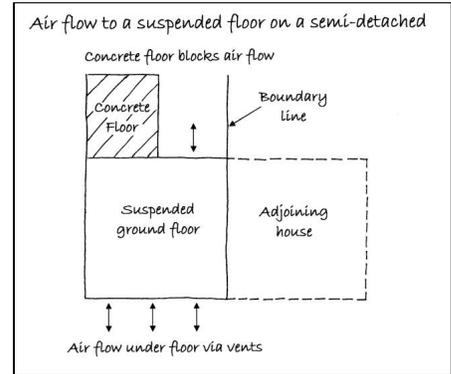
The floor is part suspended timber and part solid. Often with this type of flooring it blocks up the airflow which is needed underneath the original suspended timber floor to prevent woodworm, wet rot and dry rot. In this case there may well have been vents under the new floor, although we cannot be certain.

Original plan view of the property. Where the rear arrow is, there has now been a single storey extension which means the airbricks are blocked in theory.

ACTION REQUIRED: Present owners to provide sets of drawings for the extensions to check if air vents were put underneath the floor. Either way, we would recommend you open up the floors to check there is an air ventilation underneath the floors and we would recommend adding additional airbricks.

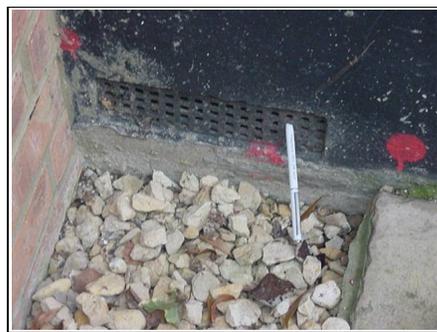
The airbricks that we can see to the side of the property are relatively low and may be acting as gutters, allowing water in.

Airbrick acting as a gutter

ANTICIPATED COST: Assuming the floor is not damaged or deteriorated then we would expect costs to be in the region of a few hundred pounds for adding additional airbricks, possibly more if you have to replace some timber; please obtain quotations.

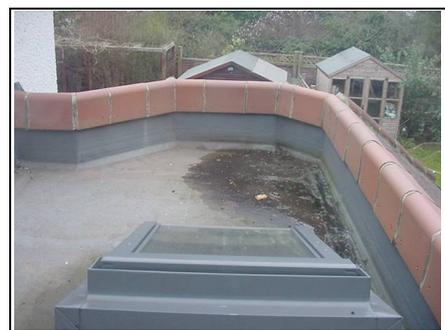
The roof windows to the flat roof extension were slightly different to usual as it has a fibreglass surround which means it is at a slight angle, which we were pleased to see, although there is ponding on the roof itself which is covered later on in this report.

Roof window to rear flat roof

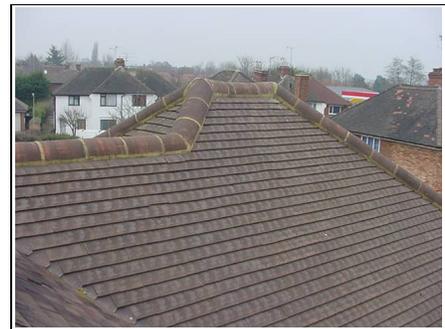
Main roof

The main roof is hipped, pitched and clad with a clay tile. The clay tiles will likely have nibs onto a close boarded roof.

ACTION REQUIRED: Please see our comments in the Executive Summary. Carry out periodic inspections and maintenance of the roof, as required.

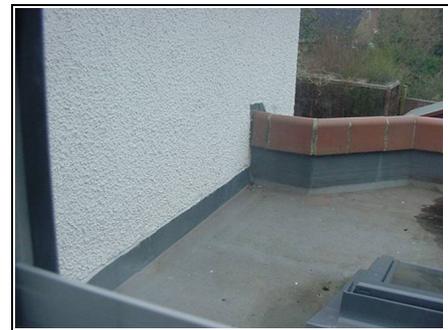
Unfortunately with this roof we can see ponding on it (this is where water is sitting on it), which does tend to deteriorate roofs quicker. Having said all of that, it is still a relatively new fibreglass roof, therefore should have some life left in it. You may live perfectly well underneath it for many years to come.

Rear flat roof

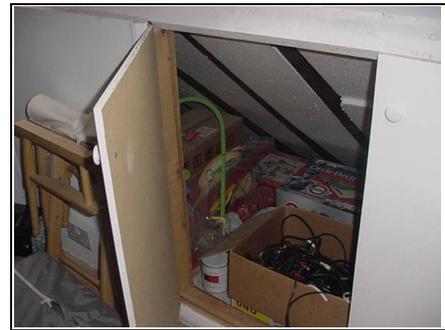
The main roof is accessed via a small hatch to the side of the building located to the rear of the room in the roof. From within this area we could see the common rafters (the ones that form the pitch of the roof) and the insulation between them. It has been viewed by torch light, which has limited our viewing slightly.

Roof access is via small hatch in side of the building

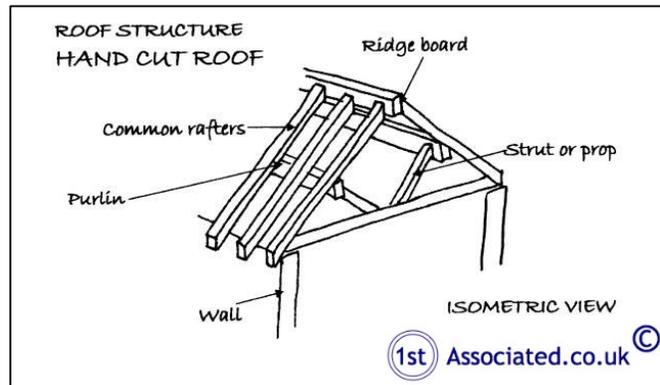
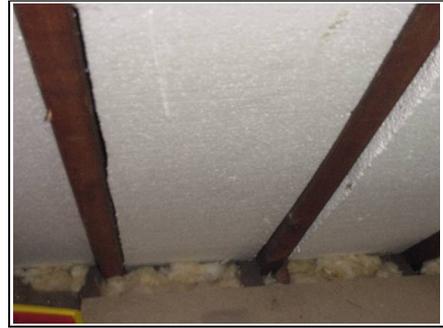
Roof timbers

We had a limited view of the roof structure. From what we know of this type of construction it is a hipped cut timber roof. There may have been amendments to it and the removal of struts or props to allow the forming of the room in the roof. This may be partly contributing to the movement that we could see although a close boarded roof such as this is extremely strong.

Our examination was limited by the general configuration of the roof, the room in the roof and the insulation. We could see approximately five percent of the roof structure. What we could see was generally found to be in average condition for its age, type and style. It is, however, feasible that there are problems in the roof that are hidden.

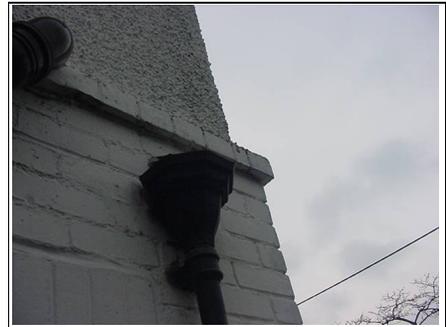
The property has a mixture of the original cast iron and plastic gutters and downpipes. They are fairly typical of what we see and are in average condition for their age, type and style. Cast iron of this age will need maintenance. If regularly maintained it lasts longer than plastic, in our experience.

Cast iron gutters and downpipe

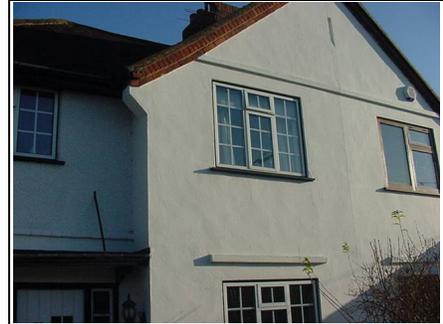
Smooth render to the front

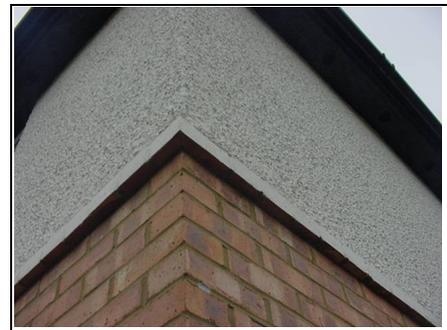
Pebbledash render

Cracking

We would remind you that any hairline cracks that appear need to be sealed as soon as possible to stop dampness and water getting in and causing blisters and hollow areas.

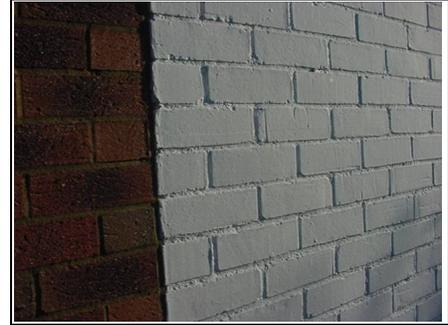
Do not underestimate the amount of time/cost it will take to repaint the property particularly as there is high level work which is likely to need scaffolding which can be expensive.

Painted brickwork

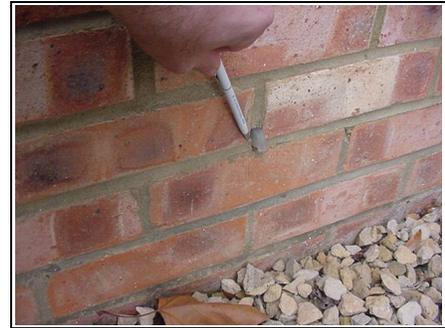
All modern properties should incorporate a damp proof course (DPC) and good building practice dictates that a differential of 150mm (6 inches) should be maintained between the damp proof course and ground levels. In this case we can see a DPC to the newer part of the property. In the older part of the property we cannot see one due to the render; there may be a slate brick behind the render plinth.

Damp proof course

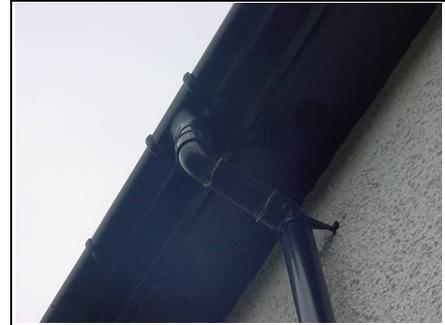
The fascias and soffits are timber. They are painted and we would comment they are in average condition for their age, type and style.

Fascias and soffits

ACTION REQUIRED: Carry out periodic inspections.

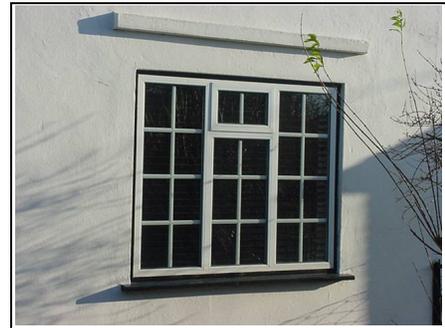
The property predominantly has aluminium windows with a protective coating, which are set within a timber frame. This type of aluminium window was common in the 1970's to 1990's, but now tends to be less fashionable partly because of condensation problems with them. Some of the windows have trickle vents and some do not.

Double glazed aluminium windows

ACTION REQUIRED: There may be a Conservation Area requirement to keep metal windows in this instance. Bearing in mind the problems with condensation we recommend your Legal Advisor checks this and advises us if there a requirement to have metal framed windows.

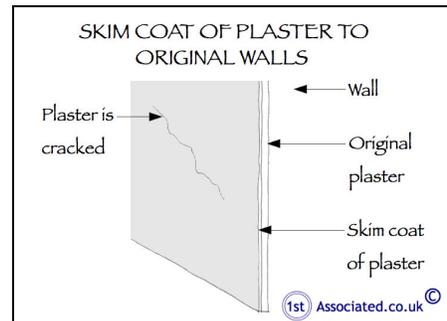
Originally these would have been constructed with a wet plaster, possibly a lime plaster. We believe they have had a skim coat of gypsum plaster which is now cracking.

ACTION REQUIRED: Please see our comments in the Executive Summary with regards to the hairline cracking that was found in many walls. This relates to a combination of things from the humidity and condensation in the property to the difficulty of skimming a lime plaster wall not prepared properly.

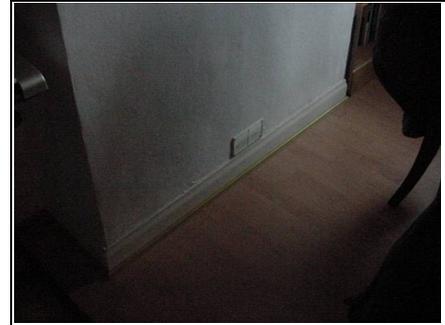
We were pleased to see that the chimneys not in use were vented, although we would much prefer larger vents.

Vented chimney

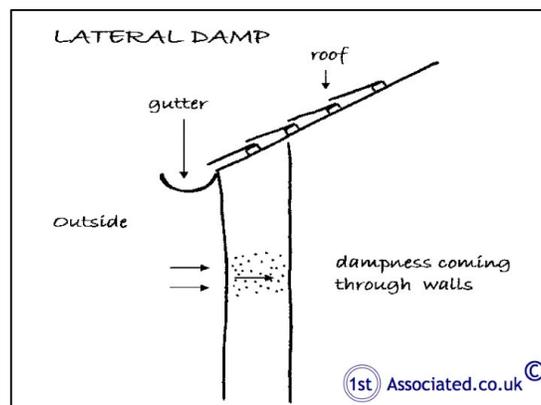
We used a damp meter on the external walls. We have found lateral dampness in the rear bedroom which we believe relates to roof problems.

Lateral dampness found in rear right hand bedroom

ACTION REQUIRED: Please see our comments in the Executive Summary.

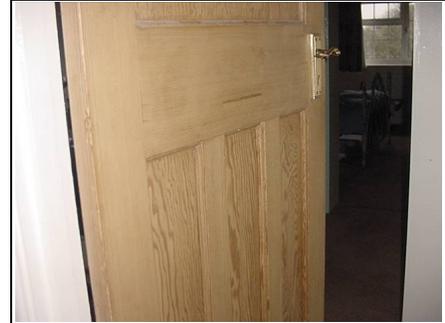
The doors looked to be the original panel doors? Although often people add these to get the original look.

Panel door

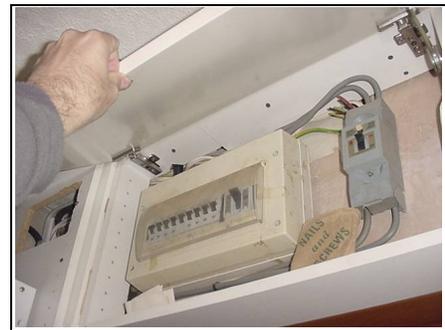
The electric fuses and consumer units were located in the kitchen and are 1980/1990's. The fuse board looked newish but better systems are now available.

Fuse Board

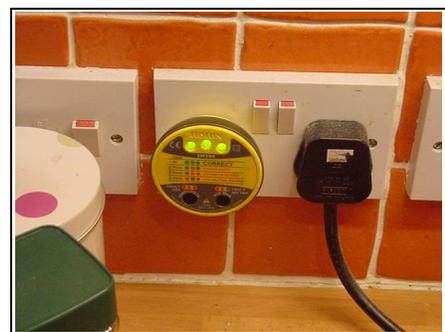
We carried out an earth test in the kitchen area to the socket point that is normally used for the kettle, this proved satisfactory.

Earth test

ACTION REQUIRED: As the property is changing occupancy an Institute of Electrical Engineers (IEE) test and report should be carried

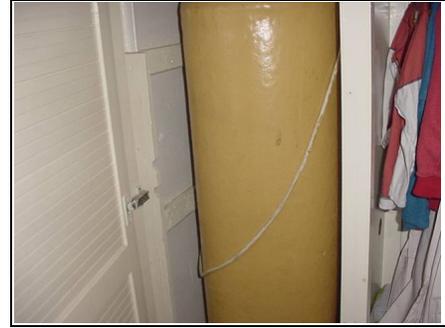
The hot water cylinder is factory insulated, which indicates that it is relatively new (in this case we mean in the last 30 years). This cylinder will therefore have a good thermal efficiency, although not as good as the more modern hot water cylinders.

Hot water cylinder

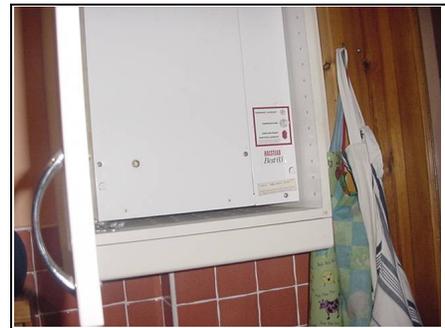
The boiler was located in the kitchen and is a wall mounted Halstead model. As far as we are aware this isn't a modern energy efficient boiler.

Boiler

Our limited inspection of the hot water and central heating system revealed no evidence to suggest any serious defects but we would nevertheless recommend that the system be tested and overhauled before exchange of contracts and that a regular maintenance contract be placed with an approved heating engineer.

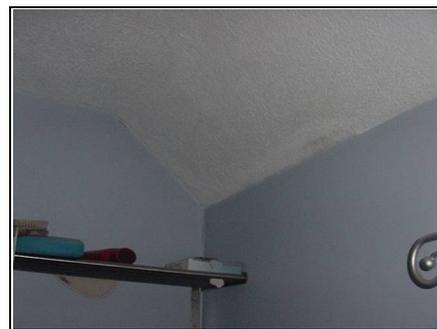
Cold bridging – please refer to our article on cold bridging at the end of the report and also our comments in the Executive Summary

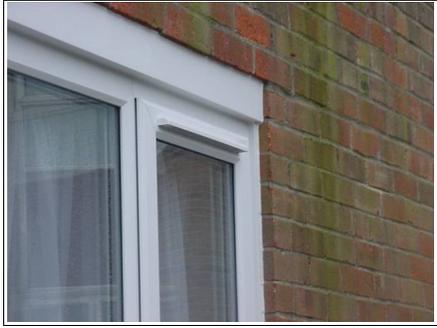
Concrete lintel visible externally
but they are not always visible

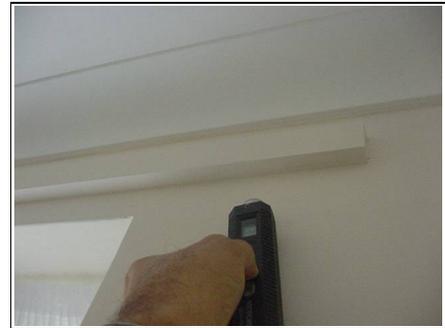
Dampness and condensation around
the concrete window lintel
