RESIDENTIAL BUILDING SURVEY

Merton, London. SW19

Firstly, may we thank you for your instructions of XXXX we have now undertaken a Building Survey (formerly known as a Structural Survey) of the aforementioned property. This Survey was carried out on XXXX

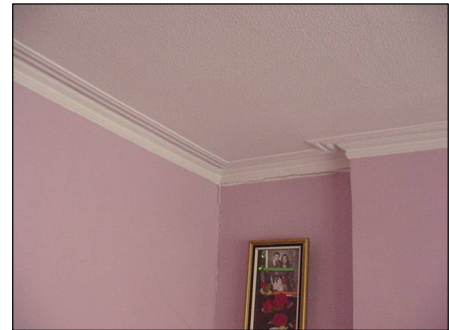
2.1 There is also movement to the right hand side of the property which we feel is a combination of issues including the movement mentioned above to the rear extension and also and mainly we feel it is due to removal of the original structural studwork partitions and replacement with a modern structural partition. This combined with the removal of the wall on the ground floor which has then had a lintel put on it, as you are aware and as we showed you, we could see the deflection present in the floor. Another possible issue could be leaking drains as they run along the right hand side of the property.

Cracking to the right hand side walls and ceiling

ACTION REQUIRED: An insurance claim needs to be made by the existing owners particularly concerning the rear extension identifying this movement. We also recommend that you have a closed-circuit TV camera report carried out in the drains as soon as possible, this is in your best interest to identify if there are any leaks to them. This is likely something that the insurance company will do as well as monitoring the property but we feel it would be prudent to have it carried out as quickly as possible.

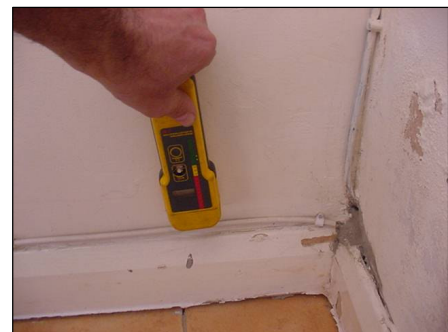
Rising damp

The suspended timber floor, you are meant to have a through flow of air which is being blocked although we did note airbricks to the front and the right hand side of the property but the airbricks to the rear looked to be blocked.

- i) Clear the debris to the side of the building to ensure that nothing is transferring the dampness into the property.
- ii) Check the ground levels, if they are too high then you need to add a French drain.
- iii) Open up the floor structure and check that there is an airflow underneath it and add vents as appropriate to ensure that there is a continuous airflow.

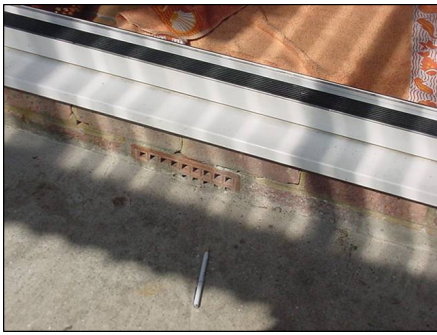
Rear airbrick partially covered

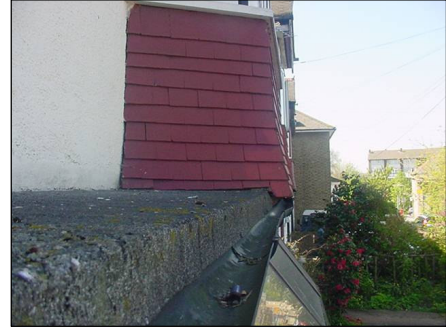
The front flat roof seemed to be lying in place rather than being fixed in place.

Poor quality front flat roof

ACTION REQUIRED: We would recommend replacement at the same time repair work is carried out to the main rear flat roof.

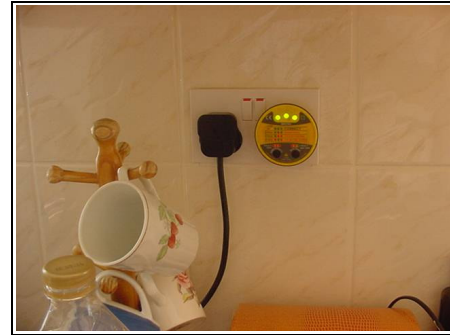
Earth Test was satisfactory.

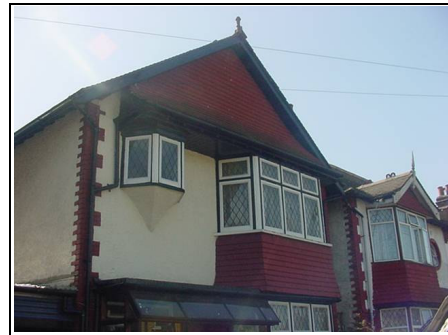
The main roof is pitched and clad with a clay tile, believed to be a nibbed clay tile overall the areas we could see which account for approximately 10% of the main roof (we had a very limited view) were in average condition. However, we would add that these tiles are old and we generally find that some repairs are required as they are starting to spall and will need repair/ replacement periodically.

General view of main roof

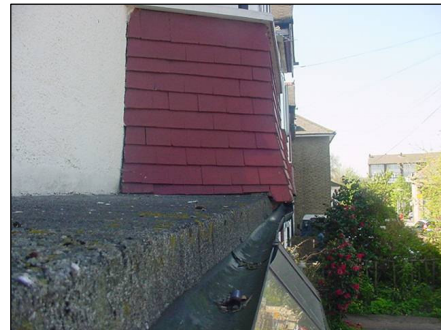
Front flat roof

The flat roof is located at the front of the property and is covered with felt. We found blistering on the roof and poor quality repairs.

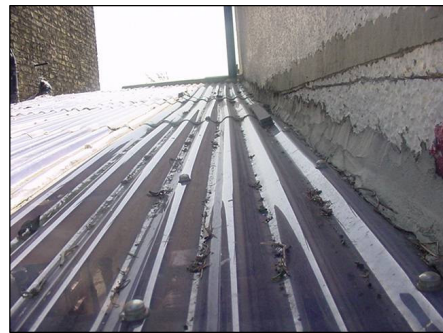
This garage type construction to the left hand side of the property (all directions as you face the property) which is of DIY construction has a basic plastic roof present. The roof is poorly bedded against your building and also looks to discharge water onto next doors property.

Plastic sheet roof

ACTION REQUIRED: You need to speak to the next door neighbours to find out if dampness is coming through and we would suggest that the structure is completely removed from being attached to next doors property. If you do take support from next door then you will need a Party Wall notice.

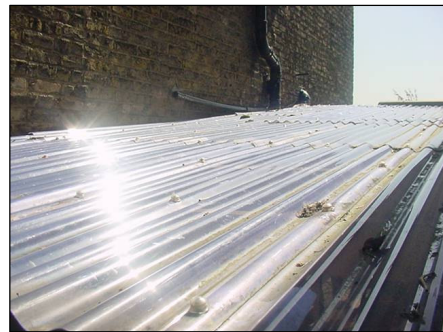
Two sides of roof discharge onto neighbour's property

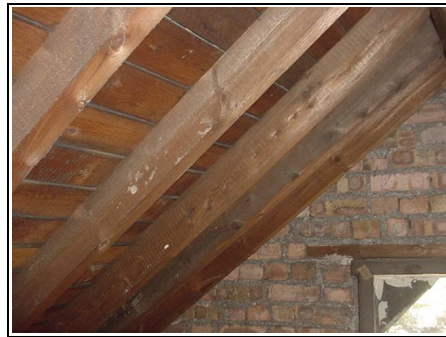
Roof timbers

Our examination was limited by the general configuration of the roof, the insulation and stored items. What we could see was generally found to be in average condition considering its age with some minor condensation and damp. It is, however, feasible that there are problems in the roof that are hidden.

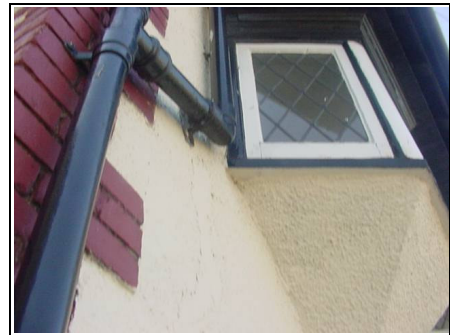
Downpipes

From ground level the gutters and downpipes looked to be plastic and appeared in average condition. There are a few repairs.

The plastic used is the older style with is effected by sun light and looses its colour slight and does become brittle over the years.

ACTION REQUIRED: We would always recommend that the gutters and downpipes are cleaned out, the joints are checked and the alignment checked to ensure that the gutters fall towards the downpipes.

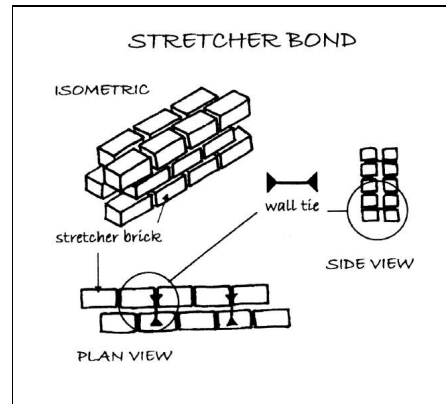
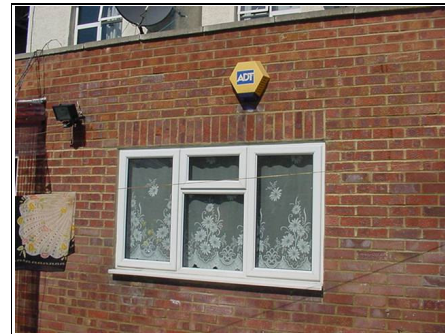
We generally found the new brickwork was not particularly good where it could not be seen for example the sides of the property which does make us wonder what else is happening where the brickwork cannot be seen. Our concern is that the rear extension is DIY standard and there is some re-pointing of brickwork required.

Stretcher bond brickwork to rear extension

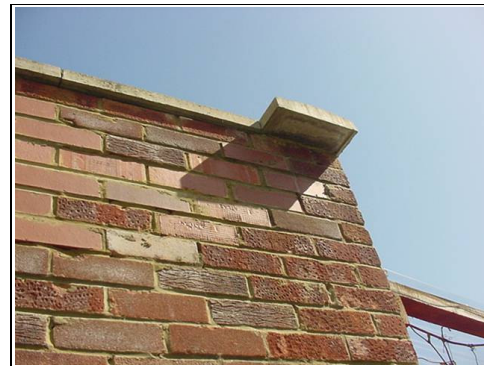
Mixture of bricks

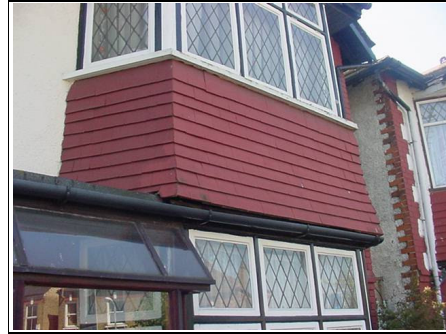
The property has vertical tiles to the front bay and the gable end, these are in average condition and were a feature of this age of property.

Vertical tiles

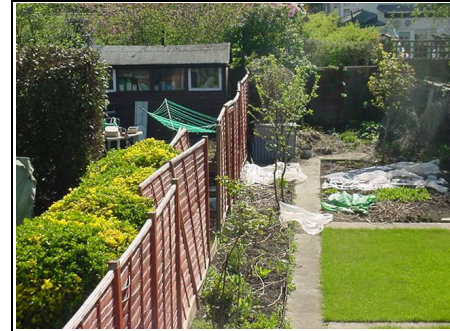
Rear garden

There are no trees within your garden that are within influencing distance of the main house.

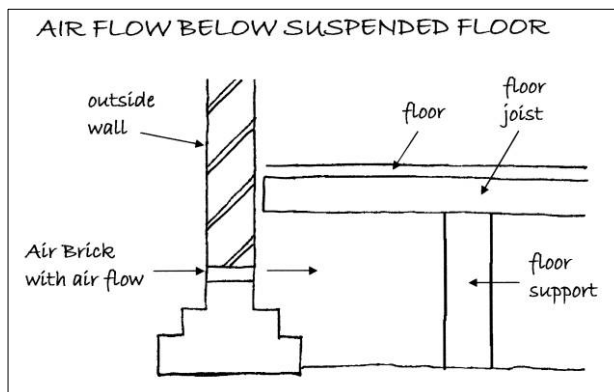
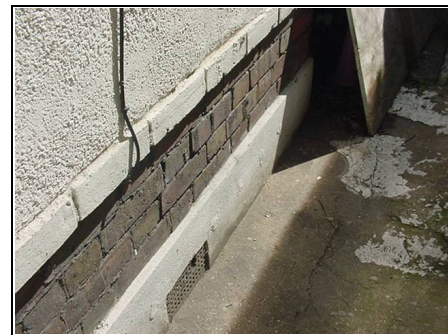
We noted air bricks at the front of the property, and rear and side which indicates a suspended floor.

Airbrick right hand side

ACTION REQUIRED: You need to ensure the air vents are kept clear to vent the floor. Please see our comments in the Executive Summary.

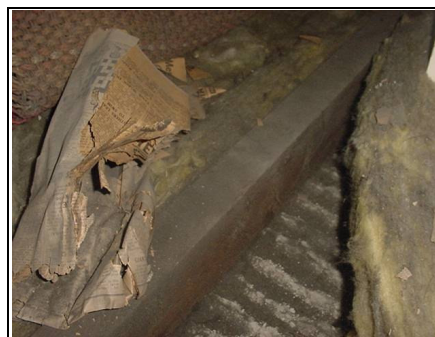
Lath and plaster ceiling

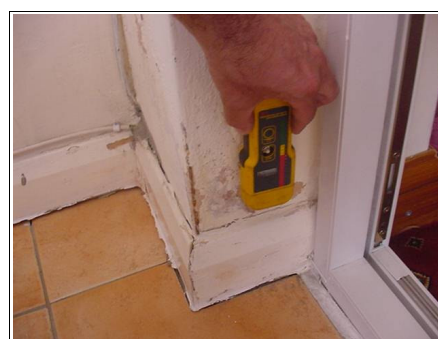
A random visual inspection and tests with a moisture meter have been taken to the perimeter walls and some internal walls. The readings we obtained indicated that there is dampness particularly to the rear of the property.

Rising damp

ACTION REQUIRED: Please see our comments in the Executive Summary

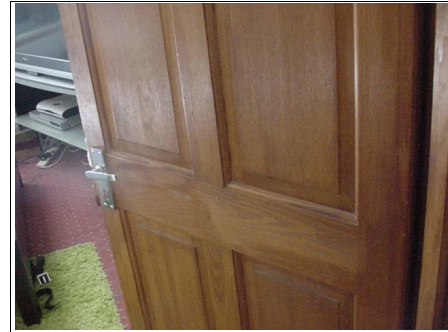
There is a mixture of doors in the property from reasonably good timber doors to the door out to the utility room which is very much a DIY installation which does not fit properly. There is also damage to the front door.

Panelled door

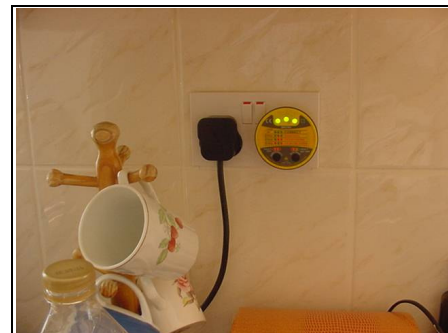
Earth Test

We carried out an earth test in the kitchen area to the socket point that is normally used for the kettle, this proved satisfactory.

ACTION REQUIRED: As the property is changing occupancy an IEE report should be carried out by a NICEIC registered and approved electrical contractor.

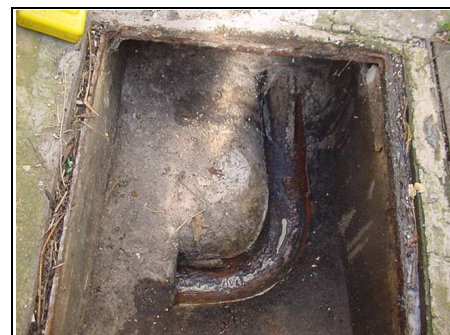
We believe that this inspection chamber/manhole is your neighbours. We duly lift the man hole/ inspection chamber cover and found the drain to be clear, we noted it was finished in brick.

Rear right hand drain

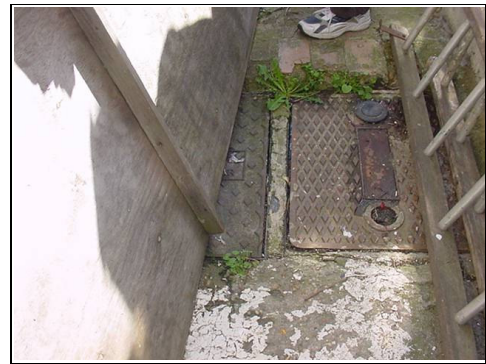
Drain at rear right hand side on next door neighbour's land

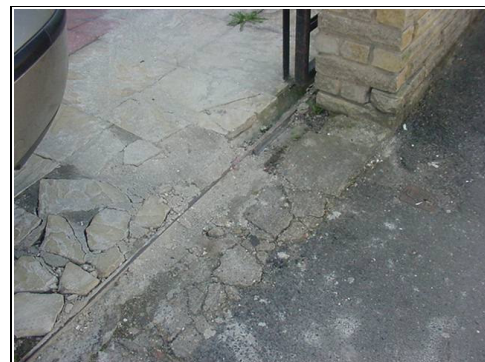
The front garden is given up to a hard standing area for parking for two vehicles. The surface is breaking up and possibly stopping the gates from working. There was a car parked on the front area which limited our view.

Hard standing to front used for parking

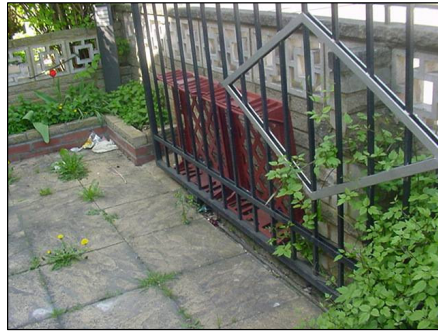
Electric gates showing general lack of maintenance to garden

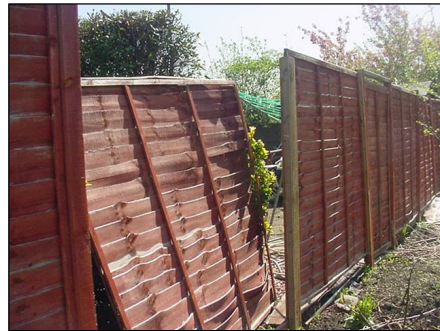
Fence needing to be secured/repared
