PROPERTY REPORT

Mitcham CR3

We have been asked to inspect and prepare a Report and Schedule of Condition for property in Mitcham, CR3.

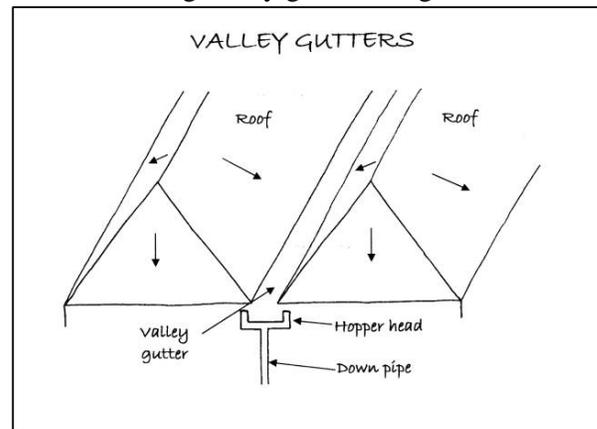
1) Leaking Valley Gutter

The main roof to the front of the property has a leaking valley gutter to the right hand side. We spoke to the owner about this who advised it was a problem with the outlet. Unfortunately, we were unable to see this area, however it is a fairly typical problem and we would recommend the following.

Leaking valley gutter on right hand side

Remember, we cannot see the condition of this roof as it is hidden from us and there may be some work required to this to stop tiles, etc, falling into the valley gutter.

ACTION REQUIRED: Supply and fit a roof light to the pitch of the roof to ensure that you can access the area without scaffolding, or a cherry picker. Next, we would recommend making a larger opening and also regularly checking the valley gutter for build up or back up of vegetation and debris.

ANTICIPATED COST: With the roof light giving a view of the valley gutter it would be best to then estimate costs. However, we would suggest, as this requires scaffolding or a cherry picker lifting device, and in addition we would recommend a sky light to be added, we would estimate the sum of £2,500 to £5,000, plus redecoration internally once the plaster has dried out; some re-plastering may be needed. Please obtain quotations.

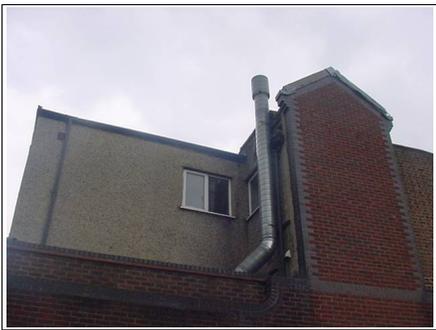
Flue

There is an extract flue to the rear left hand side of the property. We can see that the joints have been taped, indicating leakage in these areas. We would also comment that we could not see any access holes in it to allow cleaning.

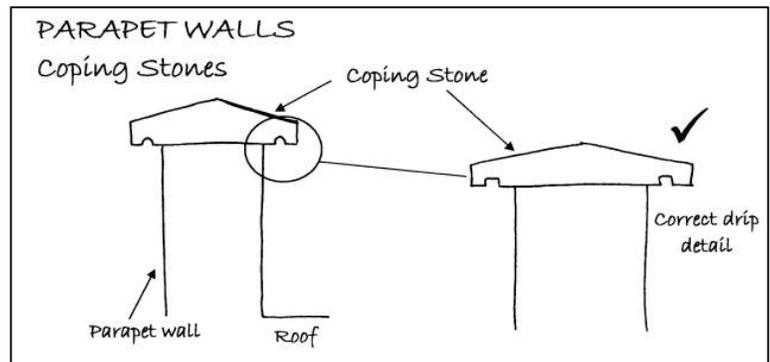
Flashing hanging off parapet wall

ACTION REQUIRED: The lead needs to be re-secured and/or replaced.

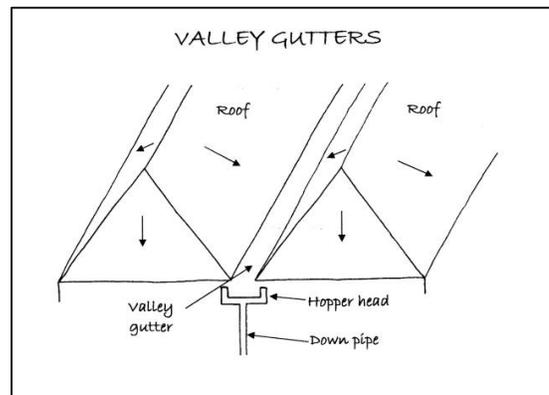
There are problems with valley gutters causing leaks within a property.

ACTION REQUIRED: Make watertight. We suggest placing a roof light on this section to allow easier visibility.

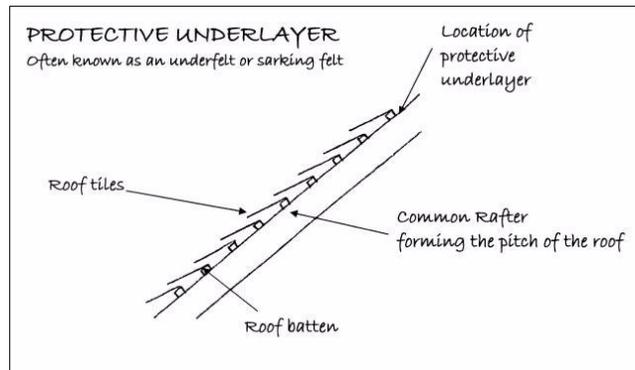
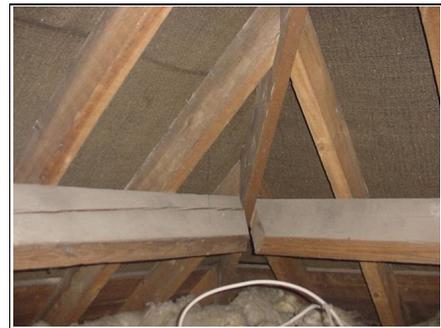
When we inspected the loft space we found a Hessian base Bitumen membrane. This type of membrane has been used since the 1960s. We generally found it to be in average condition, it is damaged in a few more places than we normally find.

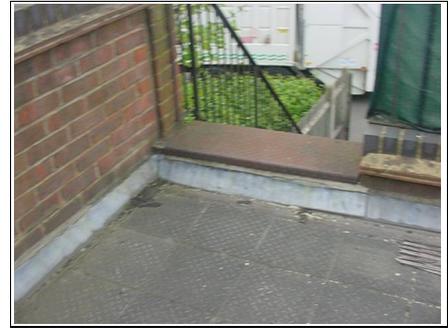
Low level first floor flat roof

The flat roof is formed in asphalt, probably on a timber decking. Asphalt is a good roofing material and lasts 20 years plus and can be repaired.

The asphalt has a protective pavia slab over it as well, which generally looked in reasonable condition.

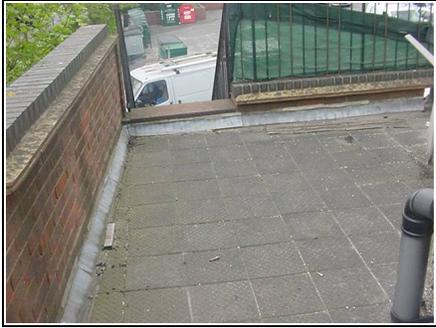
Low level first floor flat roof

If you look at the photos overleaf you can see the parapet wall with the brick coping and the tile on edge. The original parapet wall is in reasonable condition, although there is some efflorescence on it, but the lower parapet wall, which is really a secondary wall because of the properties that were taken down (if you recall we believe this was once a mid-terraced property) are allowing water to sit on it and are getting through the walls and into the render as well.

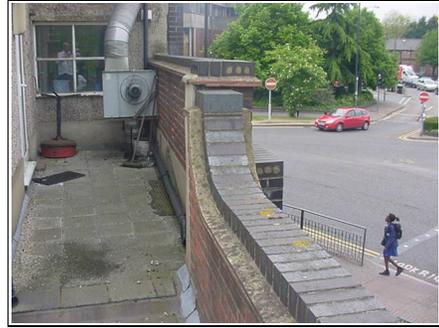
Brick coping and tile on edge

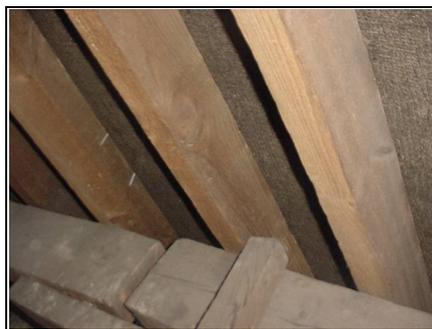
Our examination is restricted by the general configuration of the roof, the insulation and stored items. What we could see we found in generally average condition, with some minor condensation and damp.

ACTION REQUIRED: Ideally add ventilation

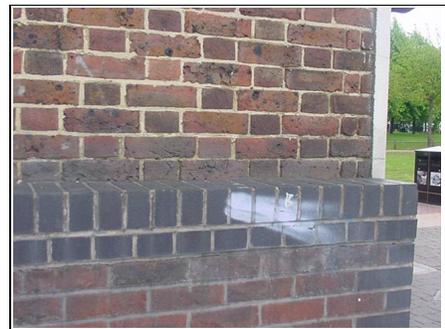
Flemish Bond brickwork

Pattern staining/dampness

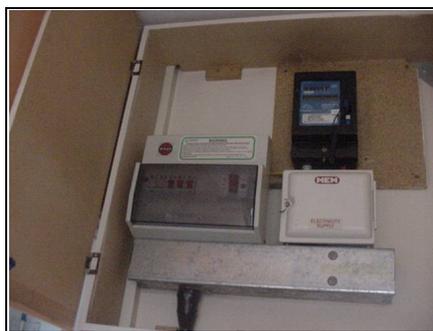
Fuseboard on first floor

There were several fuseboards; some were dated.

ACTION REQUIRED: We recommend an Institute of Electrical Engineers (IEE) test and inspection.
