JOB REFERENCE: XXXXXXXXXXXXXXXX

RESIDENTIAL BUILDING SURVEY

XXXXXXXXXXXX,
XXXXXXXXXXXX,
XXXXXXXXXX,
Norfolk NR2 XXX

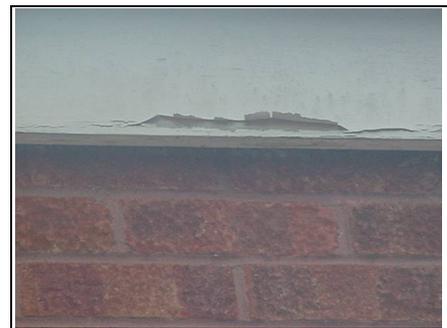
The fascia boards are in of redecoration. You will possibly need a tower scaffold for this as it is high level work.

Timber fascia boards in need of redecoration

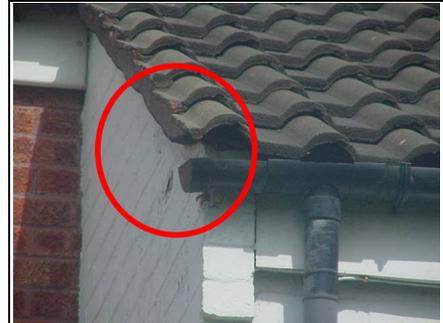
There has been minor movement to the front left side of the property, which we feel is acceptable. We believe this is due to water getting in via the brickwork and we can see that the paint has degraded.

We suspect that the dampness is coming via the roof where the verge on the tiles is not sufficient to throw the water away from the property.

Close up of left gable where dampness getting in and been slight structural movement

ACTION REQUIRED: Re-paint and make good the verge detailing. An alternatively may be to add a plastic verge (please see our article on plastic verges at the back of the report).

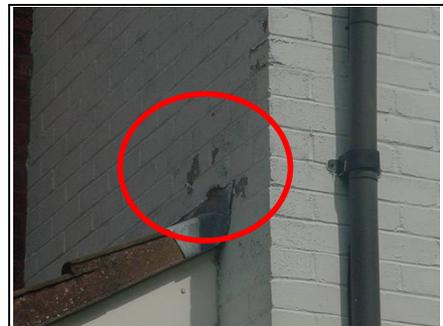
Dampness getting in to left gable

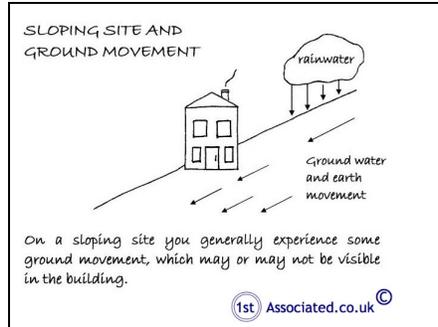
The property is on a slight slope, which means that the right side wall is in danger of having some dampness.

Sloping site

ACTION REQUIRED: We recommend you reduce the ground level around the front of the property slightly. In a worst case scenario it would mean the adding of a French Drain (see Appendices), although we think this is unlikely and should be tested by reducing the ground level.

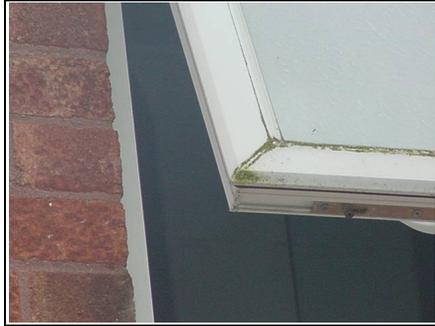
We are finding with older plastics that moss occurs. We have spoken to a plastic manufacturer regarding this and they advised that plastic does require cleaning and ultimately, depending upon what sort of plastic it is, it is not maintenance free.

Moss and mould on plastic windows

ACTION REQUIRED: We recommend you clean the plastic.

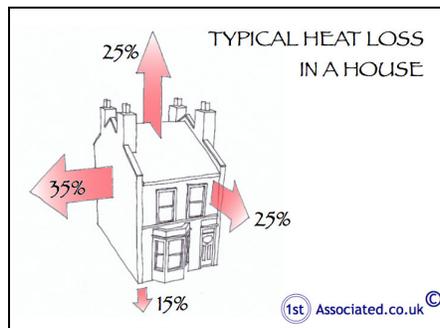
In smaller properties where there is no porch and door goes into the lounge there can be heat loss during the winter months, and equally here you have a conservatory you can get heat gain, as this can gather a considerable amount of warmth and heat up the rest of the house, if not make it too hot.

Typical heat loss

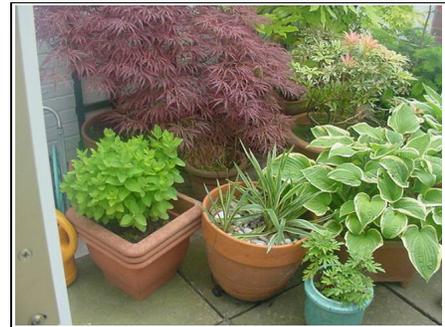
We were advised there was a manhole to the rear underneath the paving slabs, although the owner was not certain which one, and there was no obvious sign. However, we would add that as the paving slabs have not been lifted recently it does tend to indicate that there is no problem.

Manhole under slabs and pots

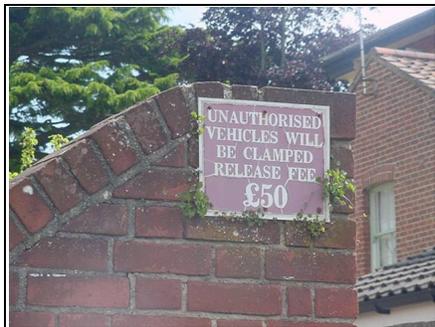
There may a slight problem with car parking, although you have a garage. The present owners do not use theirs but instead buy parking permits in the nearby car park in the Hanover Road car park. From discussions they had done so for many years.

Possible problems with parking in your parking area

ACTION REQUIRED: Speak to the existing owner. We would factor in the cost of a car parking permit or two.

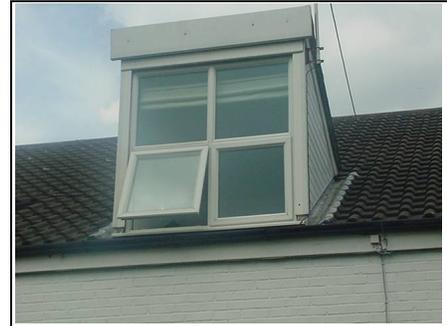
Dormer window

There is an awkward detail where the dormer window meets the main roof.

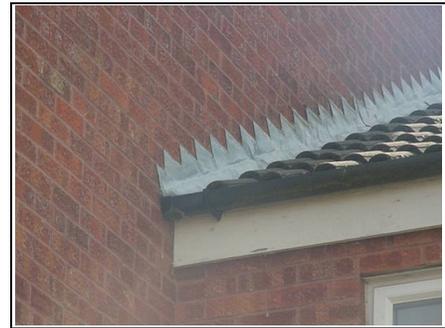
Flashing

However, it is the verge detail that we are concerned about as this seems to be letting in water. It is allowing water to drip down the side of the building causing deterioration to the paintwork, brickwork and hairline cracking.

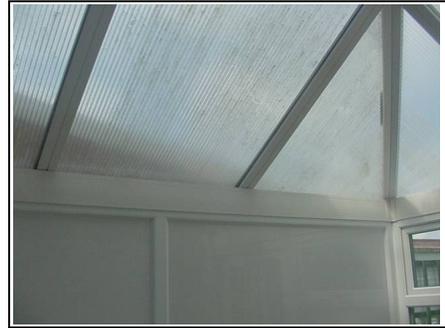
The rear conservatory roof is a polycarbonate (plastic) roof. It has a good fall but we would comment that it is in slightly below average condition due to the moss on the right hand side and it would benefit from a good clean.

Moss on outside of roof

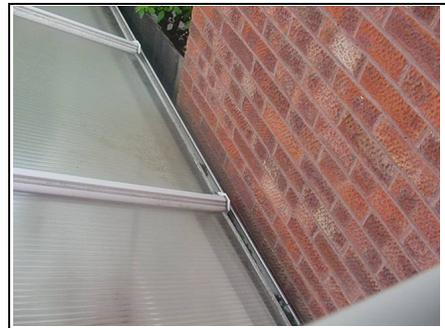
The gutter surrounding the conservatory is too small. We believe it will not catch the water properly and will overflow on to next door's wall.

Small gutter on conservatory

ACTION REQUIRED: Please see or comments in the Executive Summary.

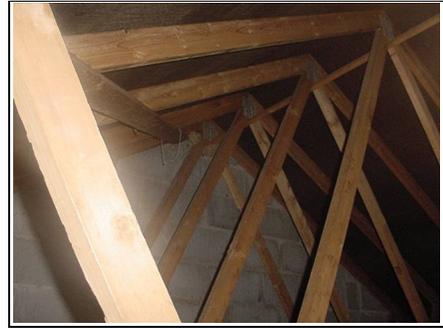
Our examination was limited by the general configuration of the roof, the insulation and stored items. What we could see was generally found to be in average condition for its age, type and style. It is, however, feasible that there are problems in the roof that are hidden.

General view of inside of roof

ACTION REQUIRED: The only way to be 100 per cent certain is to have the roof cleared and checked.

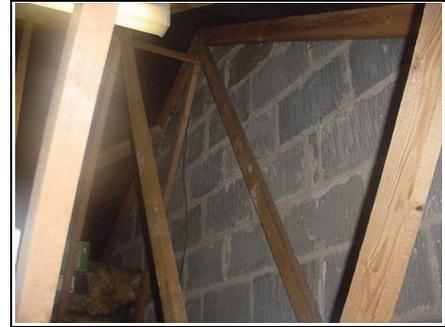
Blockwork fire wall/party wall

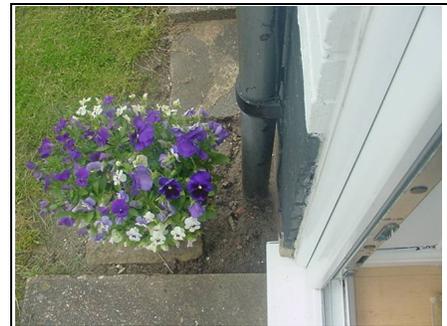
Some of the downpipes feed directly into the ground. This is a practice we are not particularly keen on.

Downpipe feeding directly into ground

ACTION REQUIRED: We would always recommend you stand outside the property next time it rains heavily and see how well the drains cope with the rainwater particularly looking at the guttering and the joints.

We also recommend that the gutters and downpipes are cleaned out, the joints are checked and the alignment checked to ensure that the gutters fall towards the downpipes.

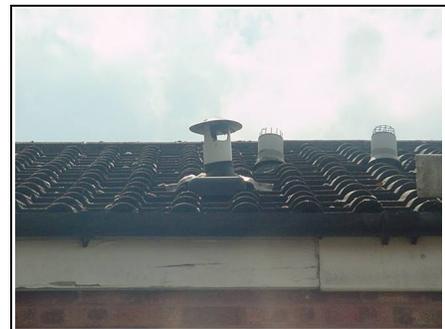
The property has internal soil and vent pipes, where we could see it at roof level which we believe to be plastic. Sometimes these are asbestos; it is very hard to tell in this instance.

Flue and soil and vent pipes

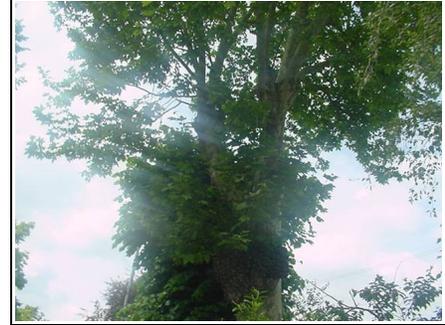
There are shared items such as trees and boundary walls and possibly the drains. We are advised that this large tree is subject to a Tree Preservation Order (TPO). A TPO is where you cannot chop or amend a tree. You have a shared responsibility for this.

Tree preservation order on this large tree

ACTION REQUIRED: Please see our comments in the Executive Summary.

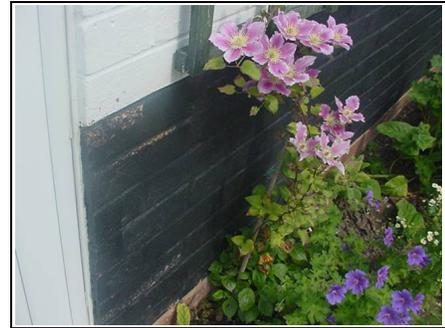
All modern properties should incorporate a damp proof course (DPC) and good building practice dictates that a differential of 150mm (6 inches) should be maintained between the damp proof course and ground levels. In this case there is no obvious visual sign of a DPC.

Tarred section to base of property

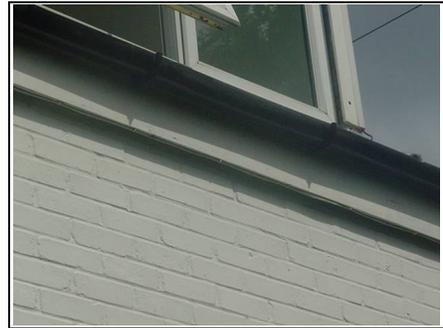
Fascia board

The fascias and soffits are painted timber. We would comment they are in average condition for their age, type and style but will be in need of some redecoration before the end of the summer of 2015.

ACTION REQUIRED: Make sure gutters and downpipes are watertight before carrying out any work on fascias and soffits.

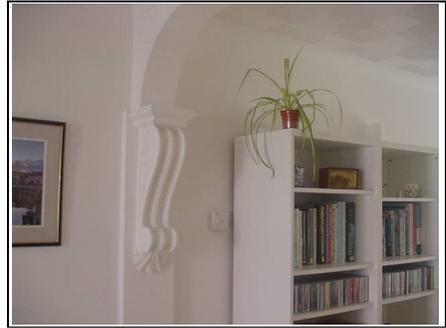
There may have been a wall removed between the front lounge and the rear part of the lounge where the dining area is presently. It would be more usual to have a pier where a wall has been removed so it may be an original design, unfortunately we have no way of knowing for certain without original drawings, which we are more than happy to comment upon if you gain such information.

Elaborate pediment that divides the room up

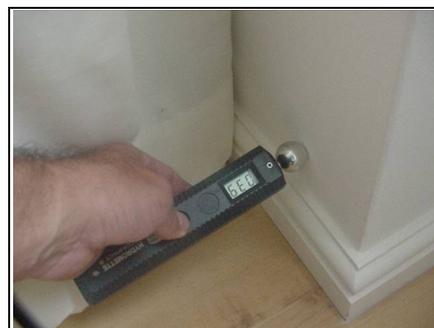
A random visual inspection and tests with a moisture meter have been taken to the perimeter walls. In this particular case we have found no significant rising damp.

Testing for rising damp

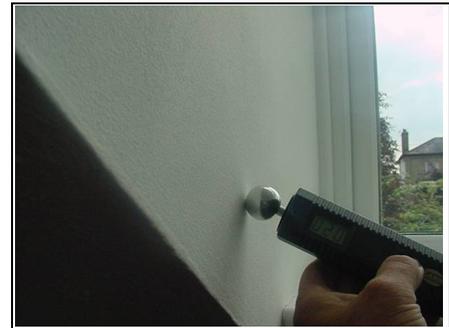
We used a resistance meter on the external walls. We have not found significant dampness, even in the areas where the hairline cracking was or the awkward roof detail.

Testing for lateral dampness

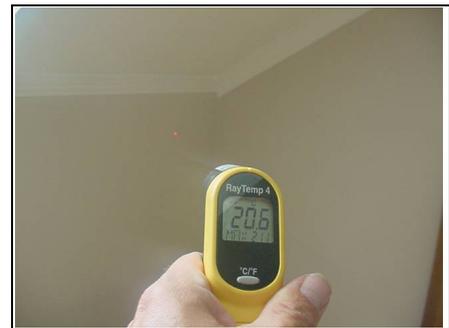
At the time of the inspection there were no obvious signs of condensation.

Checking for cold bridging
in front bedroom

ACTION REQUIRED: We would recommend large humidity controlled extract fans be added to kitchens, bathrooms and drying areas.

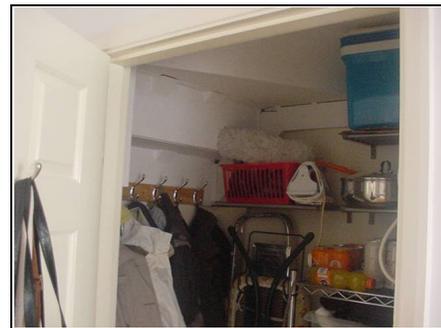
We did note that part of the stairs are not lined within the under stairs cupboard.

It is more normal today to have a half hour fire barrier to stop fire spreading from the ground floor to the first floor in a worse case scenario. You may wish to take a view on whether you add this here.

Stairs unlined in cupboard

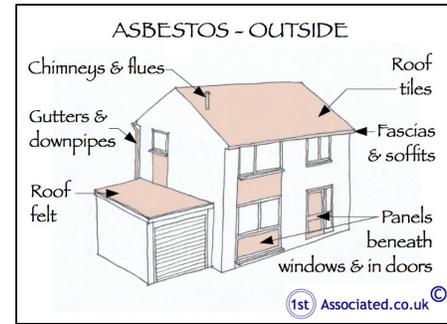
Asbestos externally

ACTION REQUIRED: If you wish to confirm you are 100 percent free of asbestos you need to have an asbestos survey carried out.

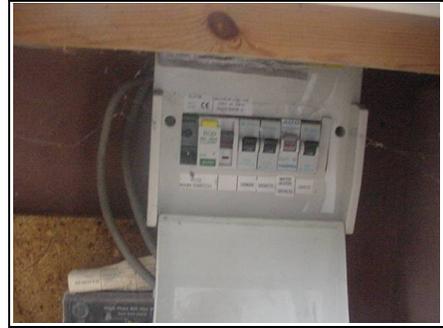
Fuse Board

The electric fuses and consumer units were located in the front left corner of hallway. The fuse board looked to be from the 1990's/2000's and better are now available.

ACTION REQUIRED: As the property is changing occupancy an Institute of Electrical Engineers (IEE) test and report should be carried out by a NICEIC registered, or equivalent, approved electrical contractor or similarly approved.

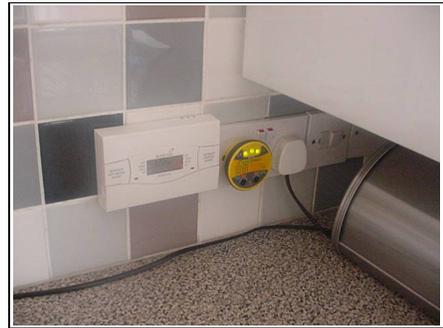
We carried out an earth test in the kitchen area to the socket point that is normally used for the kettle, this proved satisfactory.

Earth test

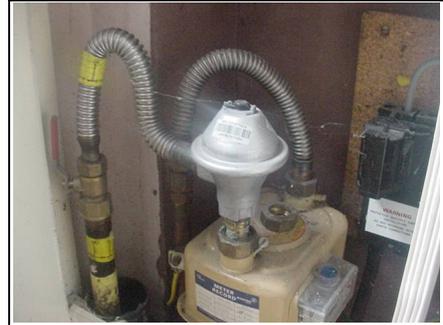
Gas meter under the stairs

ACTION REQUIRED: As a matter of course it is recommended that the entire gas installation is inspected and made good, as necessary, by a Gas Safe registered contractor. Thereafter the installation should be serviced annually.

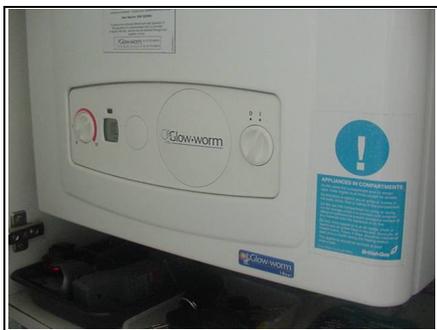
The wall mounted Glow worm boiler was located in the kitchen. Our limited inspection of the hot water and central heating system revealed no evidence to suggest any serious defects but we would nevertheless recommend that the system be tested and overhauled before exchange of contracts and that a regular maintenance contract be placed with an approved heating engineer.

Wall mounted Glow worm boiler

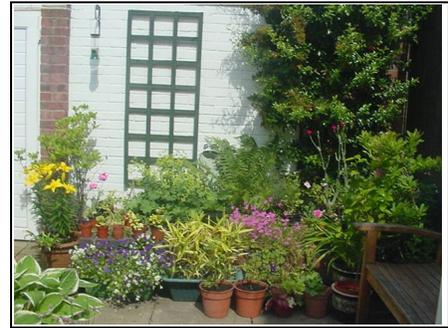
Rear Garden

There is a small rear garden. It will look larger once all the potted plants have been removed.

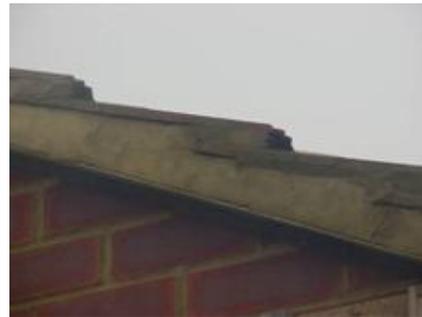
If you look closely you can see cracks to the left hand side that have been filled in with cement mortar. It is only a matter of time before they open up again.

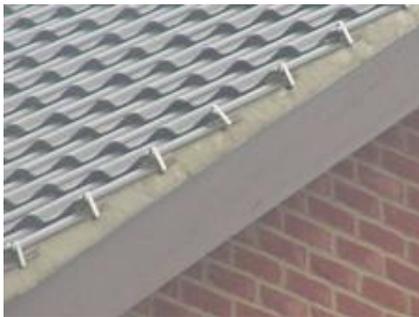
This is a cement verge which has been clipped which tends to happen in high wind areas. To be sure the tiles don't lift clips also tend to be in areas where cracking can occur to the verge.

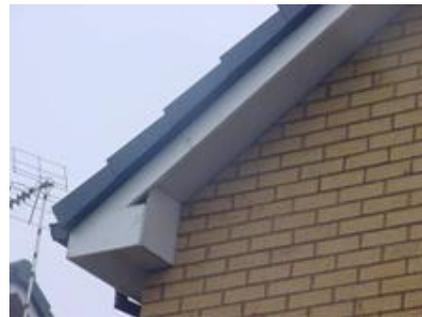
Dry verge system. Interesting lack of skill to the fascia and soffit board with the hole opening in it.

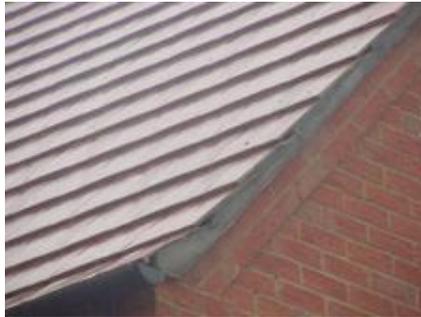
Gaps left for the water to get in

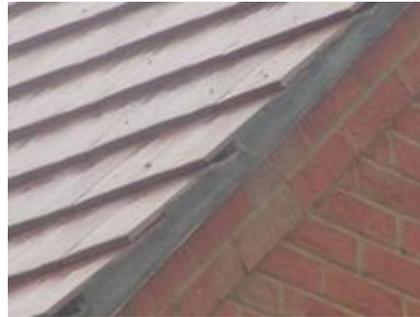
Close up of gaps

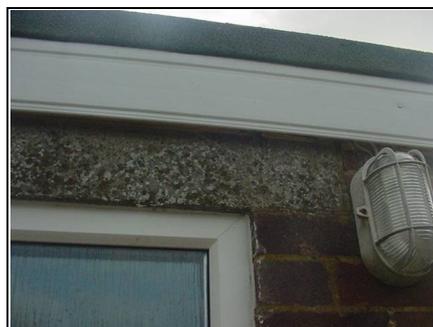
A close up view showing there is a concrete lintel over the door and window. This is where the cold bridging occurs causing condensation inside.

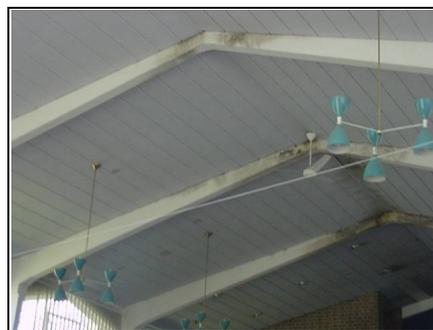
Cold Bridging in a commercial property with a concrete frame.

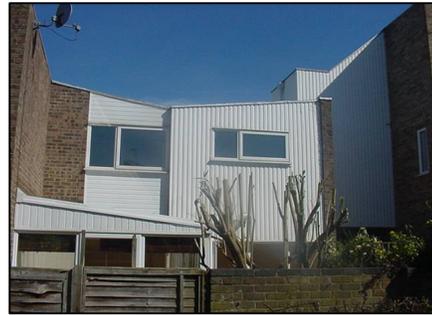
1970's property with cold bridging to the roof beams and the lintels

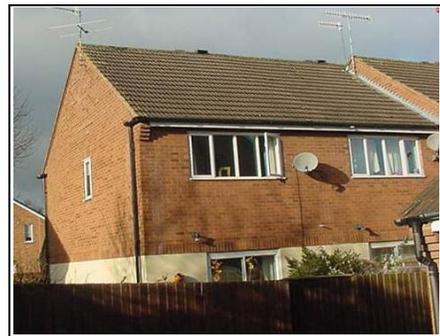
1980's property, cold bridging was found in the lintels
