JOB REFERENCE: XXXX

# RESIDENTIAL BUILDING SURVEY

**XXXX**  
**Berkhamsted,**  
**Hertfordshire.**  
**HP4 XXX**

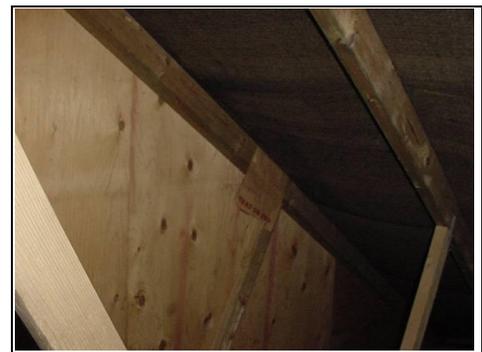
Timber lining of timber frame

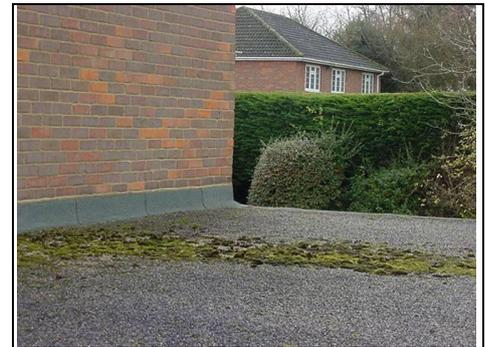
The flat roof over the garage and over the front covered area and rear is very flat with moss sitting on it; it should typically have a fall of fifteen degrees, moss sitting on it indicates that the fall is not sufficient to take the rainwater away. When we spoke to the owners about this during our question and answer session they advised that they had not had any problems over the years. When we inspected the underside of the garage roof the damp staining that we did note we were advised had been there since they moved into the property.

Moss on flat garage roof

**ACTION REQUIRED:** We recommend you clear the moss off the roof and set aside a budget to carry out repair work. We also would note

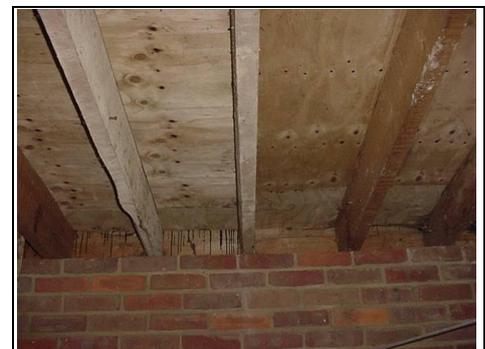
Looking up at timber of the flat roof

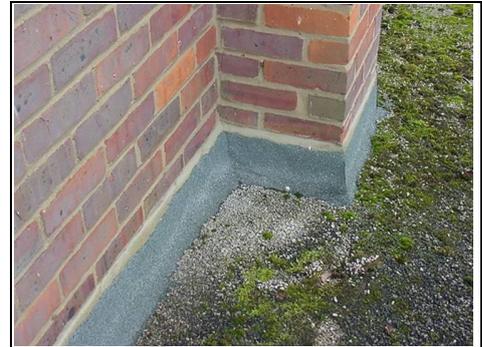
Flashings prevent dampness from entering the property, usually at junctions where materials change. Such a junction is the one between the chimney and the roof.

Lead flashing

**ANTICIPATED COST:** To have a new flashing we would expect costs in the region of £300 - £1000 and would expect ad hoc repairs to be carried out from time to time; please obtain quotations.

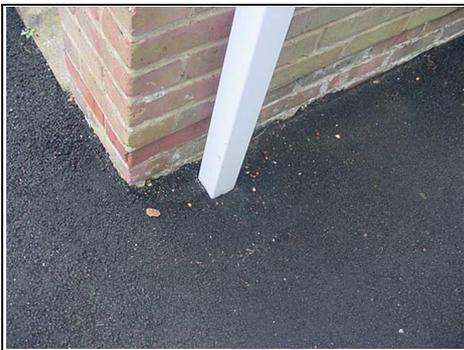
We would make a general comment with regard to your gutters and downpipes that in this age of property downpipes were discharging directly into the drainage system without a gully which although common for this age is not considered good practice as if they block you have to open up the drains.

Downpipe going directly into the ground without a gully

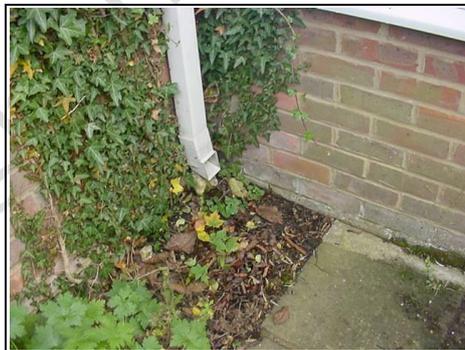
Downpipe from conservatory roof discharging onto ground

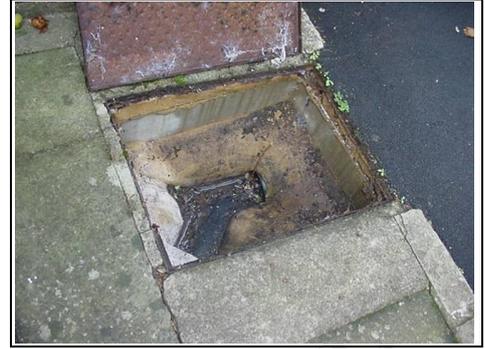
We lifted the manholes and noted that the rainwater drain was blocked to the rear right hand corner (all directions given as you face the property).

Blocked manhole

Approximately half a day to a day's labour on the gutters and downpipes to clear and secure them.

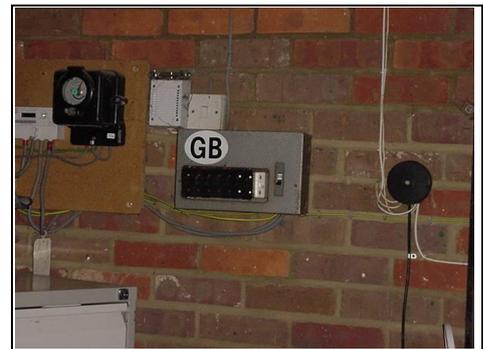
We recommend a new fuseboard is installed.

Dated fuseboard

**ACTION REQUIRED:** Install new fuseboard.

**ANTICIPATED COST:** £250-£350 plus any additional work highlighted from an Institute of Electrical Engineers (IEE) test.

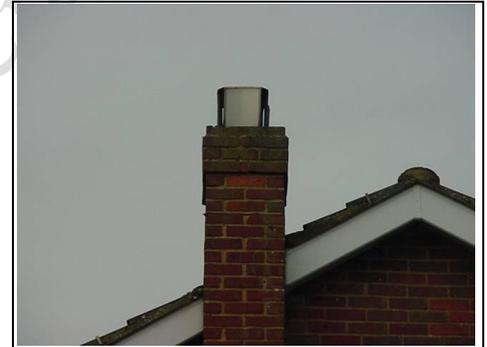
Chimney One

This chimney is brick finished with a lead flashing and has a flue on it. From what we could see from ground level it looked in average condition considering its age, type and style. Unfortunately we were unable to see the flashing, we therefore cannot comment upon them.

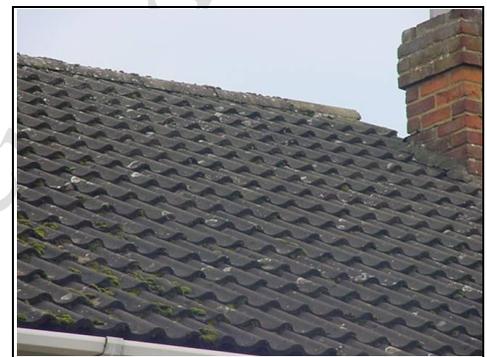
Main roof

The main roof is pitched and clad with a concrete tile and, from ground level, this looks in average condition considering the roofs age type and style. With this age of roof it will occasionally suffer from a few missing or displaced tiles, this is nothing unusual and also sometimes weathering to the ridge tiles.

**ACTION REQUIRED:** We noted some minor deterioration to the edge of the tiles where the clips are which need to be looked at again during the summer of 2012 and carry out periodic inspections and maintenance of the roof, as required.

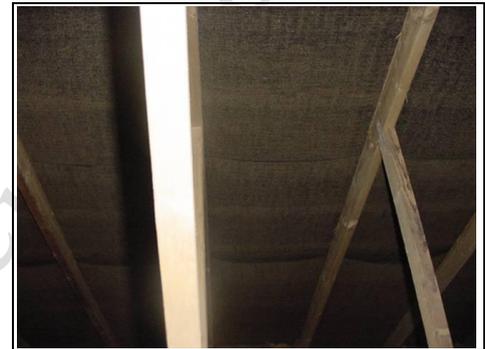
When we inspected the loft space we found a Hessian base Bitumen membrane. This type of membrane has been used since the 1960s. We generally found it to be in average condition, it is damaged in a few places than we normally find.

This photo shows the common rafters (the ones that form the pitch of the roof) and the dark area between is the underlayer.

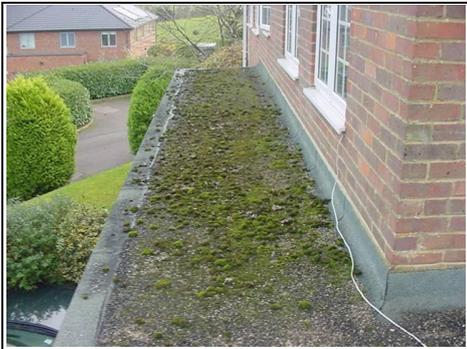
There is a flat roof to the front of the property and over the garage area. The roofs have a felt finish with mineral chipping felt to the flashing and the perimeter. There is moss sitting on the roofs indicating that the roofs are flat.

Flat roof to front

**ACTION REQUIRED:** Please see our comments in the Executive Summary.

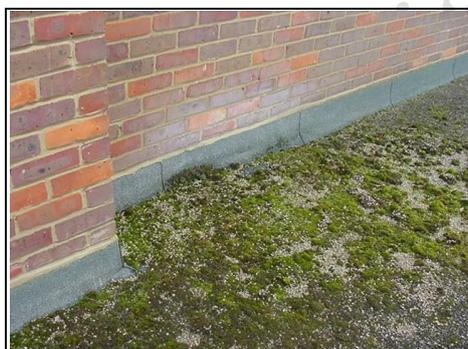
Close up flat roof

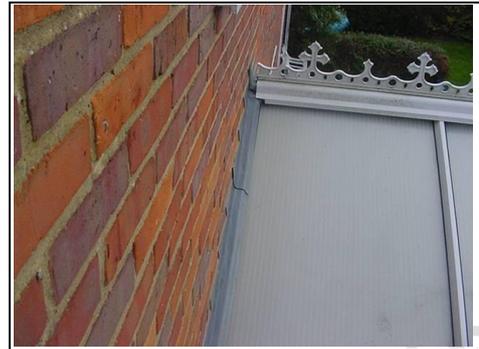
The property has a double lined polycarbonate plastic roof which are quite common in conservatories. This roof is in reasonable condition and we were pleased to see a lead flashing where the roof meets the main building which can be a problem area.

Conservatory roof

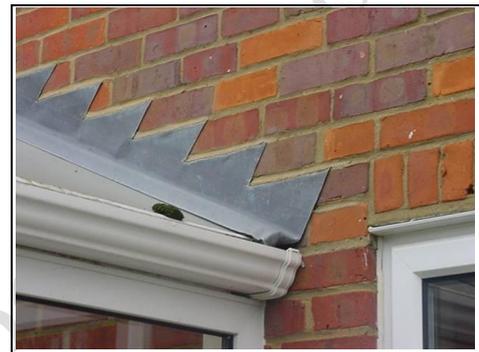
Lead flashing where conservatory meets main building

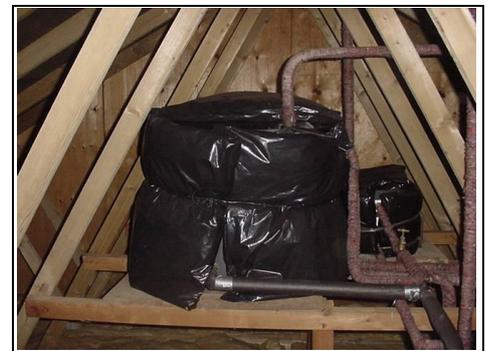
There is a plastic insulated water tank within the roof.

Water tank

We would always recommend that water tanks be drained down and cleared of any debris etc. (we have seen dead birds and other unmentionable things in these tanks). As you are cleaning your teeth with this water it is best that it is as clean as possible!

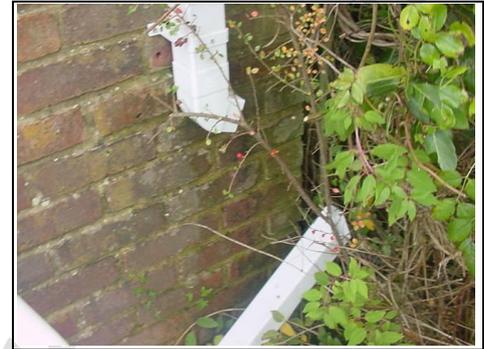
Downpipe rear left hand side

The property's gutters and downpipes are profile plastic (meaning shape).

**ACTION REQUIRED:** We would always recommend that the gutters and downpipes are cleaned out, the joints are checked and the alignment checked to ensure that the gutters fall towards the downpipes.

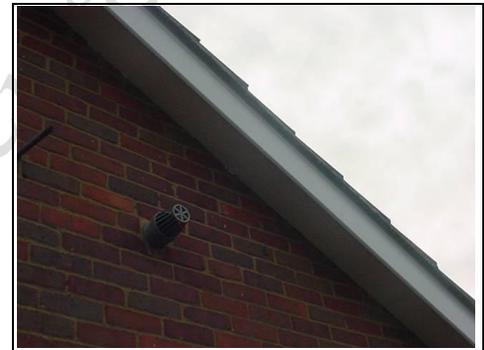
Overclad bargeboard

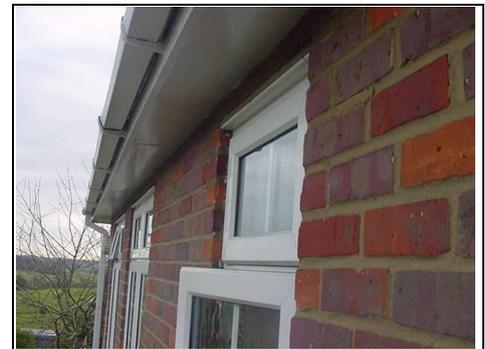
The fascias and soffits and bargeboards are a mixture of plastic and timber. The timber fascias and soffits are painted and we would comment they are in average condition for their age, type and style.

Painted timber fascias and soffits

**ACTION REQUIRED:** Please see our comments in the Executive Summary.

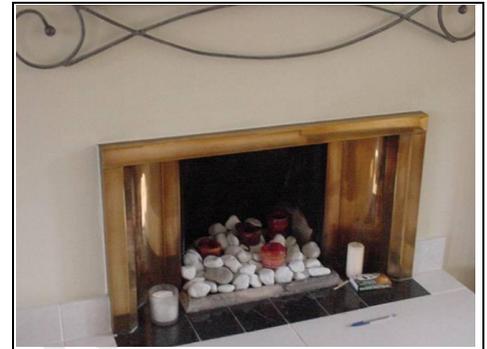
During our question and answer session the owner advised that the chimneys are not working but are able to work and last worked when they moved into the property nineteen years ago. This looks to be a decorative feature only at present.

Fireplace in through lounge

At the time of the survey no chimneys were in use. Any chimneys that you do not propose to use should be capped and ventilated to prevent dampness.

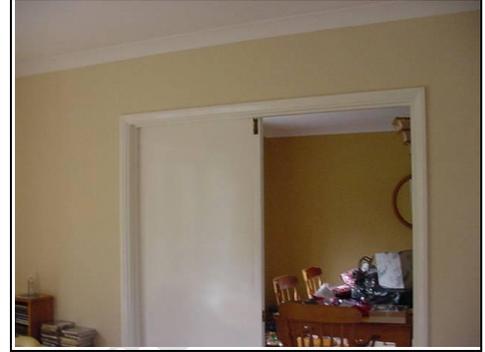
Door

The doors in the property we believe are original and are not of the best quality although they have obviously stood the test of time.

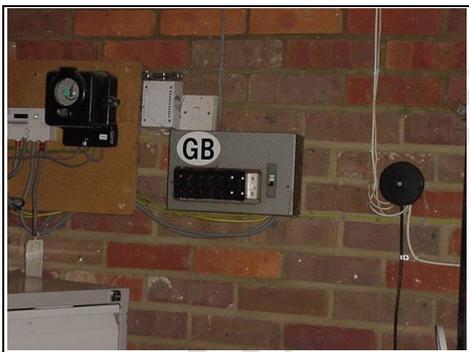
Fuse Board

The electric fuses and consumer units were located in the garage. The fuse board looked dated.

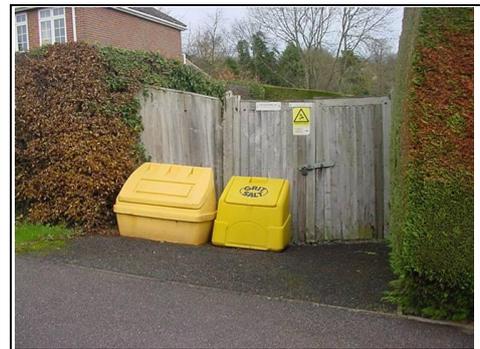
Electric board unit across road not sure if still active?

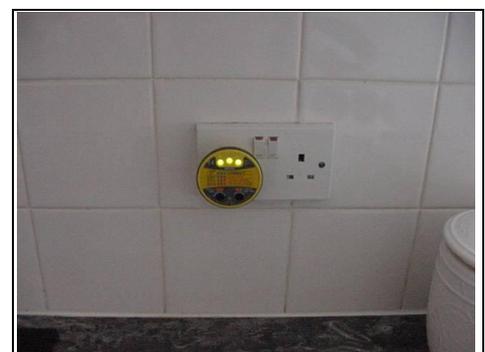
Earth Test

We carried out an earth test in the kitchen area to the socket point that is normally used for the kettle, this proved satisfactory.

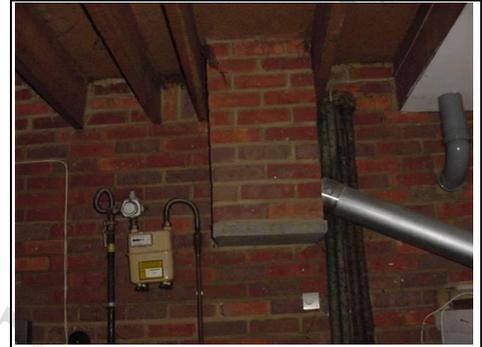
Gas meter and gas vent to right hand side of chimney

**ACTION REQUIRED:** As a matter of course it is recommended that the entire gas installation is inspected and made good, as necessary, by a Gas Safe registered contractor. Thereafter the installation should be serviced annually.

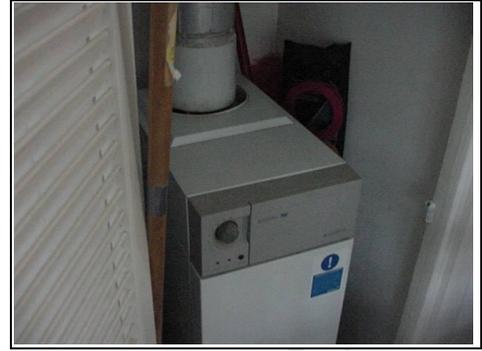
Potterton boiler

The floor mounted boiler was located off the kitchen and vented in the garage it is manufactured by Potterton and looked to a relatively old design and typically is said by the manufacturers themselves to have a life of 10-15 years so we believe it is coming to the end of its natural life.

Our limited inspection of the hot water and central heating system revealed no evidence to suggest any serious defects but we would nevertheless recommend that the system be tested and overhauled before exchange of contracts and that a regular maintenance contract be placed with an approved heating engineer.

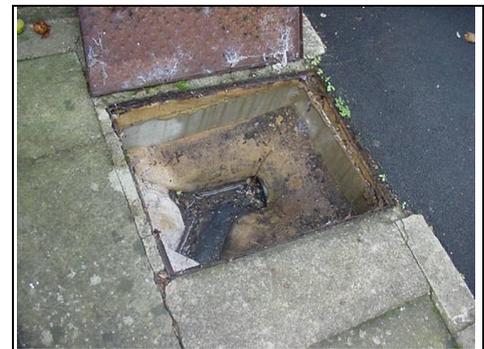
Manhole One

We duly lifted the cover and found it to be blocked at the time of our inspection.

From what we could see it is shallow and believe it relates to the rainwater drains not the foul water drains.

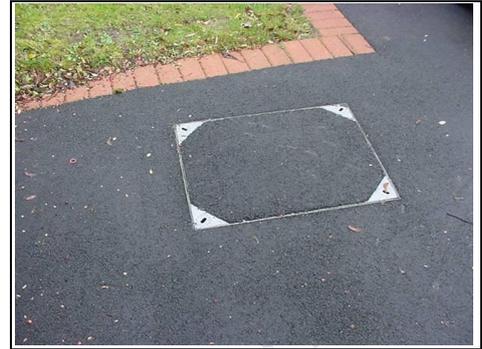
Manhole two

We were unable to lift this manhole without special lifting devices. We assume this relates to the foul water drains.

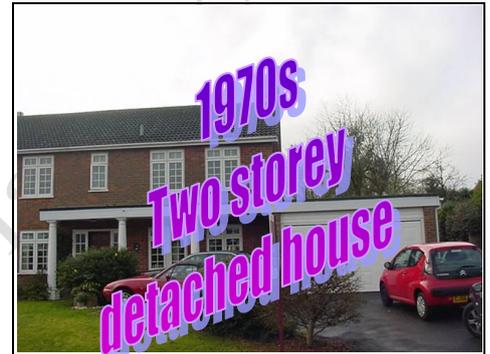
The property has the benefit of a large garage and off road parking to the front tarmac driveway. The garage has a large flat roof over it which is not insulated and there are some damp stains to the timber which are relatively minor.

Garage and parking at front

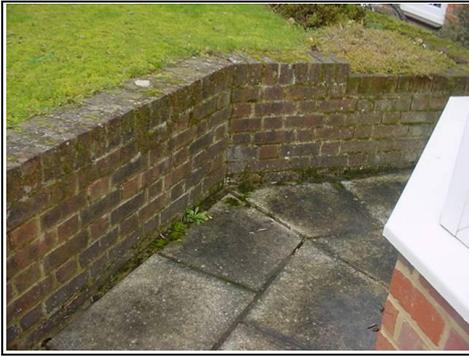
There is a largish rear garden laid predominately to lawn. As the garden is on a sloping it has been cut back and a retaining wall has been put in place. Unfortunately this retaining wall does not have any weep holes which means that water can build up behind it.

Retaining wall needs weep holes

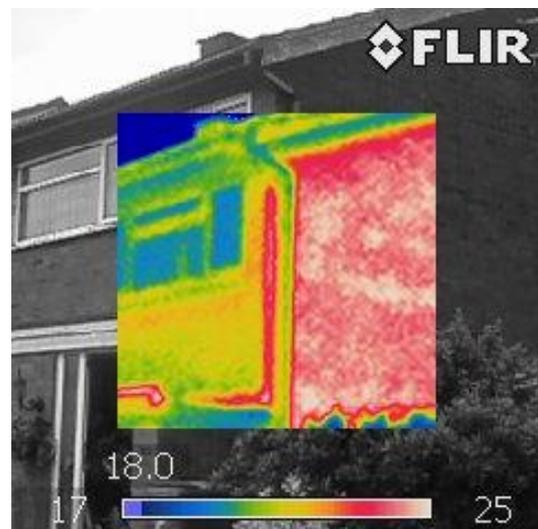
We can give two examples of this age of modern timber frame construction where the brickwork has not been tied into the timber frame correctly, in both cases we were asked to investigate noise problems. We found when thermal imaging the property that heat was coming out of various areas of the building, this in turn, when examined more closely, was due to the brick outer leaf and the timber inner leaf not being bolted together properly and air was passing through the property causing a wind chill factor.

The red thermal imaging picture shows where heat was coming out of the timber frame where it had become loose from the actual structure.
