JOB REFERENCE: XXXX

RESIDENTIAL BUILDING SURVEY

XXXX Cambridge. CB4.

**1970s/80s
semi detached
extended
property**

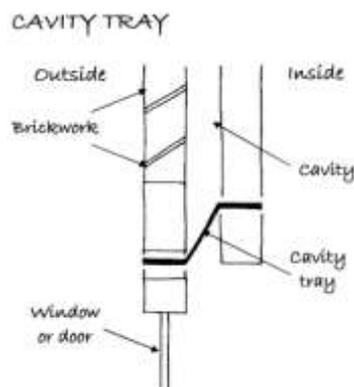
Cavity tray

Where the conservatory roof meets the main building there is a Flashband flashing which we consider a temporary product and note areas where it is starting to perish. We also noted plastic cover plates have come away to the rear left hand side (all directions given as you face the property from the front) which will be allowing dampness into the area.

ACTION REQUIRED: Replace the Flashband and also check all the mastic seals but most importantly you need to check to see if there is a cavity wall tray.

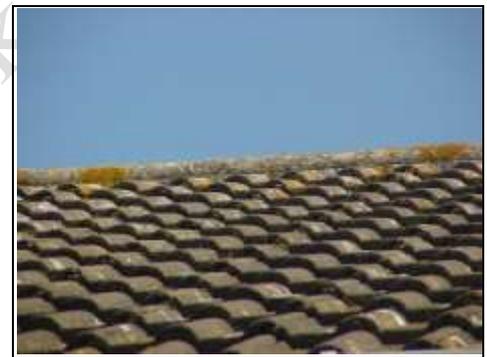
The roof is pitched and clad in a large interlocking concrete tile. From what we could see the concrete tiles are lying level and true and look in average condition considering their age with some moss which we would expect.

Concrete tiled main roof

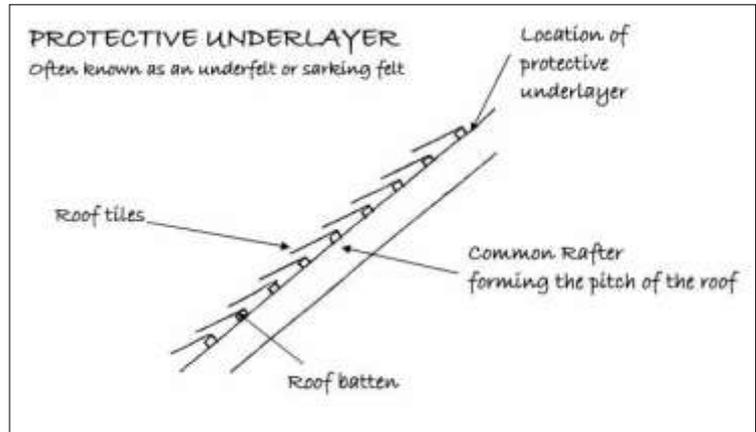
Protective Underlayer

When we inspected the loft space we found a Hessian base Bitumen membrane. This type of membrane has been used since the 1960s. We generally found it to be in average condition, it is damaged in a few places we assume this is the original underlayer which is sometimes known as a sarking felt.

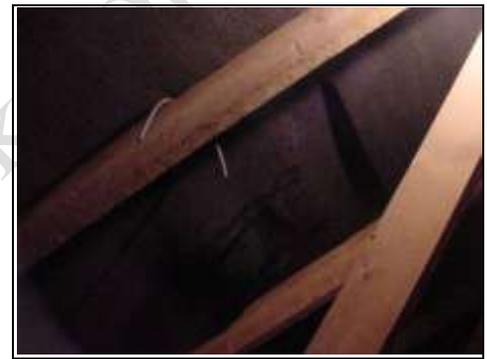
This photo shows the common rafters (the ones that form the pitch of the roof) and the dark area between is the underlayer.

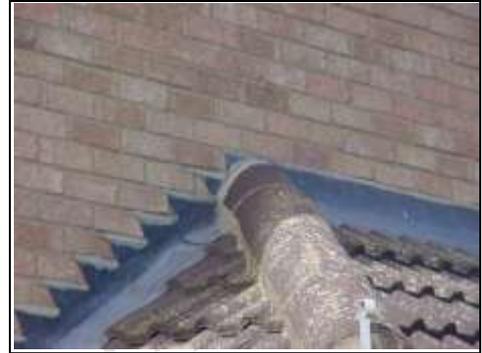
The front porch roof has a concrete tile with we are pleased to say a lead flashing which looks to have been re-pointed.

Front porch roof

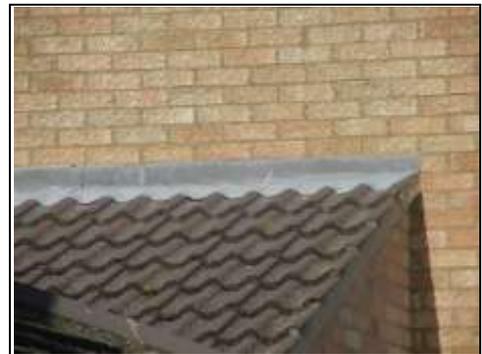
Rear extension roof

This roof has a single pitch and clad is clad with a concrete tile. Where it meets the main building we were pleased to see it has a lead flashing; sometimes we find that the pointing has come out on these but this one looked in good condition.

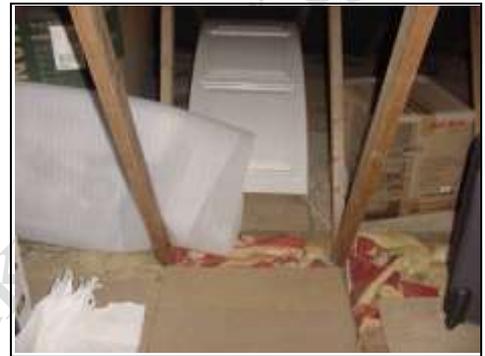
Boarding in roof space

The main roof is accessed via the loft hatch located on the landing. There is a loft ladder and some secured floorboards. We recommend that these be added, as it will make the loft space safer and easier to use.

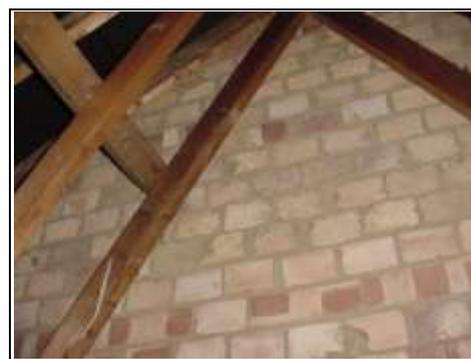
Roof timbers

Our examination was limited by the general configuration of the roof, the insulation and stored items. What we could see was generally found to be in average condition considering its age. Our visibility was limited by the floor boarding and it is, however, feasible that there are problems in the roof that are hidden by this and the stored items in the roof.

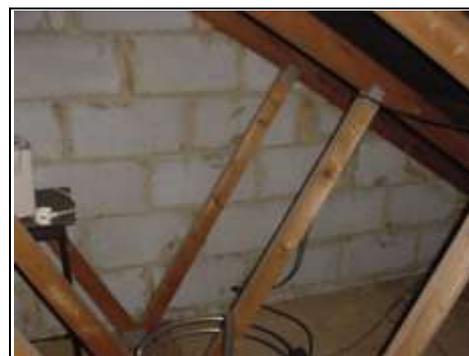
Fire wall

Firewalls help prevent the spread of fire through roofs and are a relatively recent Building Regulation requirement. In this instance the fire wall is built in blockwork.

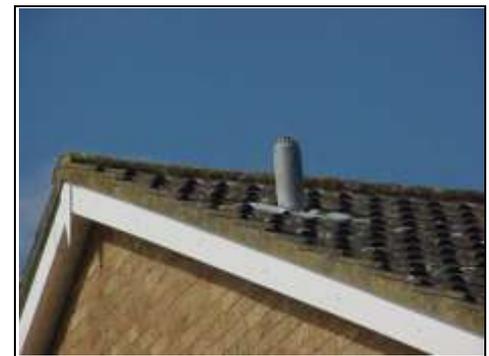
Soil and vent pipe

The soil and vent pipes are internal, they are visible at roof level and plastic.

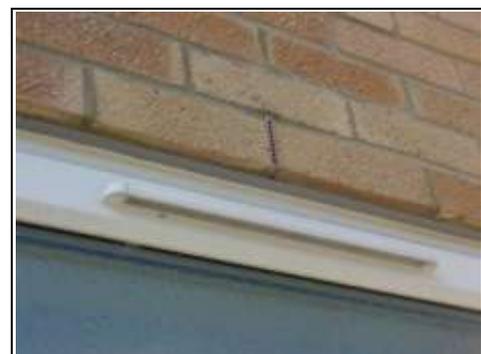
Weep holes to brickwork are in place allowing any moisture that gets into the cavity wall to come out, for example we can see them to the lintels over the some of the windows

Brickwork with weep hole/trickle vent to the extension

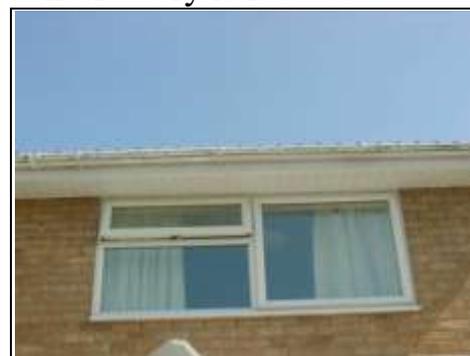
Window

The windows are plastic double glazed many of which do not have trickle vents.

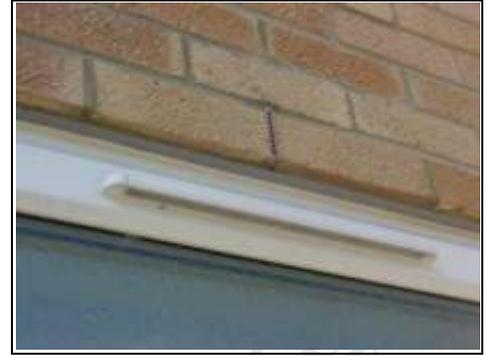
Windows to the extension have trickle vents which allows an airflow around the property.

Trickle vents to extension

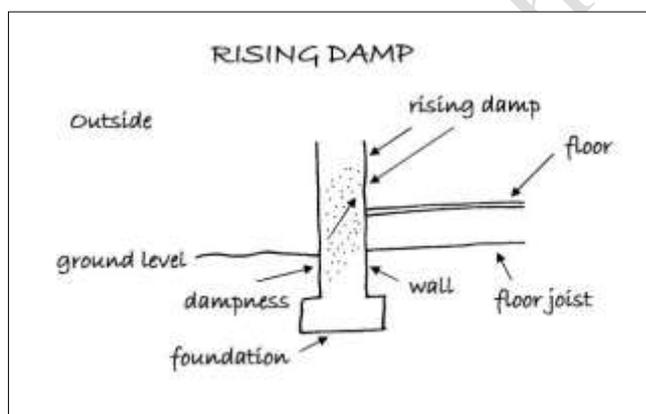
Rising damp

A random visual inspection and tests with a moisture meter have been taken to the perimeter walls and some internal walls. No evidence of any significant rising dampness was detected in the random areas checked. It is not usual in a property of this type and age to have minor dampness in the conservatory area where we have identified the damp proof course is too low.

ACTION REQUIRED: Please see our comments in the Executive Summary.

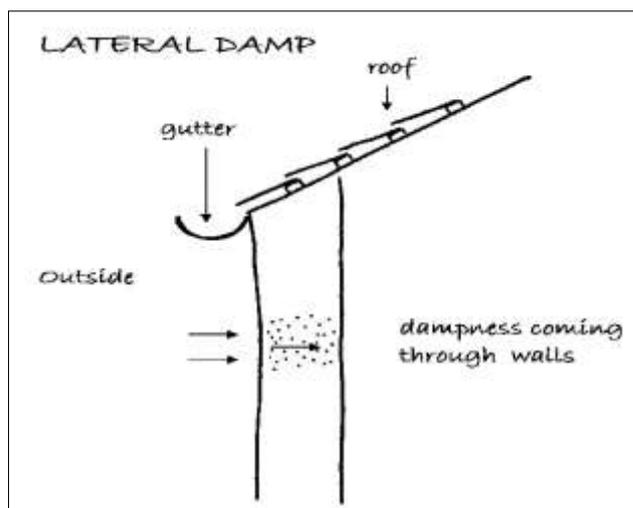
Lateral damp

A visual inspection was carried and tests were taken with a electronic conductivity meter at selected points to walls. No significant penetrating/lateral dampness was seen or detected considering the properties age type and style.

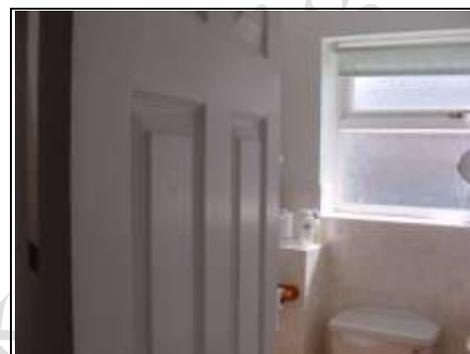
Internal door

The property has modern panel hollow core doors (sometimes referred to as egg box doors, as this is what the internal of them looks like when they are opened up), they have a paint finish and are slightly marked.

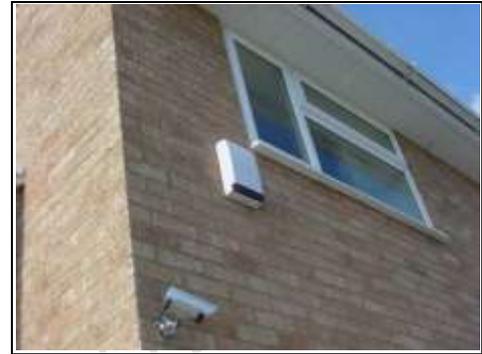
Security system

We were advised a security system has been installed however the cameras are mock, a demonstration of the alarm was given to use when we carried out our inspection at the property. A good alarm system should not only help reduce break-ins but also your insurance. We are not experts in this field and therefore cannot comment further. Further information should be obtained from the vendor and the installer at a later date.

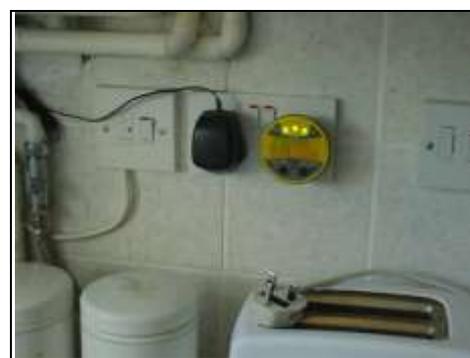
Earth Test

We carried out an earth test in the kitchen area to the socket point that is normally used for the kettle, this proved satisfactory.

ACTION REQUIRED: If there is no record of an electrical test having been undertaken within the last five years, it is recommended that the installation be tested by a competent electrician (NICEIC registered) and all recommendations implemented. Thereafter, the installation should be re-tested every five years.

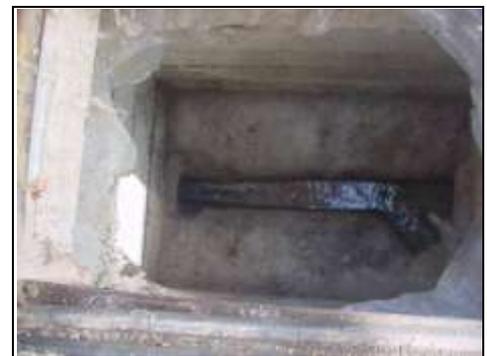
Manhole

We duly lift the man hole/ inspection chamber cover and found the drain to be free flowing, we noted it was finished in a precast concrete ring.

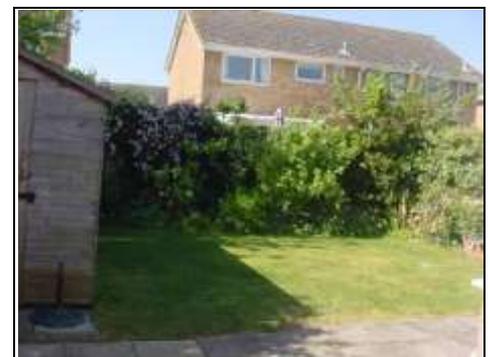
Rear garden

There is a relatively small rear garden (much of it has been taken up by the conservatory extensions) it is laid predominately to lawn with a patio area.
