RESIDENTIAL BUILDING SURVEY

New Malden, Surrey KT3

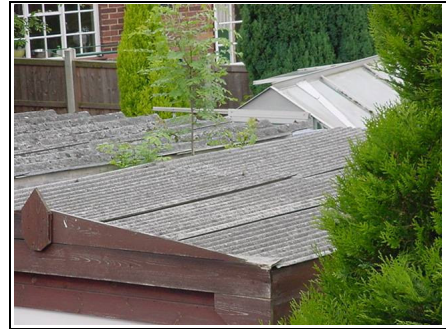
You have a garage that has an asbestos roof, as did many of the pre-fabricated garages of this era.

Products containing asbestos have, until recent years, been widely used in domestic construction and the mere presence of asbestos does not, in itself, necessarily constitute a health hazard.

Removing undamaged material may release more dust than leaving it in place and it is only when asbestos materials are in a damaged or friable condition, or during installation, modification, removal or demolition, that there is likely to be a significant health risk. We are not asbestos surveyors.

ACTION REQUIRED: Ultimately we would recommend removal and replacement of all asbestos, as we would in this case.

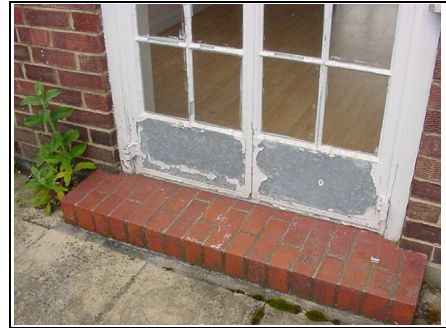
The timber work to the windows and the metal windows and doors need repair, easing and adjusting and redecoration.

ACTION REQUIRED: We believe that it would be more economical in the long term to replace the windows, as metal windows often warp and rust and become almost impossible to shut.

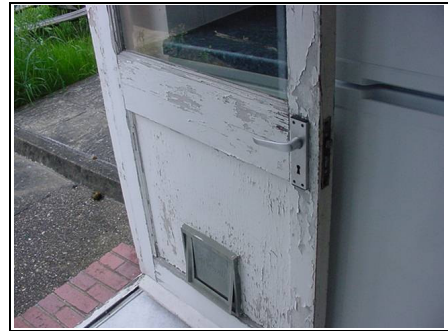
Rear Door

We believe the rear door should have additional security and possibly should be replaced as the glass could easily be broken to gain access. We do appreciate that there are bolts to the top and bottom of this door, but it is a very poor quality door.

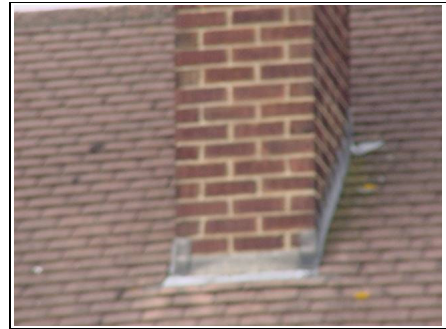
This property has one chimney, which is located to the right hand side on the party wall.

This chimney is brick finished with one chimney pot and lead flashings. From what we could see the chimney looks in average condition. Unfortunately we were unable to see the top of the chimney known as the flaunchings we therefore cannot comment upon them.

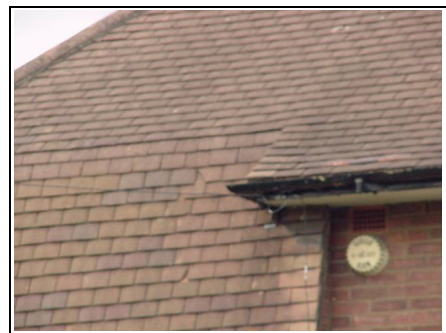
Main Roof

The roof is pitched and clad in a small nibbed concrete tile. From what we could see the concrete tiles are lying level and true and look in reasonable condition. Sometimes we find that deterioration occurs to the ridge and exposed areas such as the perimeter and so you should periodically check these areas.

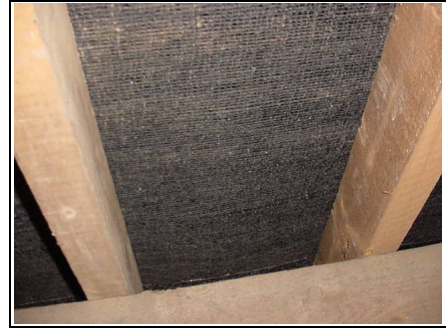
When we inspected the loft space we found a Hessian base Bitumen membrane. This type of membrane has been used since the 1960s. We generally found it to be in average condition, it's damaged in a few more places than we normally find.

This photo shows the common rafters (the ones that form the pitch of the roof) and the dark area between is the underlayer.

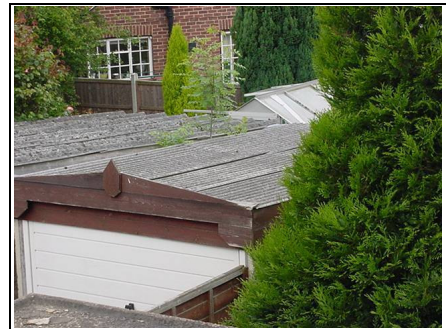
The garage roof is asbestos.

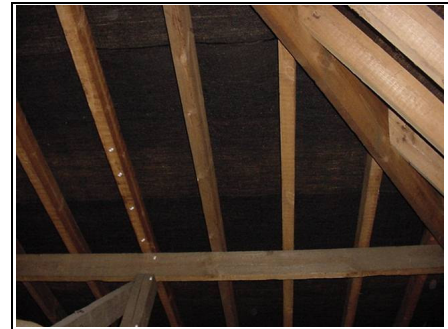
Roof Access

The main roof is accessed via the loft hatch located on the landing. There is no loft ladder, electric light or secured floorboards. We recommend that these be added, as it will make the loft space safer and easier to use. The loft has been viewed by torch light, which has limited our viewing slightly.

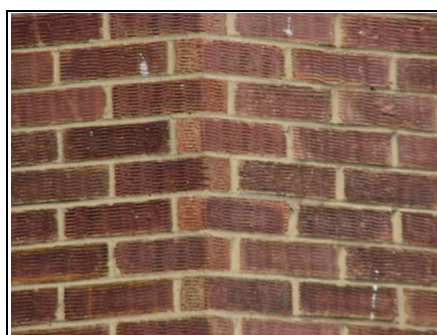
Brickwork

This property is brick finished and laid in a lime mortar originally and repointed in cement mortar. This is all bedded in what is known as stretcher bond. This is an early form of stretcher bond and does have some inherent problems with it.

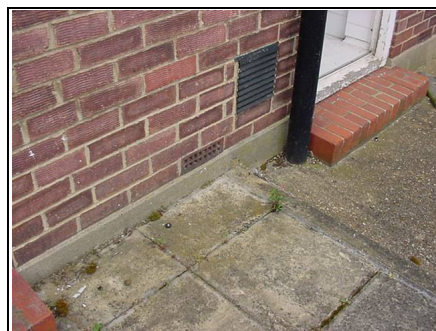
Render plinth

All modern properties should incorporate a damp proof course (DPC) and good building practice dictates that a differential of 150mm (6 inches) should be maintained between the damp proof course and ground levels. In this case, unfortunately, we can't see a damp proof course because of the render plinth. In this particular property it's possible it will have a slate damp proof course behind the render.

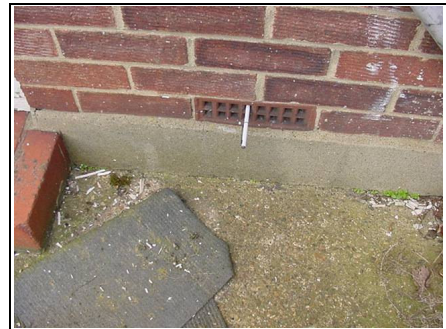
We noted air bricks to the property at both high and low levels; in this age of property it's likely to be to vent the cavity. This is an early cavity wall construction and with it possible problems can occur.

ACTION REQUIRED: Please see our comments in the Executive Summary and Brickwork Section of this report.

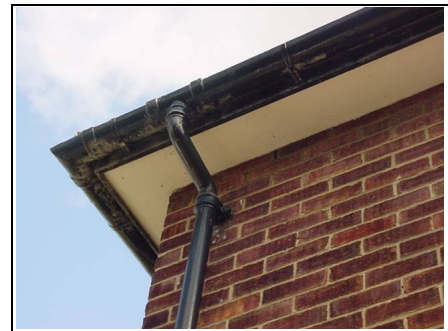
Fascias and Soffits

The property has painted timber fascias and soffits and these are in average condition, (which means there is likely to be some rot) although much of the fascia is hidden by the guttering.

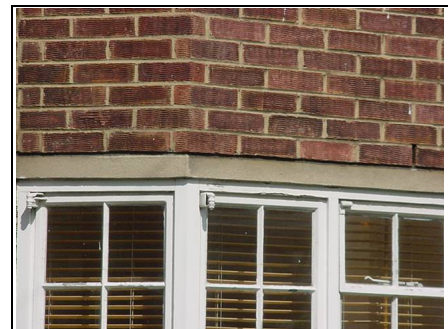
Windows and Doors

Metal windows are often known as Crittal windows. Typically these windows warp and rust and become difficult to close which, in turn, makes them draughty. In this instance some are in below average condition.

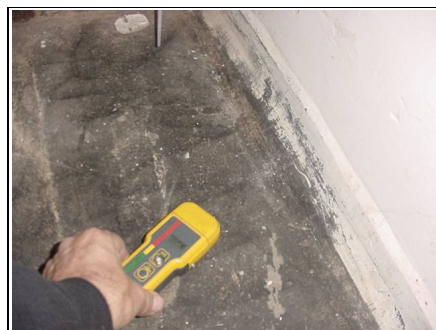
Checking for rising damp

We would add that to the rear of the property we noted a small concrete step, which may cause some dampness to the rear French door areas.

ACTION REQUIRED: This would simply mean that you have to cut back a small amount of the step.

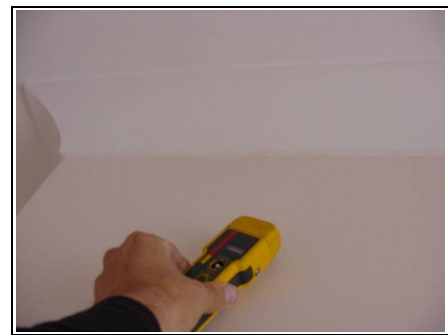
Checking for lateral damp

Tests were taken with a moisture meter at random points to internal walls. No significant penetrating/lateral dampness was seen or detected.

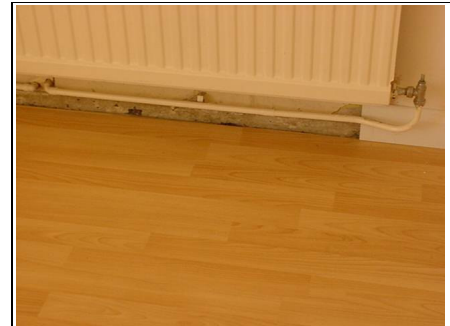
The skirtings are not finished very well even for DIY!

ACTION REQUIRED: Make good skirtings and redecorate.

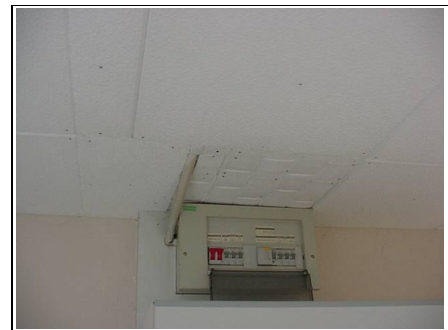
Fuse Board

The electric fuses and consumer units were located in the kitchen. We would date the fuse board as being from the 1980s / 1990s and, whilst not the best now available, it is reasonable.

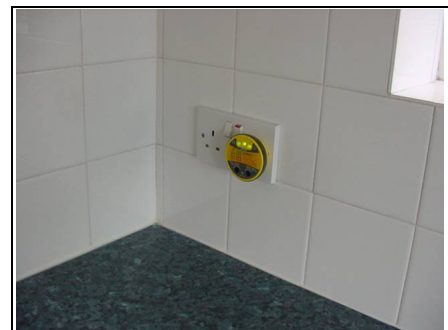
Earth Test

We carried out an earth test in the kitchen area to the socket point that is normally used for the kettle and this proved satisfactory.

ACTION REQUIRED: We are advised the property has had tenants and it should therefore have had the services regularly checked, both legally and for insurance. Your solicitor to investigate and provide a copy of the certificates to us (scanned via email please) for comment.

As the property is changing occupancy an IEE report should be carried out by a NICEIC registered and approved electrical contractor.

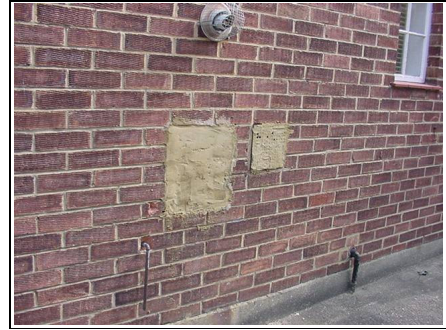
The boiler was located under the stairs; it is wall mounted and manufactured by Vaillant.

Typically we are finding that the wall mounted boilers, often known as combination boilers or 'combi' boilers, are lasting up to 15 years from new, assuming regularly serviced.

Poor quality repairs where the external boiler was removed.

ACTION REQUIRED: To ensure the boiler runs efficiently the boiler needs to be regularly serviced.

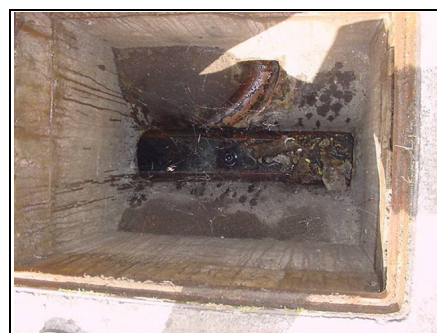
Inspection Chamber / Manhole One – Located to the Front

We duly lifted the man hole / inspection chamber cover and found the drain to be clear, we noted it was finished in concrete.

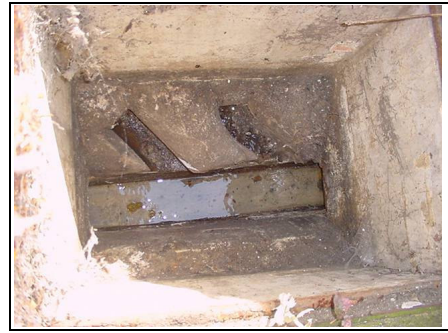
Inspection Chamber / Manhole Two – Located to the Rear

The man hole cover was duly lifted, the drain run is dry and does not look to be used; it is possibly a rain drainage pipe or has been bypassed.

The manhole is finished in concrete.

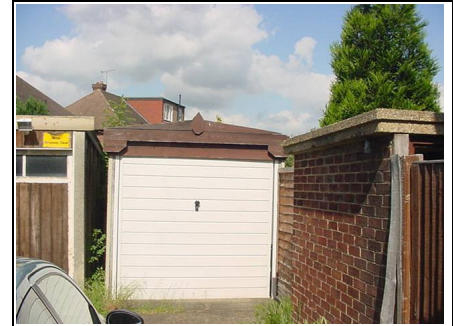
You have asbestos to the garage. In this case it appears in reasonable condition, although we would add that we are not asbestos surveyors.

We have not accessed the garage but we did note it has an asbestos roof.

You should note that work involving products containing asbestos is covered by Health and Safety legislation and you are recommended to seek the advice of the Local Authority Environmental Health Officer before proceeding with any such work.

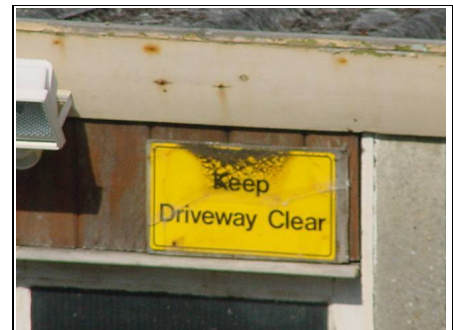
Parking

There is a problem with the shared access, which your neighbours have already advised us about. We do think you have the opportunity to have off-road parking to the front of the property if you are prepared to sacrifice some of the garden.

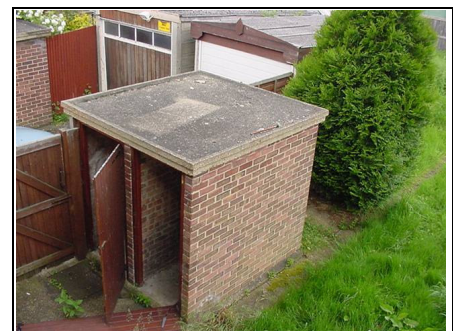
Outbuilding

The doors have come off this building.

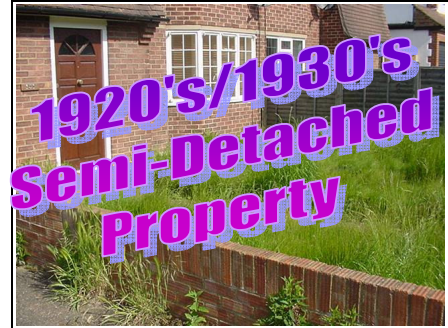
Front Garden

The front garden is presently overgrown but is a reasonable size.

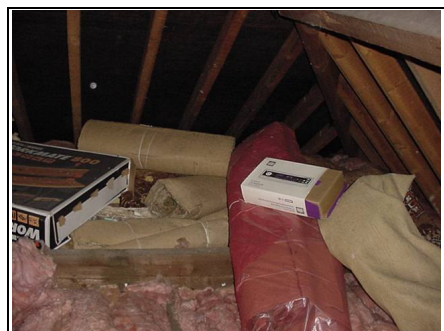
Unfortunately in this instance our inspection has been very limited due to the amount of stored items within the roof space. Also, ideally, with this age of property, we would like to open up or view the cavity wall.

Stored items within the roof space
