**RESIDENTIAL BUILDING SURVEY**  
**OF**  
**Newmarket, Cambridgeshire CB8**

**FOR**  
**Mr G**

**INDEPENDENT CHARTERED SURVEYORS**

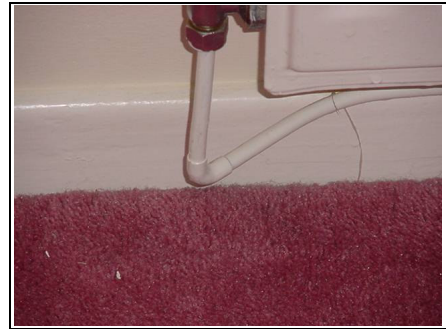
We are really not keen on micro-bore pipes as they do tend to block a lot easier than traditional larger pipes

**ACTION REQUIRED:** We recommend that the existing system is left in until it stops working or becomes very problematic and then we would suggest that you replace with a traditional system.

**ANTICIPATED COST:** In the region of £2,500 - £5,000 and the radiators will need changing as well no doubt. Quotations to be obtained.

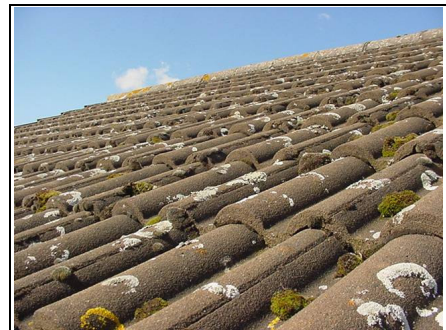
The main roof has a shallow pitch and is clad with concrete tiles. This type of roof was popular in the 1960s/70s. Taking account of the roof's age we consider it to be in average condition.

Typical problems are wind blown/driven rain getting under the tiles and rotting the battens. In this instance we were unable to lift the tiles to check.

Also moss can and has build up on the concrete tiles and needs clearing from time to time. If it is left it will block the gutters.

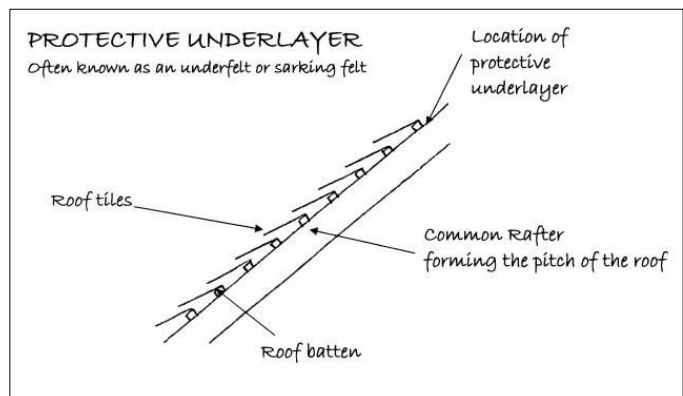
When we inspected the loft space we found a reinforced plastic sarking felt. This type of sarking felt was used in the 1970s/1980s and its use was generally stopped because it was susceptible to causing condensation unless the roofs are adequately vented, which they are usually not.

**ACTION REQUIRED:** In this case we would recommend vents are added.

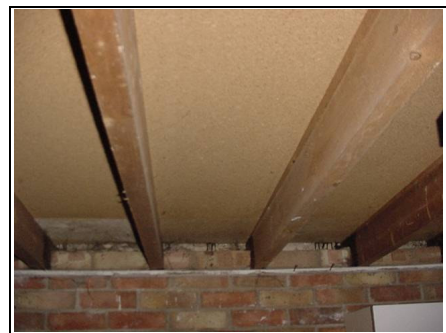
We were able to see the underside of the flat roof and there were no obvious signs of roof leaks; although it would not surprise us if there were some leaks to the edges given the condition of the flashings.

Also it could not be established if there is insulation within the roof or a vapour barrier, without the vapour barrier and combined with inadequate ventilation there will be an increase in the risk of wet or dry rot.

For your general information the latest Building Regulations require flat roofs to be ventilated. Building Regulations are not retrospective but the reason for the requirement is to make sure that any moisture that enters the roof construction is dispelled by way of ventilation. We would suggest that if the opportunity arises ventilation should be provided. This will stop the possibility of fungal growth above the ceiling in the flat roof area.

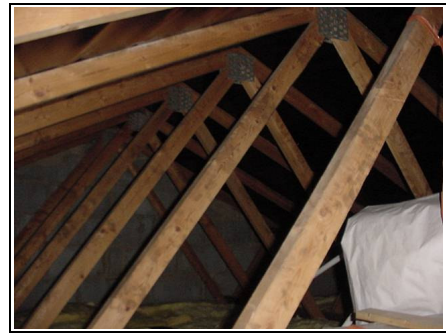
The main roof is accessed via the loft hatch located on the landing. There is no loft ladder, electric light or secured floorboards. We recommend that these be added, as it will make the loft space safer and easier to use (although it is a low roof height). The loft has been viewed by torchlight, which has limited our viewing slightly.

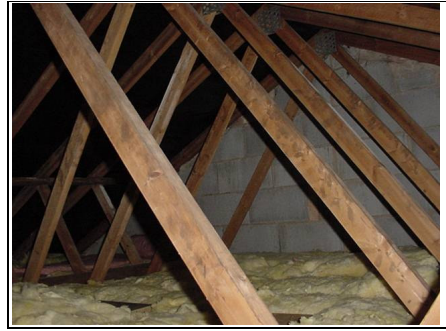
Our examination was limited by the general configuration of the roof and the insulation. What we could see was generally found to be in average condition considering its age, with some minor condensation and damp. It is, however, feasible that there are further problems in the roof that are hidden.

**ACTION REQUIRED:** Ideally add ventilation. The only way to be 100 per cent certain is to have the roof cleared and checked.

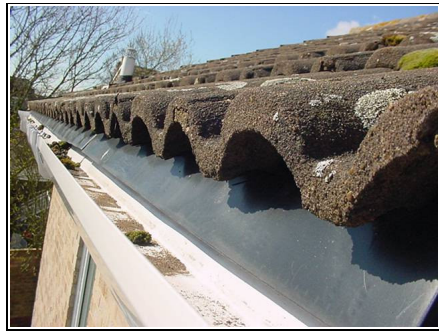
High level guttering

From ground level the gutters and downpipes looked to be what is known as profile plastic, which means the gutters and downpipes are shaped. There may be some minor leaks, but we feel that most people could live with these.

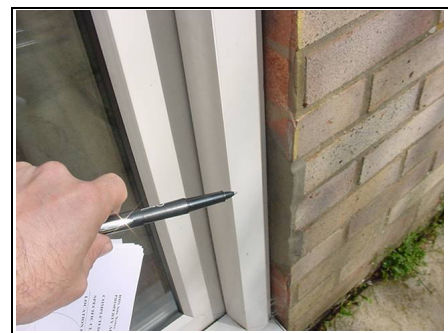
The rear patio door has been cut from an original window; our pen indicates where the cut bricks are.

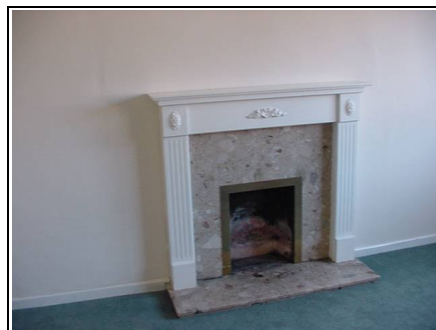
There is hairline cracking around the chimney; we believe this may have been where some dampness got through or a decorative chimneybreast was in place. We checked the area for dampness and did not find anything.

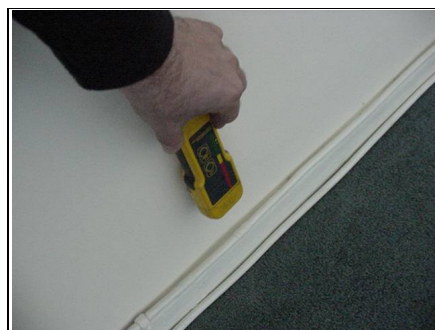
Checking for Rising Damp

No evidence of any significant rising dampness was detected in the random areas checked. It is not usual in a property of this type and age to have minor damp particularly to the rear around the French doors that have been added, as usually a damp proof course is not added at the same time. We believe most people will be happy to live with this.

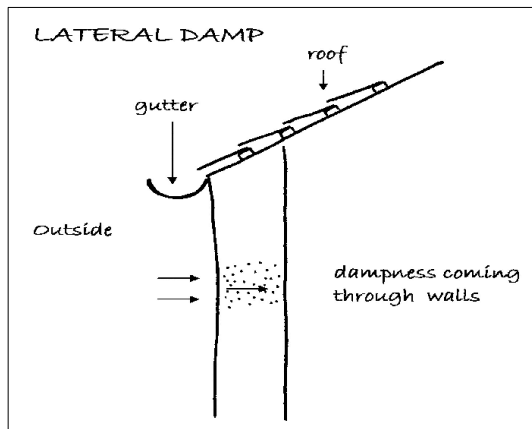
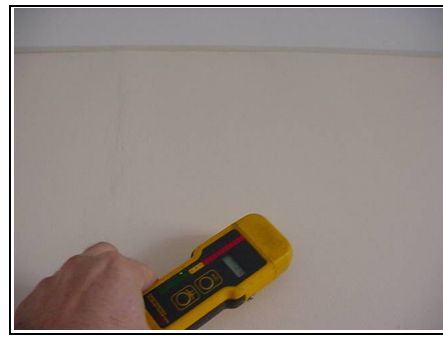
Tests were taken with a moisture meter at random points to internal walls, floors and other surfaces. No significant penetrating/lateral dampness was seen or detected.

Checking for Lateral Damp

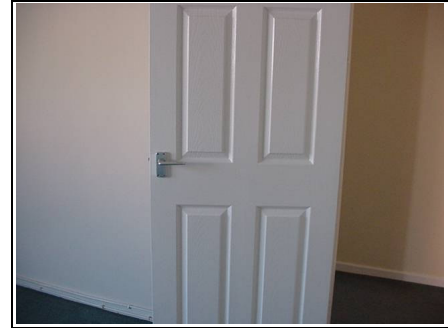
The property has hollow core doors (sometimes referred to as egg box doors, as this is what the internal of them looks like when they are opened up), which have a pressed and painted finish.

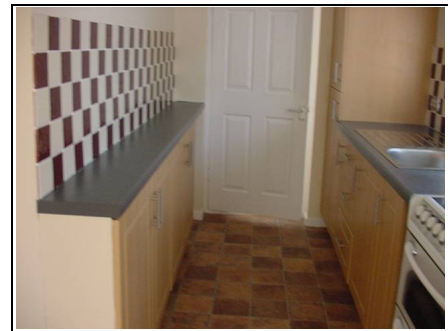
Galley-style Kitchen

From our cursory visual inspection the kitchen looked in reasonable condition, although it has suffered from some minor day-to-day marks.

Quite unusually the full height cupboard at the rear also has the soil and ventilation pipe travelling through it, which does reduce the size of the cupboard.

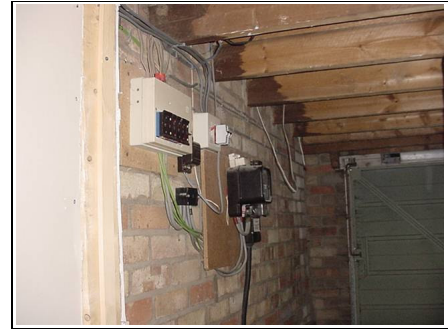
The electric fuses and consumer units were located in the garage. We would date the fuse board as being from the 1960s/1970s. Rewireable fuses are now superseded. Far better fuse boards are now available.

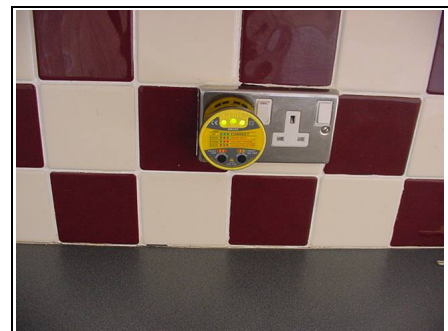
We carried out an earth test in the kitchen area to the socket point that is normally used for the kettle and this proved satisfactory.

We would comment the electrics look to be to a DIY standard in some areas.

**ACTION REQUIRED:** As the property is changing occupancy an IEE report should be carried out by a NICEIC registered and approved electrical contractor.

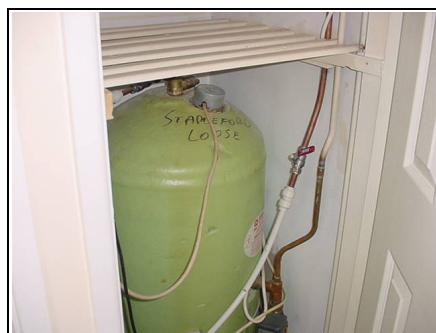
The hot water cylinder is factory lagged, which means it is relatively new (within the last 30 years in this case).

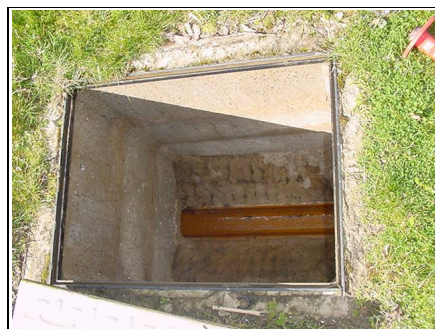
We duly lifted the man hole / inspection chamber cover and found the drain to be free flowing; we noted it was finished in brick.

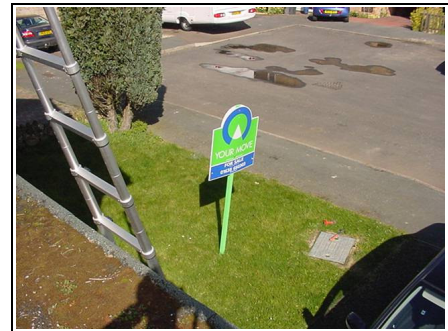
The front garden consists of a small grassed area and driveway.

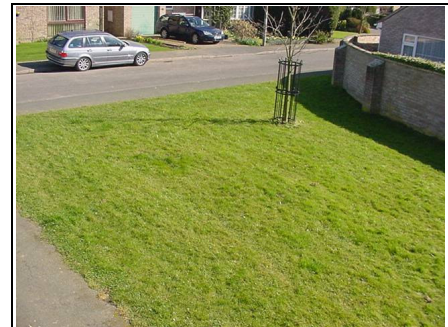
Right of Way on the left hand side

To the left hand side there is a right of way. You need to establish exactly where the boundary is.

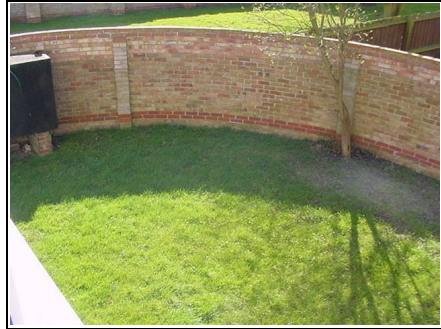
Rear Garden

The rear garden is laid mainly to lawn; it also includes a few trees, the oil tank and a shed.

The wall is relatively high for a single brick wall; you should therefore periodically check that it is stable, as it has a public footpath to the rear of it.
