# RESIDENTIAL BUILDING SURVEY

Powys  
LD8

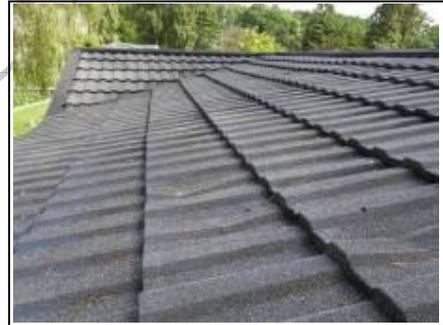
Main roof

We understand from the vendor, that the roof is of square cut timber frame construction, formed in two halves since the caravan itself is in two halves under the ridge line, therefore there are two mono-pitched roofs which abut to form the main roof.

The outer roof coverings are finished with Decra metal panels with a pressed mock roof tile pattern, finished with a Santex finish.

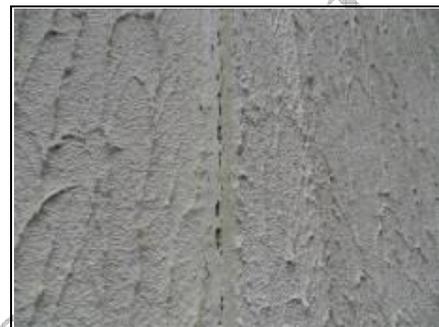
Timber frame wall – external textured finish

We have mentioned previously the importance of the vapour control layer within the wall construction but we cannot confirm whether one is provided. We assume that the plywood sheets are butt jointed together and then applied with the textured finish externally. It is always likely that there will be some minor movement between the plywood sheets due to seasonable moisture and temperature variations and you should periodically check the walls for any evidence of cracking around the part of the board joints and you should ensure these are maintained watertight to prevent water penetration into the structure, causing decayed timber framing.

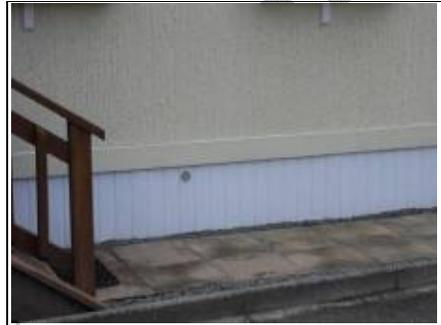
A ventilator to UVPC perimeter cladding to floor void

### Low Level Air Bricks

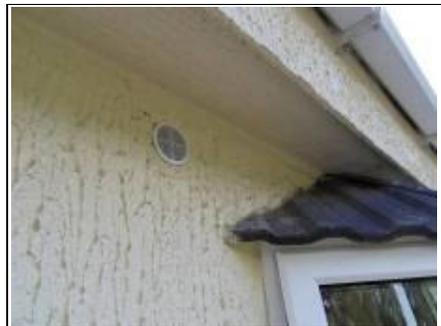
High level air brick to front elevation in lounge

Ventilation grills are provided to give natural background ventilation to the caravan in a number of rooms and these are both high level and low level and should be kept clear and open at all times.

**ACTION REQUIRED:** Ensure the air bricks are clear.

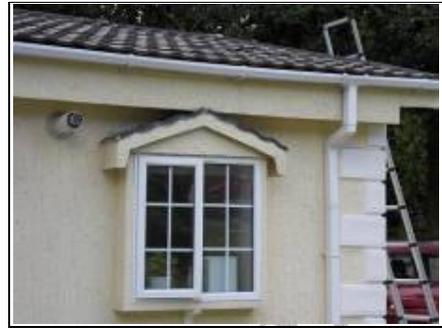
UVPC window

The property has double glazed UVPC windows without trickle vents which generally look to be of a average quality. We would draw your attention to the fact that sealed double glazed units can fail, particularly as a result of poor workmanship during installation. Failure of the seal leads to condensation between the two panes of glass and simply replacing the affected units may not provide a satisfactory long-term solution.

In this case two of the windows to the oriel bay windows on the front and rear of the premises are affected, where it is believed they receive most extremes of temperature and exposure to sunlight.

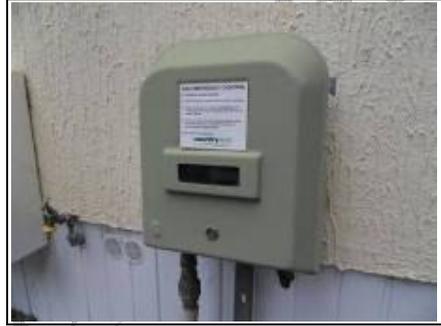
Gas meter on right hand side wall

All gas appliances, pipework and flues should be the subject of an annual service by a competent engineer, i.e., a member of Gas Safe; works to gas appliances etc., by unqualified personnel is illegal. Unless evidence can be provided to confirm that there has been annual servicing we would recommend that you commission such a service prior to use to ensure safe and efficient operation.

**ACTION REQUIRED:** As a matter of course it is recommended that the entire gas installation is inspected and made good, as necessary, by a Gas Safe registered contractor. Thereafter the installation should be serviced annually.

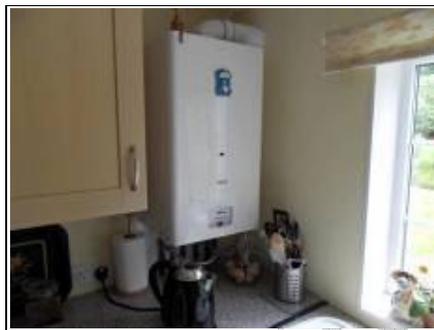
Wall mounted boiler

The boiler was located in the kitchen. It is manufactured by Jaguar, but there were no model number or types.

It was noted to be a combination boiler with integral programmer for the central heating operation.

Our limited inspection of the hot water and central heating system revealed no evidence to suggest any serious defects but we would nevertheless recommend that the system be tested and overhauled before exchange of contracts and that a regular maintenance contract be placed with an approved heating engineer.

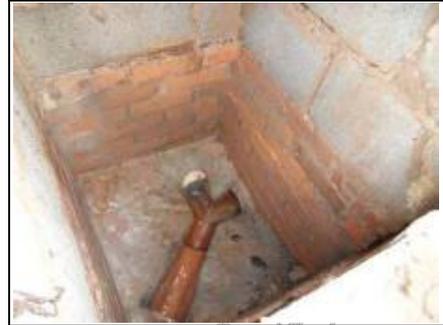
Manhole

Whilst we do not believe there is a requirement for the building to comply to Building Regulations for permanent structures, the foul drainage to the rear has a chamber which is covered by a loose laid timber panel. Not only could this become detached it is poorly sealed and does not comply with regulations.

From what we could see it comprises brick and block construction with a cement mortar benching at low level and plastic drainage pipes.

The inspection chamber is covered with a loose laid piece of plywood, not a proper manhole cover and frame. This should be upgraded.

**ACTION REQUIRED:** We must recommend this is upgraded in accordance with Building Regulations.
