RESIDENTIAL BUILDING SURVEY

**Barking,
IG11**

INDEPENDENT CHARTERED SURVEYORS

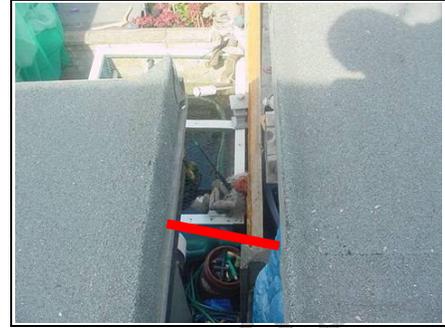
Gap between roofs of covered area
(red line)

Full Planning Permission would require a metre's gap between you and your neighbour for allowing for maintenance, unless there is prior agreement with your neighbour to form a party wall.

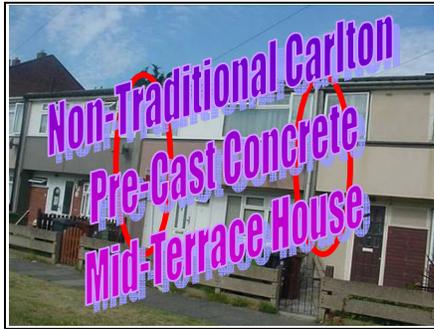
Concrete walls – red lines indicate where the concrete walls start

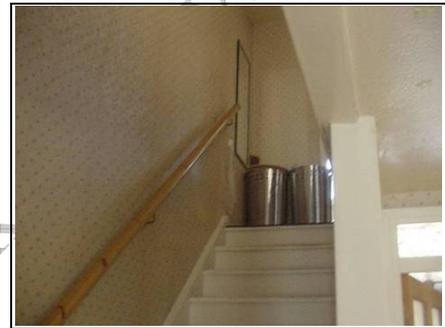
Most types of concrete property are generally prone to condensation and need to be appropriately heated, cooled and ventilated.

Wallpaper coming on stairway

ACTION REQUIRED: Add large humidity controlled extract fans.

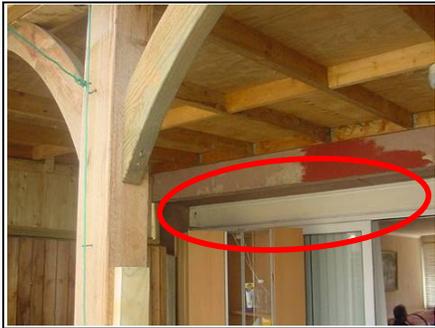
There looks to be a steel frame to the front and rear of the property. This has not been identified as an element with the construction of the Carlton pre-cast concrete house, however from what we can see there looks to be metal beams to the front and rear of the property and there also looks to be some rust, for example, within the bathroom area.

Metal beam

ACTION REQUIRED: Install large humidity controlled extract fans to the humidity generating areas, the bathroom and kitchen and also areas where you will carry out drying. We spoke about this and you mentioned you are likely to use the front left hand room for this type of activity, we therefore recommend you also have an extract fan there.

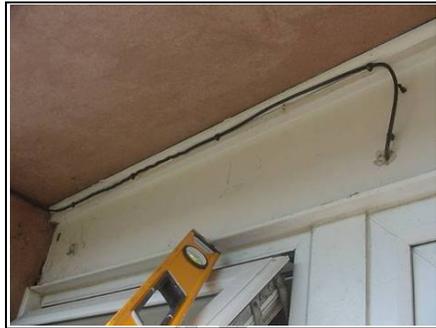
Metal beam

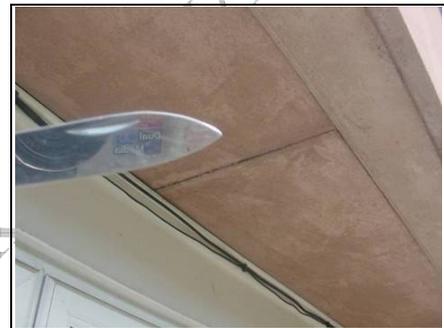
Possible asbestos infill panels

ACTION REQUIRED: We would always recommend all asbestos is removed from a property by an asbestos specialist as not only can it cause health problems, it also, we believe, affects value as there are perceived problems with it.

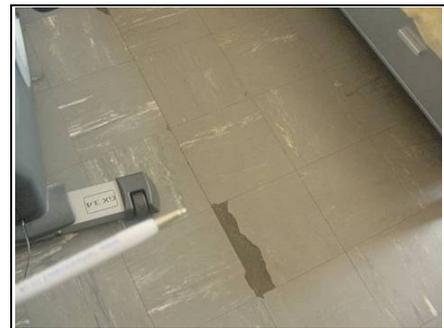
We also noted some thermo-plastic floor tiles to the front right hand bedroom, again these are known to contain asbestos.

Thermo-plastic floor tiles

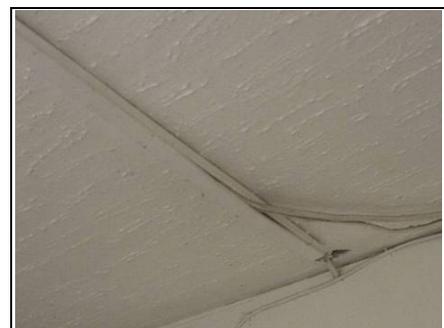
Artex ceiling – do not rub down

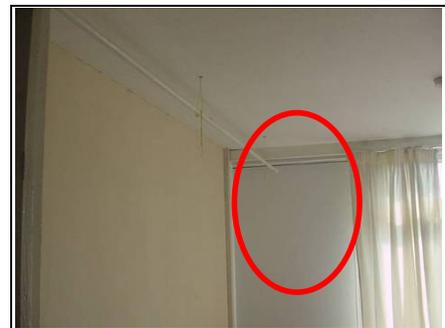
At first floor level you have rendered panels to the front and rear, but the areas we are most concerned about is where you have plastic panels, such as adjacent to the doors and windows.

Plastic panel – add an extract in this room if it is used for drying clothes

ACTION REQUIRED: We would recommend improving these by having a traditional brick in these areas on the ground floor to the front and rear of the property (some work has already taken place to the rear of the property) and at high level we would recommend you add in an inner wall, effectively forming what is known as a dry lined construction or false wall construction, to improve the insulation value.

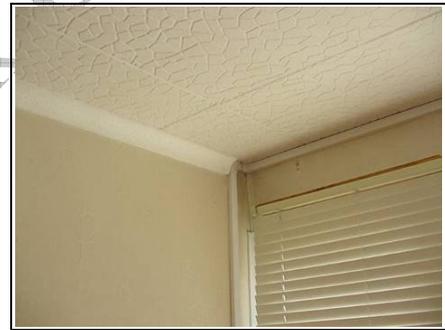
There are polystyrene ceiling tiles in the through lounge. These are generally not accepted by mortgage companies as in a worst case scenario of a fire they would drip liquid plastic on to you and are therefore best removed or over clad.

Polystyrene tiles in front lounge

ACTION REQUIRED: We recommend removing the polystyrene tiles and redecorate, or alternatively over-clad the existing ceiling with a plasterboard.

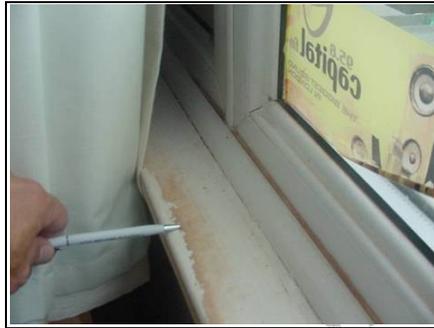
Window sill need cleaning

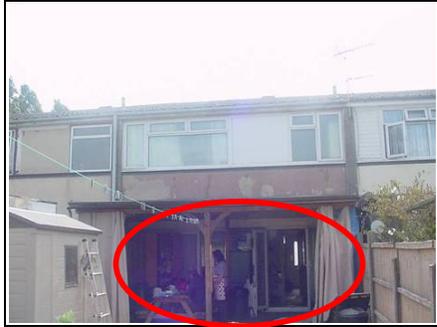
Rear covered over area

ACTION REQUIRED: Your legal adviser to check and confirm Local Authority Approval has been obtained or that the Local Authority is in agreement that it is not needed, as the owners advised during our question and answer sessions.

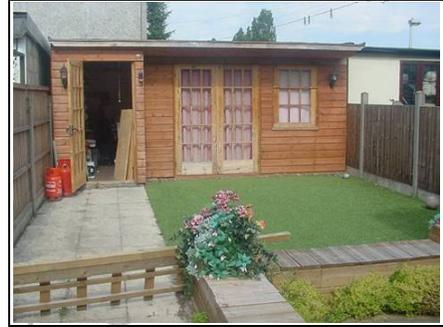
Summer house in rear garden

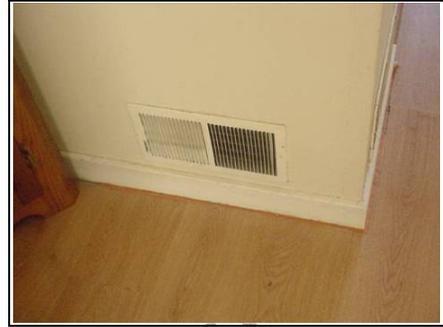
The property has warm air heating; some consider it to be the best type, as you have warm feet and a cool heat, but many consider it a problem as it passes dust around the property, we have heard it can be problematic if you are asthmatic.

Warm air heating

ACTION REQUIRED: We would recommend you live in it if at all possible for at least a year before you make a decision. It is more traditional in England to have a boiler and water fed radiators but many people prefer these just because they are familiar with them.

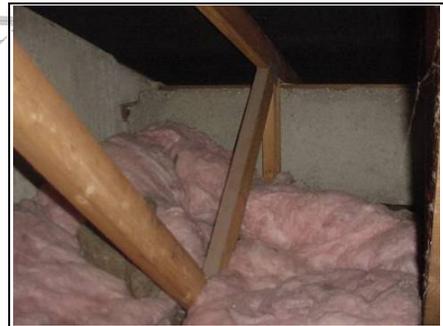
When we inspected the loft space we found a Hessian base Bitumen membrane. This type of membrane has been used since the 1960s. We generally found it to be in average condition, with damage in some areas which is what we typically find.

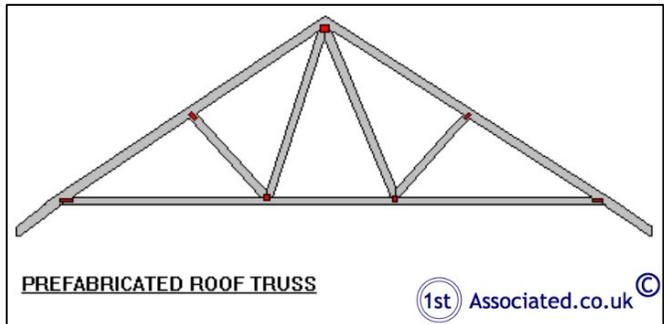
The property has a pre-fabricated timber roof rafter. These are made in a factory and transported to site and then lifted into place. Without the manufacturer's calculations and installation details we cannot comment categorically on the roof.

Pre-fabricated timber roof

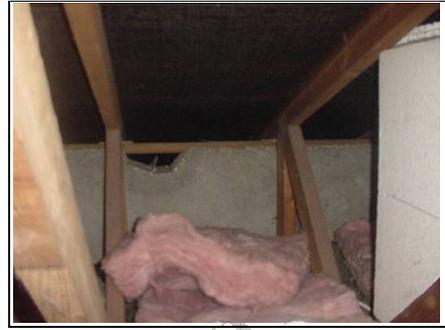
General view of inside of roof

Our examination was limited by the general configuration of the roof and the insulation. What we could see was generally found to be in average condition for its age, type and style. It is, however, feasible that there are problems in the roof that are hidden.

ACTION REQUIRED: The only way to be 100 per cent certain is to have the roof cleared and checked.

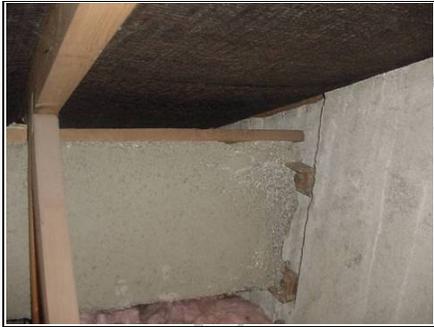
Looking at metal joint to front

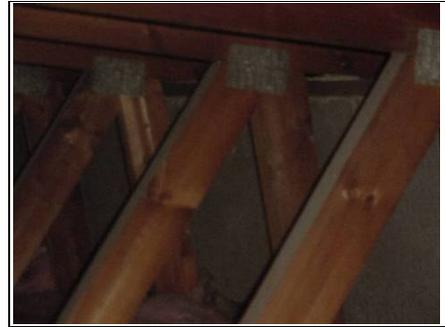
General pre-fabricated truss rafters

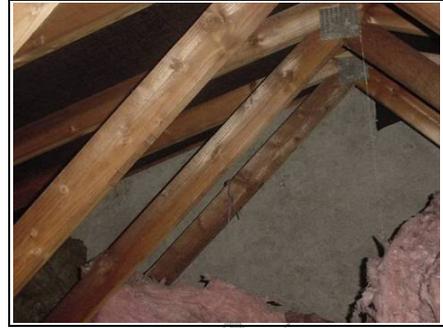
Concrete fire wall

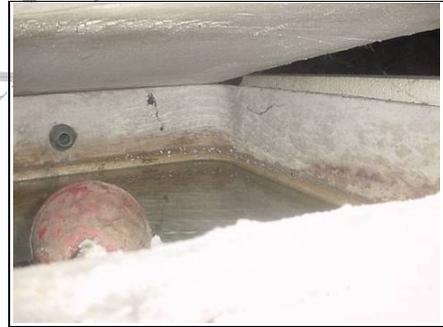
There is an asbestos water tank.

Asbestos water tank

We would always recommend that water tanks be drained down and cleared of any debris etc. (we have seen dead birds and other unmentionable things in these tanks). As you are often cleaning your teeth with this water it is best that it is as clean as possible!

ACTION REQUIRED: Please see our comments in the Executive Summary.

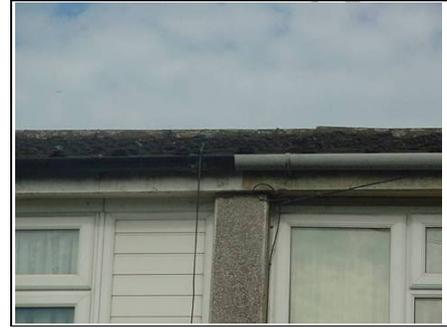
The property has grey plastic gutters and downpipes and are in average condition for their age, type and style. There may be a slight weakness where it abuts next door's black plastic gutter.

Plastic gutter

There may be some minor leaks but most people would be happy to live with these providing repairs are carried out within the next six to twelve months.

ACTION REQUIRED: We would always recommend you stand outside the property next time it rains heavily and see how well the drains cope with the rainwater particularly looking at the guttering and the joints. We also recommend that the gutters and downpipes are cleaned out, the joints are checked and the alignment checked to ensure that the gutters fall towards the downpipes.

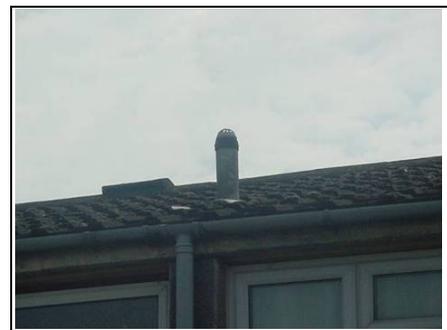
Asbestos soil and vent pipe

ACTION REQUIRED: Please see our comments in the Executive Summary.

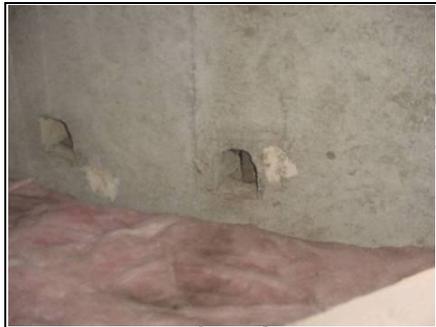
In this case we believe the walls and the floors are pre-cast. We can see this within the roof where we noted lifting eyes, which lift the pre-cast concrete into place.

Lifting eyes – bringing the concrete in

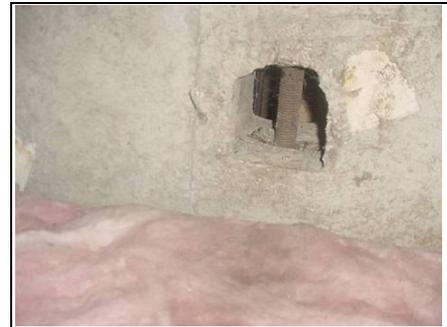
Close up of lifting eye, which also shows the reinforcement bars that are within the concrete

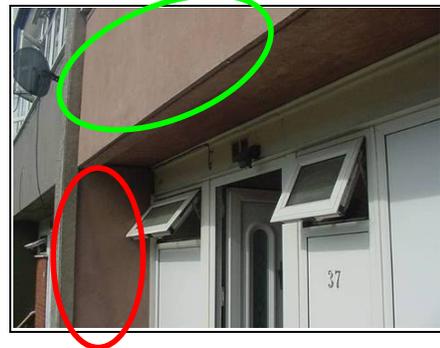
Vertical concrete (red oval) and horizontal concrete (green oval)

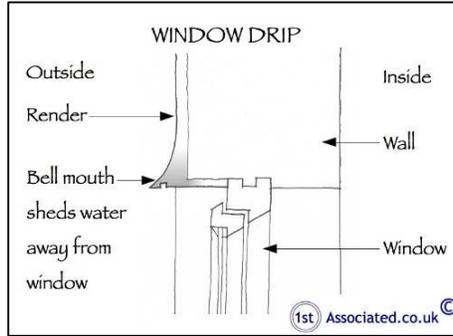
On a traditional property there would tend to be a bell mouth detail, as shown in our sketch below. In this case there is no bell mouth detail but there is a drip detail, which we were pleased to see.

Window drip

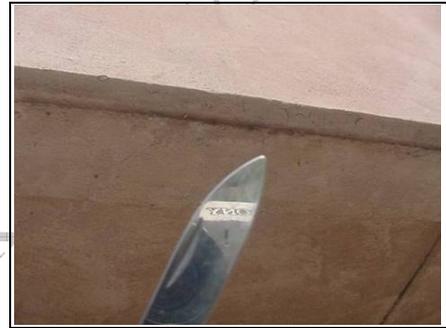
Drip detail to bottom of render

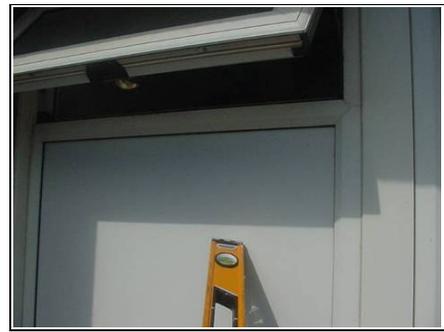
There are plastic in fill panels at high and low level.

Plastic in fill panels

ACTION REQUIRED: We recommend these improved by the adding of an internal wall, often known as dry lining

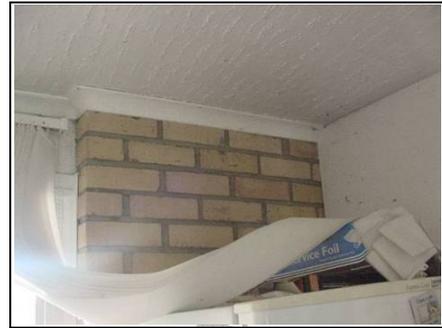
The bricks are in a Stretcher Bond pattern but we do not know if it is a true cavity wall.

Small area of brick to rear kitchen

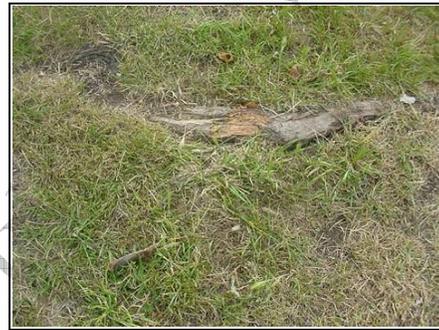
Tree root

ACTION REQUIRED: See our comments in the Executive Summary.

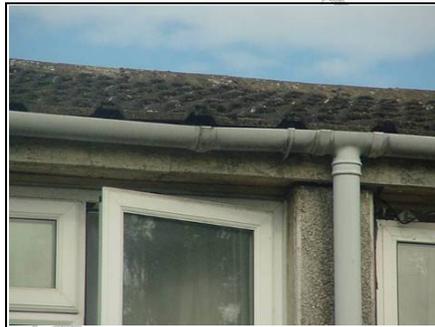
We had a close up inspection of the fascias and soffits and they look to be concrete, however interestingly on the literature that was available to us it identifies the fascias as being aluminium. We believe if this was the case that they have been removed when the new(ish) grey gutters and downpipes were added. We would comment that they are in average condition for their age, type and style.

Concrete fascias and soffits

Our concern with the way the guttering is now, is that if the gutters leak they will soak into the concrete and cause deterioration.

ACTION REQUIRED: We recommend some protection is added between the gutters and the concrete.

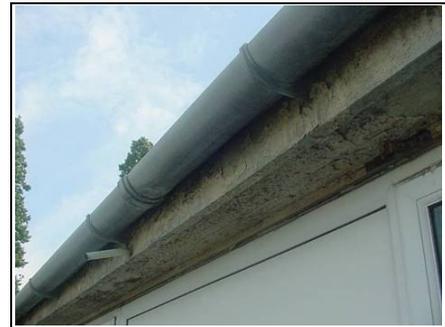
Close up

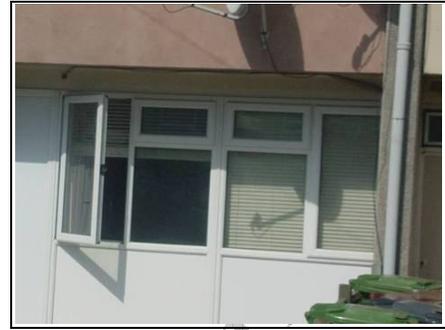
The property has plastic double glazed windows without trickle vents, which generally look to be of below average quality, and would comment they look to be from the cheaper end of the market, with the misting up of the window in the rear bedroom.

Windows without trickle vents

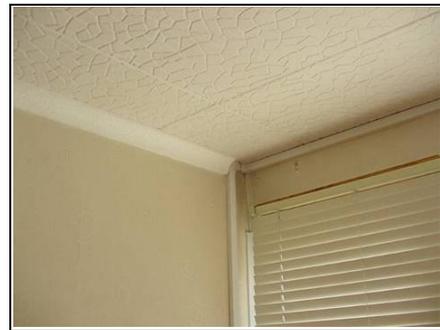
There are polystyrene tiles in the through lounge and the ceilings are insulated; we do know with how much.

Polystyrene ceiling tiles

ACTION REQUIRED: Please see our comments in the Executive Summary.

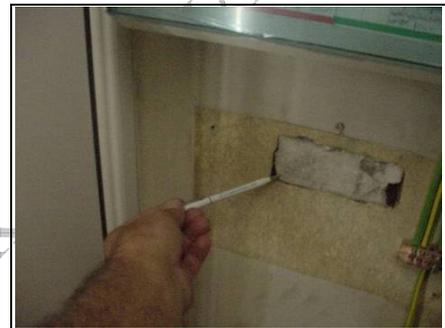
One thing that did throw us was this insulation that was visible on one of the internal walls. It may be that here was a plastic panel in this area that was exposed when a fuse box was put in place. Unfortunately, this is one part that we have not been able to establish, the only way would be to open up the walls.

Cut out panel within electric cupboard showing insulation

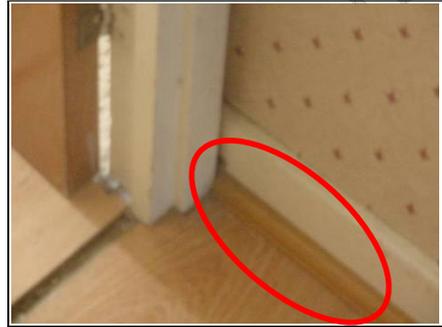
The laminate has a quadrant bead around it and is opening up in places and we would say that it is poor quality and from the cheaper end of the market.

Quadrant beading

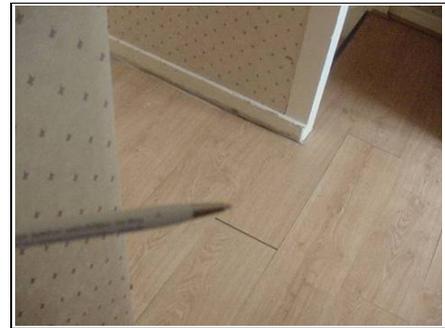
Laminate starting to open up

ACTION REQUIRED: See our comments in the Executive Summary.

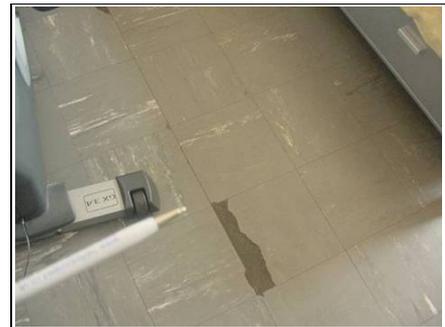
Thermo-plastic floor tiles

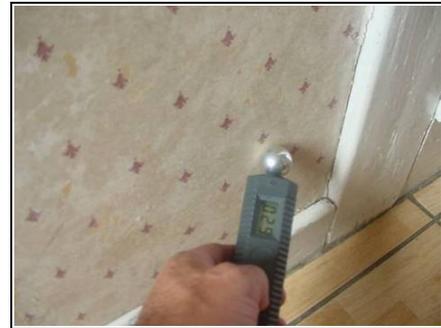
A random visual inspection and tests with a moisture meter have been taken to the perimeter walls. In this particular case we have found no significant rising damp, but please see our comments in the Executive Summary about condensation.

Testing for rising damp

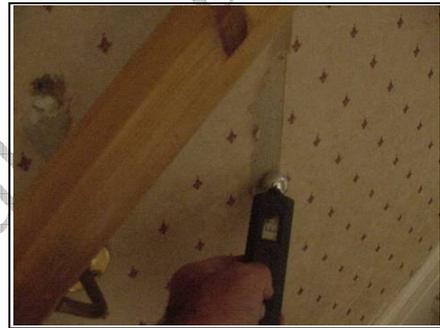
We used a resistance meter on the external walls. We have not found significant dampness, but please see our comments on condensation.

Testing for lateral dampness

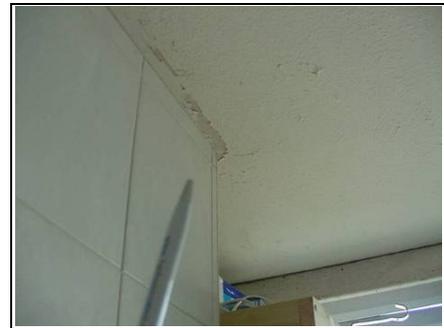
At the time of the inspection there were signs of condensation to the ceilings. We also believe there are signs of condensation to the walls on the staircase, for example.

Condensation in bathroom

ACTION REQUIRED: We would recommend large humidity controlled extract fans be added to kitchens, bathrooms and drying areas.

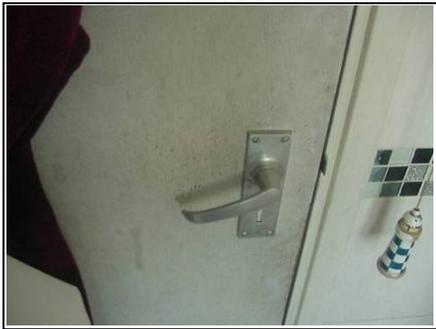
The property has hollow core doors (sometimes referred to as egg box doors, as this is what the internal of them looks like when they are opened up), they have a paint finish and are slightly marked but nothing unusual. This can be seen in the cupboard where the door has been cut in half.

Bathroom door – needs redecorating

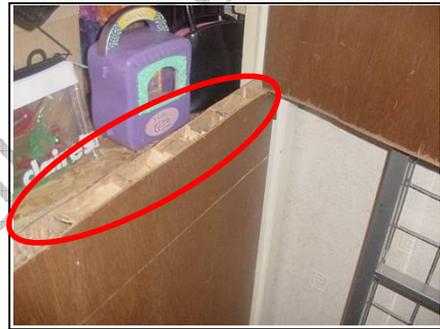
Cupboard door cut in half to reveal egg box door

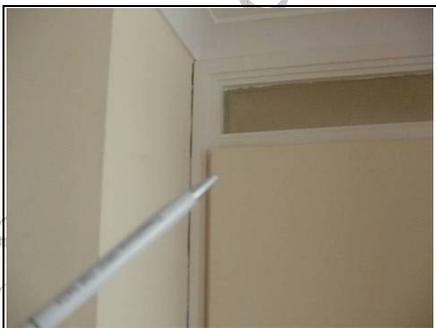
We noticed that some of the doors do not fit properly, sometimes indicating slight movement in the property.

Door does not fit

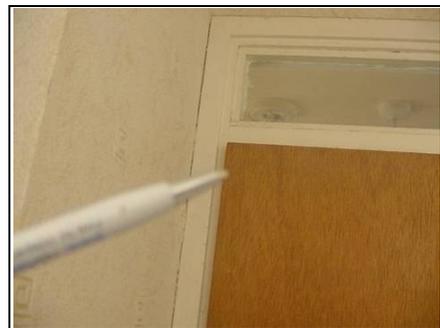
Door does not shut very easily

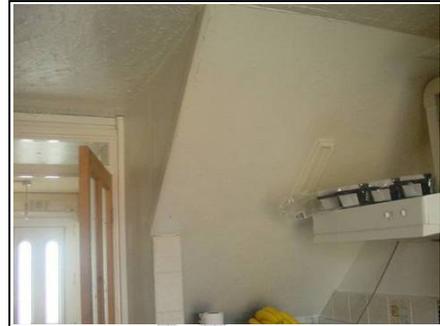
We were unable to examine the underside of the stair timbers due to it being lined, which precluded our inspection, so we cannot comment further upon the stair structure. We can, however, say that the lining gives a resistance to the spread of fire if such circumstances were to occur.

Lined stairs

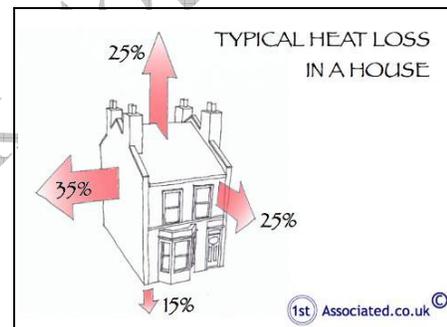
Some roof insulation was present although not to current Building Regulations requirements of 300mm. In this instance there is about 200mm to 300mm.

Typical heat loss

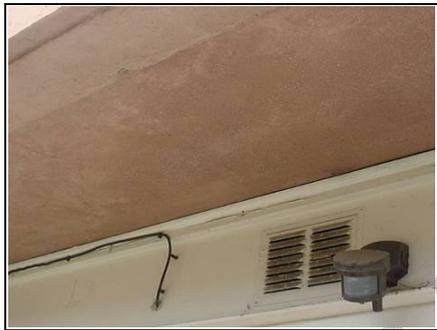
A security system has been installed, however it does not work and is just there for show.

Security system does not work

It is a personal decision as to whether you feel one is necessary. We are not experts in this field and therefore cannot comment further. We suggest you contact a member of NACOSS (National Approval Council for Security Services), obtainable through directory enquiries, or your local Police Force for advice on a security system.

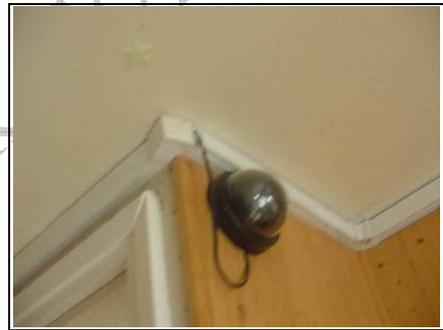
Security system there for show

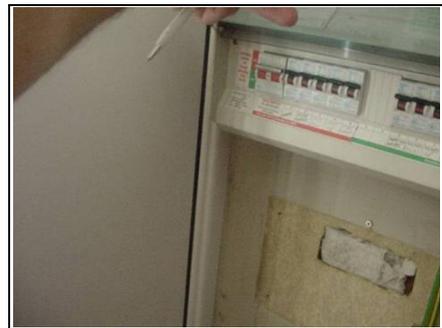
Fuse Board

The electric fuses and consumer units were located in the left hand corner of the front reception room. The fuse board looked as though it was from the 1980's/1990's and better are now available.

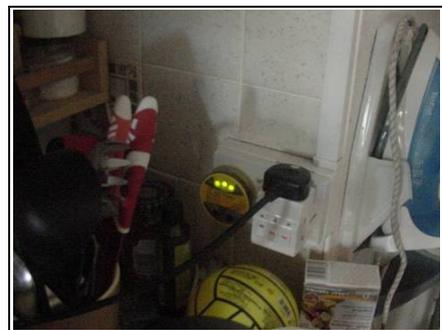
Earth test

We carried out an earth test in the kitchen area to the socket point that is normally used for the kettle, this proved satisfactory.

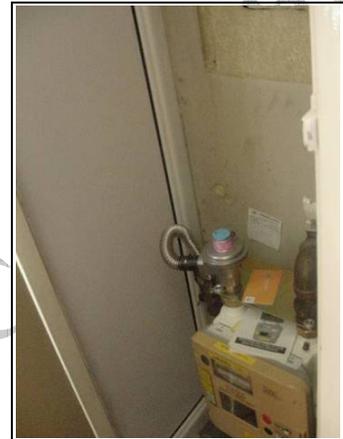
Gas meter

All gas appliances, pipework and flues should be the subject of an annual service by a competent engineer, i.e., a member of Gas Safe; works to gas appliances etc., by unqualified personnel is illegal. Unless evidence can be provided to confirm that there has been annual servicing we would recommend that you commission such a service prior to use to ensure safe and efficient operation.

ACTION REQUIRED: As a matter of course it is recommended that the entire gas installation is inspected and made good, as necessary, by a Gas Safe registered contractor. Thereafter the installation should be serviced annually.

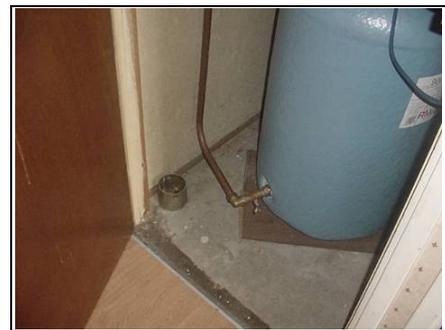
There is a hot water cylinder located in the airing cupboard. It has is factory insulated, which indicates that it is relatively new (in this case we mean in the last 30 years). This cylinder will therefore have a good thermal efficiency, although not as good as the more modern hot water cylinders.

Factory lagged hot water cylinder

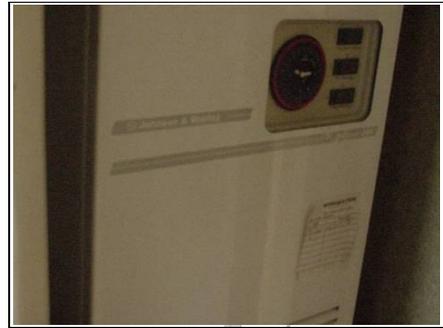
Our limited inspection of the hot water and central heating system revealed no evidence to suggest any serious defects but we would nevertheless recommend that the system be tested and overhauled before exchange of contracts and that a regular maintenance contract be placed with an approved heating engineer.

Johnson and Starley
warm air system

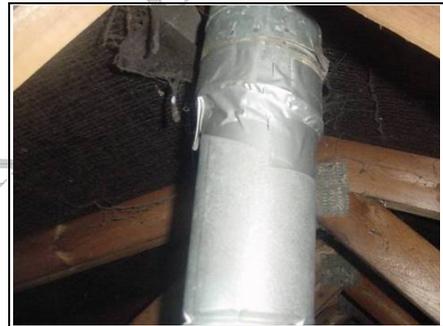
The warm air system had a metal flue. Flues are sometimes lined with asbestos, but we were unable to see whether it was or was not in this instance.

Flue to boiler in roof space

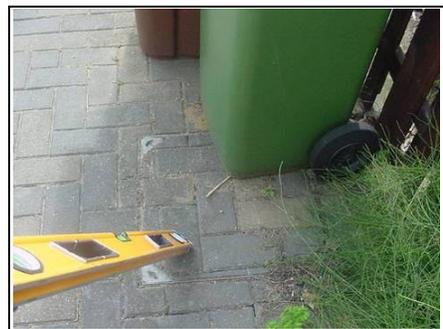
Manhole to front

We were unable to lift the manhole during the course of our inspection.

ACTION REQUIRED: Have a closed circuit TV camera report of the drains. Please see our comments in the Executive Summary.

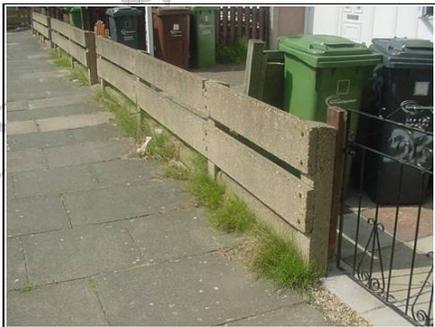
There is a small front garden area, which has been concreted over and, as was popular in those days when everything was done in concrete, it even had a front concrete fence.

Concrete fence to front – concrete and asbestos were common materials during this Era of construction

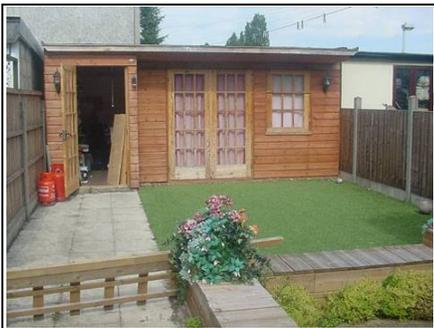
The summer house to the rear of the garden is currently being used as an office. It has a felt roof.

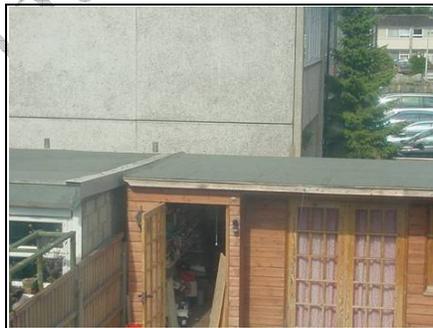
Felt roof

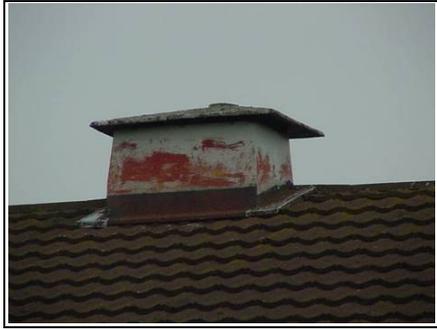
Asbestos original chimney non traditional house

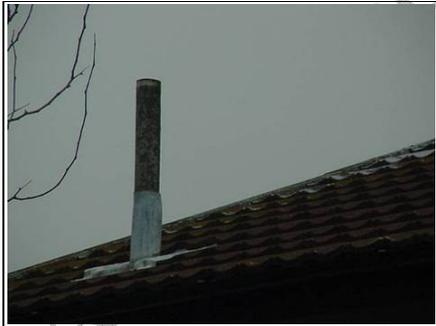
Original asbestos soil and vent pipe on a non-traditional house

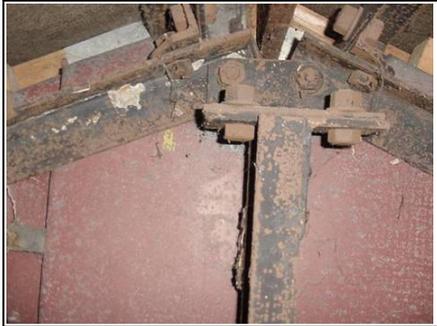
Rusting to a lightweight metal frame or damage or deterioration to the metal frame of a non-traditional house

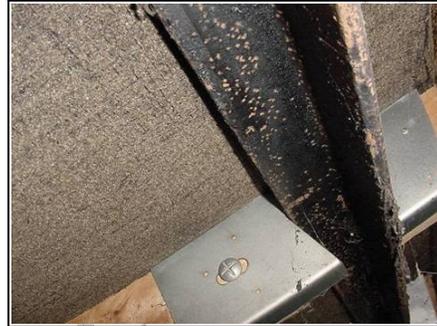
Some fixings replacements/repairs to a non-traditional house

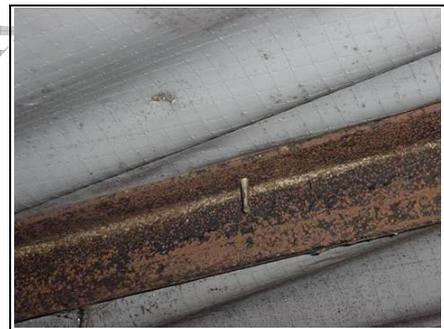
Rusting within the roof between the insulation and plastic protective underlayer

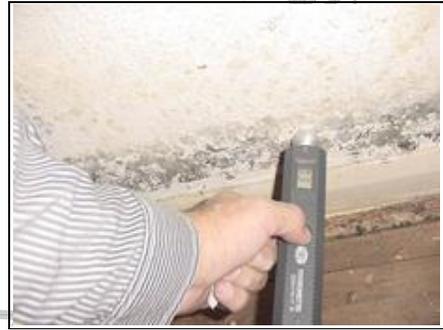
Black mould and high damp meter readings
