RESIDENTIAL BUILDING SURVEY

Cheshire

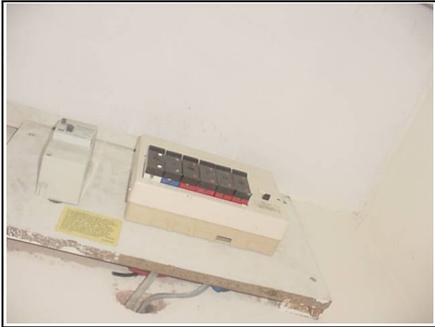
Both the electric units have been switched off and both of them are from the 1960's/1970's.

Fuse Board in ground floor flat

ACTION REQUIRED: We recommend that the whole system is replaced and an Institute of Electrical Engineers standards (IEE) test and report carried out by an NICEIC registered and approved electrical contractor or equivalent.

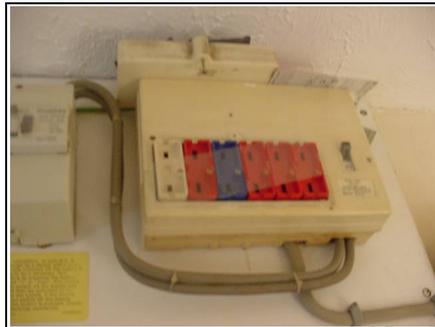
Fuse Board in first floor flat

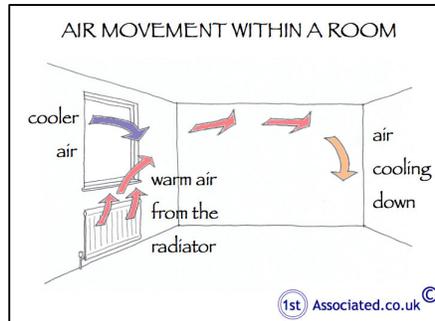
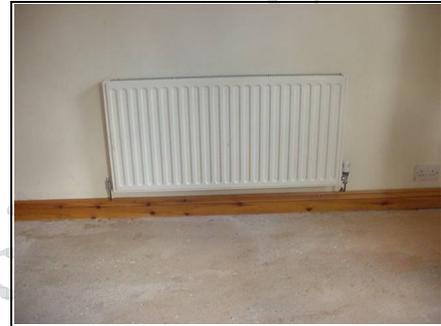
Internal radiator

At the same time as you are changing the radiators from single panel to double panel radiators we also recommend they are re-positioned underneath the windows. This should not be hard with the suspended timber floor and joints and floorboards at first floor level.

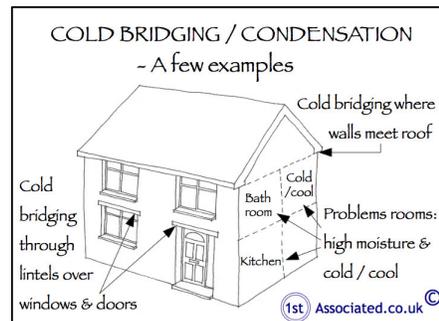
Condensation in first floor

ACTION REQUIRED: Whilst the problem is not 100% possible to stop it can be improved by adding humidity controlled extract fans to the bathrooms/shower rooms and kitchens. At the time of our inspection we noted the form of condensation within the cupboard in the bedroom in the first floor.

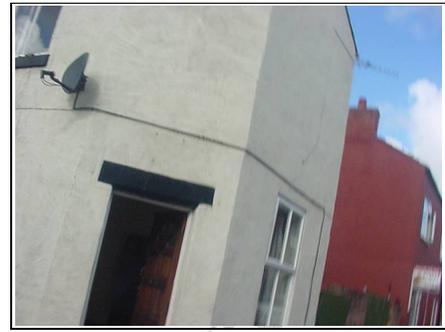
The property has been rendered externally and you will need to paint this to keep the property watertight, with a masonry paint rather than a plastic based paint that looks to have been placed on it presently which simply stops the property from breathing, very much like a Cagoule, whereas what you need is a Gore-tex type finish.

Large area of render to paint

ACTION REQUIRED: We recommend redecoration by 2013. It is important that the correct paint is used.

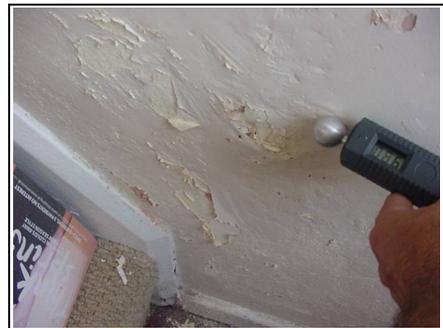
You have rising damp. We can see that chemical injections have been inserted into this property before. We believe that a property of this age needs to breathe rather than having an injected damp proof course. The difficulty you have with the dampness to the floor of the property is that there is no proper air flow underneath the property.

Rising damp to stairs at bottom of entrance to first floor

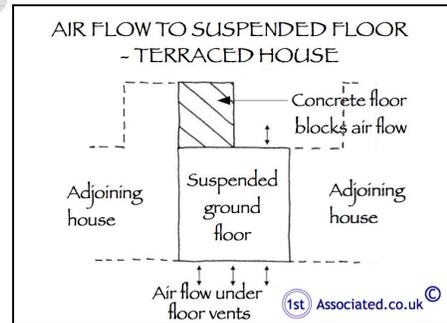
We believe the original suspended timber floor has been partially blocked by concrete in the corner section of the property where the old cellar used to be. This has blocked the ventilation to the timber floor which can cause deterioration. If you recall, we asked you to jump up and down on the front bedroom floor and there was quite a bit of flex/deflection to it.

Where cellar used to be

ACTION REQUIRED: We recommend you open up the suspended floor and check the condition of the joists (timbers). It may well be possible to through vent the area with some timber repairs; alternatively, it may not! The only way to be certain is to open up the floor. Ideally, you need to open up the floor before you purchase the property as this would give you a better indication of the costs.

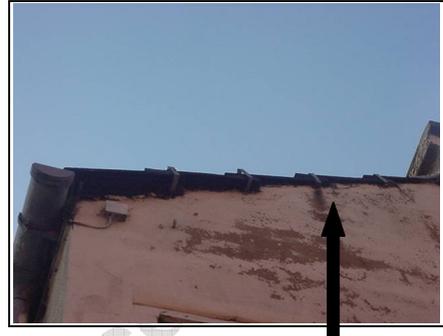
1. To the rear there is not a sufficient overhang to the tiles. This means the water is discharging down the rear render of the property which is soaking into the cement render like blotting paper. This is also causing some sulphate attack to the rear chimney.

Insufficient overhang to the tiles

ACTION REQUIRED: You need to have a roofer for a few days to check the roof and the flashings and ensure that the overhang is correct. You may also need to carry out some re-rendering work. We have already mentioned this in the Bad Section but we do feel it warrants promoting to the Ugly Section.

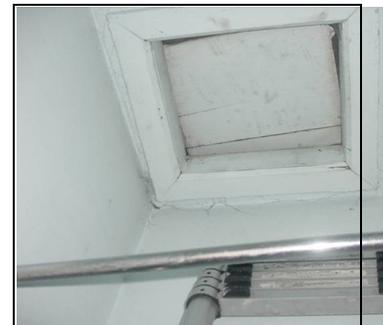
We would also add that we have not been able to see into the roof properly.

Small loft hatch 22

ACTION REQUIRED: We recommend that a wider access hatch is cut into the ceiling and that it is fully lit and boarded, together with a permanent ladder. We would be more than happy

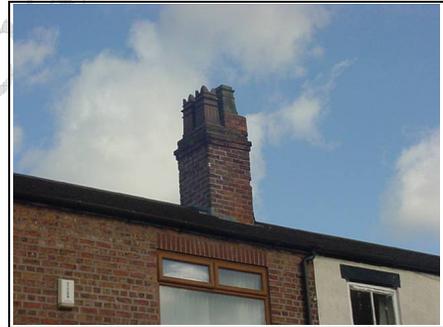
Chimney

This chimney is brick finished with part lead flashing and four number chimney pots, half of which are yours. From what we could see from ground level it looked in average condition needing some pointing considering its age, type and style.

ACTION REQUIRED: We can see that some of the flashing was missing. You need to check this and ensure that there is flashing to the entirety of the chimney. We have recommended in the Executive Summary that you have a roofer for a few days and this is one of the jobs they should carry out.

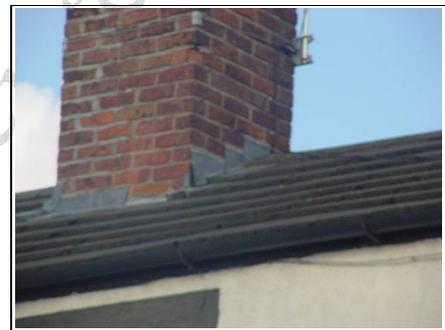
The main roof covering is concrete tiles. Due to the pitch of the roof we could not see them very well. They look to be a flat interlocking concrete tile. Originally the roof would have been a slate roof covering, as was popular in the majority of this type of Victorian property which would be much lighter.

The re-roofing of a slate roof with concrete tiles is relatively common. However, it has in some cases led to problems in the form of roof spread. A common one being roof spread. This occurs because the concrete tiles are much heavier than the original slate tiles (particularly when wet), which results in additional stress and strain being placed upon the roof structure and the walls, in some cases causing movement.

Concrete roof tiles

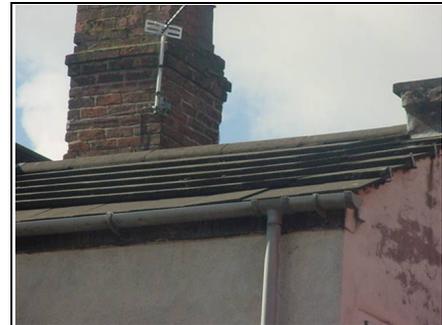
We suspect there is no tilting fillet to the last tile on this roof. It is very difficult to see due to the angle. The adjoining sketch shows you what a roof with no tilting fillet looks like.

No tilting fillet

ACTION REQUIRED: We suggest that that when your roofer gets up on to the roof using a long ladder or a tower scaffold they check to see if there is a tilting fillet.

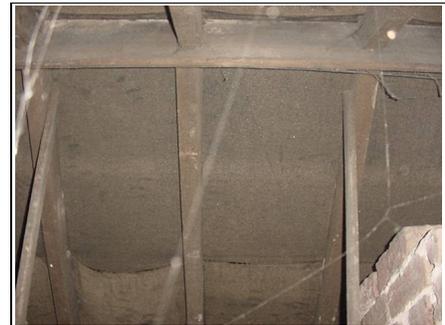
When we inspected the loft space we found an older style Bitumen membrane. This type of membrane has been used since the 1960s. We generally found it to be in average condition, with damage in some areas which is what we typically find. Again we reiterate that our view was limited.

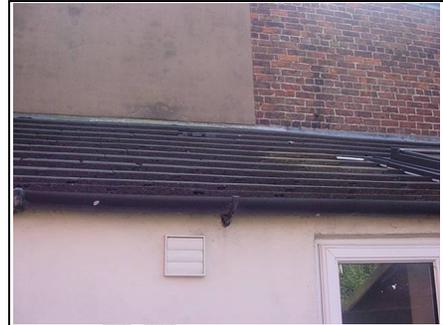
Low level pitched roof

This roof also has a concrete tile that we believe to be interlocking. We were pleased to see a lead flashing where it meets the main building, although it does look like this is leaking from within the roof. With a shallow pitch such as this it can be subject to wind driven rain.

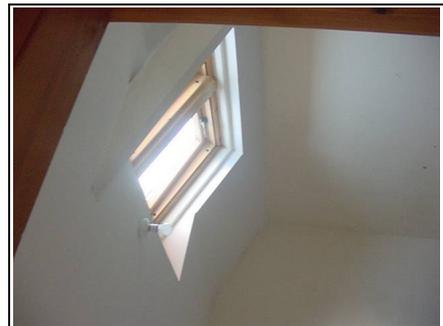
Roof window

The property has a purpose made roof light, which looked in average condition. The important factor with roof lights is the flashing around them.

It seems inevitable with roof windows that they will sooner or later leak. If this doesn't occur then they seem prone to condensation. Keep a cloth handy!

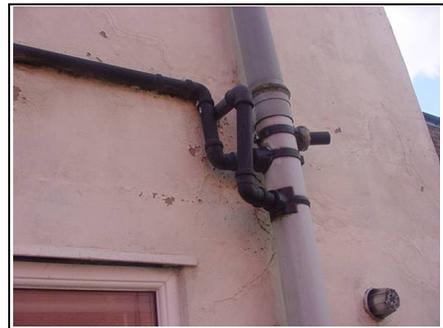
Tangle of pipes on the soil and vent pipe

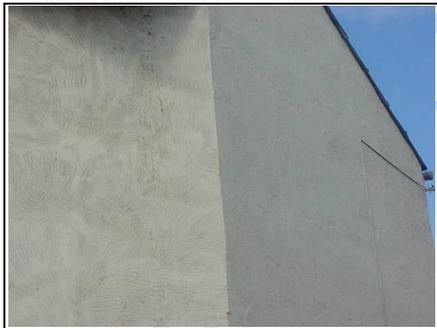
This property looks to have had a cement based render added and in addition to this it looks to have a modern paint on it.

Lots of painted render

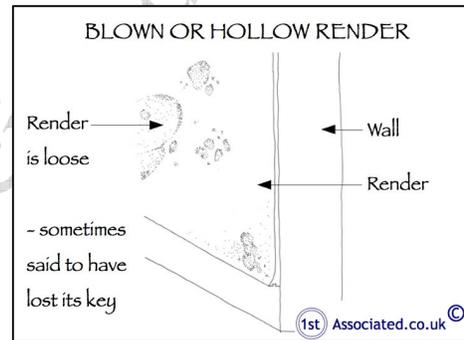
We have carried out a tap test (literally hitting the render with the back of a hammer). We found it to be in slightly below average condition for its age, type and style.

ACTION REQUIRED: Please see our comments in the Executive Summary.

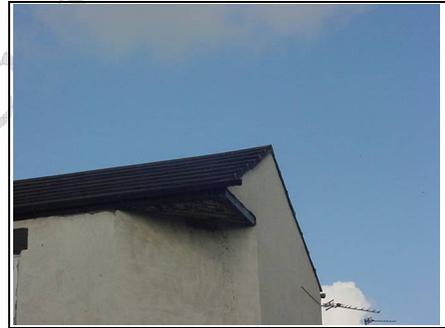
The fascias and soffits are timber. They are painted / stained and we would comment that they are likely to need work with the gutters in the condition they are.

Timber fascias and soffits

ACTION REQUIRED: When the gutters are being checked you can also check the condition of the fascias and soffits.

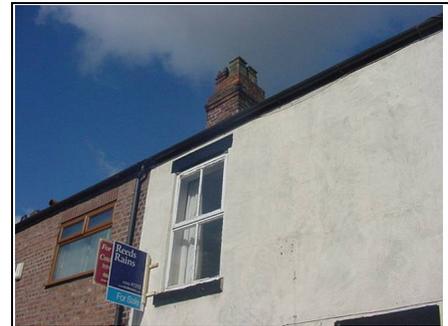
The property has a mixture of timber casement windows in a sliding sash style/look and plastic double glazed casement windows to the rear without trickle vents, which generally look to be in below average condition, and which we believe are from the cheaper end of the market. We would comment that some of the double glazed units have failed. Failure of the seal leads to condensation between the two panes of glass and simply replacing the affected units may not provide a satisfactory long-term solution.

Timber casement sliding sash style window to front

ACTION REQUIRED: Repair windows. Please see our comments in the Executive Summary.

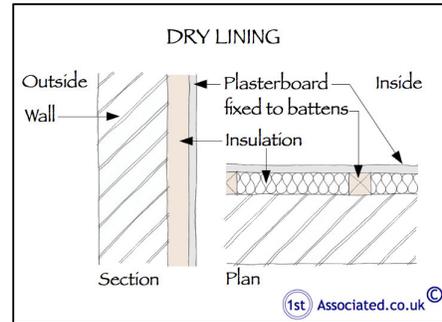
Originally these would have been constructed with a wet plaster with a lime mix. It has now in lots of areas had dry lining added. It is very important that you realise the dry lining/hidden walls is hiding a considerable amount of dampness. We suspect that when you open up the floors the dampness will be such that it will have affected some of the floors joists, particularly where the timbers are embedded into the outer brickwork on the ground floor.

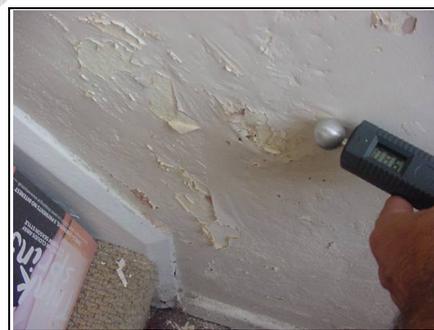
A random visual inspection and tests with a moisture meter have been taken to the perimeter walls. In this particular case we have found rising damp. We believe this dampness comes from the concrete floor acting like blotting paper and then this being drawn into the building.

Rising damp to stairs at bottom of entrance

ACTION REQUIRED: Please see the Executive Summary. It may be a long drawn out process to get this property dry.

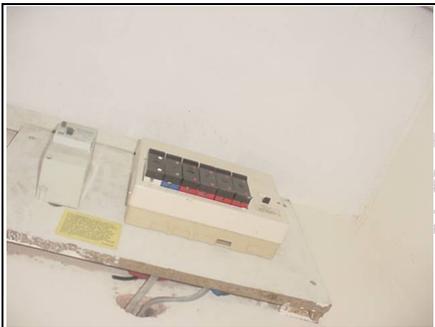
The electric fuses are dated and it is best to start again with new electrics. In multi occupied properties a defective fuse board can be particularly dangerous.

Fuse Board in ground floor flat

ACTION REQUIRED: As the property is changing occupancy an Institute of Electrical Engineers (IEE) test and report should be carried out by a NICEIC registered and approved electrical contractor or equivalent. Please see our comments in the Executive Summary.

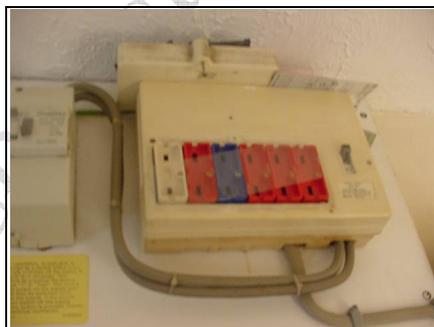
Fuse Board in first floor flat

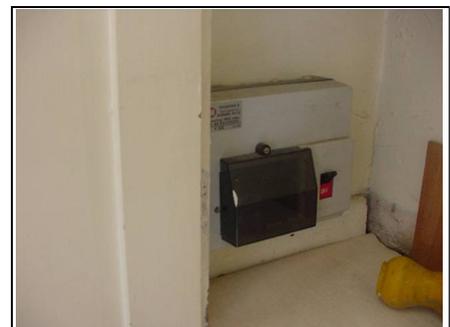
Electric unit in cupboard on first floor – not sure what this is for

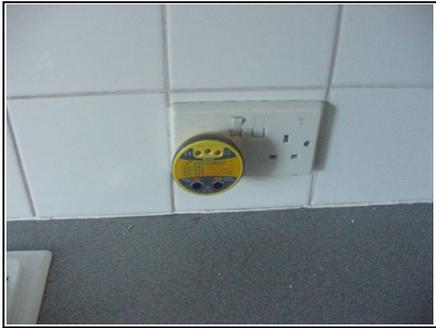
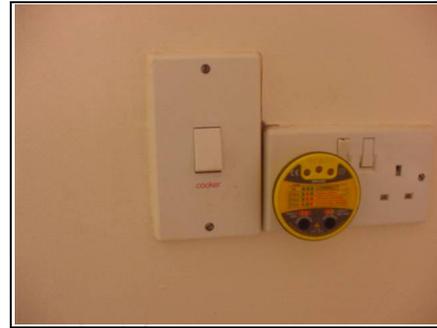
We tried to carry out an earth test in the kitchen areas on the ground and first floor that is normally used for the kettle, but the electrics were off and we did not feel it appropriate to switch them back on with the condemned stickers, etc.

Electric off on ground floor

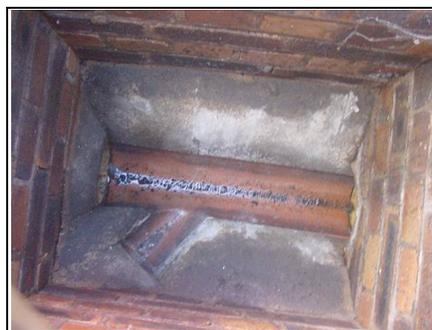
Rear drain

We duly lifted the cover and found it to be free flowing at the time of our inspection.

From what we could see it is brick built.

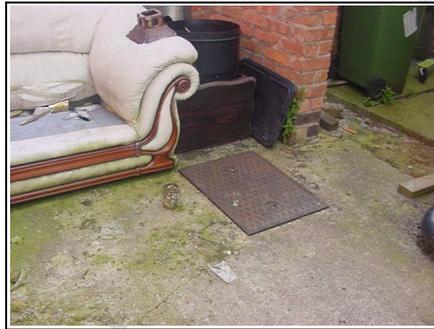
Rubbish needs clearing

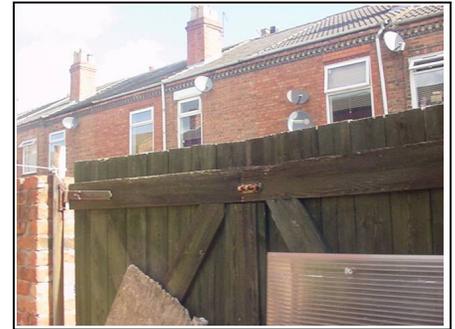
The rear of the property may be used for a parking area. There is a double wooden gate that will need fixing beforehand.

Rear double gates need re-fixing
