RESIDENTIAL BUILDING SURVEY

**XXXX Banbury,
Oxfordshire. OX15 XXX**

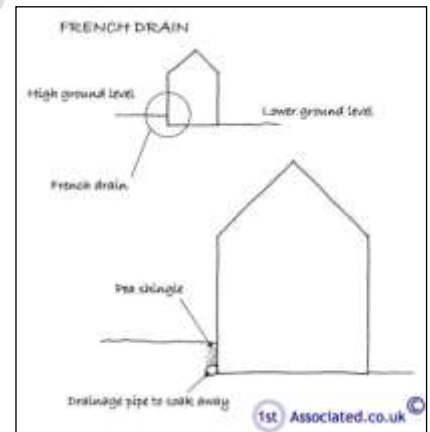
French drain

ACTION REQUIRED: You may wish to consider adding a French gully around the property which interestingly was common with this sort of property many years ago. You should watch closely next time it heavily rains to see if water discharges you may wish to add a French gully.

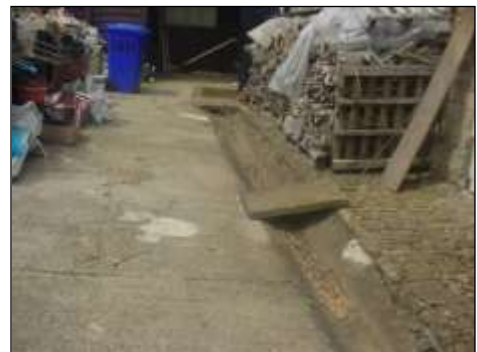
The rainwater gully in the adjoining property

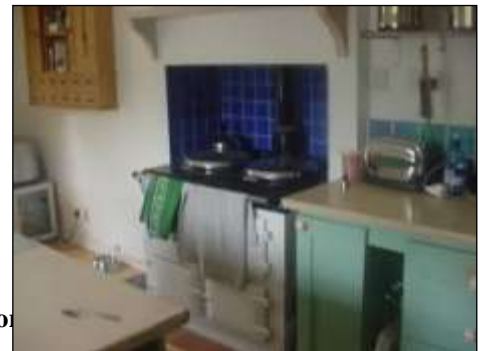
We noted that the property has an older style Baxi Boiler (not seen) they have many things to recommend them such as their simple mechanism however they are now getting dated.

We also noted microbored pipes to the radiators these in our experience do tend to block and not circulate the water particularly well.

ACTION REQUIRED: We would recommend having the entire system flushed although when having discussions the owner they advised that the Aga can almost warm the house on

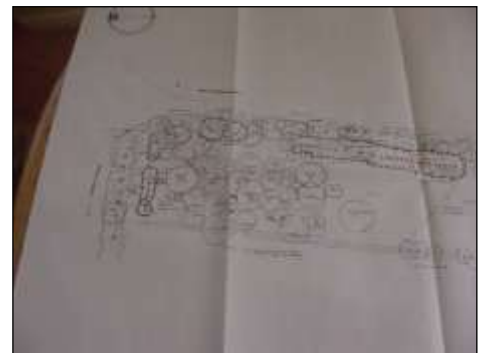
Plan of position of trees
