**RESIDENTIAL BUILDING SURVEY  
OF  
Penzance, Cornwall TR19**

**FOR  
Mr A and Ms P**

**INDEPENDENT CHARTERED SURVEYORS**

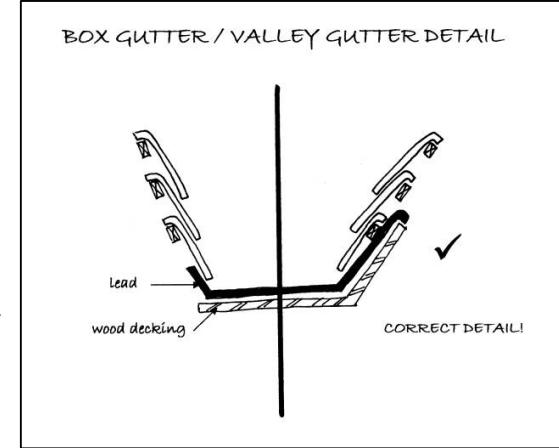
### **2) Awkward box gutter between rear of property and rear roof and no access to roof void to check condition**

Close up of box valley gutter

**ACTION REQUIRED:** We recommend that an access panel is made to this roof area and that the timbers are duly inspected. We would be more than happy to comment on any photos if you wish to forward these to us of inside the roof space once you have gained access.

**ANTICIPATED COST:** In the region of £200 to £400 to have an access hatch formed, plus any associated costs. Please obtain quotations.

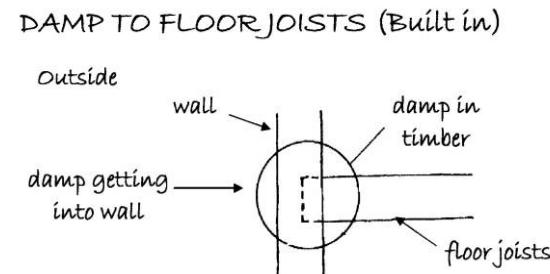
We noted on the first floor that there was deflection over and above what we would normally expect, even in this age of construction. This is likely to be because the floor joists are embedded into the walls.

In our experience of this type of flooring, we have often found herringbone strutting, this is a cross bracing system. However, as there is no ceiling on the shop area/front left hand side and the rear left hand side we can see that there is no herringbone strutting. Whilst we believe herringbone strutting would help we feel that the fundamental problem is that there is an element of wet rot within the joist ends, though we do not feel this is excessive.

**ACTION REQUIRED:** Return to the property and check that you are happy to live with the amount of deflection at first floor level.

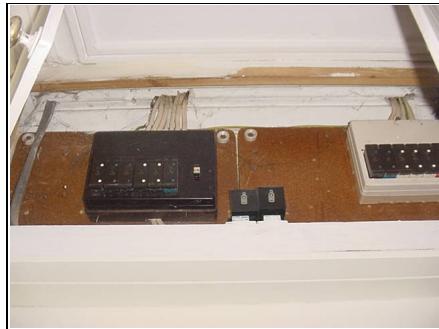
Electrics in hallway

The electric fuseboards; one in the hallway and the one in the reception room on the left hand side, are from the 1960's and are dated.

**ACTION REQUIRED:** We would have these changed with the latest fuseboard. We would also, at the same time, get an NICEIC test and report on the property by a registered IEE (Institute of Electrical Engineers) recommended contractor and carry out the work recommended.

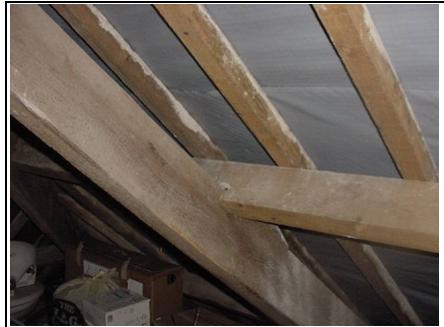
We would comment that the plastic membrane can sometimes sweat and cause damage and deterioration. With a modern protective underlayer we have completely moved away from the sealed and smothering effect that plastic underlayers give to more of a gortex breathable underlayer.

This photo shows the common rafters (the ones that form the pitch of the roof) and the grey area between is the plastic underlayer.

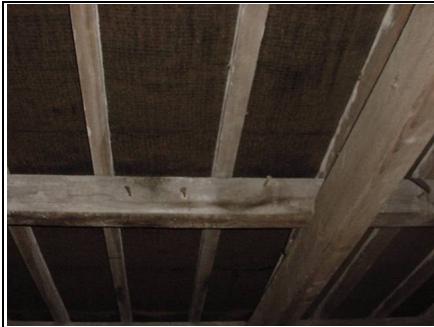
The older areas of the roof have darker areas between the common rafters. This is the Hessian based underlayer.

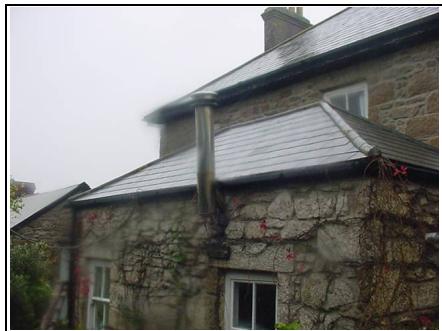
Rear low level roof

This roof is constructed in a similar slate to the main roof. It is a small hipped roof. Please see our comments in the Executive Summary with regard to the awkward junction between the main building and this roof. Other than this we consider the roof to be in average condition.

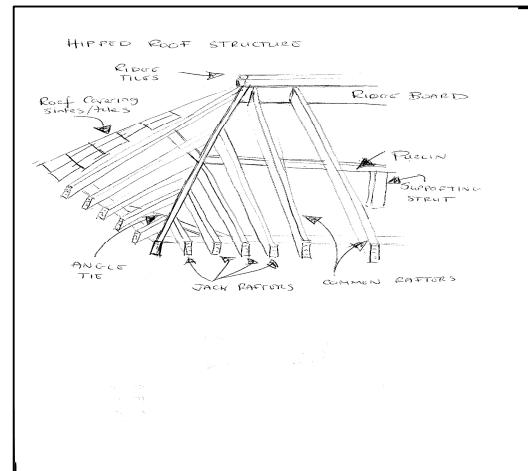
This type of roof structure has what is known as a cut hipped timber roof. This is a roof that is purpose made and hand built on site. Without the original design details we cannot categorically confirm that there are no defects; however it is in line with what we typically see.

Hipped roofs are known for slippage /movement which can occur in the structure. In this case, we feel it is within acceptable limits.

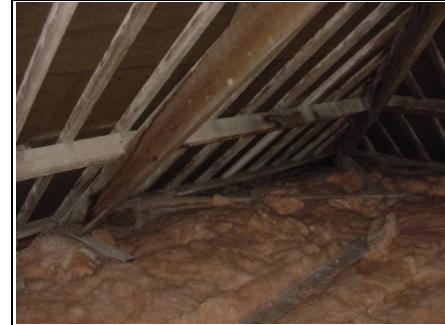
Left hand roof space

We found the roof timbers generally in average condition considering their age. Our inspection was limited, as the left hand side of the roof is covered with insulation and we were unable to see some of the roof joists (please see adjoining photo). We have inspected the roof structure for:

**ACTION REQUIRED:** The only way to be 100 per cent certain is to have the roof to the left hand side cleared of insulation and checked, and the right hand side cleared of stored items and checked.

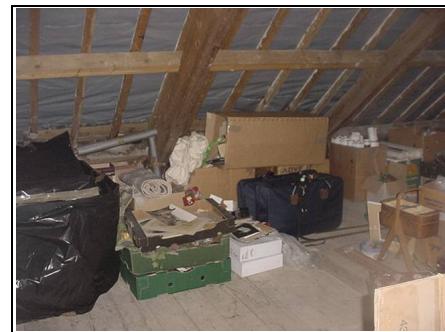
Mass of stored items

Our examination was limited by the general configuration of the roof, the insulation and stored items. As mentioned what we could see was generally found to be in average condition considering its age. It is feasible that there are problems in the roof that are hidden.

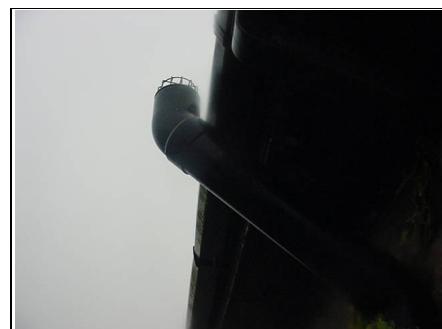
Soil and vent pipe

The soil and vent pipes are plastic. They appear to be satisfactory where a surface inspection is possible.

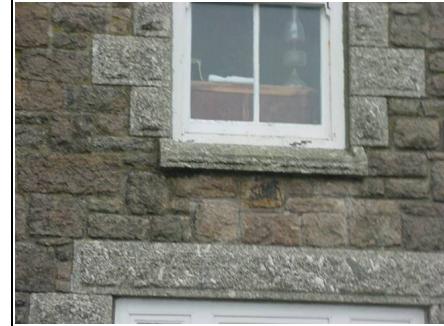
Coursed stonework

The walls are formed in coursed granite, within a thin lime mortar joint to the front, with semi-coursed stonework at the side and other areas of the property. Generally, from what we could see, the walling is in average condition for its age, type and style.

The pointing is in reasonable condition. To the sides and the rear, where a wider joint has been used, re-pointing will be needed from time to time.

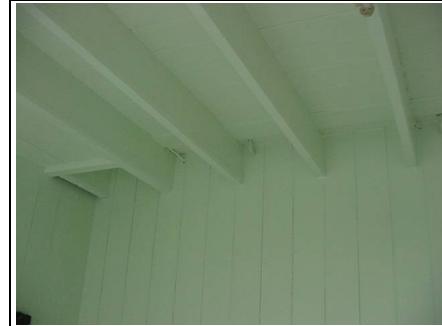
As should be expected with a building of this age, the ceilings have been finished in a variety of ways, from the original lath and plaster to more modern plasterboard. To the shop area, for example, no ceiling at all!

Shop ceiling

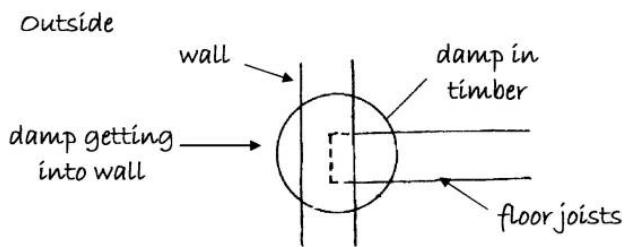
### DAMP TO FLOOR JOISTS (Built in)

We feel the first floor, construction is joist and floorboards as this is typical in this age of property. Given the age of the property the timbers are likely to be embedded in the walls, which means that some wet rot is likely without opening the floors up we cannot comment further.

**ACTION REQUIRED:** Please see our comments in the Executive Summary.

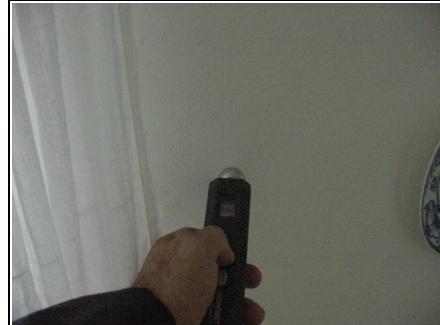
A visual inspection was carried. No significant penetrating/lateral dampness was seen. We would, however, comment that there was an above average number of areas of hollow or blown plaster. Please see our earlier comments.

Checking for lateral dampness

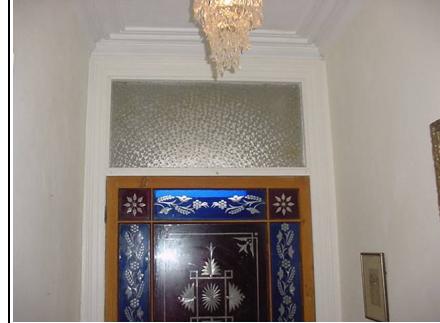
The property has timber panel doors and, all things considered, they are in reasonable (although not ideal) condition and fit acceptably. The owner advised that she had hung some of the doors.

We like the margin lights around the main door

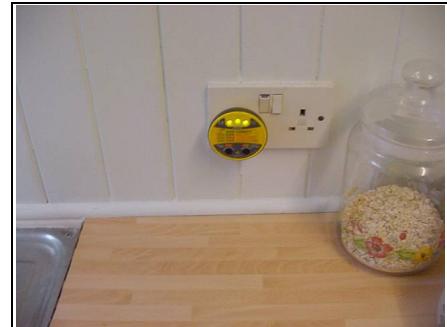
We carried out an earth test in the kitchen area to the socket point that is normally used for the kettle and this proved satisfactory.

Earth test

**ACTION REQUIRED:** It is recommended that the installation be tested by a competent electrician (NICEIC registered) and all recommendations implemented. Thereafter, the installation should be re-tested every five years.

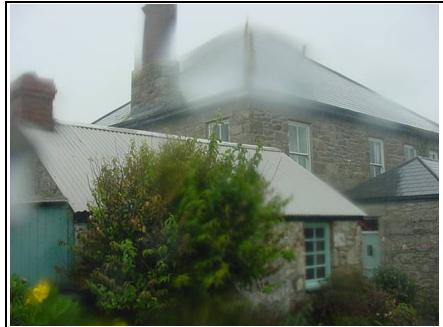
Outbuilding one,  
with outbuilding two behind it

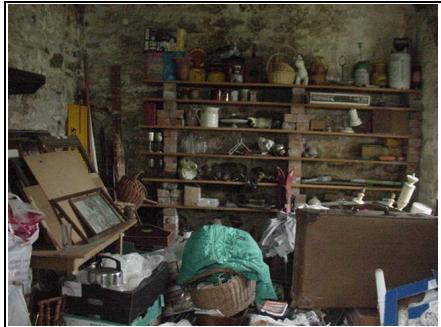
Inside outbuilding one

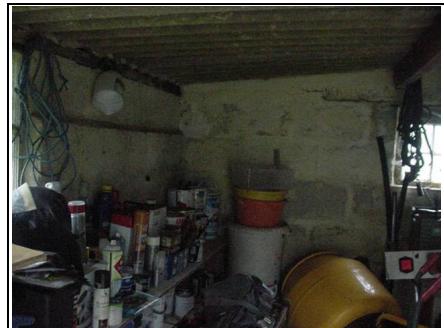
There is asbestos in the outbuilding roofs, which we recommend is removed as soon as possible. Please see our comments in the Executive Summary.

Note asbestos to the roof

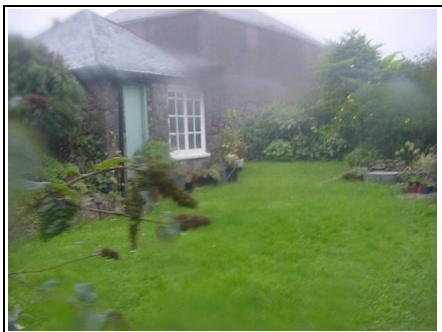
Outbuilding three

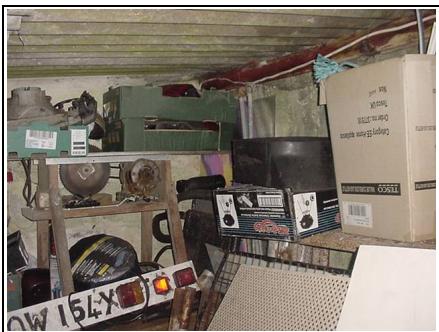
Inside outbuilding three

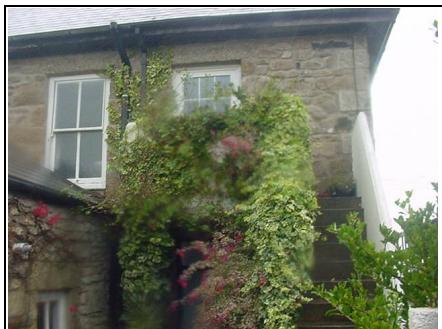
There is both an inside and an outside staircase. In this instance, the outside staircase is stone and we were advised that these were once the stairs up to the doctor's surgery. We can see that some dampness is getting into it. The staircase, therefore, does need to be monitored to ensure it does not degrade.

Outside staircase

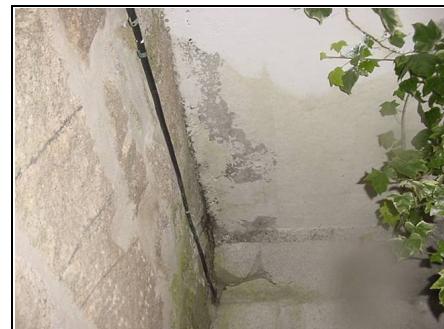
Underneath outside staircase

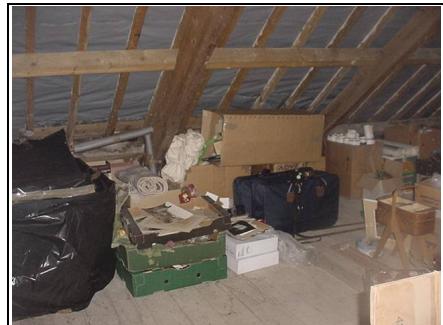
Unfortunately in this instance our inspection has been very limited due to not opening up the ground floor or the first floor. There were stored items within the main roof and the mass insulation to the left hand roof stopped us from viewing of the joists.

Mass of stored items in roof
