# RESIDENTIAL BUILDING SURVEY

Pinner

Edwardian  
Semi-detached

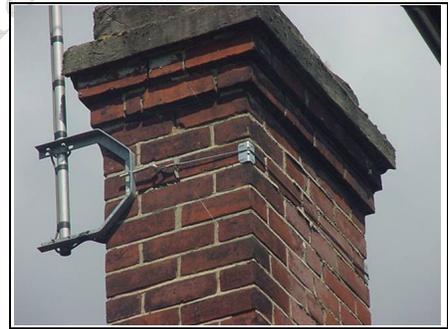
This chimney is brick finished with a lead flashing and an aerial attached at high level. It could generally do with some repointing work to stop the dampness from getting in but our main concern is that the chimney seems to have been removed at ground level. Whilst we can't see any indication that there is any structural defect within the front room nevertheless it should have had approval to be carried out.

We would comment that the chimney may have been capped at the top but we couldn't see this from our various vantage points.

**ACTION REQUIRED:** Repoint and please see our comments with regards to your solicitors enquiries in the Executive Summary.

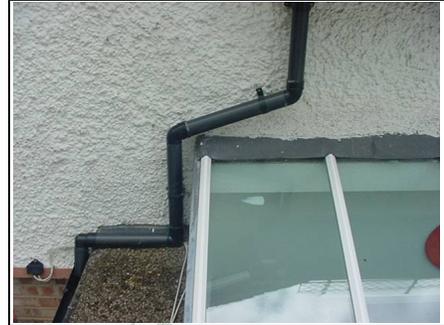
Roof light

It seems inevitable with roof lights that they will sooner or later leak. If this doesn't occur then they seem prone to condensation particularly as this one is close to the kitchen. Keep a cloth handy!

**ACTION REQUIRED:** We would recommend someone repositions the insulation/sealer. This we believe is to stop wind from getting underneath the roof light glass and lifting it.

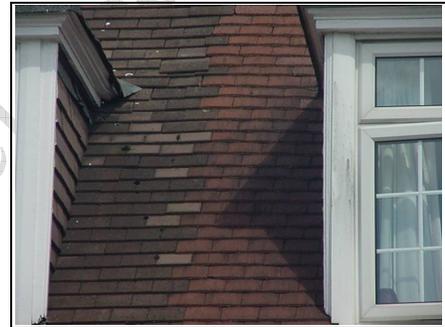
Roof tiles (right hand side)

The main roof is pitched and clad with small nibbed concrete tiles. It looks in reasonable condition; we can see a few of the tiles have moved. It does look to have been re-roofed due to its lighter colour however during our question and answer session the owner advised that it hadn't been re-roofed in their time there.

**ACTION REQUIRED:** Your solicitor to specifically ask if the property has been re-roofed (because it could equally be the adjoining owner's property that has been re-roofed). If it has been re-roofed then is there some form of guarantee available.

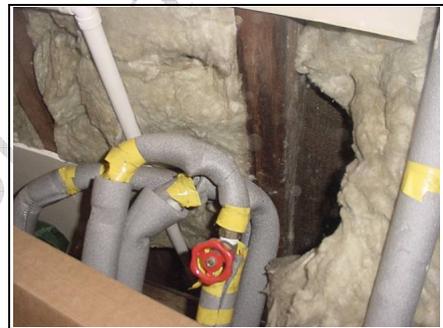
Unfortunately within the main roof the vast majority of it was lined therefore hiding the timbers and the sarking felt and we believe insulation. We did move back a small section of insulation to see a hessian based sarking felt beneath. We would add it is unusual to find the entirety of the roof lined.

An area of the insulation moved back where we can see the hessian based sarking felt

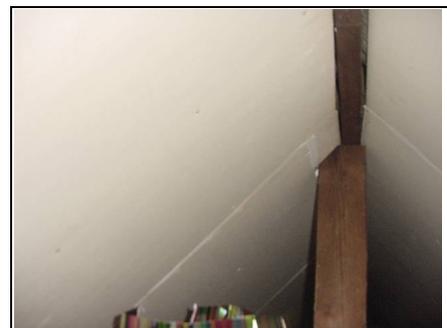
Roof space lined, this hides the common rafters (the ones that form the pitch of the roof) and also the sarking felt and the chimney

**ACTION REQUIRED:** Please see our comments within the Executive Summary with regard to damp staining to the ceiling and the adjoining landing area.

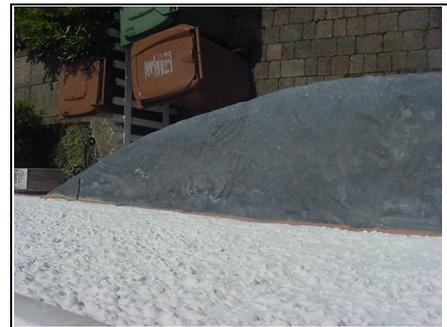
The front of the property has a bow window which is a nice feature; this has a small lead covered roof which looks in reasonable condition. The photo is taken looking down onto the lead roof from the window above.

Lead roof to the front of the property over the bow bay window

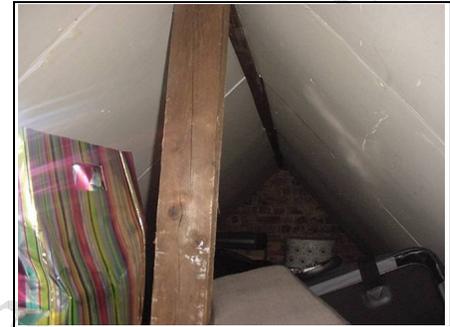
Roof timbers

In this instance we have not been able to inspect the roof timbers. We would normally inspect the roof structure for:

Our examination has been severely limited.

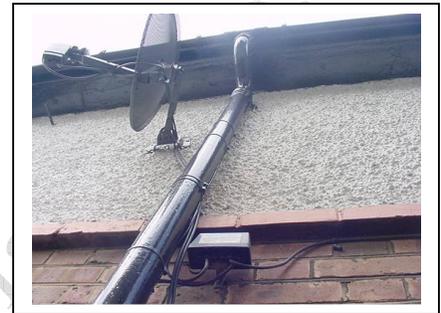
Gutter and downpipe

The reason it is in this convoluted manner is because the roof window is in the way of where it would have originally terminated.

**ACTION REQUIRED:** We would always recommend that the gutters and downpipes are cleaned out, the joints are checked and the alignment checked to ensure that the gutters fall towards the downpipes.

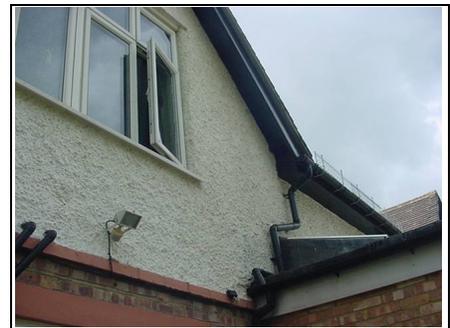
Stepped pipe from different angle

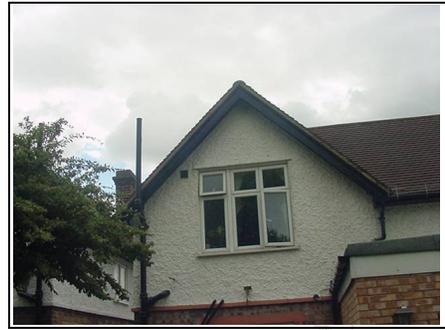
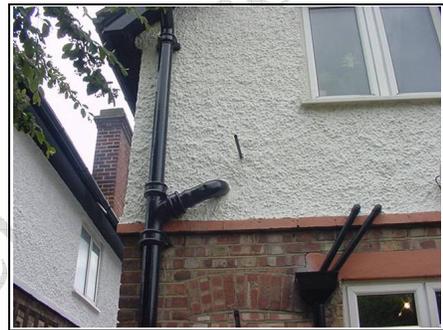
Soil and vent pipe

The soil and vent pipe is located to the rear of the property. It is in the original cast iron and looks in reasonable condition although cast iron of this age can start to crack particularly to the rear and rust if not well maintained.

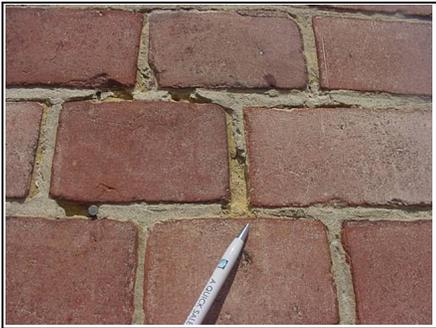
Here you can see that cement mortar is coming away. You should take the opportunity to repoint in a lime mortar which allows the property to breathe better.

We would much prefer to see this property being repointed in a lime based mortar as this allows the wall to breathe better.

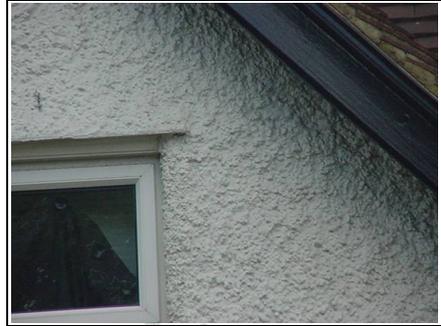
The walls to this property in the upper levels are finished in a painted roughcast render. A good quality render is judged normally by the detailing. We were pleased to see a drip above the windows as you can see on the adjoining photo and it was detailed down to a brick course at first floor level.

Drip detail in the render

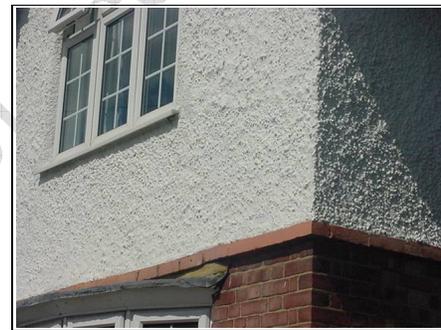
Brick course at first floor level

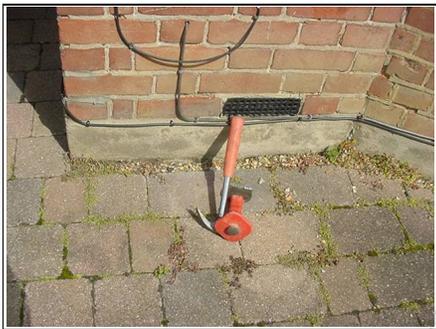
The floors to this property are what is known as a suspended timber floor. This means there should be a throughflow of air beneath. Subfloor ventilation is essential in discouraging rot and on no account should the airbricks be obstructed. In this case the airbricks are not obstructed and are visible to the front and rear of the property although the rear extension has effectively blocked part of the airflow under the building.

Airbrick to the front

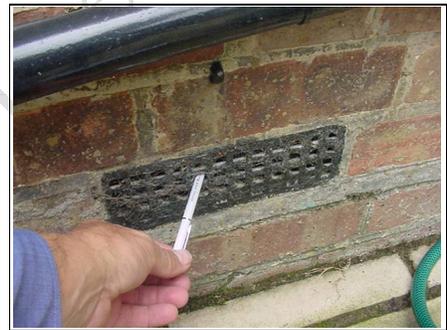
Airbrick to the rear

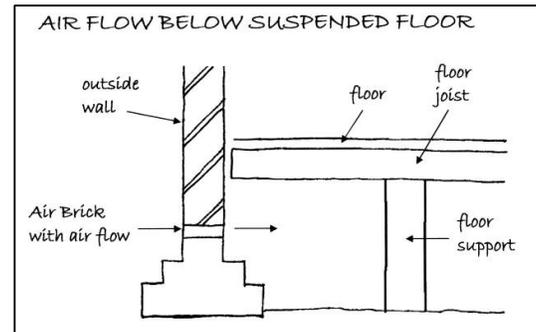
The floors to the front of the property are suspended timber floors. The floor to the rear felt solid underfoot so we have assumed they are formed in concrete, however, we have not opened up the floors or lifted the carpets/floor coverings. We believe the rear extension has possibly blocked up the air ventilation of the floor. Additional airbricks or running vents should be fitted to allow an airflow underneath the suspended timber floor.

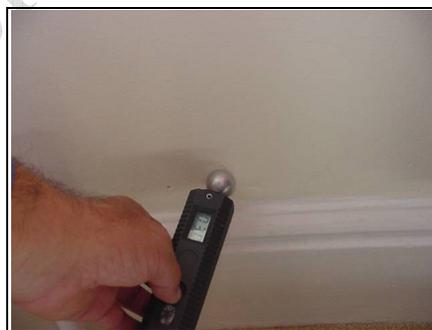
A random visual inspection and tests with a moisture meter have been taken to the perimeter walls and some internal walls. We didn't find any excessive dampness although it has to be borne in mind that we are carrying out the test in the middle of summer therefore there may be some dampness that is prevalent in the middle of winter.

Testing for dampness

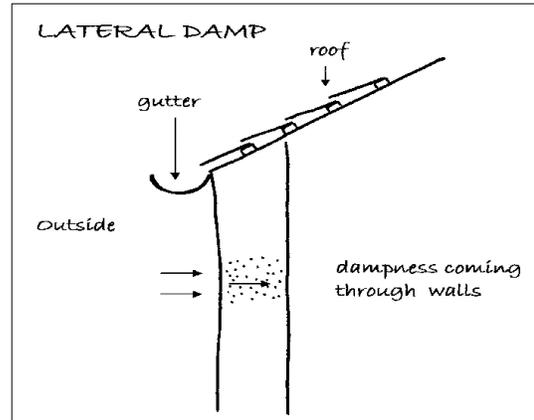
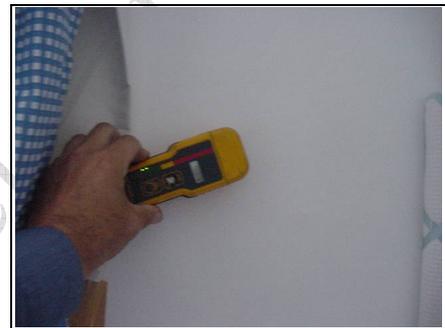
Tests were taken; we didn't find any actual damp in the selection of areas that we tested.

Testing for lateral dampness

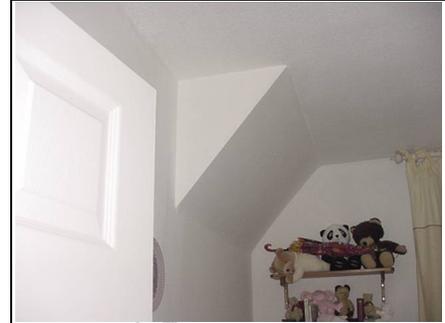
Modern pressed doors have been installed often known as egg box doors due to the construction internally.

Modern pressed doors

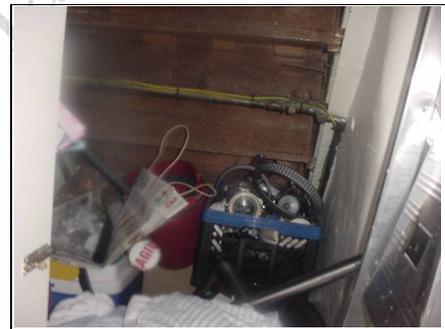
We noted that the underside of the staircase was exposed. It is more normal today to have a half hour fire barrier to stop fire spreading from the ground floor to the first floor in a worse case scenario. You may wish to take a view on whether you add this.

Underside of stairs

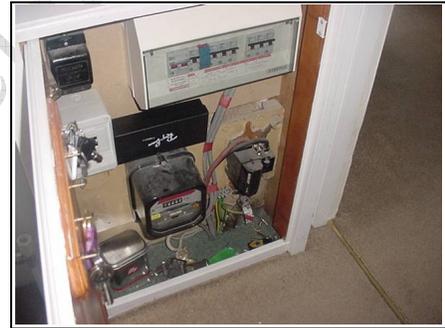
The electric fuses and consumer units were located to the left hand side as you enter the property. The fuse board looked newish.

Fuse board

**ACTION REQUIRED:** As the property is changing occupancy an IEE report should be carried out by a NICEIC registered and approved electrical contractor.

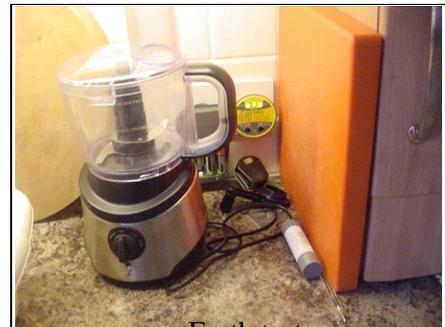
We carried out an earth test in the kitchen area to the socket point that is normally used for the kettle, this proved satisfactory.

Earth test

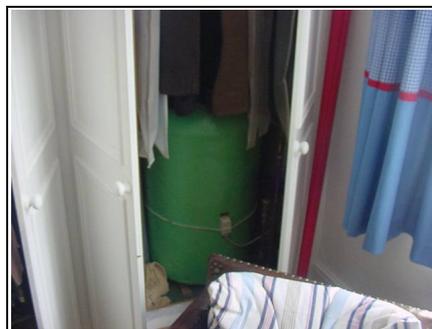
The hot water cylinder was located in the front bedroom; it is factory insulated so should have good thermal efficiency.

Hot water cylinder located in the front right hand bedroom

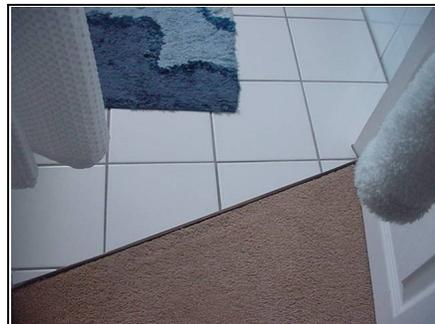
The property has a three piece bathroom suite, consisting of a bath, wash hand basin and WC. The bathroom felt slightly dated and we are not that keen on tiles on the floor as we do find that when putting a tile onto a wood floor ultimately the joints go. Various aqua floors, laminates and linos offer a sealed waterproof floor which we feel is better than a tiled floor although you may like this style and be prepared to put up with the regrouting.

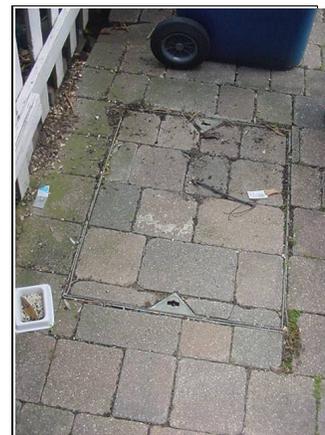
We were unable to lift the manholes although we did run the taps for fifteen minutes to half an hour.

Manhole to the front of the property

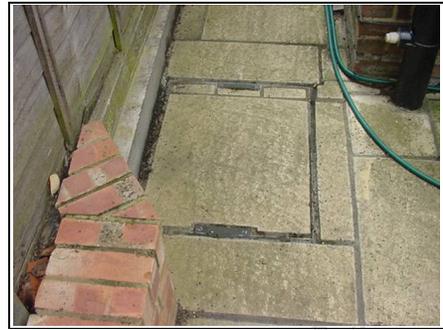
As above.

Manhole to the front of the property

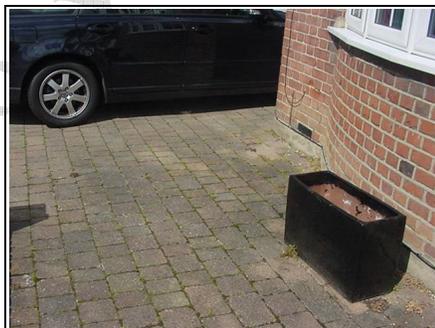
The whole of the front has been paved over with a brick paving.

Front garden/paved area

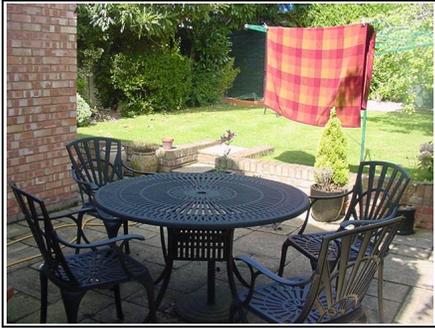
Mainly grassed but as we have mentioned a high conifer hedge to the rear where the garage is. There is a patio area that is hidden away to the side of the house outside of the kitchen.

View of rear garden from patio area

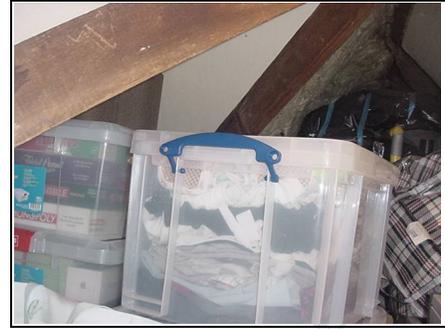
Unfortunately in this instance our inspection has been very limited as we haven't opened up the floors, we were particularly interested in the ground floor. We have had a very limited view of the roof due in particular to the lining and the flooring that has been added. We haven't had the benefit of being able to lift up the drains.

Stored items
