RESIDENTIAL BUILDING SURVEY

**Pinner,
HA5**

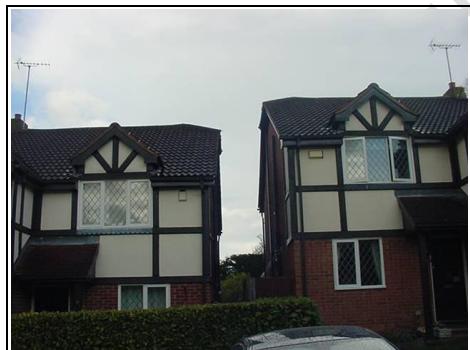
The property is on a sloping site (and whilst perhaps not as much as the adjoining sketch, this does illustrate it).

What this means is that any rainwater and surface water will transfer from the right hand side property to the left hand side with your property in the middle. This means you may get dampness and mould on the right hand side of your property.

This photo shows the difference in roof levels as viewed from the front of the property

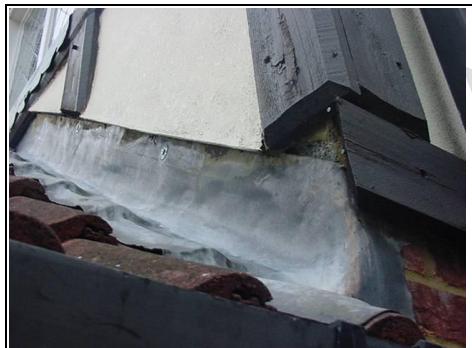
To the low level front of the property around the garage and entrance area there is lead flashing. This we assume has come away at some point and has been screwed and washer fixed back in place. This is rather unusual and in fact we have not come across it before. As far as we can see this is because the lead has not been bedded into the joints sufficiently and it has come away. This is a fairly common thing on this more modern type of property and where, we generally believe, the builders simply do not have the skills needed for older materials.

Flashing screwed in place

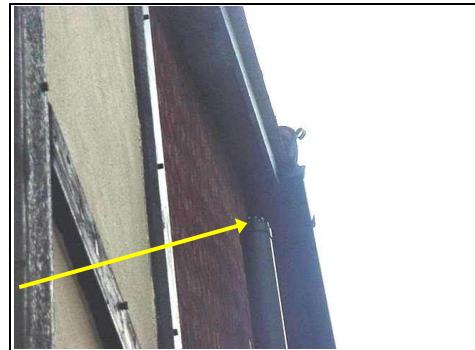
This soil and vent pipe is lower than it should be, it should be above the roof ridge level to discharge vapour.

Soil and vent pipe below roof level

ACTION REQUIRED: Increasing the height of the soil and vent pipe is a difficult amendment to make. We suggest you live in the house before you look at moving it and then consider if it is necessary to move it.

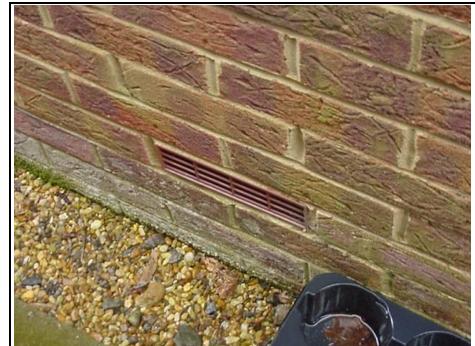
The property has a mixture of different floor types. Traditionally we would have expected a concrete floor. In this case we noted air bricks which we normally associate with an older style property with a timber floor. However they are added into modern properties where there is a sloping site/clay soil/chemicals or gases present in the earth below.

Airbrick

ACTION REQUIRED: Your legal advisor to specifically ask if they are aware why the airbricks have been added to the property.

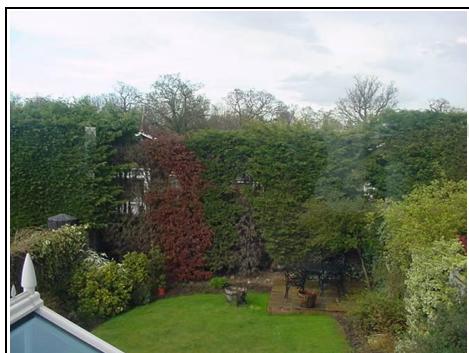
The property has Leylandii to the rear which gives you privacy. However, it does need to be kept under control as it can grow quickly. Having said that, there is a section that looks to have died that may need replacing.

Leylandii to the rear of the garden

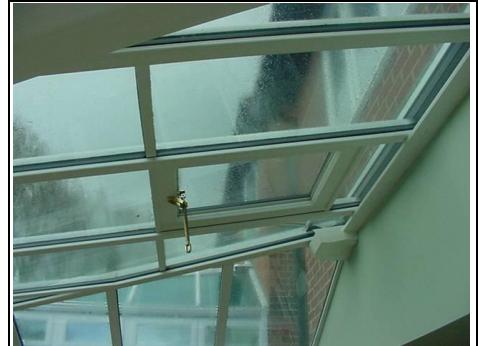
In our experience large conservatories such as the one at the rear of the property need to have the heat gain/heat loss regulated. We would normally see blinds in conservatories of this size and also cooling and heating systems. However we would however comment that we were pleased to see that there was a venting window at roof level to allow the heat out.

Venting window

ACTION REQUIRED: You may wish to add double panelled radiators. You should also budget for a good quality heating/cooling system in the conservatory as well as blinds.

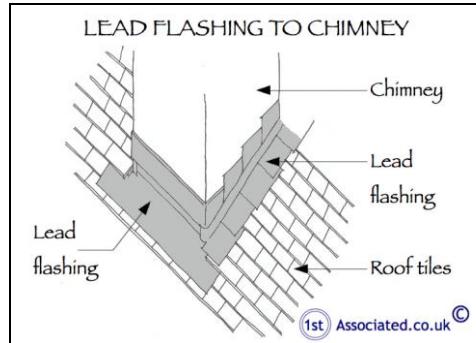
Our adjacent sketch shows how to correctly fit lead flashing on a chimney.

ACTION REQUIRED: We suggest that when the lead flashings to the front of the property are being repaired and fitted correctly that the one on the chimney also has a close up inspection by someone with a long ladder that can really view the chimney properly.

ANTICIPATED COST: A few hundred pounds unless there are problems with the chimney (we saw no indication of this within the roof which will require scaffolding to fix).

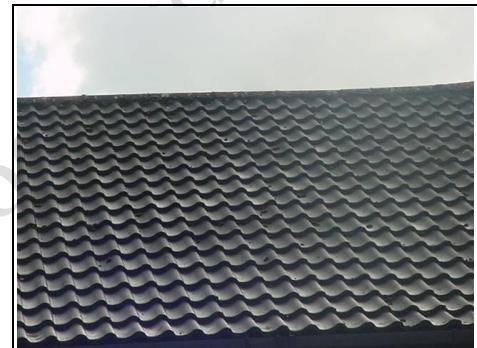
The main roof is pitched and clad with a concrete pantile style tile and, from ground level, this looks in average condition considering the roofs age type and style.

Main roof

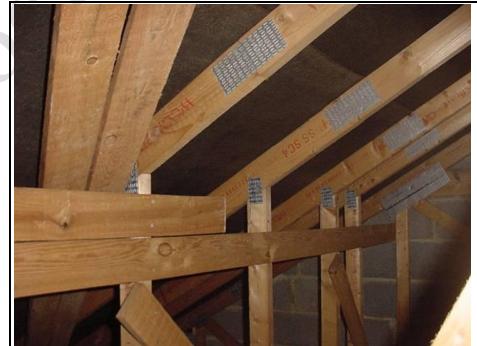
When we inspected the loft space we found a Hessian base Bitumen membrane. This type of membrane has been used since the 1960s. We generally found it to be in average condition, with damage in some areas which is what we typically find.

This photo shows the common rafters (the ones that form the pitch of the roof) and the dark area between is the underlayer.

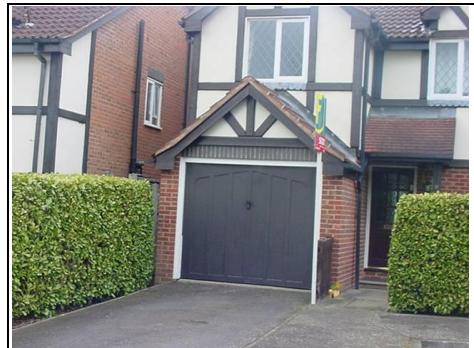
The front roofs go over the garage and the porch entrance. In both cases they have been screwed and washer fixed, they should have been embedded.

Front roof

ACTION REQUIRED: Please see our comments within the Executive Summary

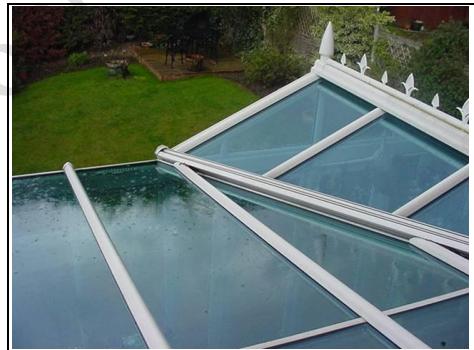
We were pleased to see that no awkward details have been created by the adding of the conservatory roof. Where the conservatory meets the main property the lead flashing looks to have been bedded in with a mastic (although we can't see how deep this has been bedded in).

Glazed Conservatory roof

We would add that we seem to find with all large conservatories that they all leak sooner or later. Unfortunately without being in the property when it rains for a prolonged period of time we cannot confirm one hundred percent that this conservatory is watertight.

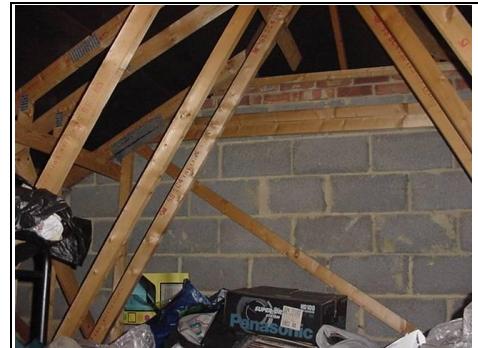
General view of inside of roof

Our examination was limited by the general configuration of the roof the insulation and stored items. What we could see was generally found to be in average condition for its age, type and style. It is, however, feasible that there are problems in the roof that are hidden.

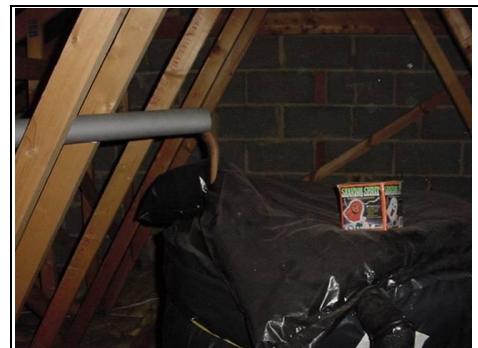
There is a plastic water tank which is insulated within the roof space.

Water tank

We would always recommend that water tanks be drained down and cleared of any debris etc. (we have seen dead birds and other unmentionable things in these tanks). As you are often cleaning your teeth with this water it is best that it is as clean as possible!

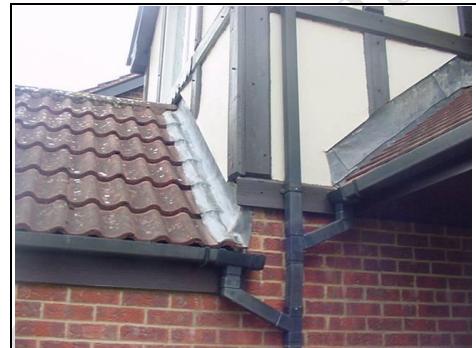
The gutters and downpipes are plastic. There are some slightly awkward guttering details that are part of the original design.

There may be some minor leaks but most people would be happy to live with these providing repairs are carried out within the next six to twelve months. In this case we believe that the clearing of moss and leaves will be beneficial.

Gutters and downpipes

ACTION REQUIRED: You need to clear the leaves from the gutters. We would always recommend you stand outside the property next time it rains heavily and see how well the drains cope with the rainwater particularly looking at the guttering and the joints.

We would also recommend that the gutters and downpipes are cleaned out, the joints are checked and the alignment checked to ensure that the gutters fall towards the downpipes.

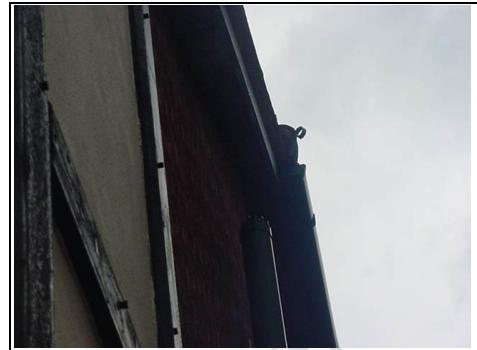
The property has a plastic soil and vent pipe that doesn't terminate at approximately one metre above roof level.

Soil and vent pipe

ACTION REQUIRED: Please see our comments within the Executive Summary

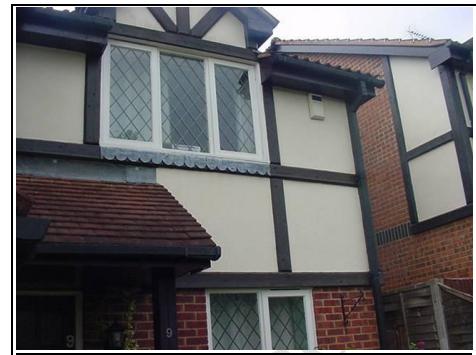
Render

We noted some cracking in the render and we would remind you that any hairline cracks that appear need to be sealed as soon as possible to stop dampness and water getting in and causing blisters and hollow areas.

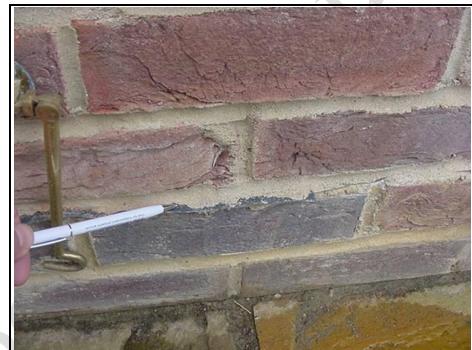
All modern properties should incorporate a damp proof course (DPC) and good building practice dictates that a differential of 150mm (6 inches) should be maintained between the damp proof course and ground levels. In this case, we could see the one to the conservatory however the one to the main property wasn't clearly visible but given its age it is likely to have had one built in as brickwork proceeded and has been hidden.

Damp proof course - conservatory extension

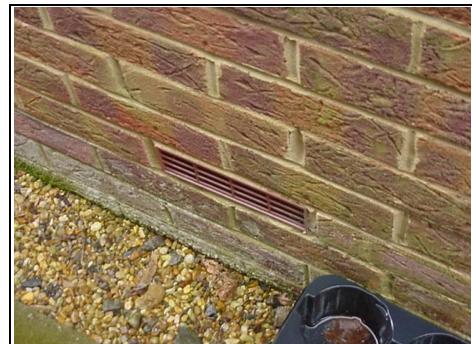
Nevertheless the air bricks that we can see externally are essential as they allow a through flow of air and this helps to reduce the chances of deterioration. Please see our comments in the Executive Summary as the reason for the air bricks is important to understand.

Air brick

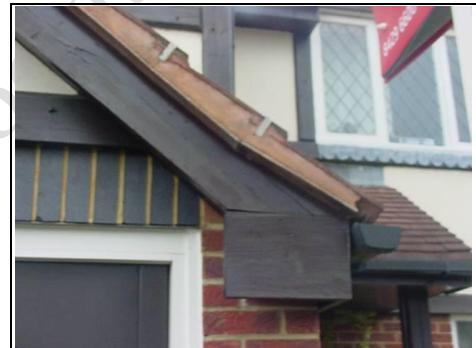
The fascias and soffits are timber. They are stained and we did not notice any obvious problems. However we are aware that this property is occupied by an estate agent and that they will be presenting the property in the best possible manner.

Fascias and soffits

ACTION REQUIRED: Make sure gutters and downpipes are watertight before carrying out any work on fascias and soffits.

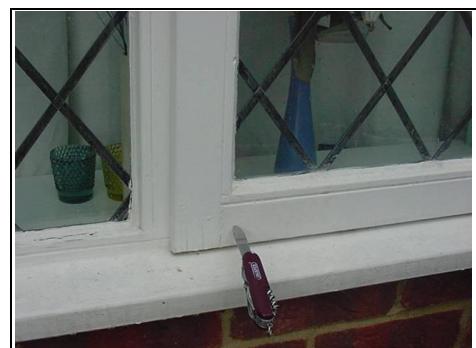
The property has a mixture of different types of windows from the original timber windows to the main property which generally we find that unless these are kept in very good order the timber will be of such poor quality that it rots fairly quickly. In this case after carrying out our knife test at ground level we didn't find any problems. We were pleased to see what appear to be trickle vents on some of the windows.

Timber test carried out

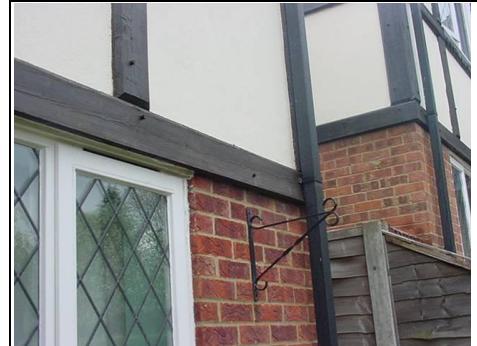
We could not see any trickle vents within the conservatory which are a modern requirement (but not required on a refurbishment or extension but which we consider to be good practice).

Old style trickle vent in window

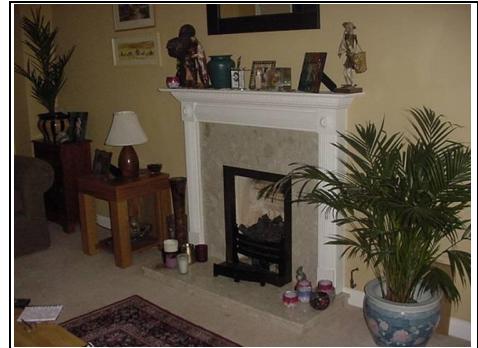
The fire/fireplace is on the left hand side of the property. At the time of the survey it was not in use.

Fireplace

ACTION REQUIRED: You need to check with the owners that it works.

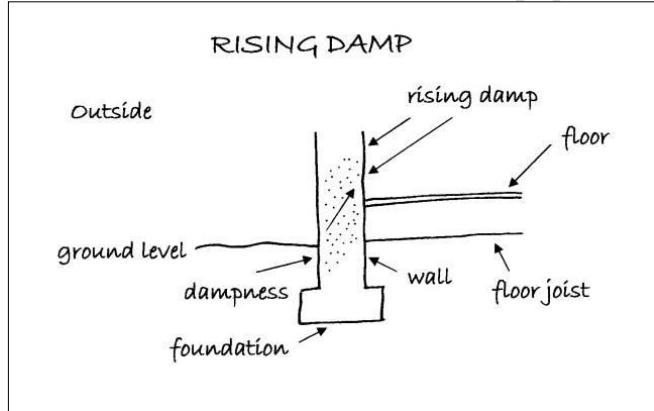
We cannot test for rising damp in this property as it is dry lined

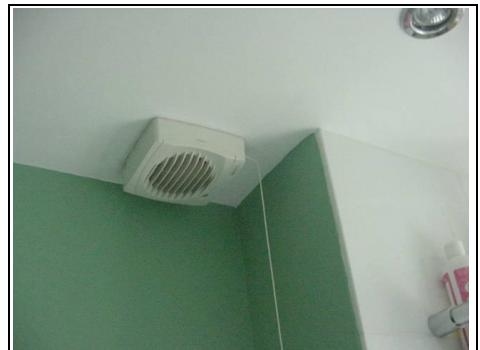
We did note pull cord extract fans in the bathrooms. We would recommend these are changed to humidity controlled extract fans. We have used these and they work very well. They switch themselves on when the condensation gets to a high level and then they switch off again when it reaches the correct level (with no effort involved whatsoever).

Extract fan in bathroom

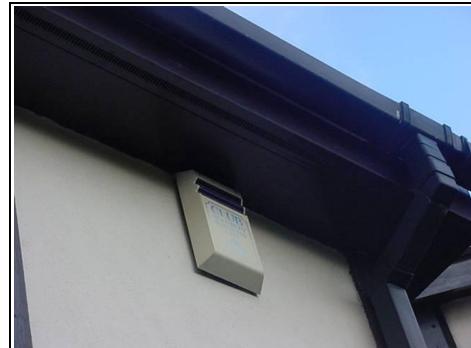
We noticed a security alarm on the front of the property. In our experience most security alarms are not working.

Security alarm

ACTION REQUIRED: Further information should be obtained from the vendor (the estate agent) and the installer at a later date.

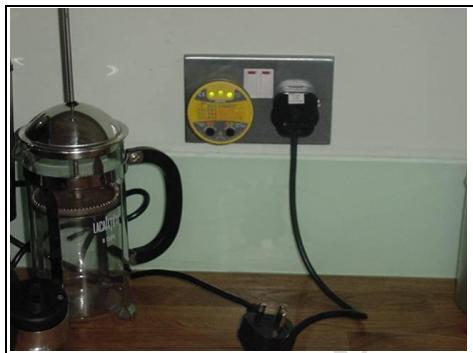
We carried out an earth test in the kitchen area to the socket point that is normally used for the kettle, this proved satisfactory.

Earth Test

ACTION REQUIRED: As the property is changing occupancy an Institute of Electrical Engineers (IEE) test and report should be carried out by a NICEIC registered, or equivalent, approved electrical contractor or similarly approved.

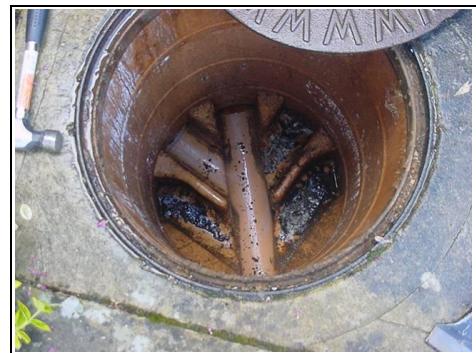
Manhole one

We duly lifted the cover and found it to be free flowing at the time of our inspection.

From what we could see it is plastic.

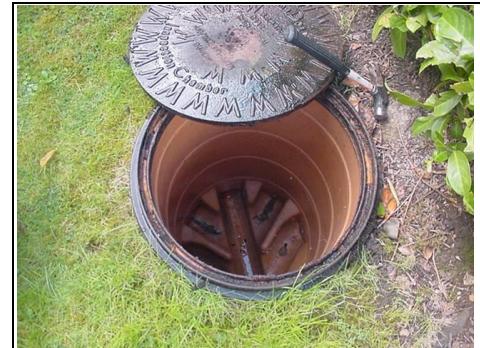
Manhole two

We duly lifted the cover and found it to be free flowing at the time of our inspection.

From what we could see it is plastic.

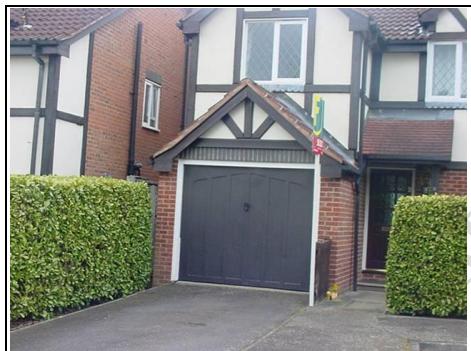
Garage

The property has an integral garage to the front left hand side. This has a lot of items stored in it.

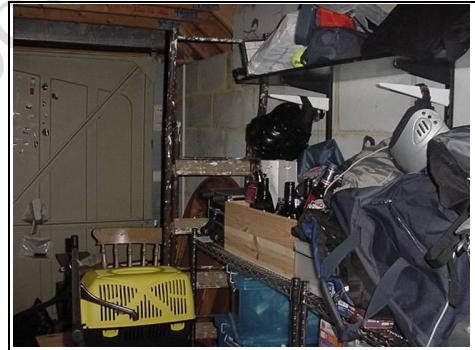
Garage has a lot of stored items

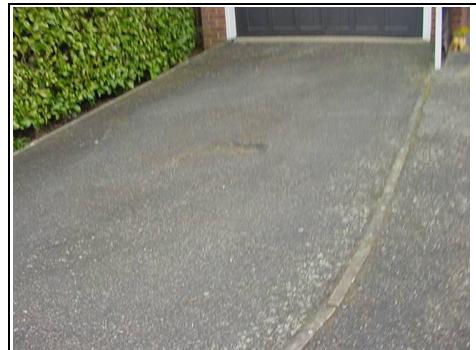
Driveway

There is a driveway to the front left hand side of the property.

ACTION REQUIRED: Please see our comments within the Executive Summary

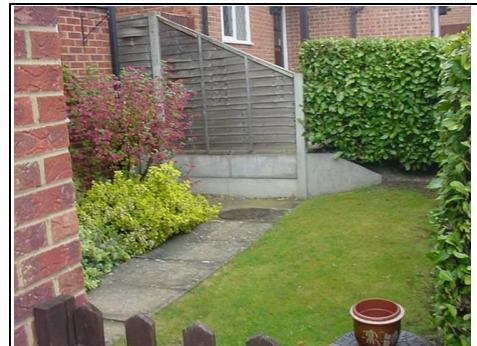
Front Garden

The property has a small front garden and is enclosed by hedges and fencing.

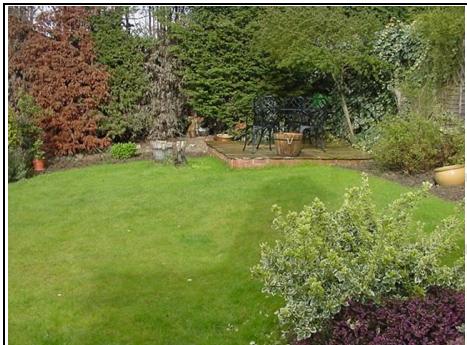
Rear Garden

There is an averaged size garden with patio/seating area which is secluded by the conifers to the rear.

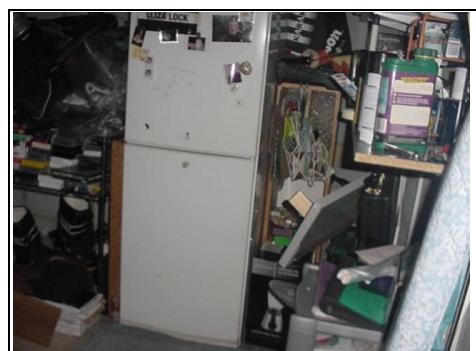
Stored items in garage
